**CSID No. 3512 Avista Service Center Garage  
Operation and Maintenance Plan**

Spokane Service Center Garage  
1411 East Mission Avenue  
Spokane, Washington

for  
**Avista Corporation**

October 20, 2022

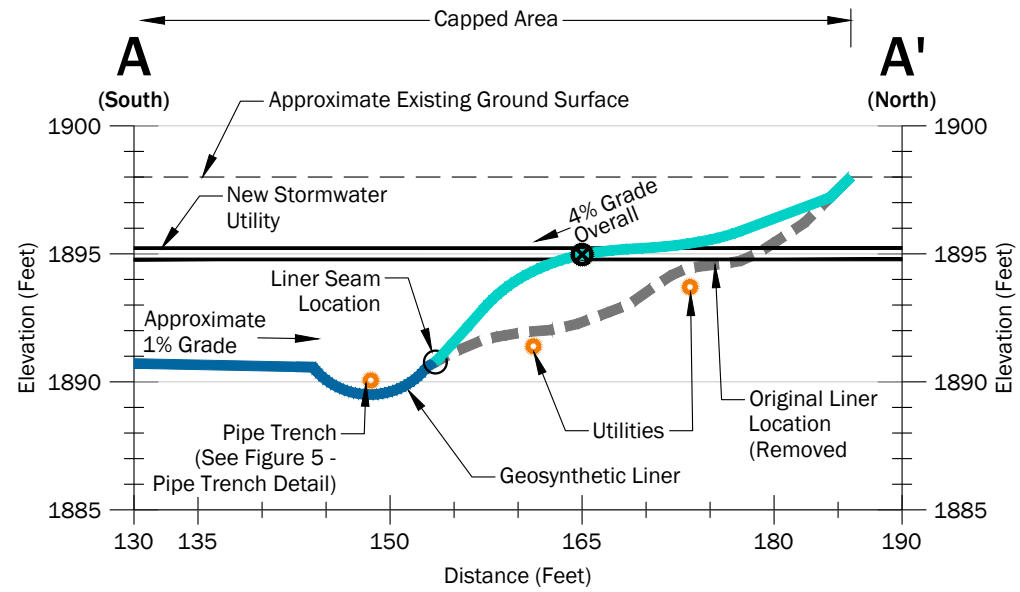
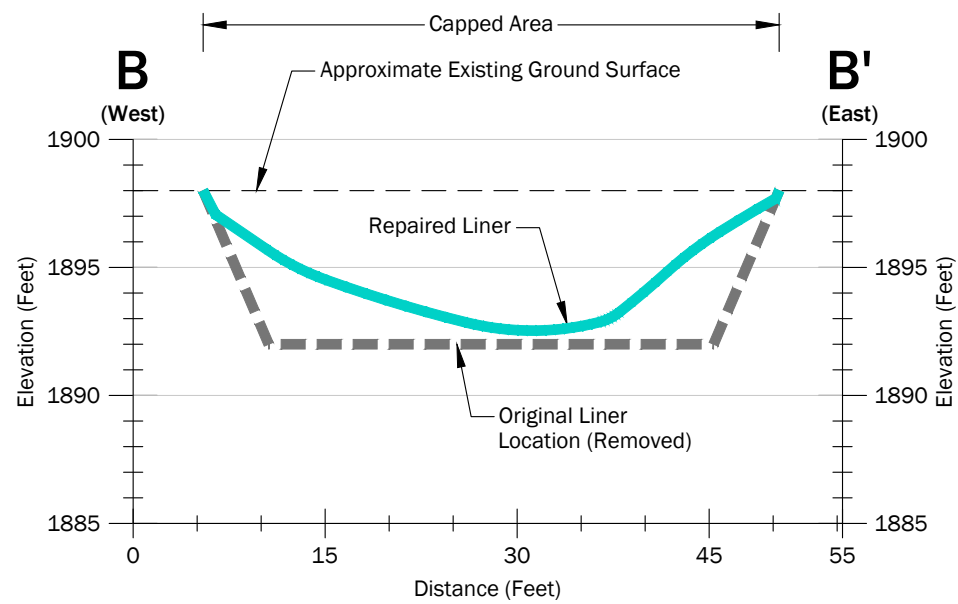
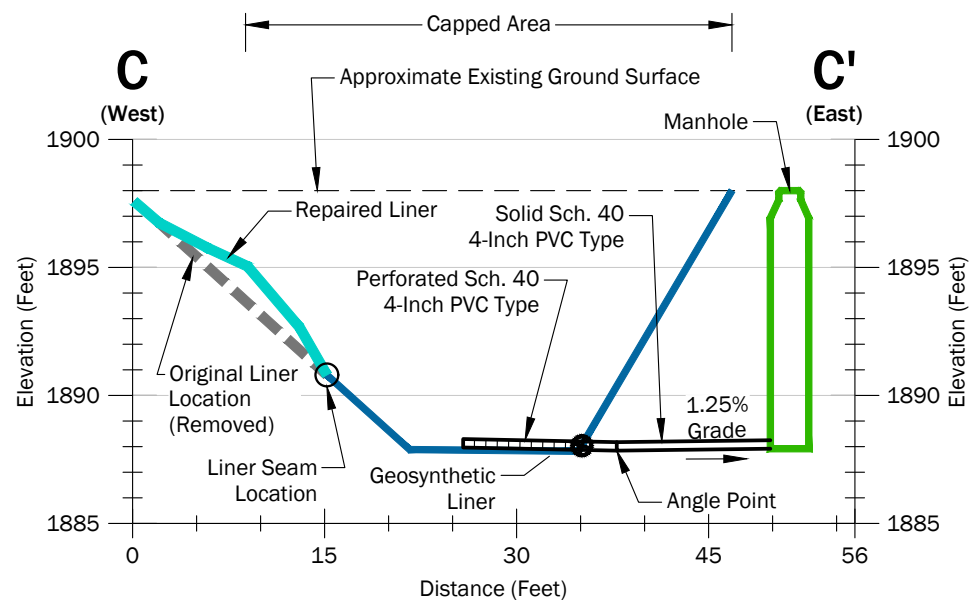
<b>Cross Sections A-A', B-B' and C-C'</b>	
Avista - Service Center Garage Spokane, Washington	
	<b>Figure 4</b>

**CROSS SECTION A-A'**  
SCALE: F04

**CROSS SECTION B-B'**  
SCALE: F04

**CROSS SECTION C-C'**  
SCALE: F04

During construction of a new parking garage near the capped area, Avista's construction contractor damaged the northern portions of the LLDPE liner while excavating to install a water line and stormwater drainage pipes. The damage to the liner compromised the remedial action conducted in 2018 by damaging the barrier controlling infiltration to the contaminated soil. The liner damage was discovered by Avista on December 6, 2019. In January 2020, the liner was excavated using a track hoe and soil was cleared from the liner using a vactor truck and pressurized water. The liner was repaired by placing a new section of liner in the excavation and welding the new section of liner to the portion of the liner that was intact (GeoEngineers 2020). The new utilities within the excavation penetrated the liner and were booted through the liner during the repair. The repaired section of liner has a modification to the grade, but the footprint is the similar and the liner will guide infiltrated water to the drain pipe connected to Avista's stormwater system. The repaired liner design and as-built diagram are shown in Figures 3 through 5.

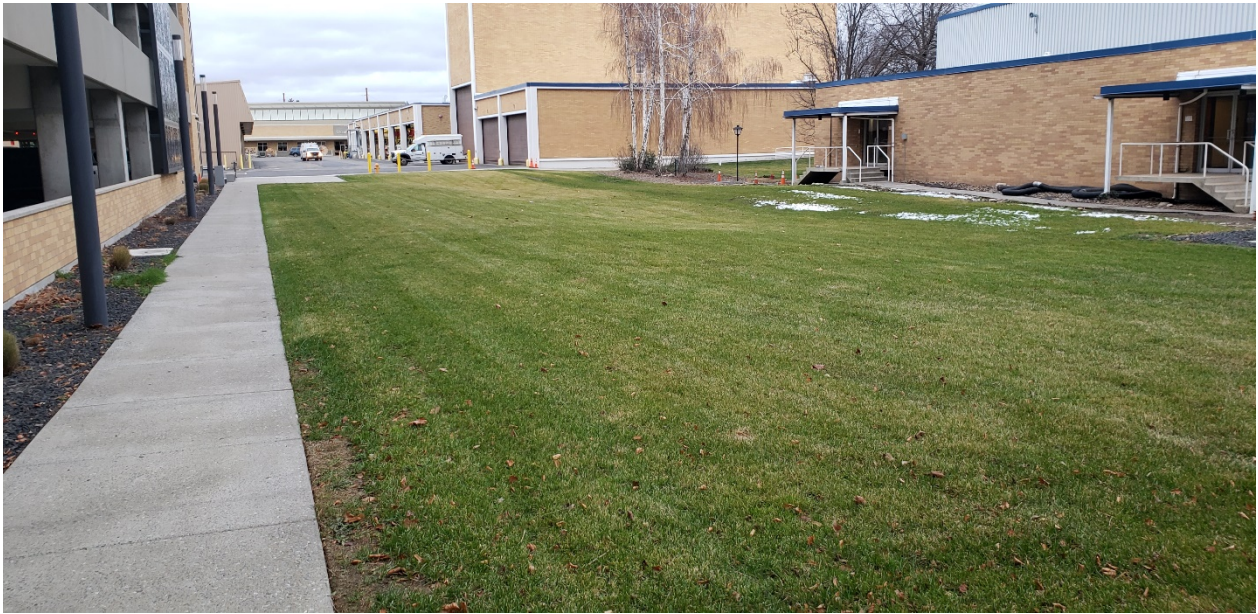
Photograph 1. Photo of the cap area (Inspection Area 1), looking northeast.

Cap inspections will be conducted annually to assess the integrity of the cap. Since the cap material is covered in soil and sod, the cover material will be inspected to maintain the integrity of the liner. During the inspections, Avista's representative will document and photograph the capped area. The site is divided into three inspection areas as shown in Figure 6. Photographs of inspection areas are found in Figures 7 and 8. Inspection areas include:

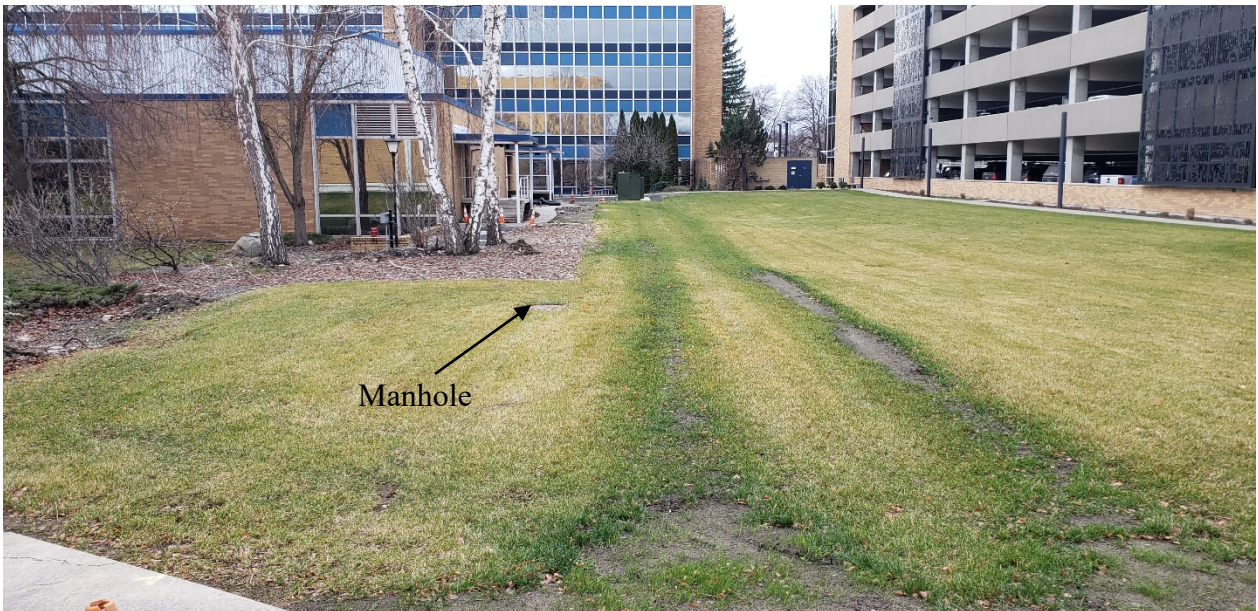
Photograph 2. Photo of manhole containing the drainage pipe (Inspection Area 2), looking south.

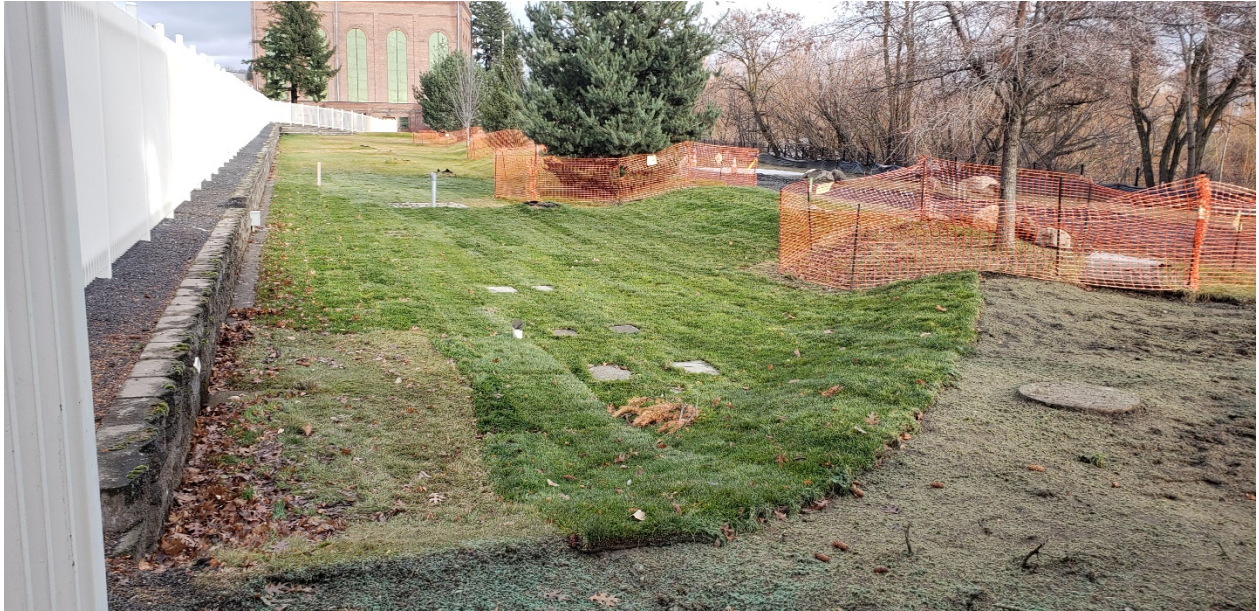
**Photograph 3. Photo of the infiltration basin where drained water from the cap discharges (Inspection Area 3), looking north.**
