TO: Chris Kelley, Washington State Department of Ecology
FROM: Meg Strong, LG, LHG
DATE: June 6, 2022
PROJECT: Agreed Order 6069: 8801 Property
PROJ. #: 21-1-12567-030
SUBJECT: Modified Excavation Plan for Area 4

Hotspot removal at 8801 East Marginal Way South, Tukwila, Washington (8801 property, Figure 1) has been completed, except in Area 4. The Area 4 hotspot excavation targets the removal of polychlorinated biphenyls (PCBs) (as the primary component) and copper (as a secondary component) that are present within former backfill material in the southwest corner of the 8801 property. The Area 4 hotspot excavation was suspended when it was discovered the lateral and vertical extent of PCBs and copper above their respective remediation levels (0.5 milligram per kilogram (mg/kg) PCBs and 250 mg/kg copper) was greater than anticipated. To delineate the extent of PCBs and copper above their remediation levels, the entire southwest corner of the 8801 property was investigated by advancing 84 borings and collecting and analyzing 189 soil samples at depths from 1 to 15 feet below ground surface (bgs). Based on the results of the investigation, some of the soil containing copper at concen

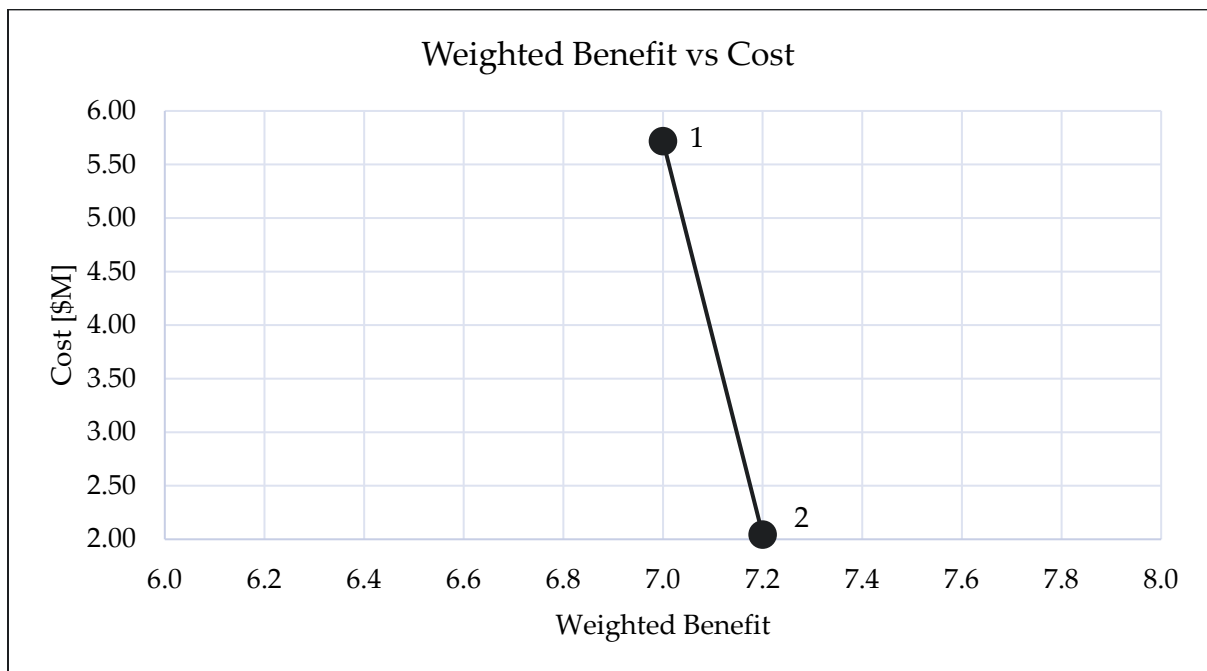
Exhibit 3: Graph Showing Comparison of Benefit/Cost Ratio for Excavation Alternatives

Alternative 1 has an estimated cost of \$ 5.72 million and a weighted benefit score of 7.0. Alternative 2 has an estimated cost of \$ 2.04 million and a weighted benefit score of 7.2. Accordingly, Alternative 2 has a more favorable benefit/cost ratio.

The estimations, calculations, and rankings of alternatives are summarized in the DCA (Tables 2 through 4). A graph illustrating the cost versus the weighted benefit of each alternative is provided as Exhibit 4:
