Re: No Further Action opinion at the following contaminated Site:

Site Name: Avista Corp Spokane Service Center
Site Address: 1411 E Mission Ave, Spokane
Cleanup Site ID: 3512
Facility/Site ID: 31739484
VCP Project ID: EA0343

This O&M Plan is intended to fulfill the requirements found in the Model Toxics Control Act (MTCA) WAC 173-340-400. The elements of this O&M Plan will be implemented to monitor cap conditions and provide the procedures to respond to potential damage to the protective remedial cap or emergency situations. This plan includes (1) a description of the remedial cap system and post-remediation site conditions; (2) the parties responsible for monitoring and maintaining the implemented corrective action; (3) maintenance procedures; and (4) reporting requirements. The location of the site relative to surrounding properties is depicted on Vicinity Map, Figure 1 and the locations of existing site features are depicted on Site Plan, Figure 2.

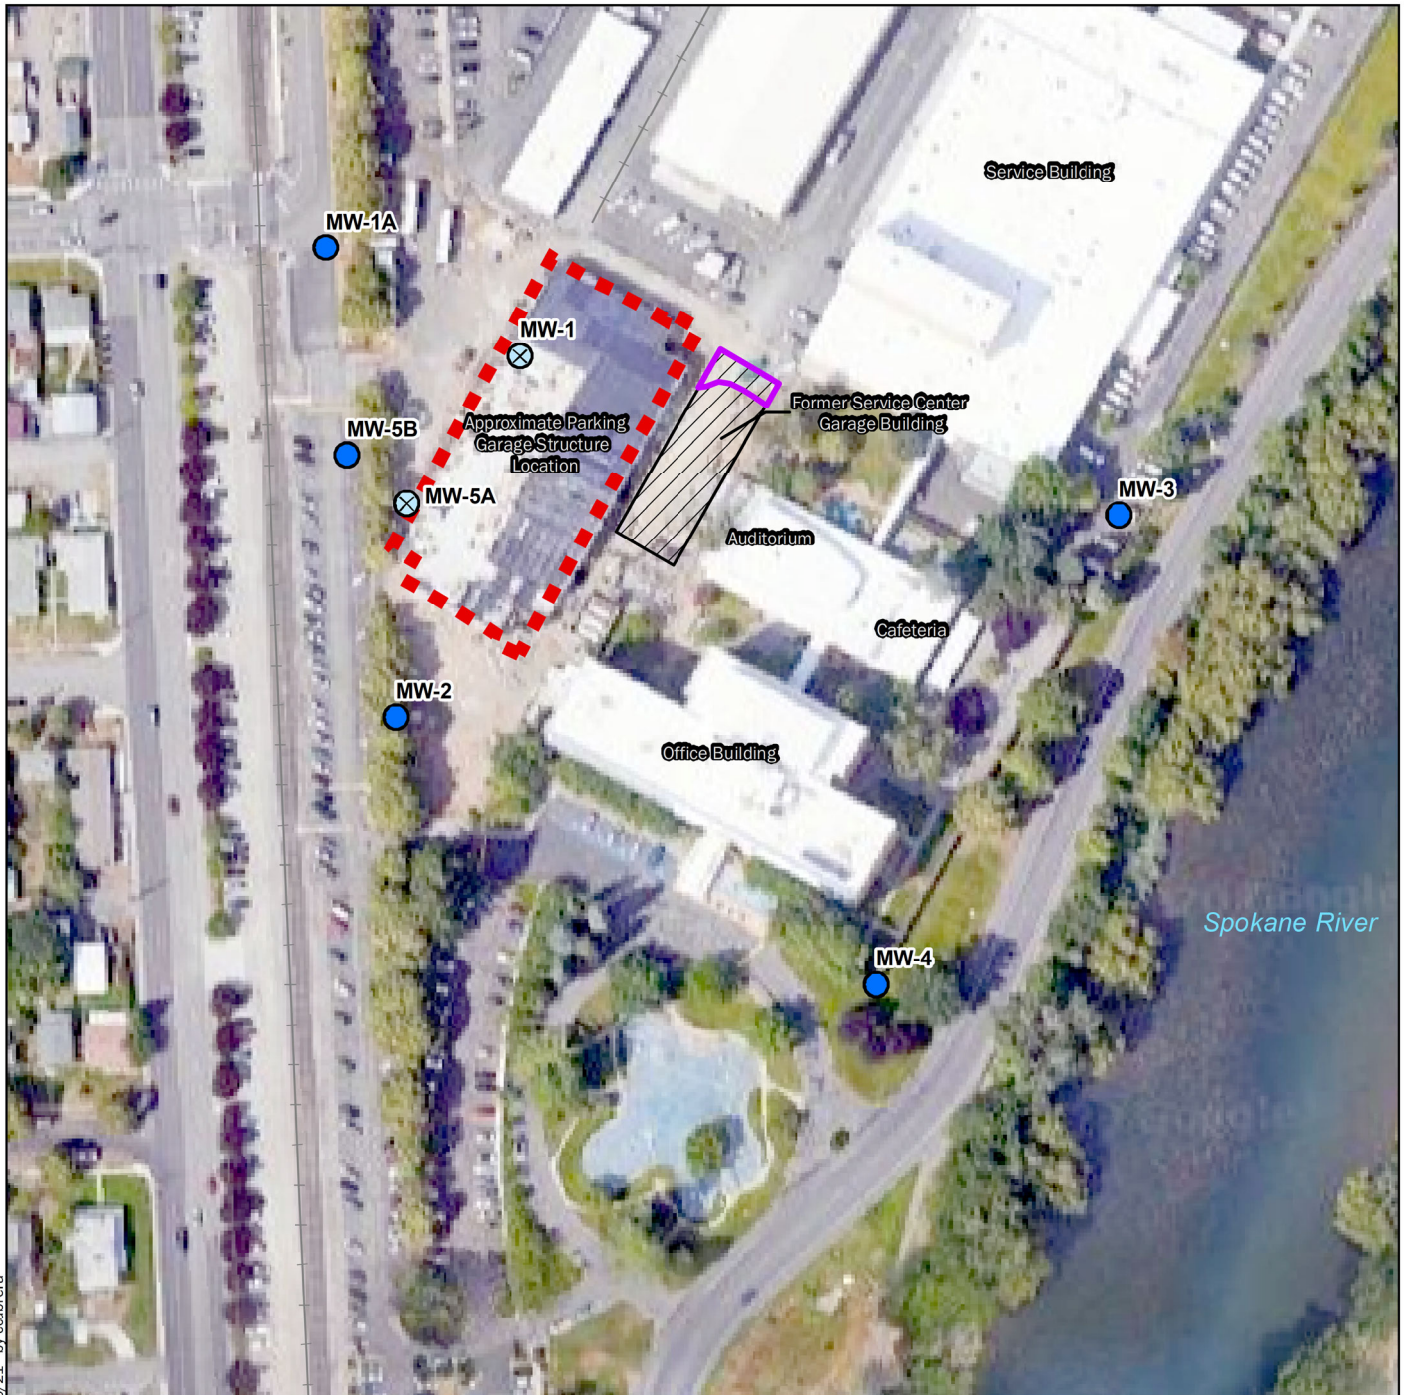
Site Plan	
Avista – Service Center Garage Spokane, Washington	
	Figure 2

- Well ID and Approximate Location
- ⊗ Former Monitoring Well
- Approximate Area of Repaired Liner
- Approximate 2018 Remedial Excavation Area (Capped Area)
- Approximate Parking Garage Structure Location

The Service Center Garage building was located on the Avista Spokane campus which resides on a 19.62-acre parcel in Spokane, Washington. The site is shown on Figure 2.

Avista demolished the Service Center Garage building in August 2018 and moved vehicle service operations to a new facility located in the northern area of the campus. The Service Center Garage building was located adjacent to the Auditorium/Cafeteria building as shown in Figure 2. Several canopies were located west of the Service Center Garage building and were demolished after completing demolition of the Service Center Garage building to make way for the current new parking structure.
