INSPECTION AND MAINTENANCE PLAN FOR CKD RECLAMATION AREA COVERS

Ravensdale Site, Washington

Submitted To: Holcim (US) Inc.
1170 Transit Drive
Colorado Springs, CO 80903

Submitted By: Golder Associates Inc.
18300 NE Union Hill Road, Suite 200
Redmond, WA 98052 USA

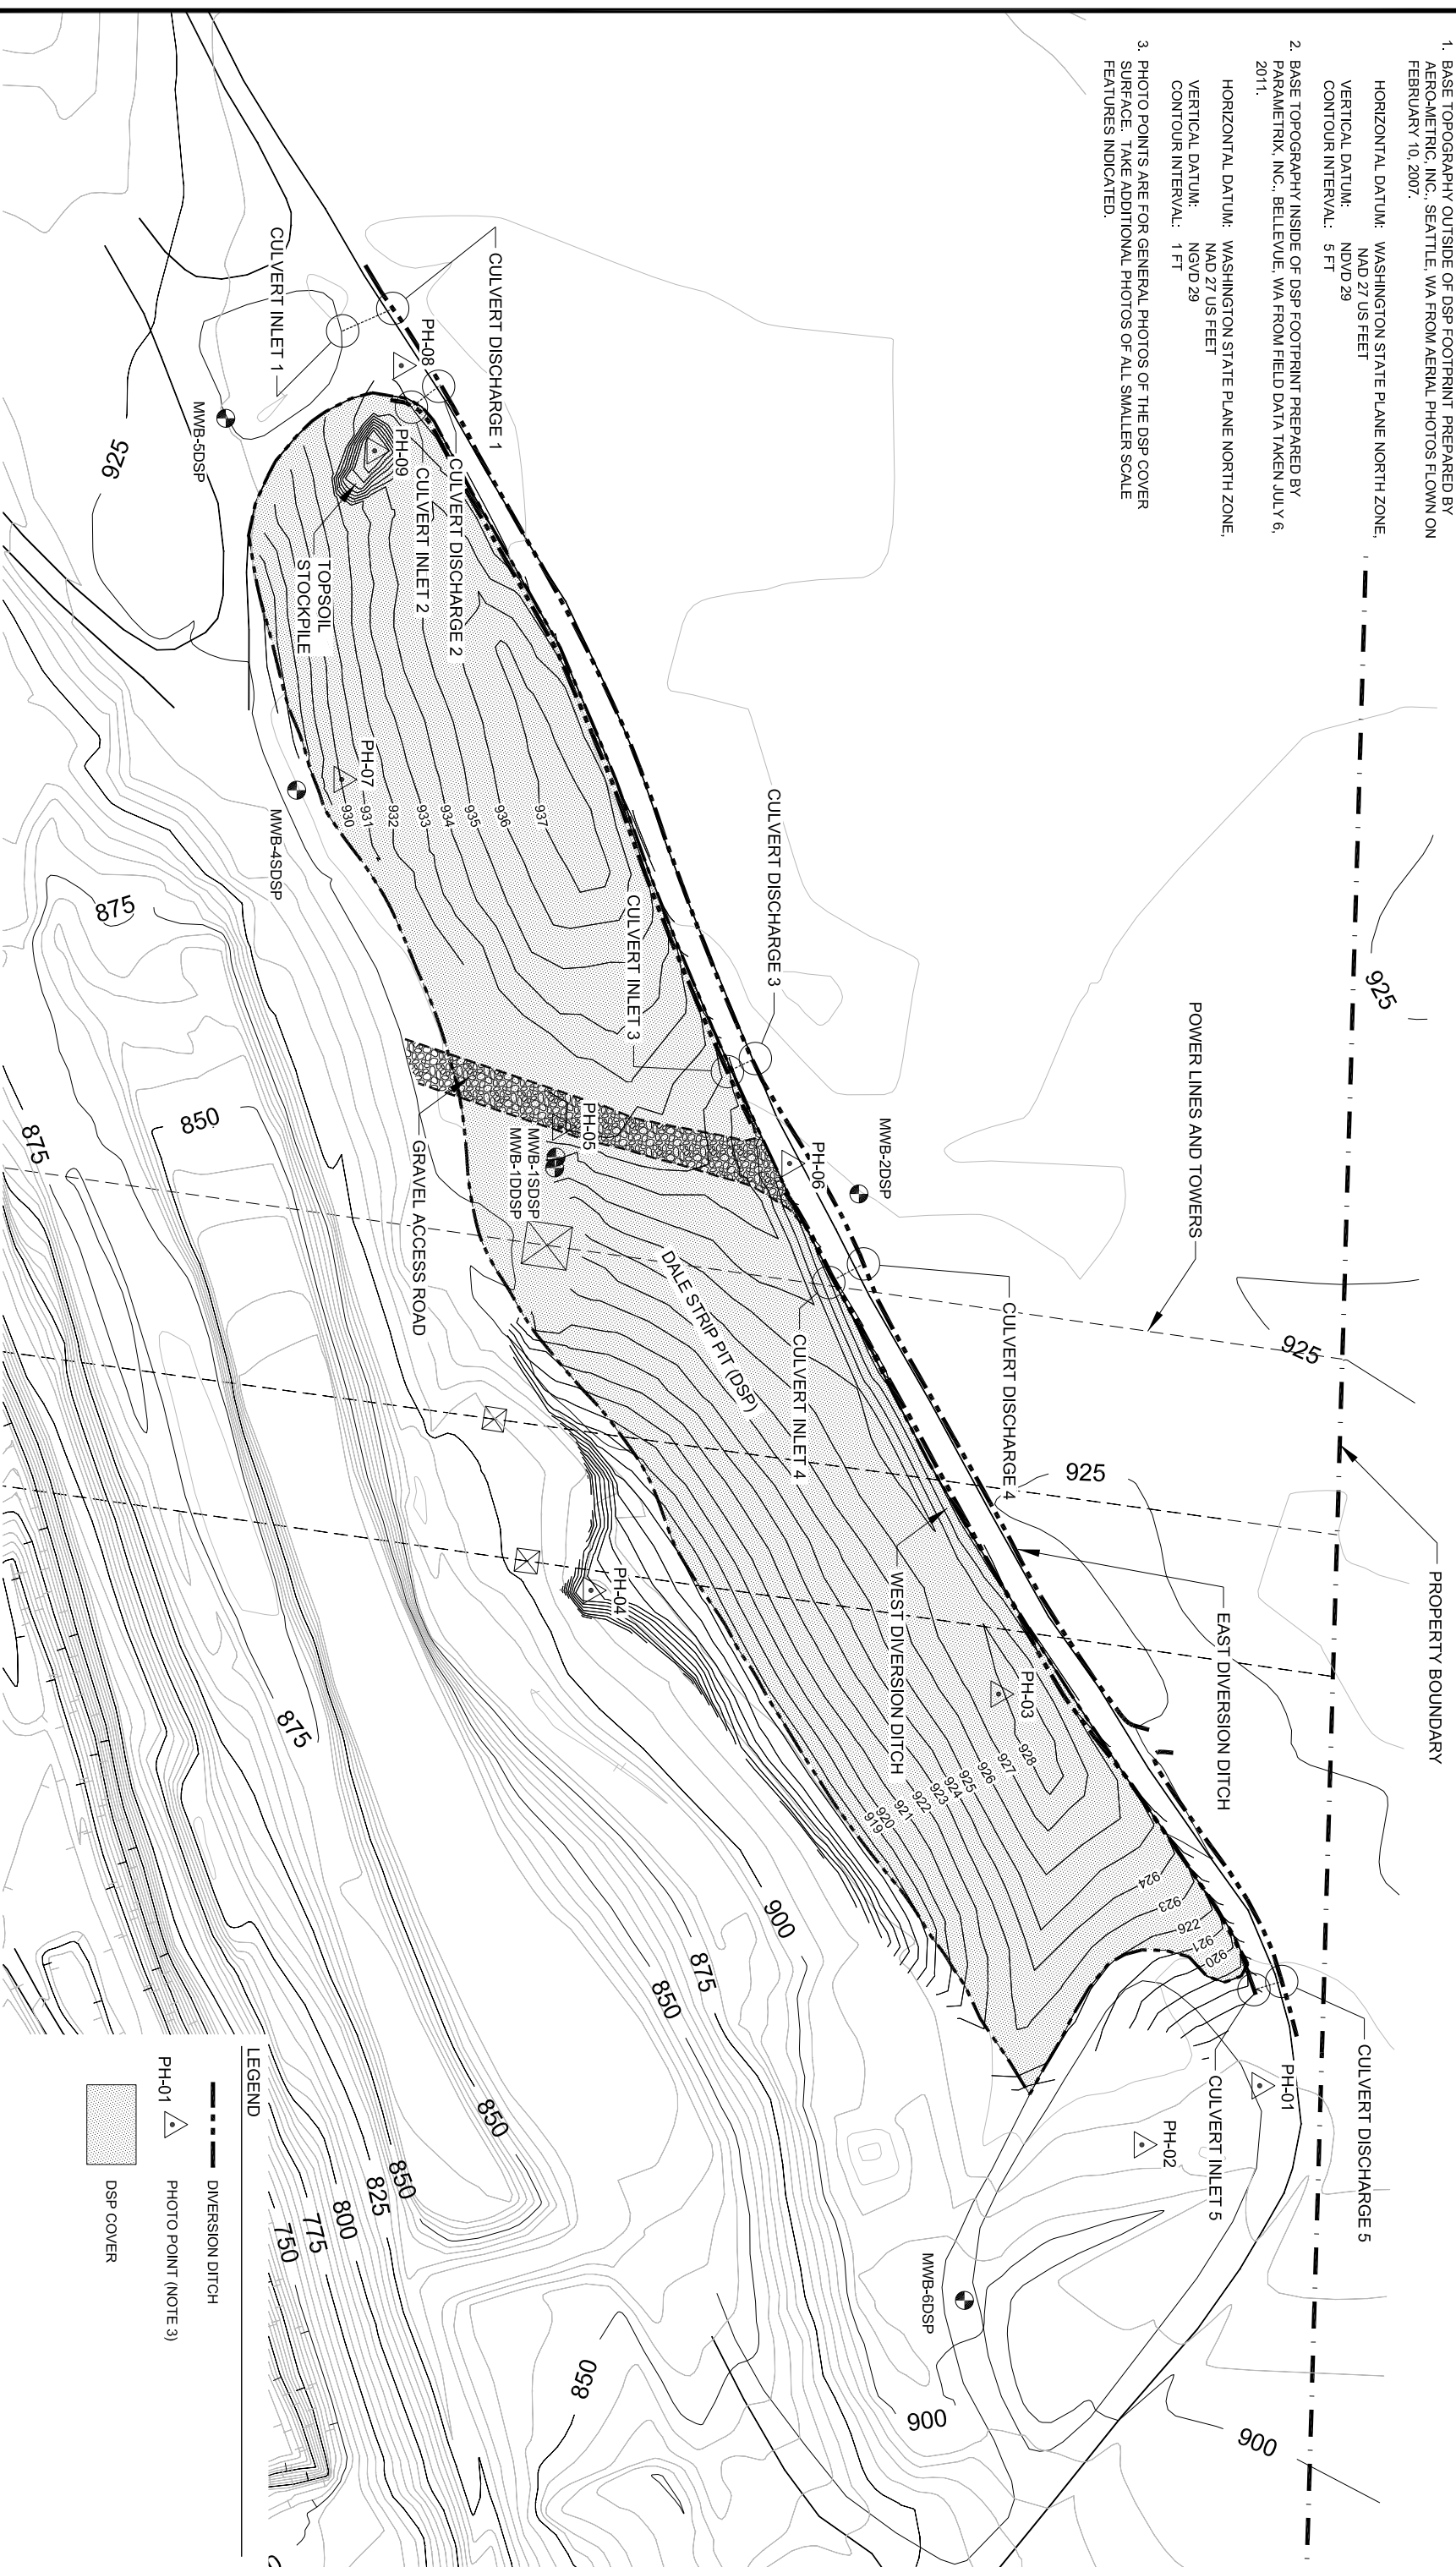
1. BASE TOPOGRAPHY OUTSIDE OF DSP FOOTPRINT PREPARED BY AERO-METRIC, INC., SEATTLE, WA FROM AERIAL PHOTOS FLOWN ON FEBRUARY 10, 2007.
 HORIZONTAL DATUM: WASHINGTON STATE PLANE NORTH ZONE,
 VERTICAL DATUM: NAD 27 US FEET
 CONTOUR INTERVAL: 5 FT
2. BASE TOPOGRAPHY INSIDE OF DSP FOOTPRINT PREPARED BY PARAMETRIX, INC., BELLEVUE, WA FROM FIELD DATA TAKEN JULY 6, 2011.
 HORIZONTAL DATUM: WASHINGTON STATE PLANE NORTH ZONE,
 VERTICAL DATUM: NAD 27 US FEET
 CONTOUR INTERVAL: 1 FT
3. PHOTO POINTS ARE FOR GENERAL PHOTOS OF THE DSP COVER SURFACE. TAKE ADDITIONAL PHOTOS OF ALL SMALLER SCALE FEATURES INDICATED.
