STATE OF WASHINGTON
DEPARTMENT OF ECOLOGY

Re: Opinion on Proposed Cleanup of the following Site:

Site Name: Texaco 211544
Site Address: 8701 Greenwood Avenue N, Seattle, WA 98103
Cleanup Site ID: 6416
Facility/Site ID: 63538329
VCP Project ID: NW3329

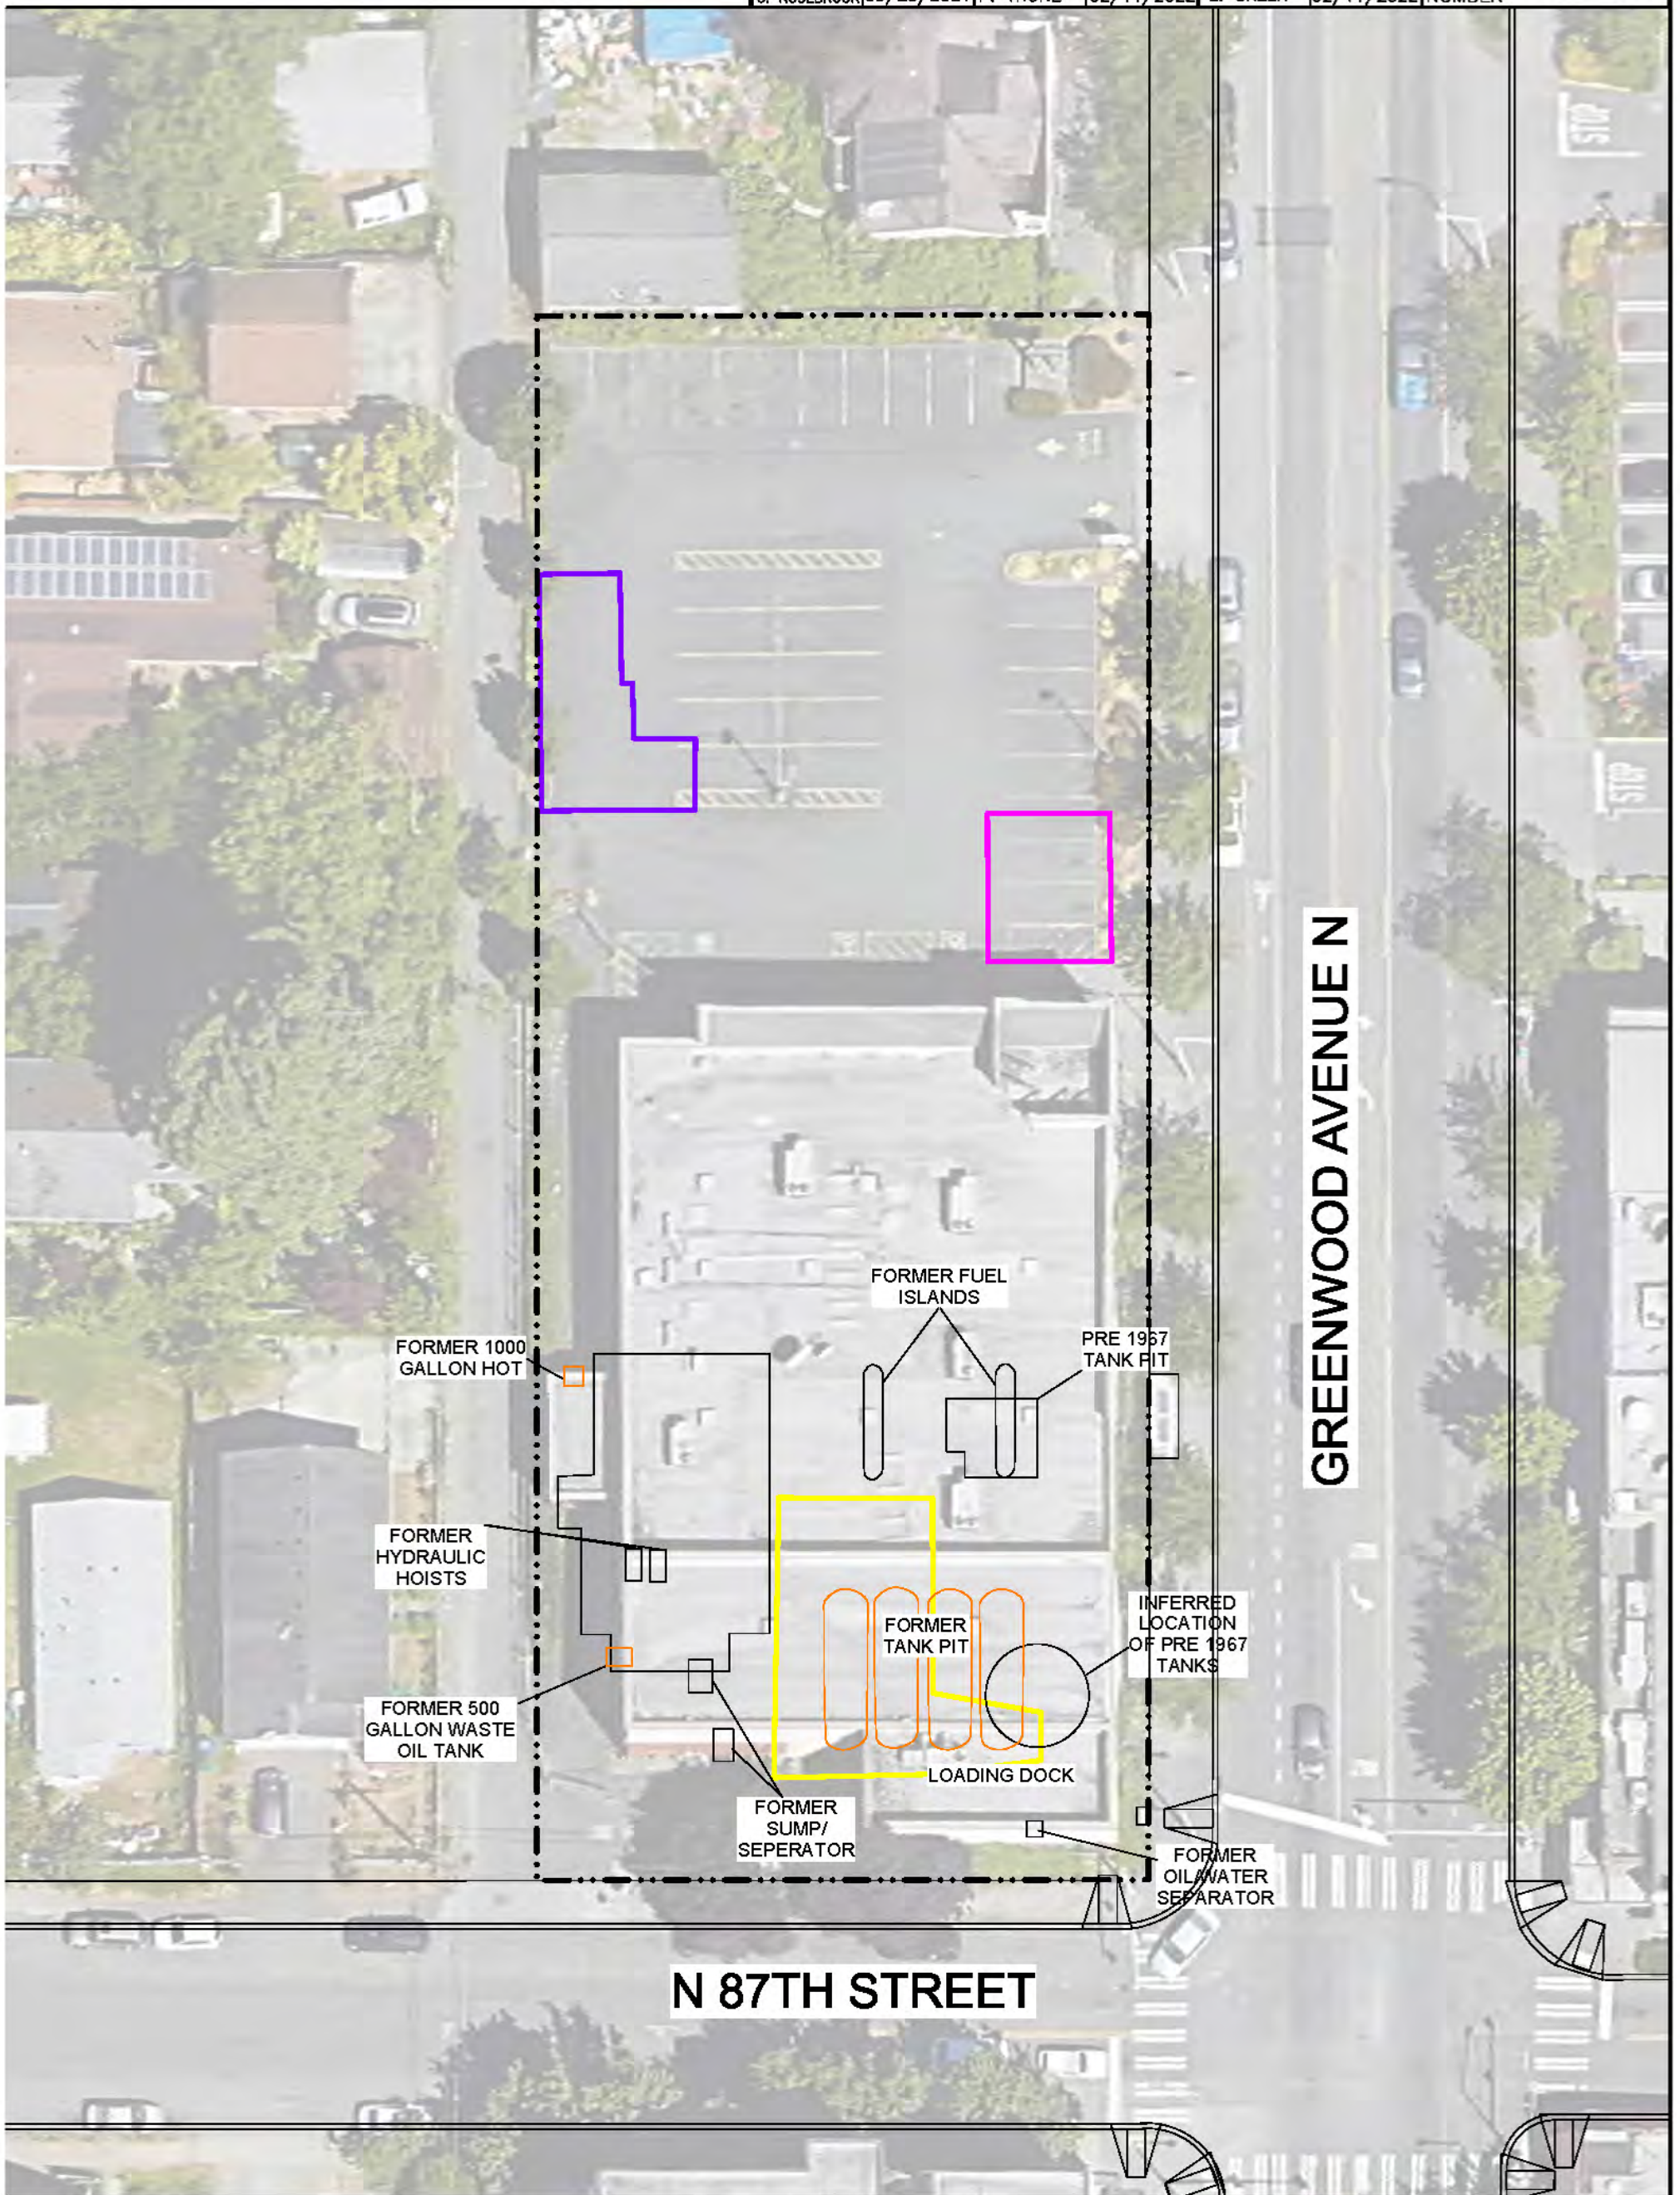
**FIGURE 2
SITE PLAN WITH HISTORICAL
FEATURES OF INTEREST**

FORMER TEXACO 211544 FACILITY
8701 GREENWOOD AVENUE N
SEATTLE, WASHINGTON

Ecology understands that former Site features including USTs and hoists were located on the southern portion of the Property (see **Enclosure A Figure 2**). Therefore, contaminated soils located along the north property boundary are likely related to the SMI Inc. Trust Site. The Method A cleanup level should be used to evaluate soil contaminated with TPH in this portion of the Property.

Property History and Current Use: The Property was initially developed in the 1940s as a service station. The initial configuration of the site is not well understood due to poor documentation, but records indicate that one 4,000-gallon, one 3,500-gallon, and one 2,000-gallon fuel underground storage tanks (USTs) were part of the initial development. One 550-gallon waste oil storage UST, one pump island, and two service bays was also reportedly located on the Property. In 1967, the property was upgraded with two pump islands, two 10,000-gallon gasoline USTs (replacing the existing fuel storage USTs), and one 1,000-gallon heating oil UST. An additional 4,000-gallon gasoline UST was installed in 1971. From 1951 to 1955, a dry-cleaning business operated in the central portion of the Property. The approximate locations of historical Site features are shown on **Figure 2**.

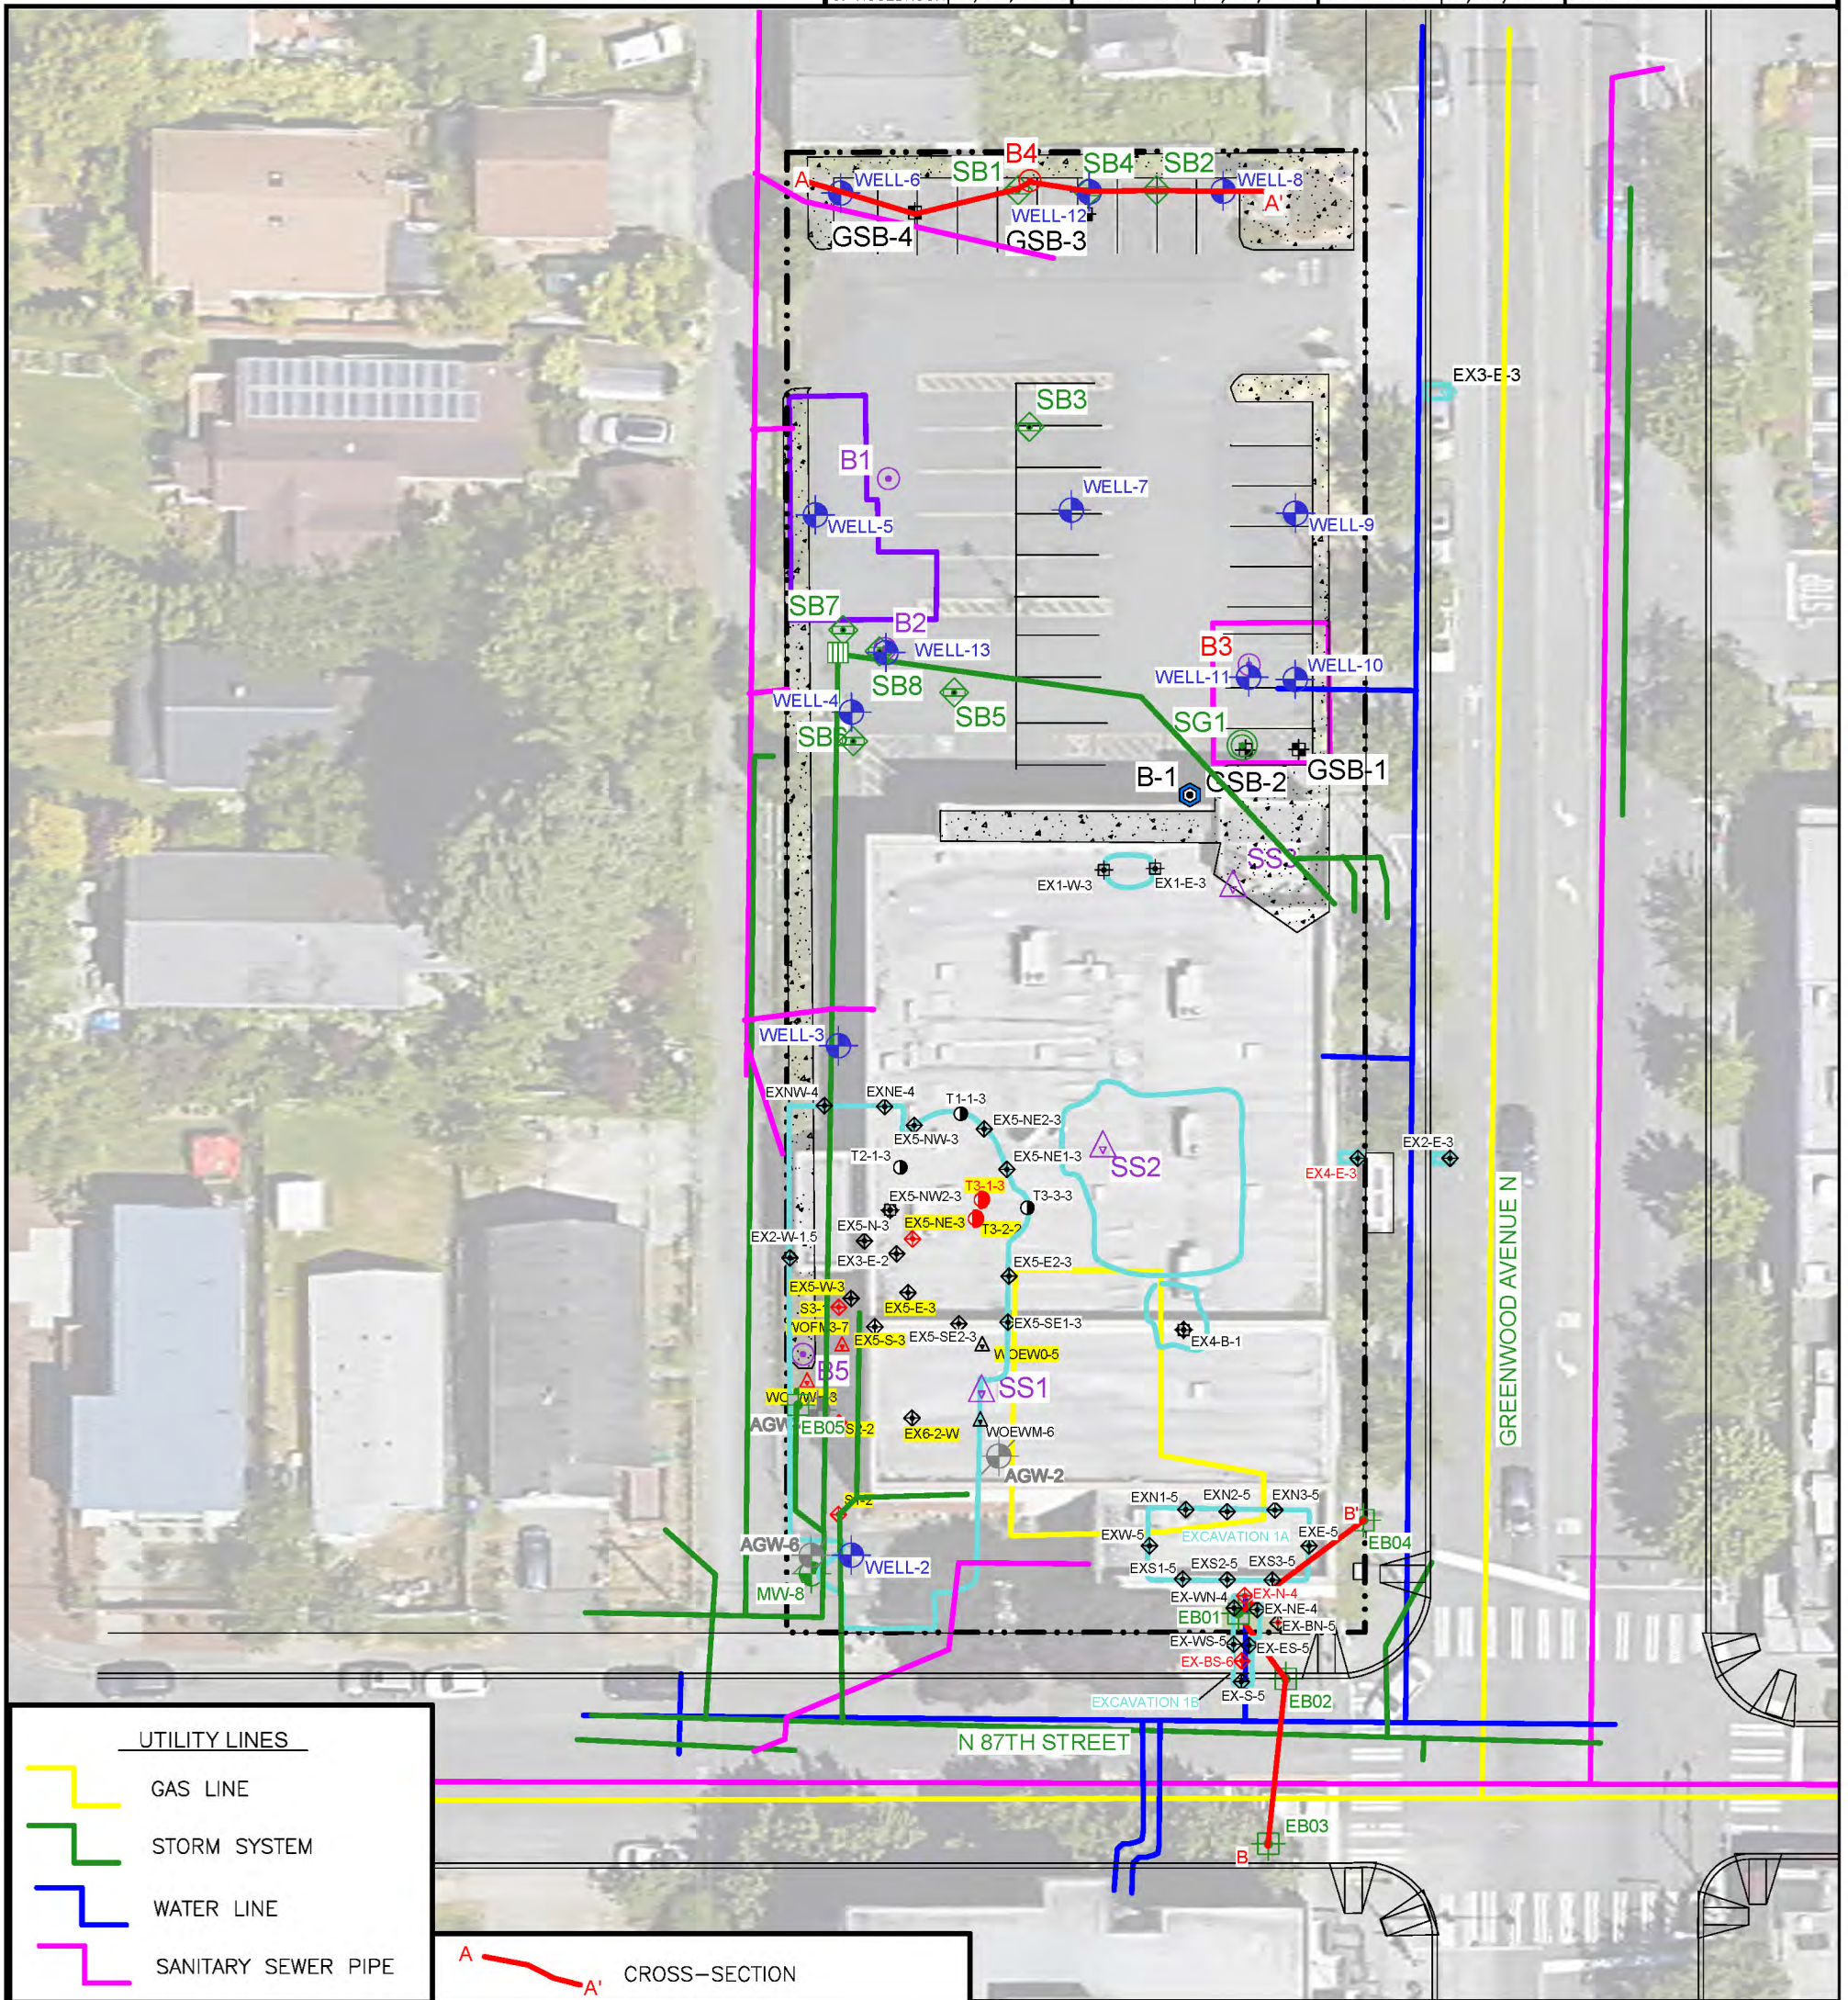
FIGURE 3
SAMPLE LOCATION DIAGRAM

- PROPOSED STRUCTURE LOCATION
- SUBJECT PROPERTY BOUNDARIES
- ENVIRONMENTAL ASSOCIATES, INC SOIL BORING LOCATION APRIL 1997
- LEFT COAST SERVICES LLC SOIL BORING LOCATION NOVEMBER 2020
- PARTNER SOIL BORING LOCATION MARCH 2021
- PARTNER SUB-SLAB SOIL GAS PROBE LOCATION MARCH 2021
- ENVIRO. RESOLUTION INC. SOIL SAMPLE LOCATION REMAINING FOLLOWING EXCAVATION 1996
- MONITORING WELL LOCATION PER ENVIRO RESOLUTIONS INC.
- FORMER VANITY CLEANERS PER CITY DIRECTORY 1951-1955, LOCATION BASED ON 1950 SANBORN MAP
- FORMER LAUNDRY PER 1930 HISTORICAL SANBORN MAP
- PRIOR PCS EXCAVATION MARGINS

FORMER TEXACO 211544 FACILITY
8701 GREENWOOD AVENUE N
SEATTLE, WASHINGTON

Soil contaminated with TPH-G and TPH-D above the Method B cleanup level was discovered in the central portion of the north Property boundary in May 2021 during Site investigation activities (**Figure 3**). As previously noted, this contamination is assumed to be part of the SMI Trust Inc. Site.

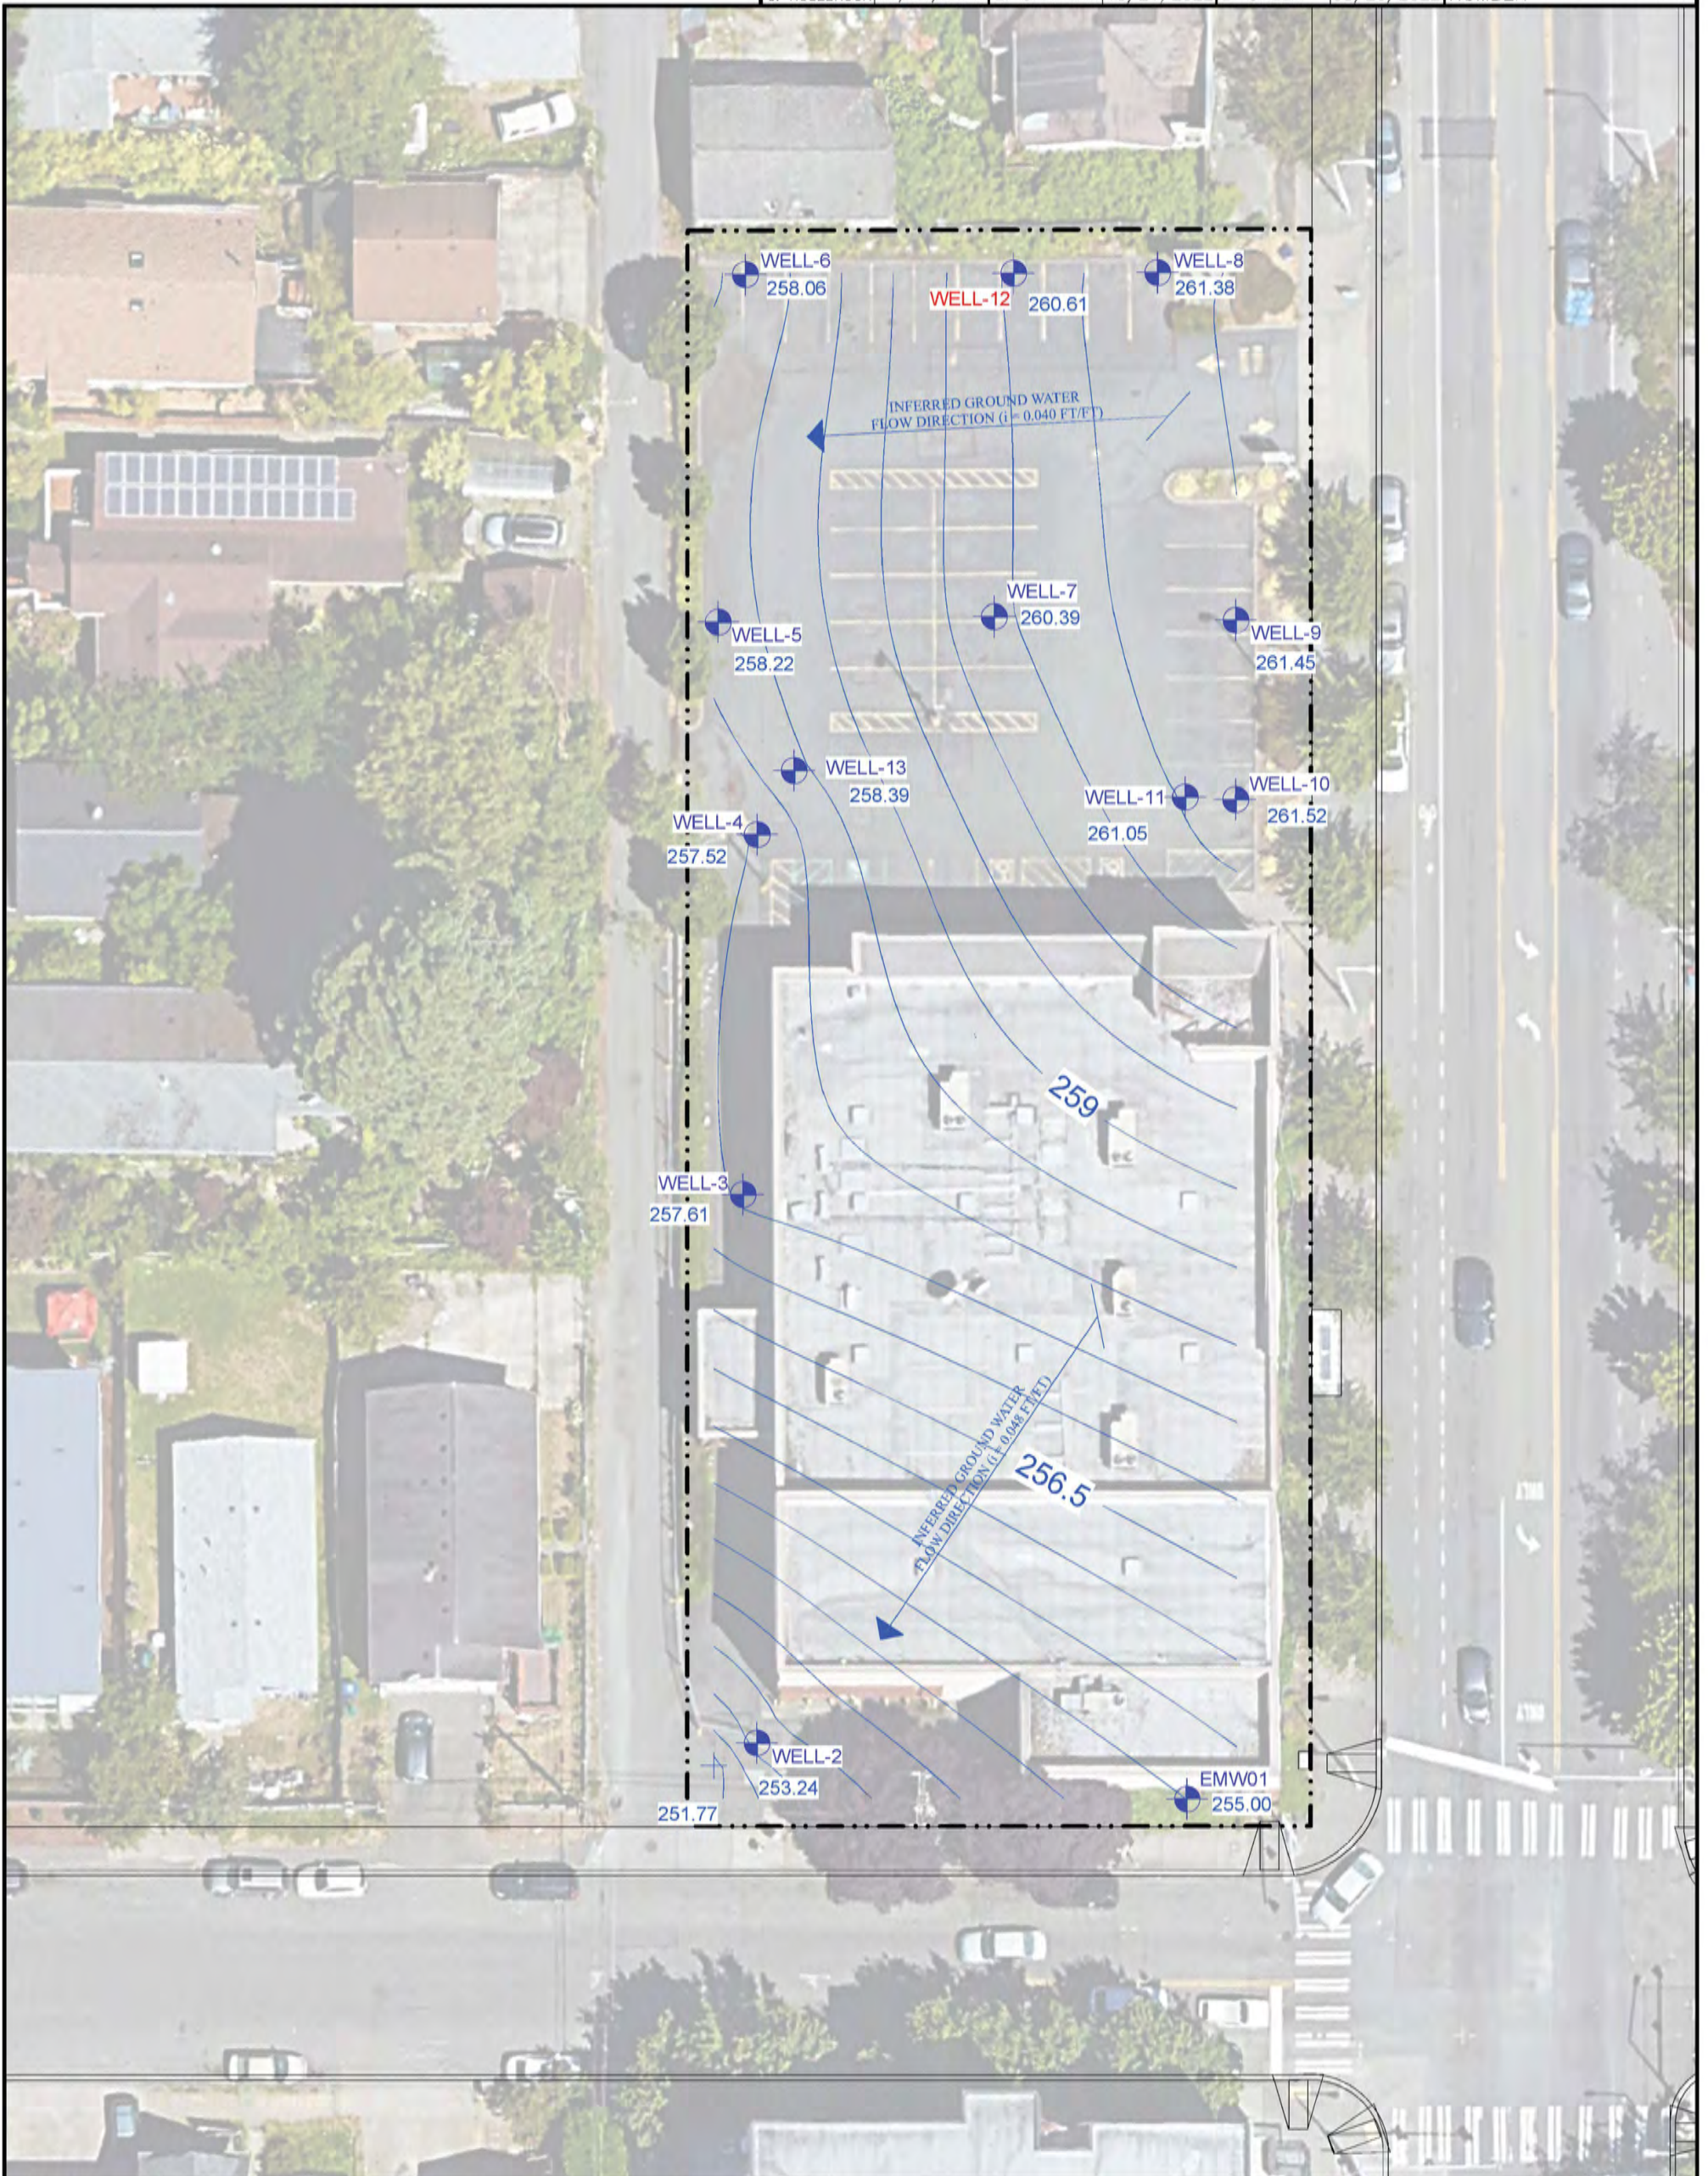
FIGURE 3
GROUND WATER POTENTIOMETRIC SURFACE MAP - FOURTH QUARTER 2022

PROPOSED KIDDIE ACADEMY PROPERTY
8701 GREENWOOD AVENUE N
SEATTLE, WASHINGTON

Shallow groundwater on the site occurs in the silt and peat layers below fill. Depth to groundwater has been observed at 0 to 7 feet bgs. Despite the periodically very shallow depth to water, no seeps have been noted on the Property. Groundwater flow at the Site is oriented to the west on the northern portion of the Property and to the southwest on the southern portion of the Property (**Figure 4**). The average hydraulic gradient is approximately 0.044 feet/foot.

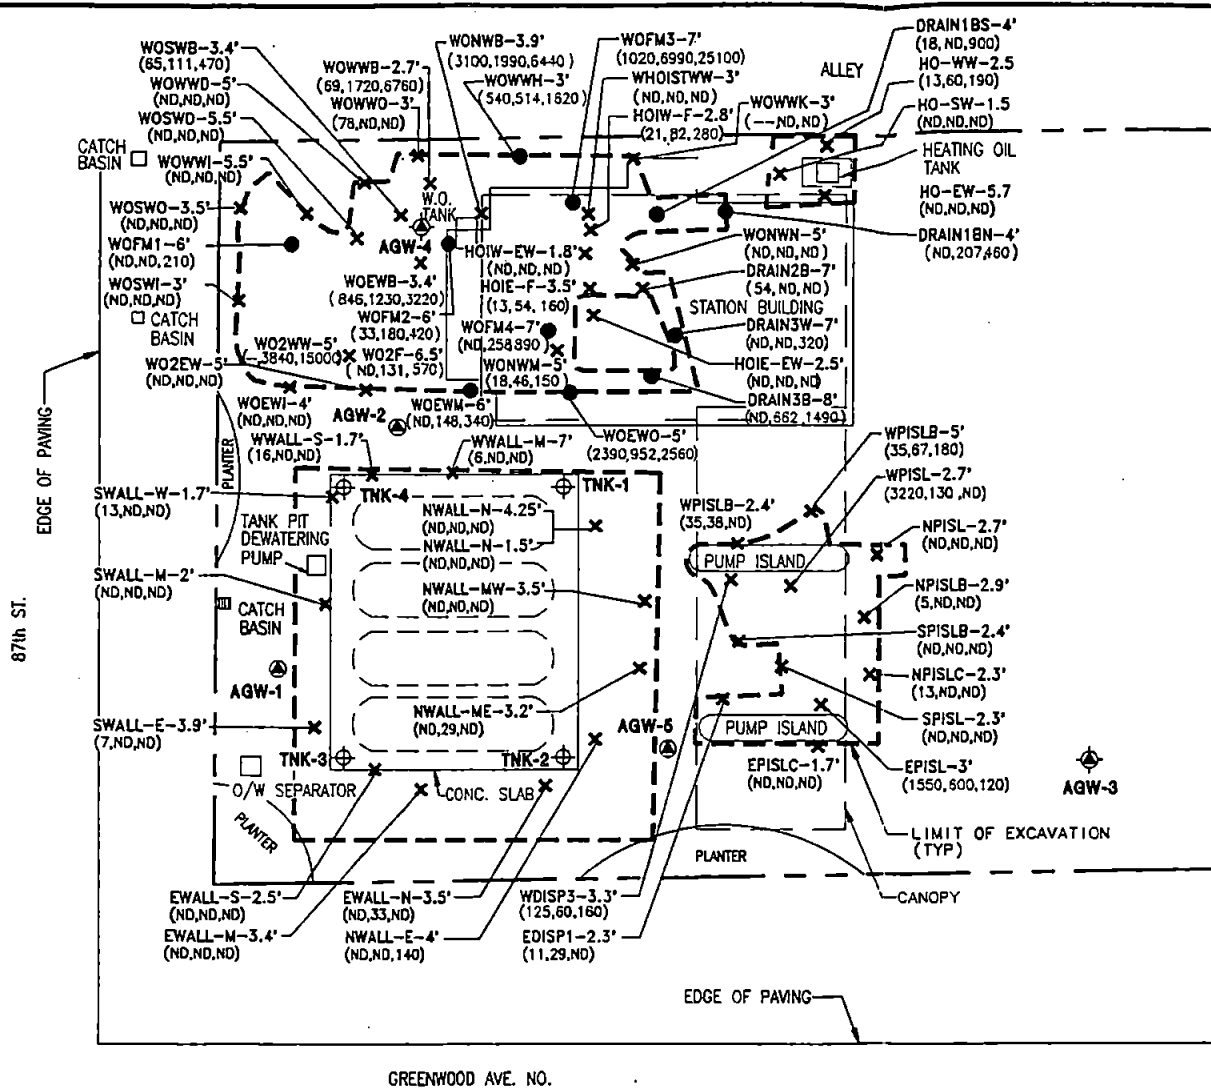
Figure 3
 8701 GREENWOOD AVENUE NORTH
 SEATTLE, WASHINGTON
 SOIL SAMPLE LOCATIONS AND
 LABORATORY RESULTS
