Lower Duwamish Waterway Source Control Sufficiency Evaluation Report Upper Reach

Prepared for: U.S. Environmental Protection Agency

Toxic Cleanup Program
Northwest Region Office
Washington State Department of Ecology
Shoreline, Washington

June 2023

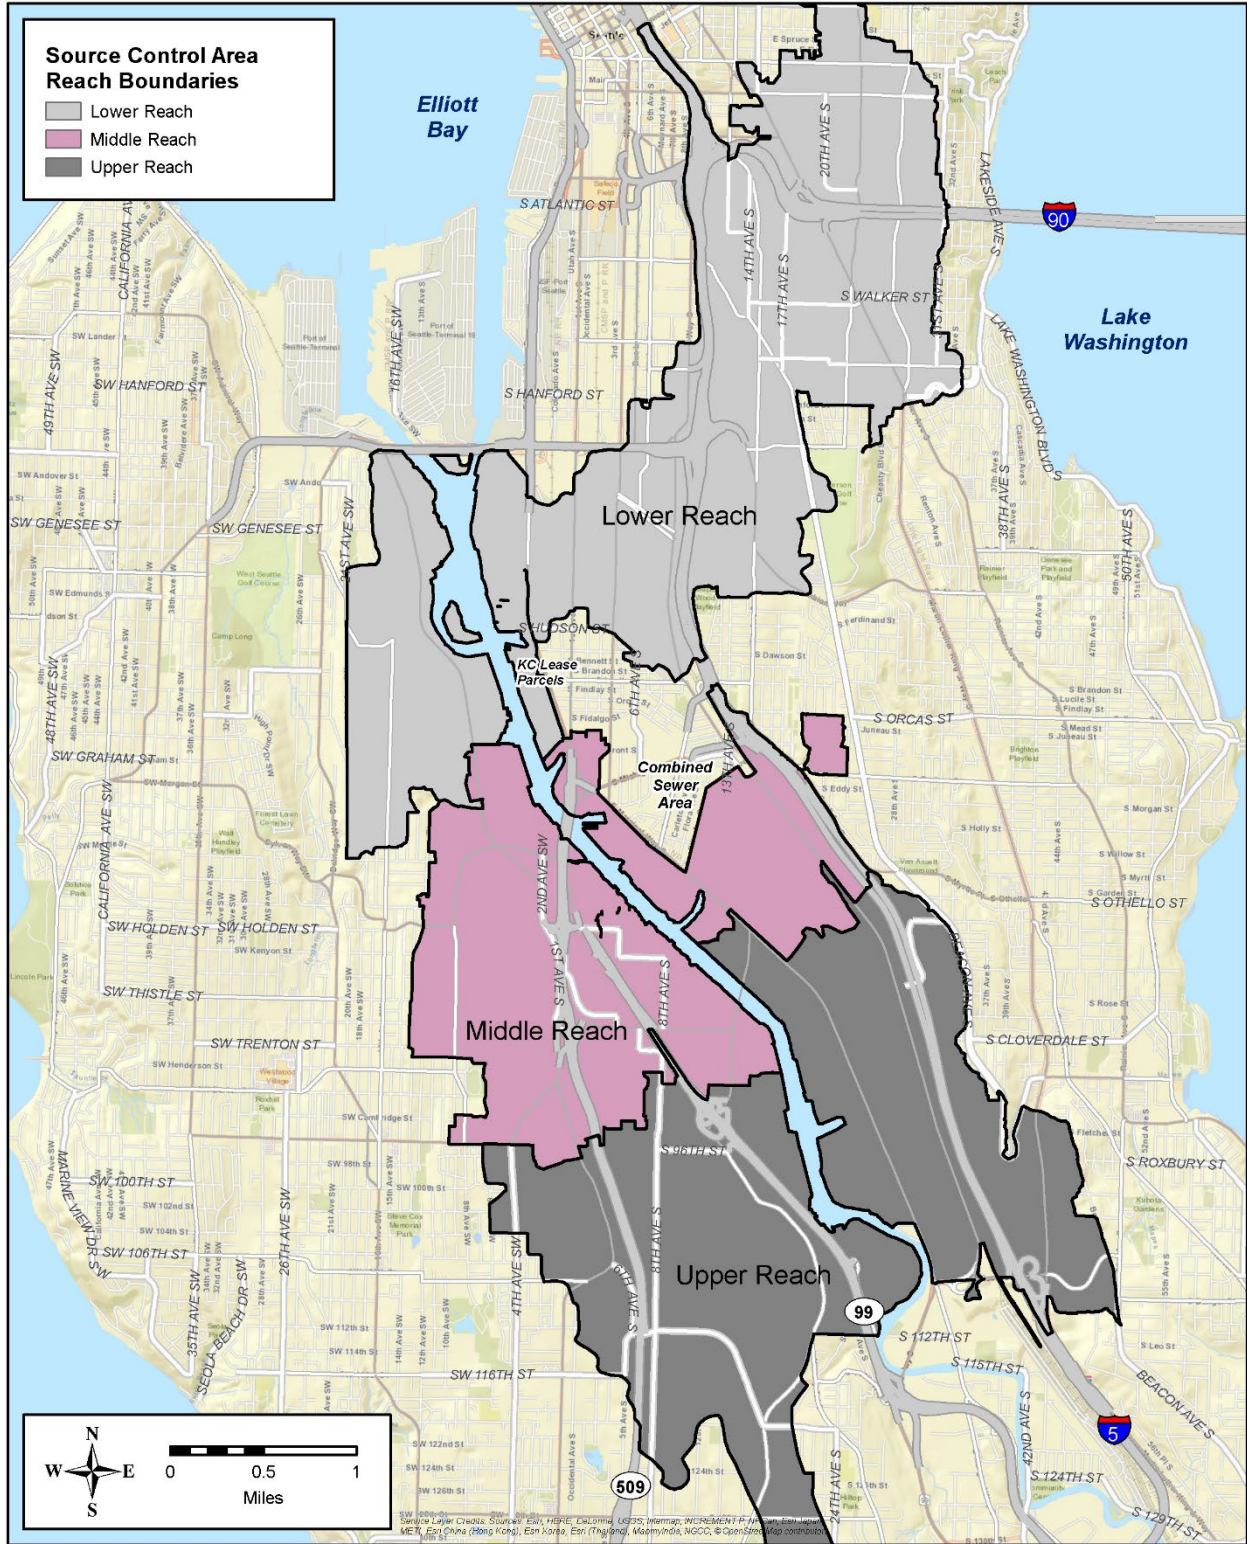
Figure 3: Lower Duwamish Waterway Reach Boundaries

Ecology organized the 24 SCAs as the Upper Reach, Middle Reach, and Lower Reach of the LDW (Figure 3). Ecology uses an upstream-to-downstream approach to source control.
