STATE OF WASHINGTON
DEPARTMENT OF ECOLOGY

Re: No Further Action opinion for the following contaminated Site:

Site name: Everett Masonic Corporation *a.k.a.* View Ridge Plaza
Site address: 220 Olympic Blvd, Everett, Snohomish County, WA 98203
Facility/Site ID: 20079
Cleanup Site ID: 12644
VCP Project No.: NW3244

Ecology has determined that no further remedial action is necessary to clean up contamination at the Site.

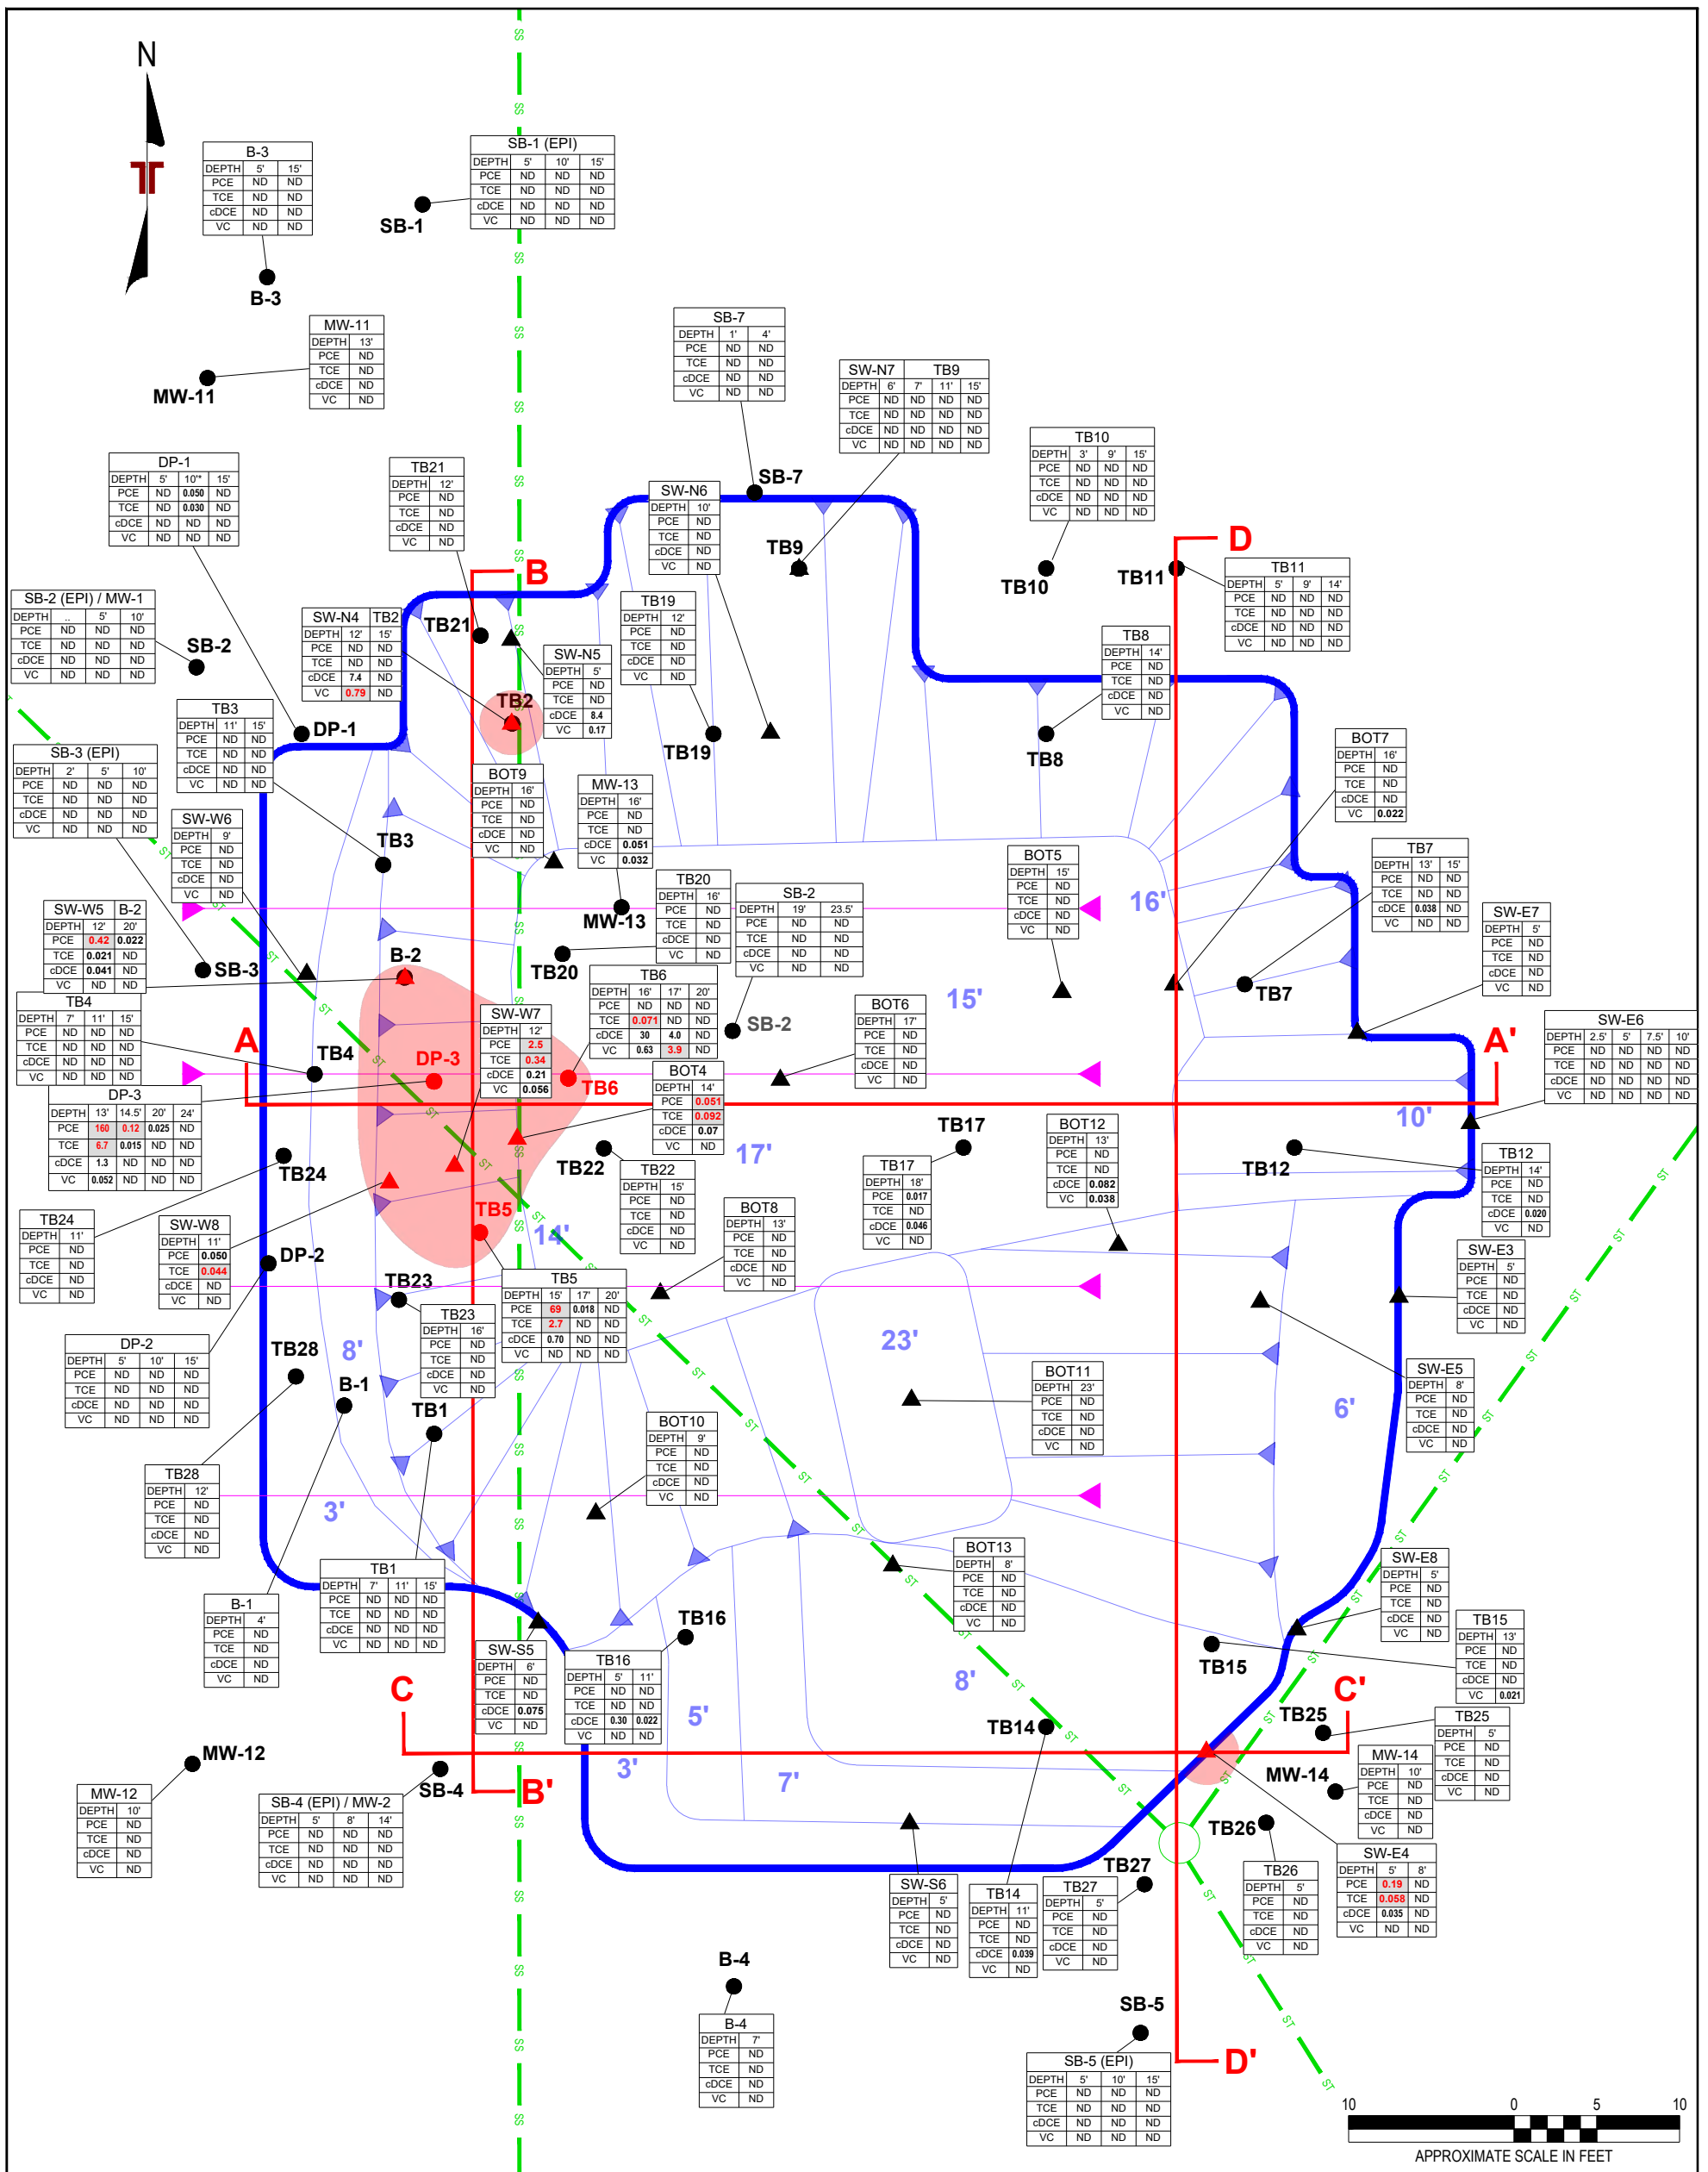
Figure 3

EXCAVATION DIAGRAM WITH IN-PLACE SOIL SAMPLES
 View Ridge Plaza
 220 Olympic Boulevard
 Everett, Snohomish County, Washington

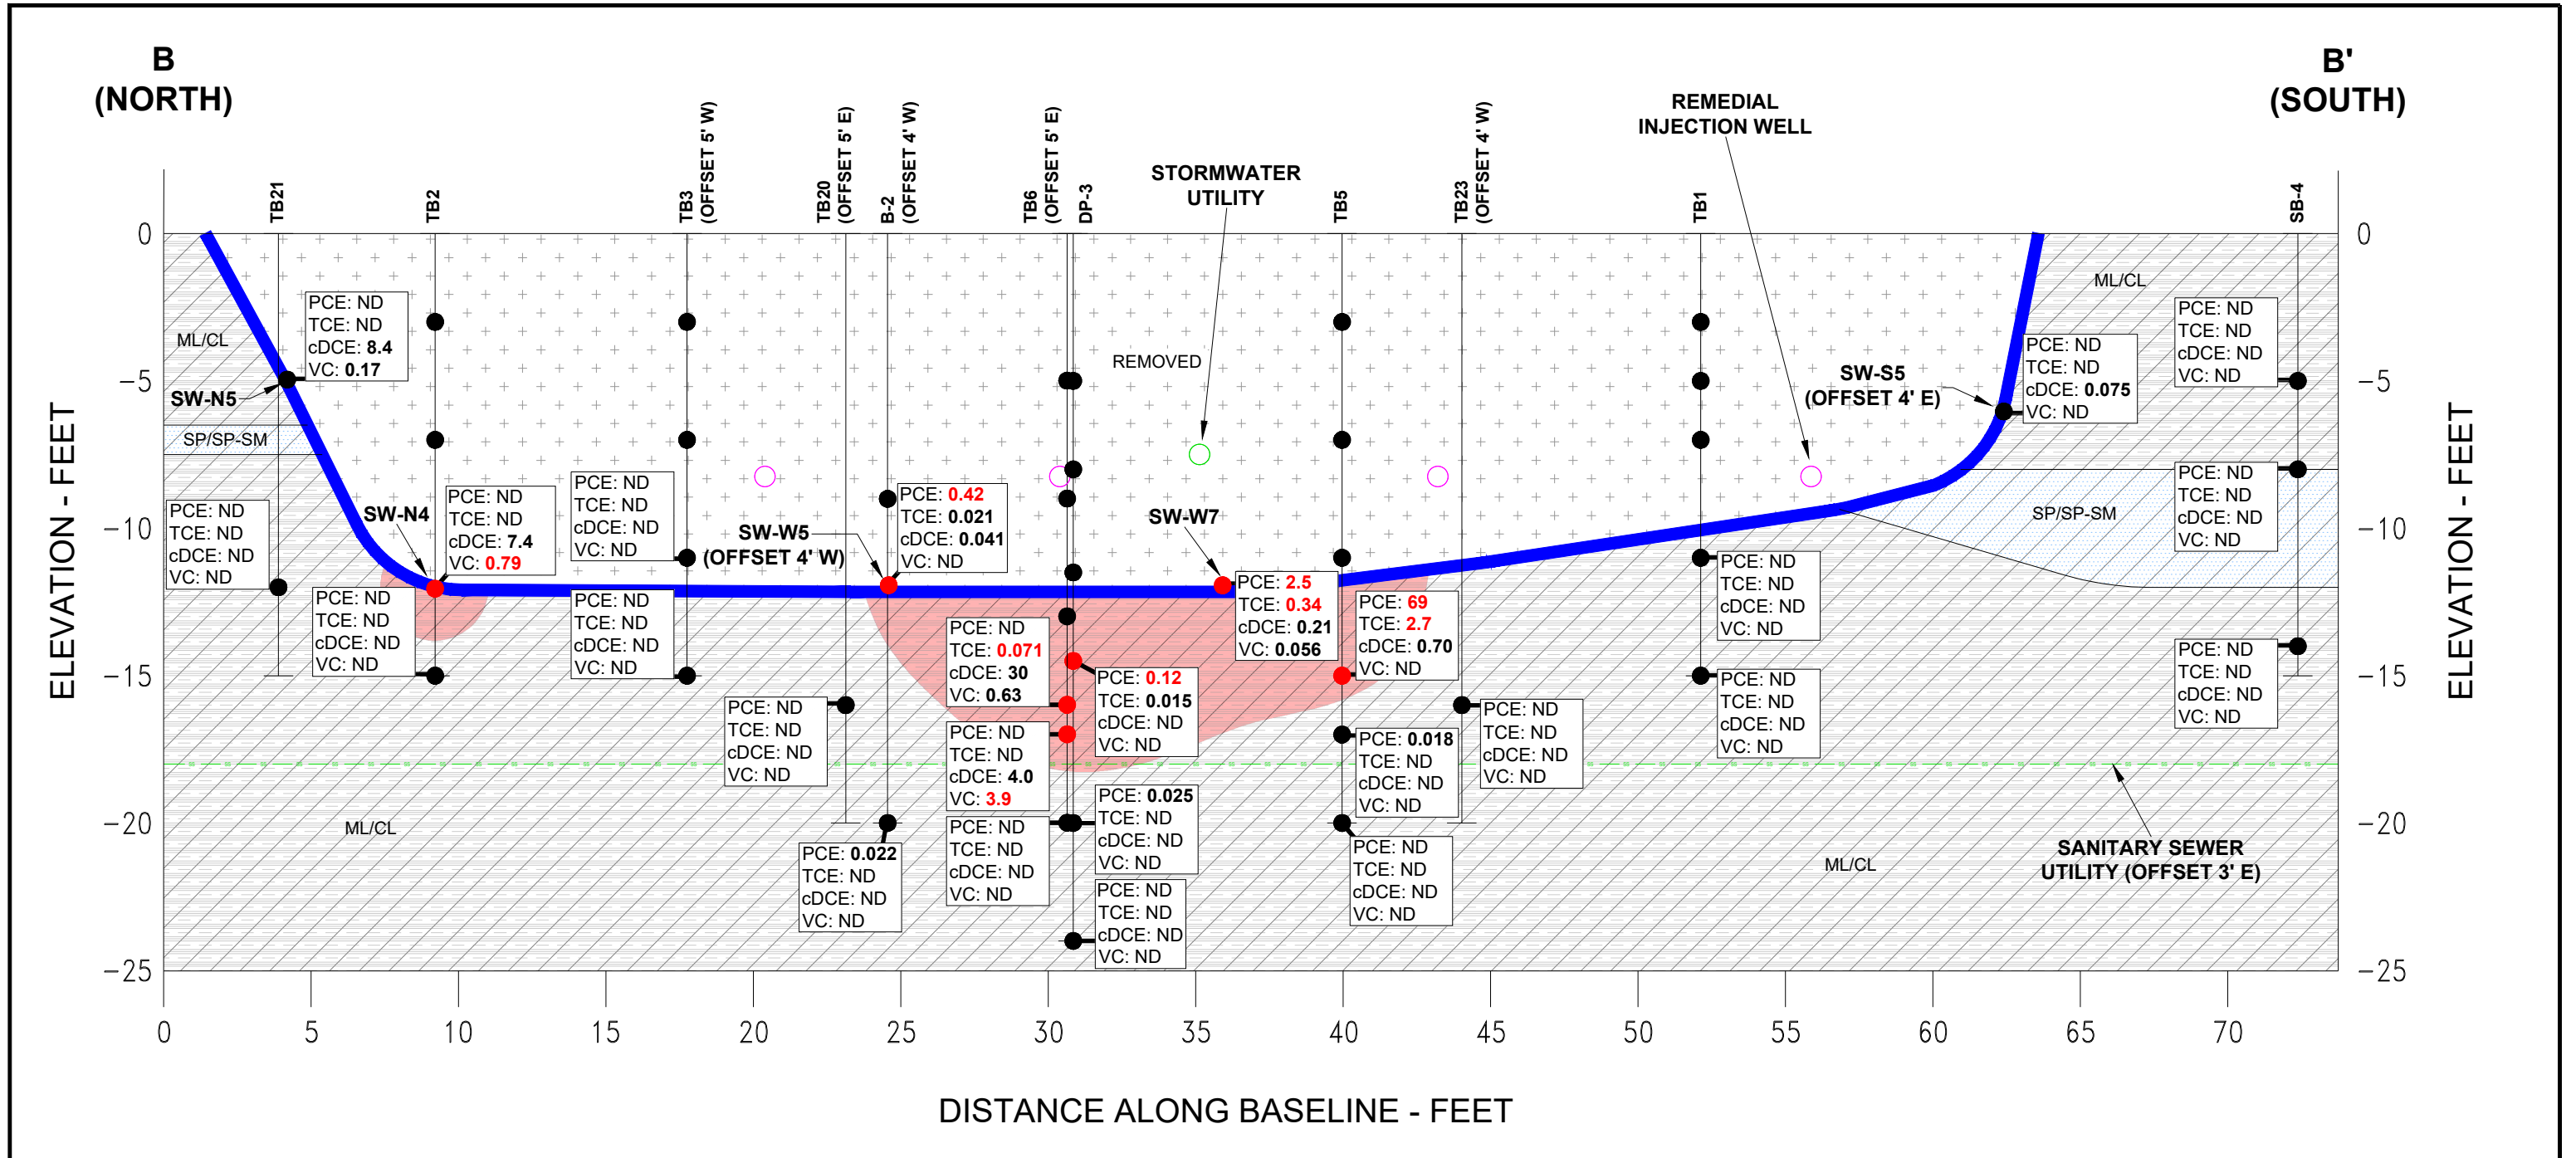
Figure 5

<p>SOIL BORING</p> <p>TB1 BORING NUMBER</p> <p>OFFSET 8' E APPROXIMATE DISTANCE AND DIRECTION OF BORING FROM BASELINE</p> <p>NUMBER AND APPROXIMATE SOIL SAMPLE LOCATION WITH ANALYTICAL DATA (mg/kg)</p> <p>NOTES: • PLEASE REFER TO CROSS SECTION LINES ON EXHIBIT 3.</p>	<p>APPROXIMATE LIMIT OF REMEDIAL EXCAVATION</p> <p>APPROXIMATE LOCATION OF SOIL IMPACTS ABOVE MTCA CLEANUP LEVELS LEFT IN PLACE</p> <p>REMOVED: CLEAN BACKFILL</p> <p>ML/CL: SILT TO SILTY CLAY WITH MINOR AMOUNTS OF SAND AND/ OR GRAVEL</p> <p>SP/SP-SM: SAND WITH VARYING AMOUNTS OF SILT AND GRAVEL</p>	<p>SANITARY SEWER UTILITY LINE</p> <p>REMEDIAL INJECTION WELL</p> <p>UNDERGROUND UTILITY LINE</p> <p>SOIL SAMPLE WITH cVOC CONCENTRATIONS BELOW MTCA CULs AND/OR LABORATORY REPORTING LIMITS (ANALYTICAL RESULTS NOT DISPLAYED FOR REMOVED SAMPLES)</p> <p>SOIL SAMPLE WITH cVOC CONCENTRATIONS EXCEEDING MTCA CULs</p>	<p>TETRACHLOROETHENE PCE 0.05</p> <p>TRICHLOROETHENE TCE 0.03</p> <p>CIS-1,2-DICHLOROETHENE cDCE 160</p> <p>VINYL CHLORIDE VC 0.67</p> <p>ALL CONCENTRATIONS ARE IN MILLIGRAMS PER KILOGRAM (mg/kg). VALUES DETECTED ARE IN BOLD TYPE. VALUES DETECTED ABOVE MTCA CLEANUP LEVELS ARE IN RED BOLD</p> <p>MTCA - MODEL TOXIC CONTROL ACT. ND - NOT DETECTED ABOVE LABORATORY REPORTING LIMIT. SEE LABORATORY REPORT FOR FULL LIST OF ANALYSIS.</p>

Project Mngr: KSB	Project No: 81207449	<p>Terracon Consulting Engineers and Scientists</p> <p>21905 64th Avenue W, Ste 100 Mountlake Terrace, WA 98043 PH: (425) 771-3304 FAX: (425) 771-3549</p>	<p>CROSS SECTION B-B'</p> <p>View Ridge Plaza 220 Olympic Boulevard Everett, Snohomish County, Washington</p>	<p>EXHIBIT</p> <p style="font-size: 2em; font-weight: bold;">5</p>
Drawn By: JWD	Scale: NOT TO SCALE			
Checked By: KSB	File No: Exhibit 5			
Approved By: MYW	Date: September 2021

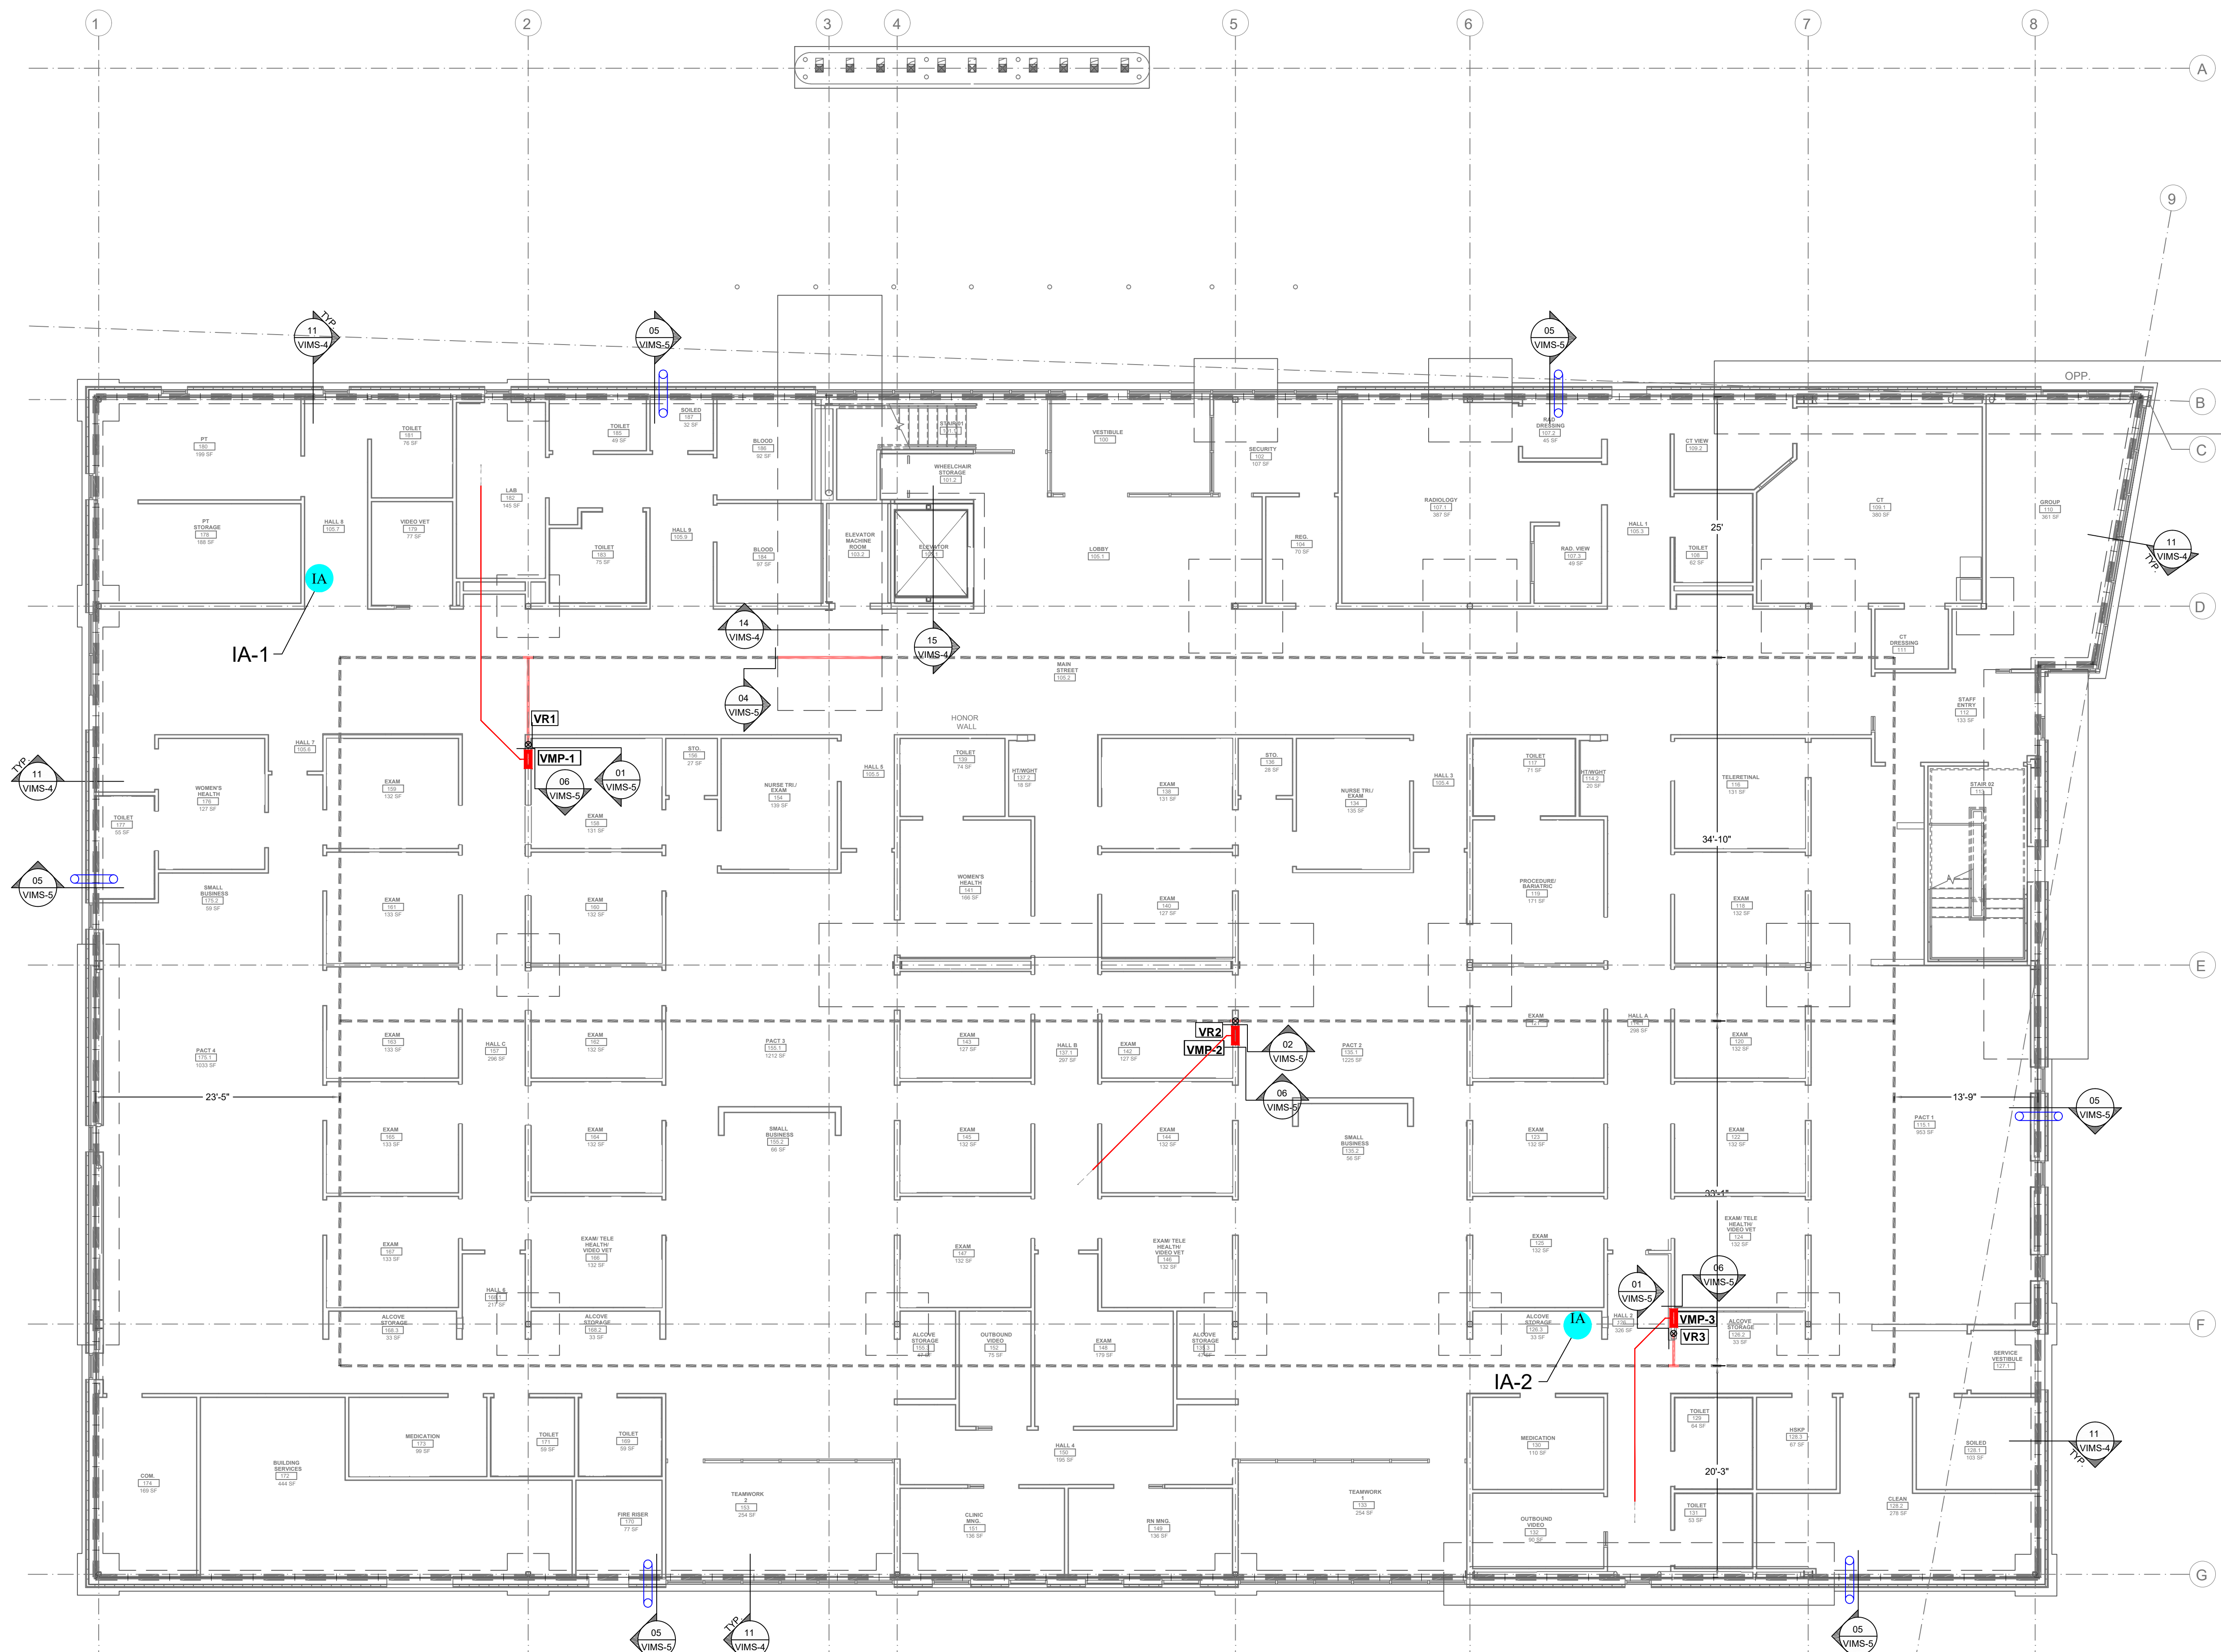
- 3-INCH I.D. 0.125-INCH SLOTTED SCH 40 PVC VAPOR COLLECTION PIPING
- 3-INCH I.D. SOLID SCH 40 PVC BELOW SLAB CONVEYANCE PIPE
- VACUUM MONITORING PROBE WITH ACCESS PANEL
- EXTENT OF VAPOR INTRUSION MITIGATION SYSTEM MEMBRANE PERIMETER INLET VENT
- VR1 ○ VENT RISER PIPE FROM SUB-SLAB
- IA ○ INDOOR AIR SAMPLE LOCATIONS
- VMP-1 ■ VACUUM MONITORING PROBE SAMPLE LOCATIONS
