STATE OF WASHINGTON
DEPARTMENT OF ECOLOGY

Re: Opinion pursuant to WAC 173-340-515(5) on the *Work Plan for Additional Environmental Services* for the following Hazardous Waste Site:

- **Site Name:** Mowhawk Flush Doors (also - Seattle Door, SEEDORCO, Sauder Door, Premdor)
- **Site Address:** 747, 777, and 787 - 6th Street South (formerly 733 and 815), Kirkland, Washington
- **Facility/Site No.:** 98437118
- **VCP Project No.:** NW 1543

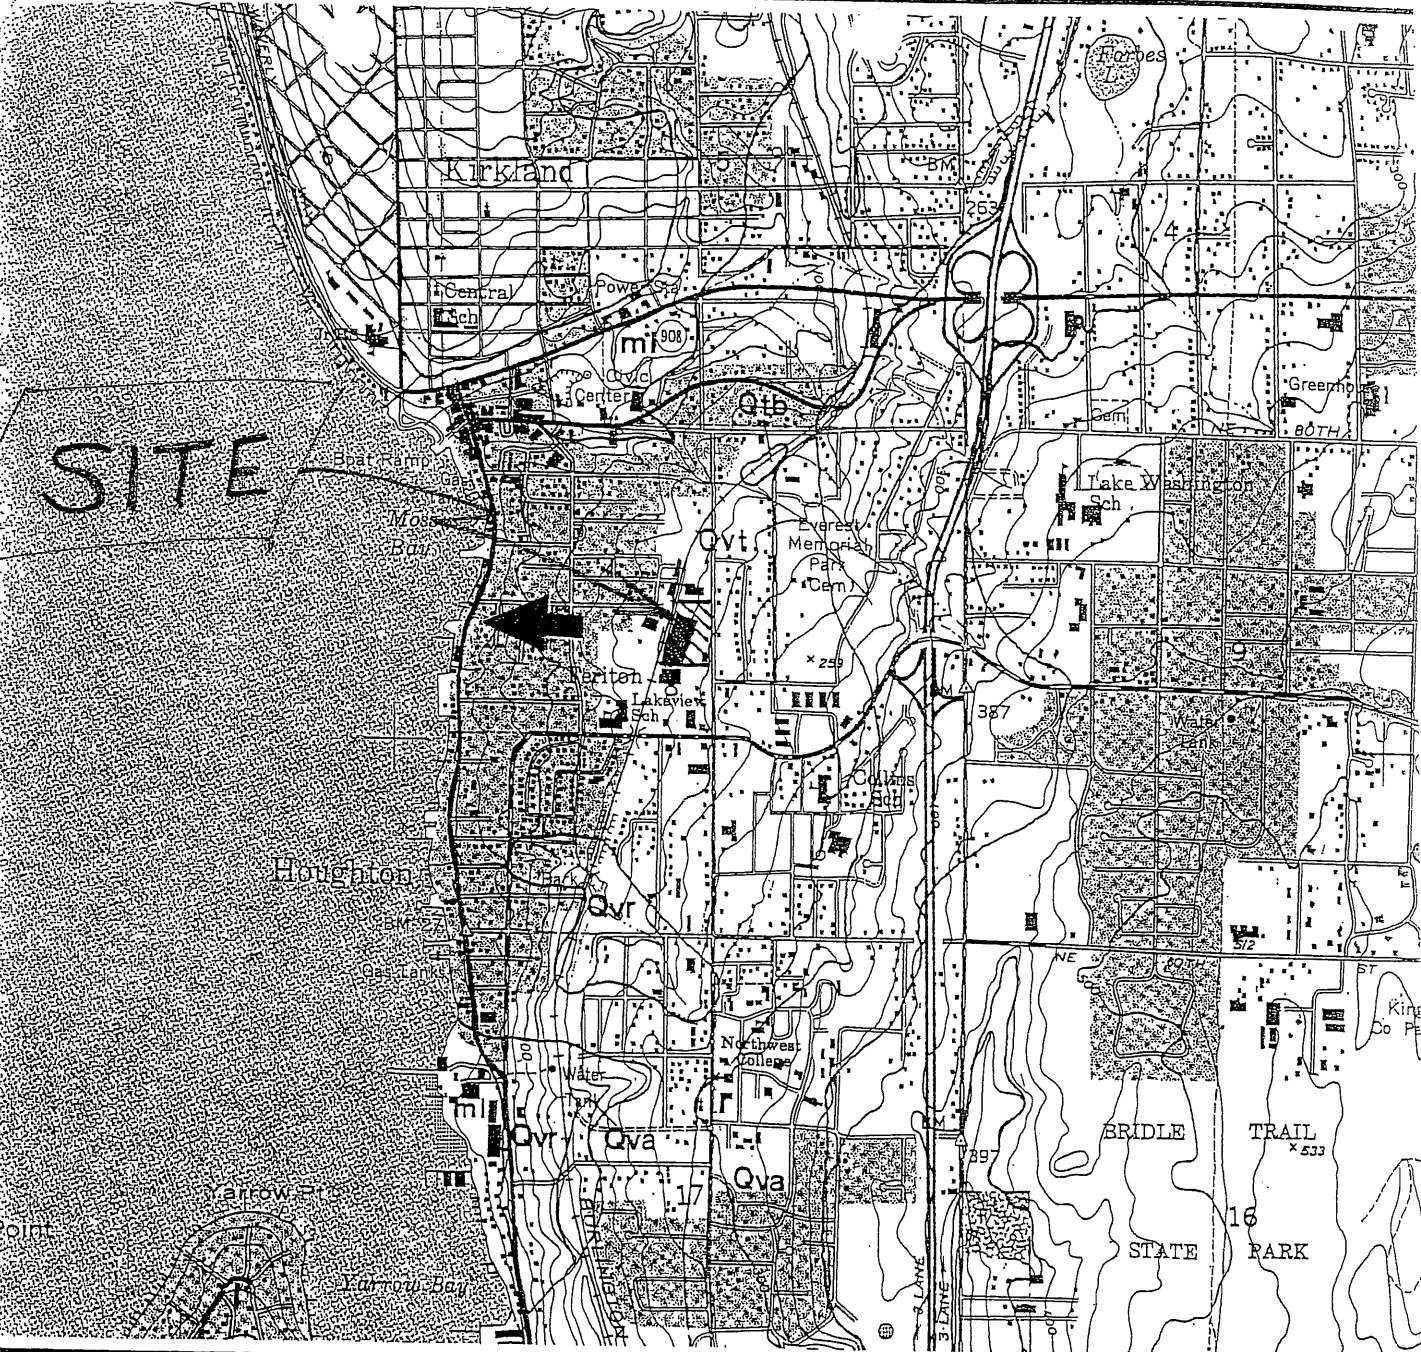
SITE

PROBABLE DIRECTION OF REGIONAL SHALLOW GROUNDWATER FLOW

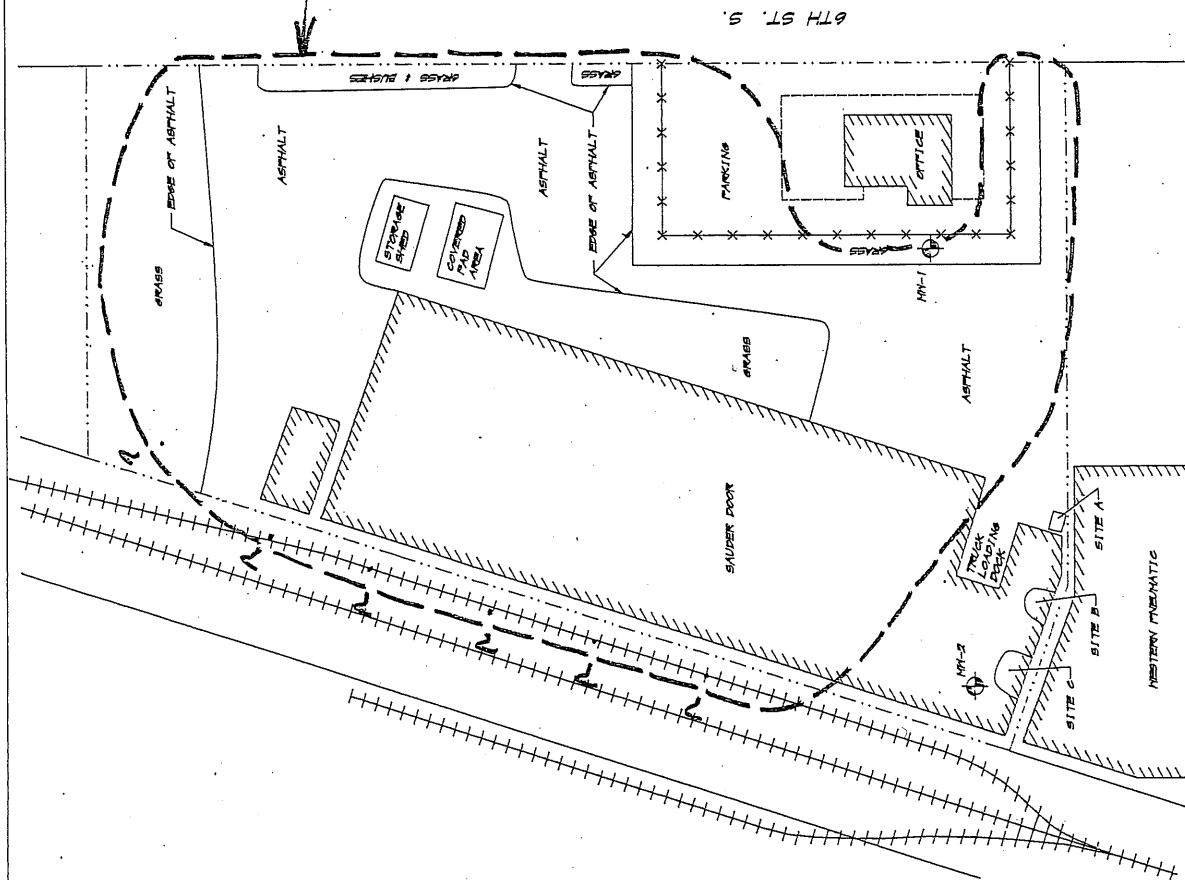
BASE MAP

LEGEND	
STREET	EXPLANATION
---	PROPERTY BOUNDARY
x-x-x-x	FENCE LINE
MM-1	MONITORING WELL LOCATION

APPROXIMATE BOUNDARY
OF SITE
M. ADAMS, ECOLOGY
SEPT, 2009

SAUDER DOOR COMPANY
815 6TH. ST. S.
KIRKLAND, WASH.
