STATE OF WASHINGTON
DEPARTMENT OF ECOLOGY

Re: No Further Action opinion for the following Property associated with a contaminated Site

Site name: Nelson Distributing Granite Falls
Property address: 201 W. Stanley St, Granite Falls, Snohomish County, WA 98252
Facility/Site ID: 48574863
Cleanup Site ID: 12684
VCP Project No.: NW2982

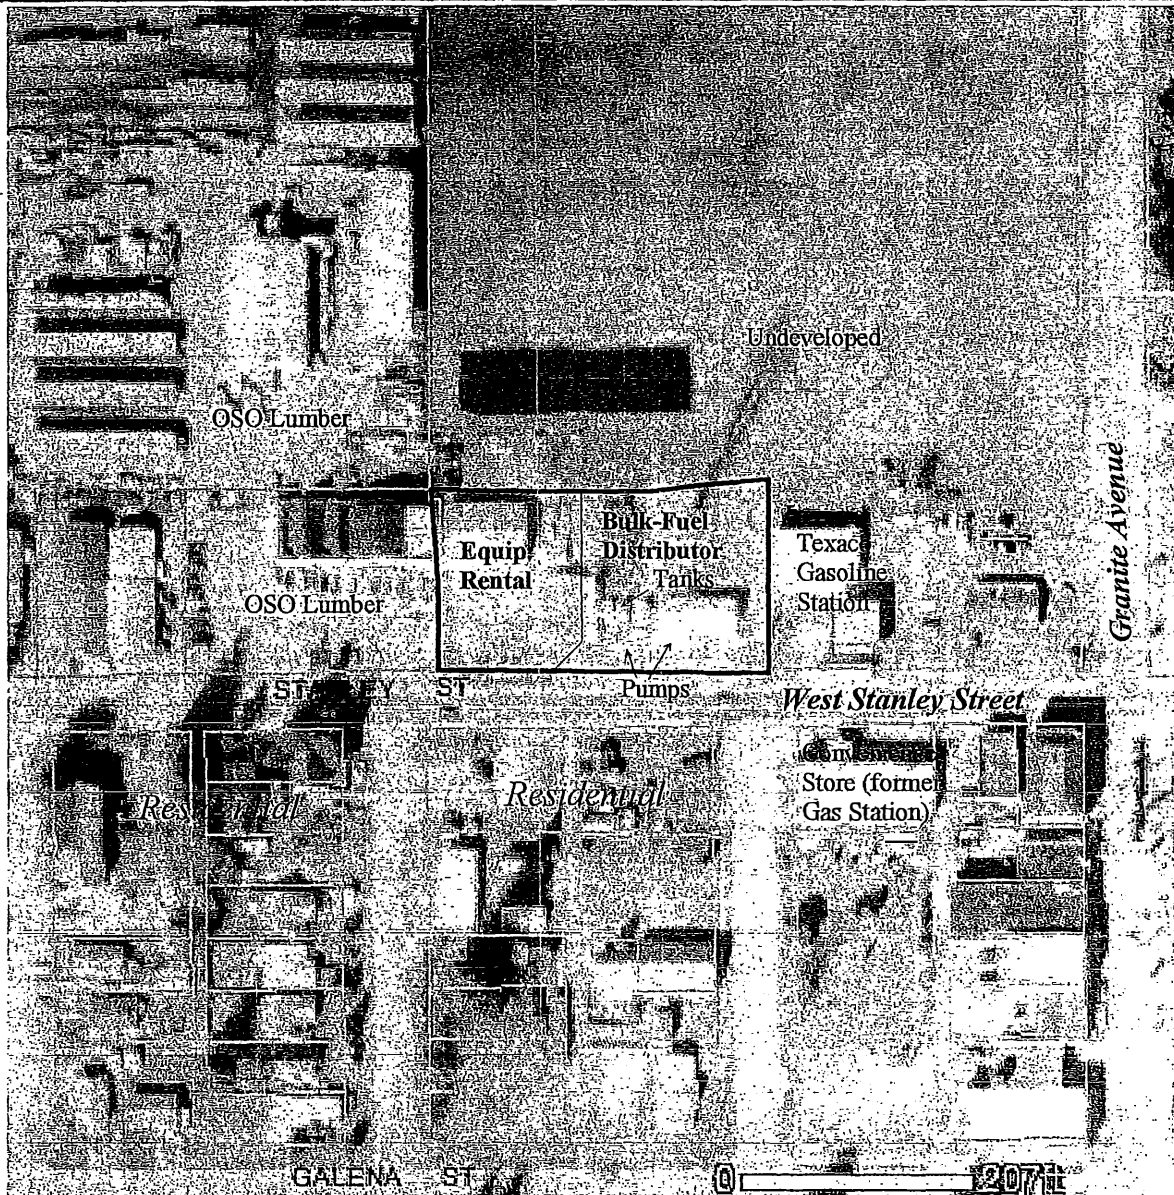
SITE PLAN

Shallow groundwater flow direction deduced by GeoEngineers in 1998.

**Bulk-Fuel Facility
201 West Stanley Street
Granite Falls, Washington**

Plate 2 Site Plan

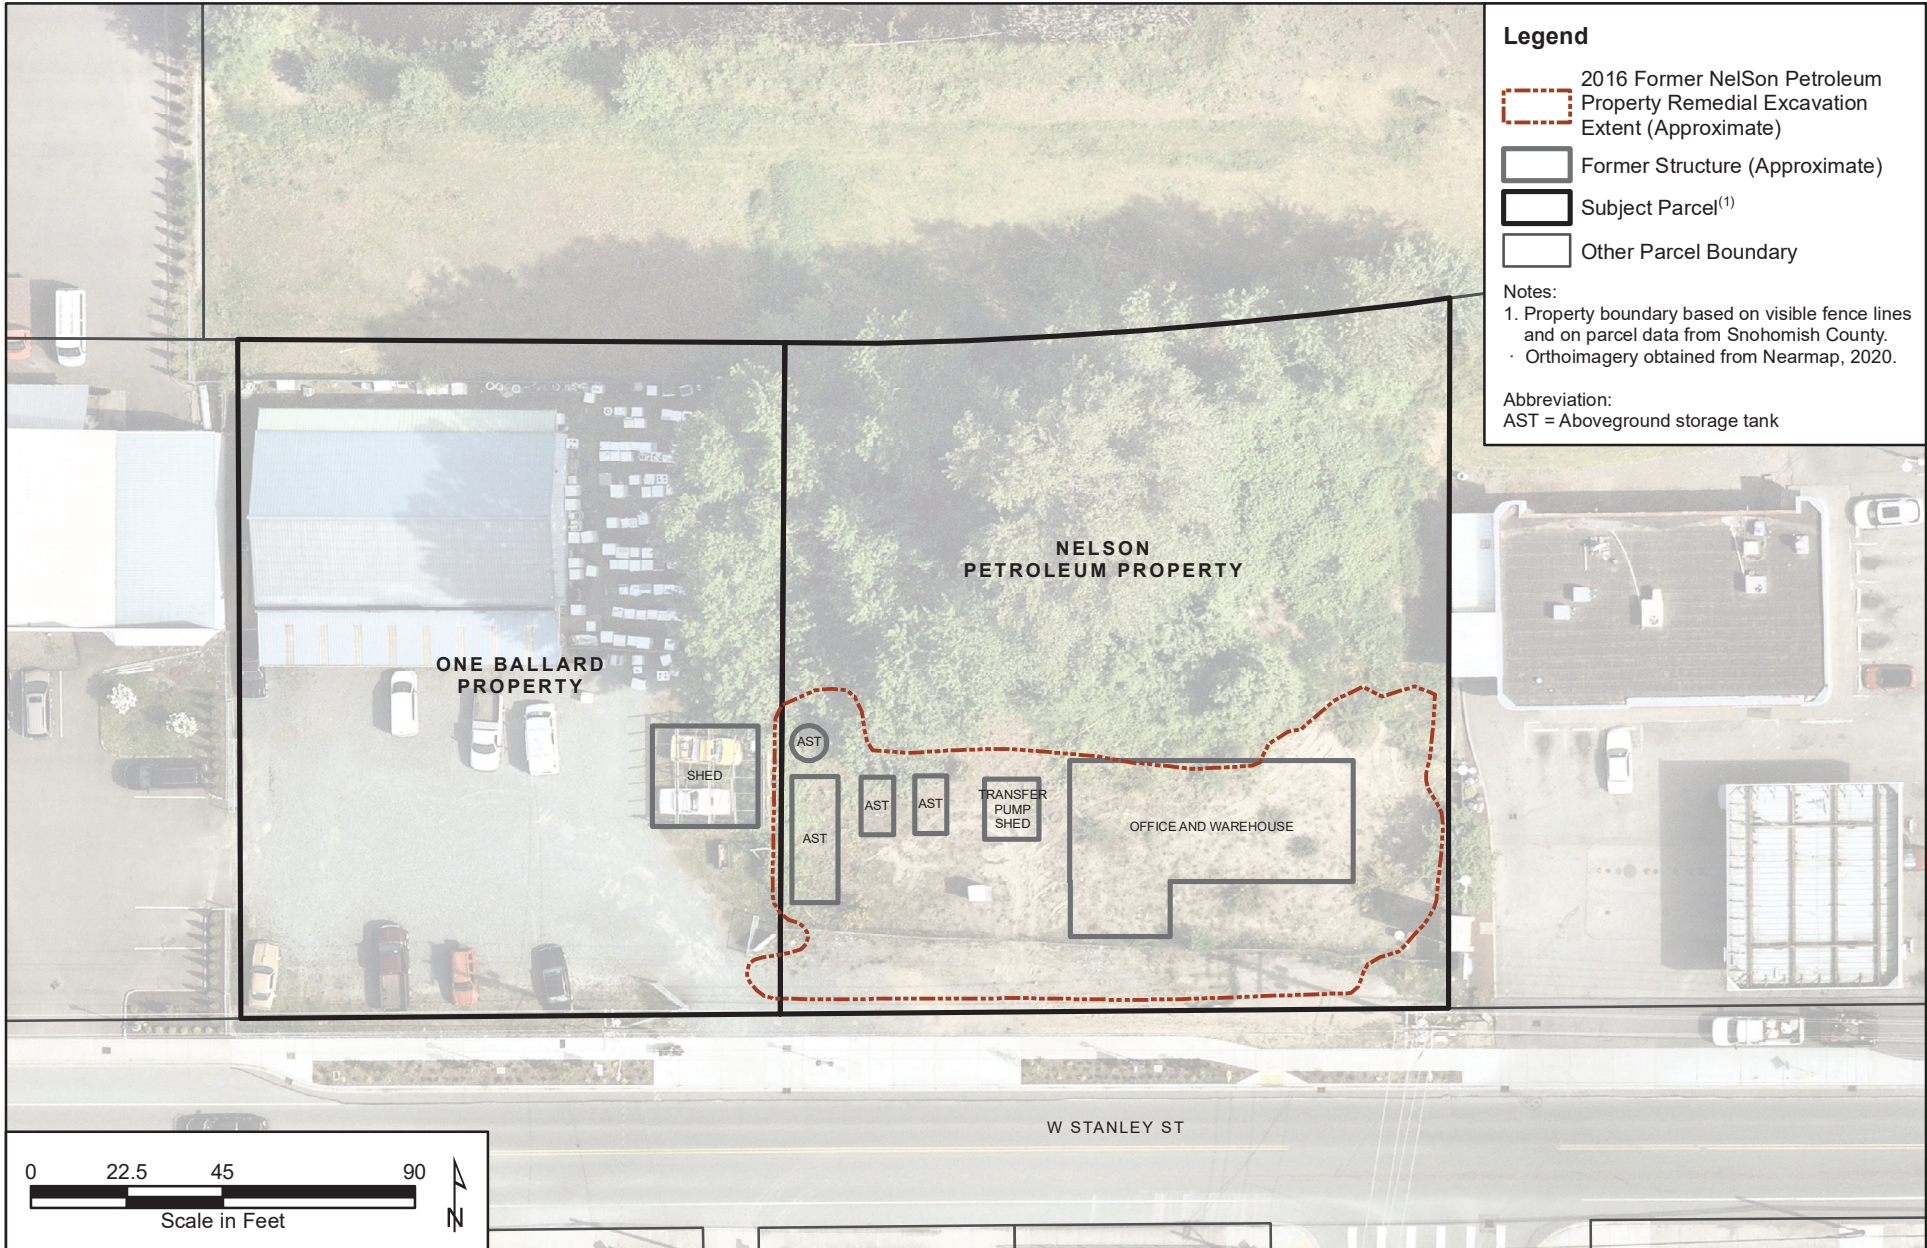
- 2016 Former NelSon Petroleum Property Remedial Excavation Extent (Approximate)
- Former Structure (Approximate)
- Subject Parcel⁽¹⁾
- Other Parcel Boundary

Figure 1 Property Features (Soil Boring Locations)

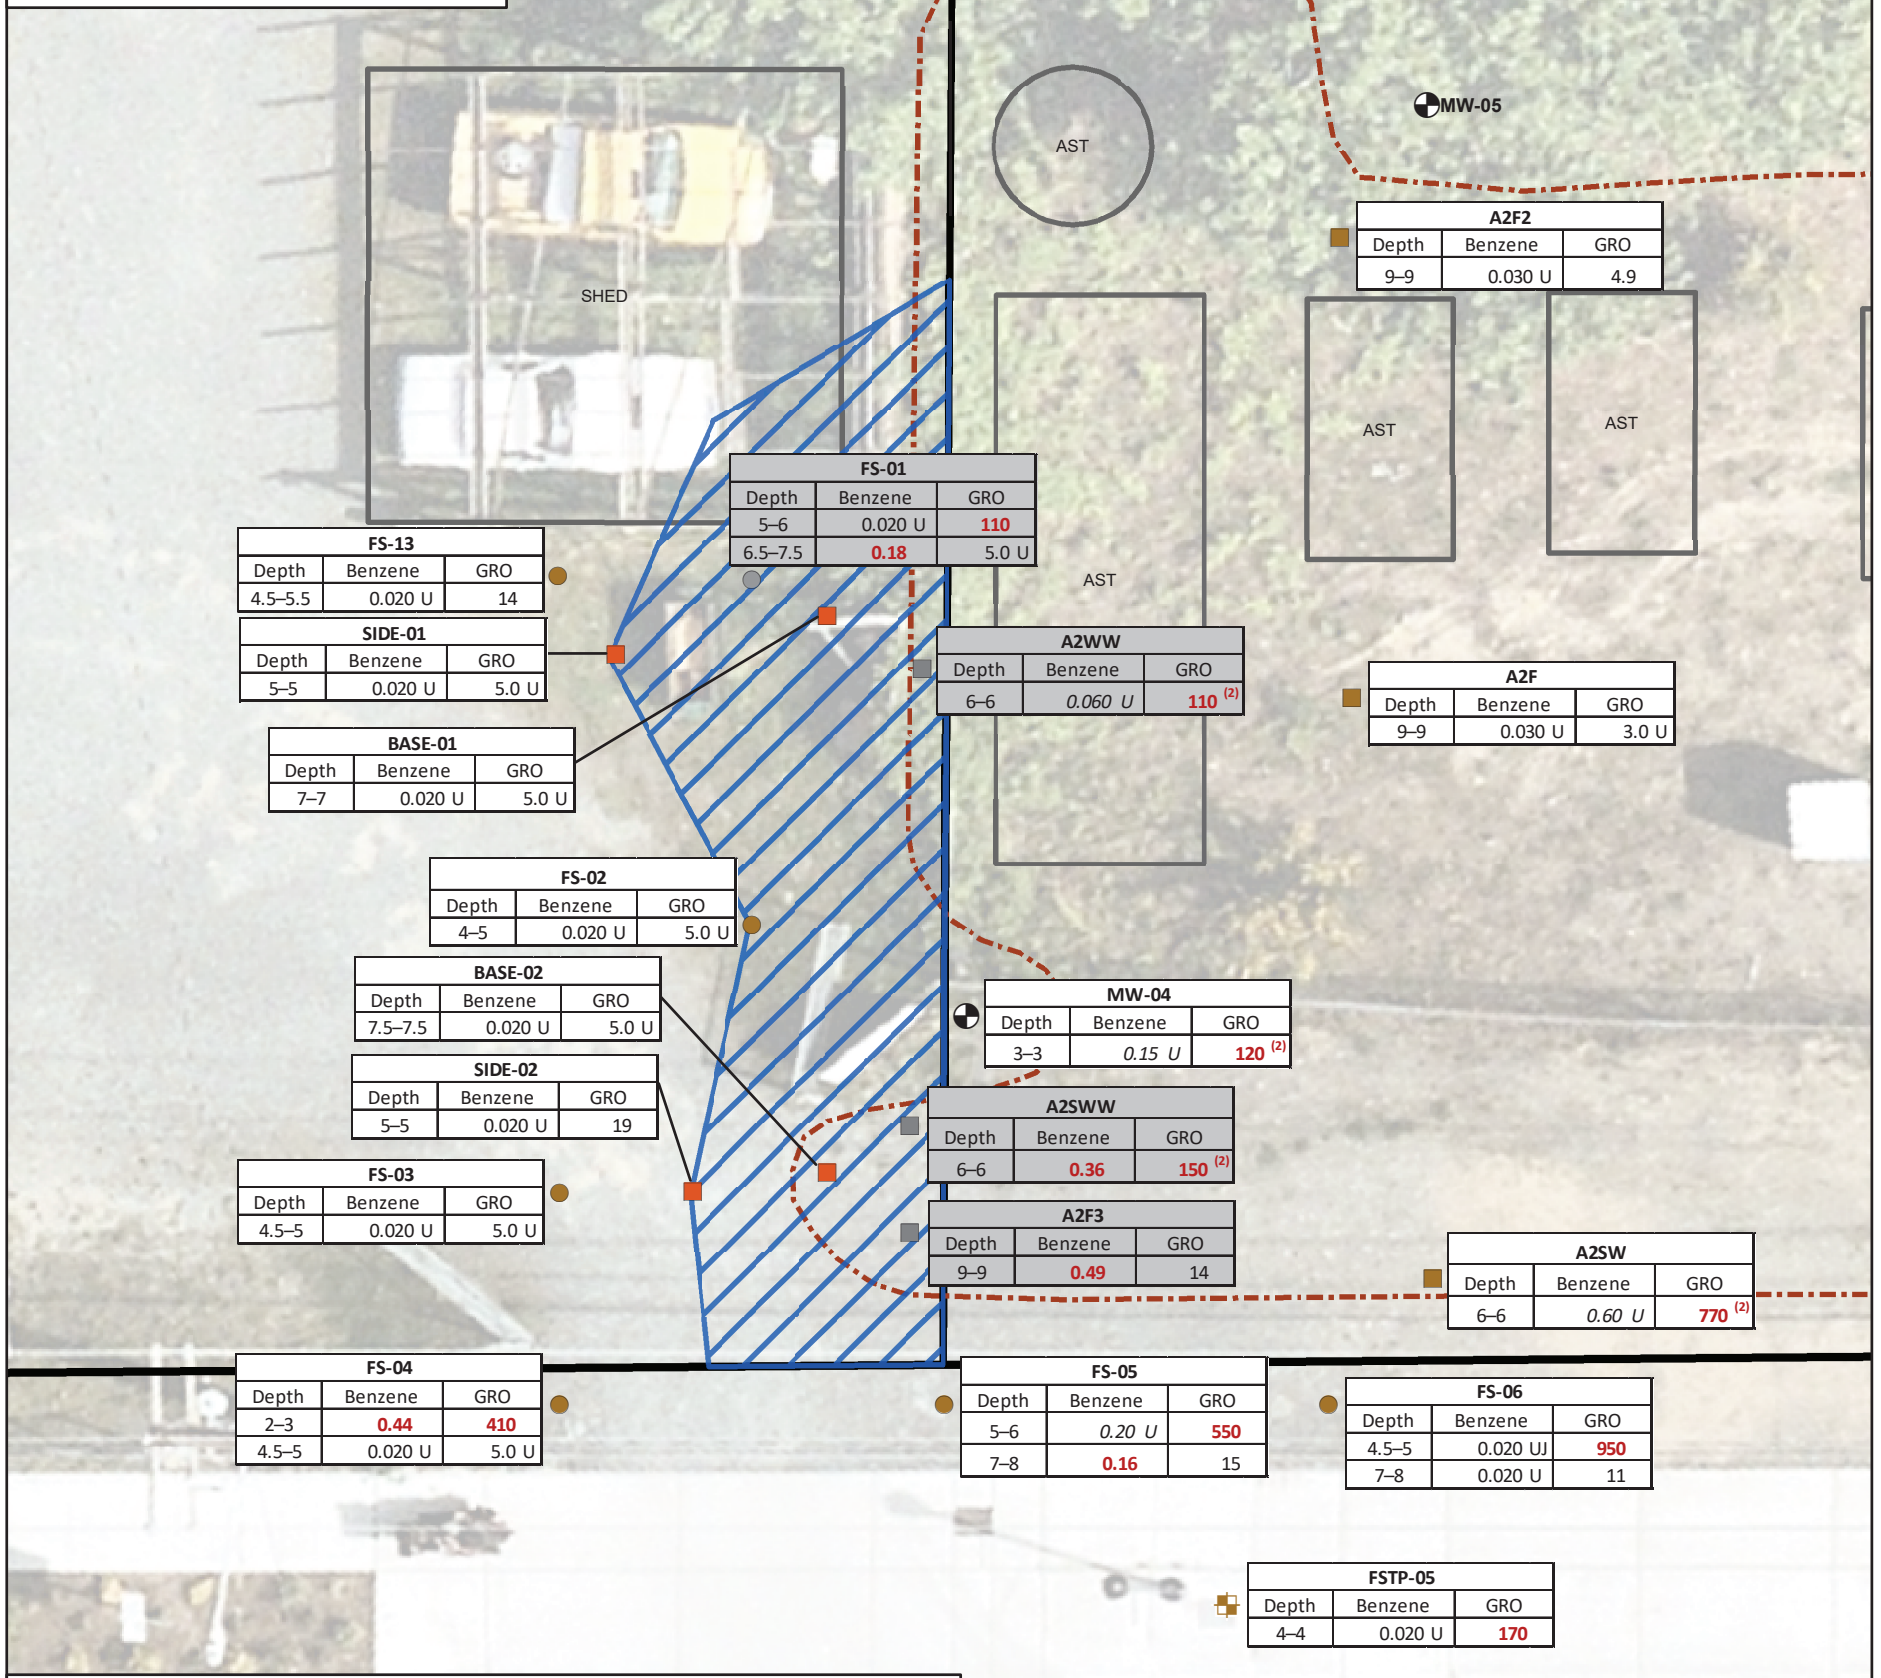
- Notes:
1. Property boundary based on visible fence lines in the east and west and on parcel data from Snohomish County in the north and south.
 2. Sample contains highly weathered gasoline.
 - Results shown in **RED BOLD** indicate a result that exceeds the MTCA Method A cleanup level for benzene (0.030 mg/kg) or GRO (30 mg/kg)
 - *Italics* indicate a reporting limit that exceeds the applicable cleanup level.
 - Depths are presented in feet bgs and benzene and GRO results are presented in mg/kg.
 - Direct push soil sample depths are approximate due to sample compression.
 - Measuring point for 2016 confirmation soil samples is presumed to be higher than current ground surface.
 - Orthoimagery obtained from Nearmap, 2020.

Based on the results of the 2016, 2021, and 2023 excavations, remaining contamination is found beneath West Stanley Street to the south of the 201 West Stanley Street Property. Additional excavation into the Right-of-Way was not allowed by the City of Granite Falls.

Figure 2 Excavation and Confirmation Sample Summary
