STATE OF WASHINGTON
DEPARTMENT OF ECOLOGY

Re: Opinion pursuant to WAC 173-340-515(5) on Remedial Action for the following Hazardous Waste Site:

- **Site Name:** TD Auto Body & Repair
- **Site Address:** 1209 East Fir Street, Seattle, Washington 98122
- **Facility/Site No.:** 2501
- **Cleanup Site ID No.:** 2666
- **VCP Project No.:** NW3194

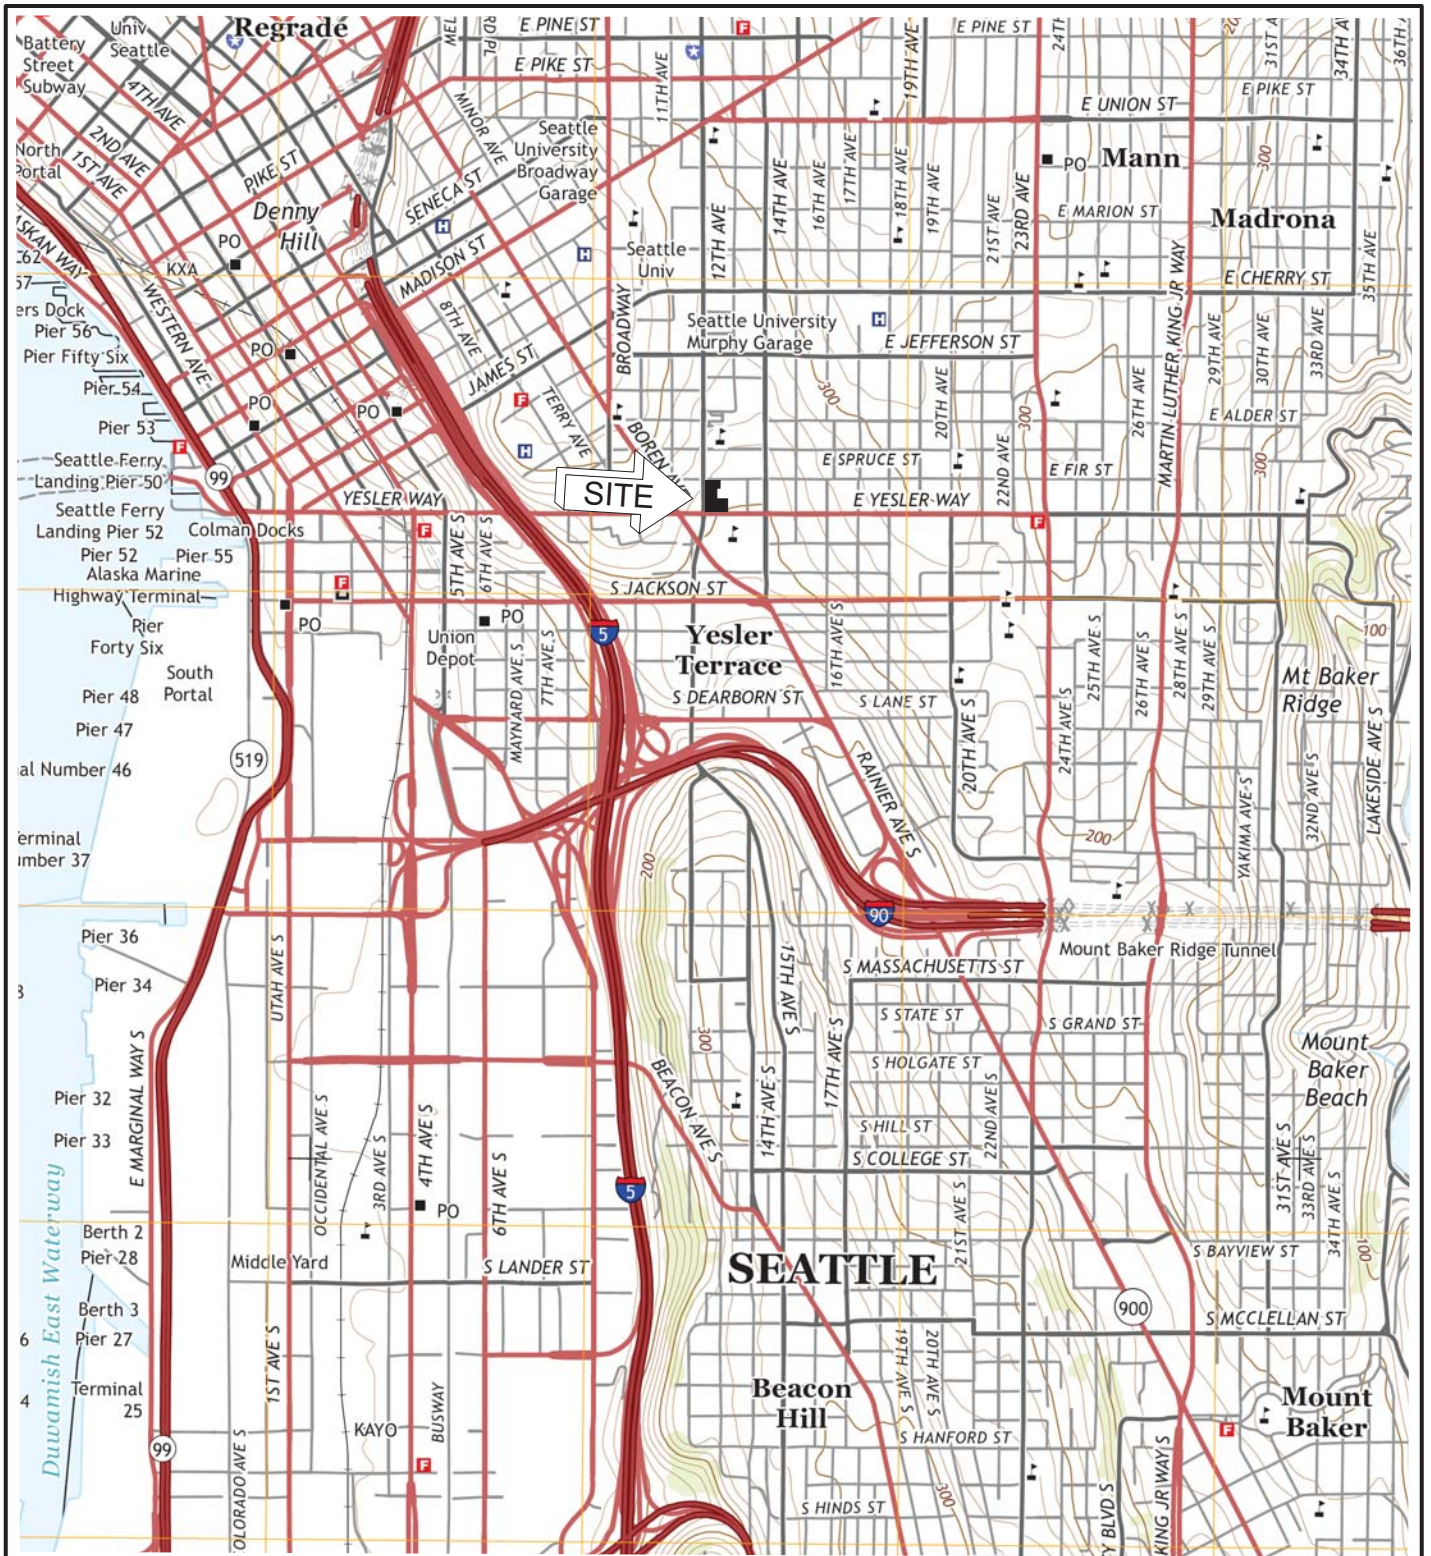
Enclosure A: Figure 1

Figure 1 - Site Map

These four parcels are collectively referred to as Property in this opinion letter (see **Enclosure A, Figure 1, Figure 2**).

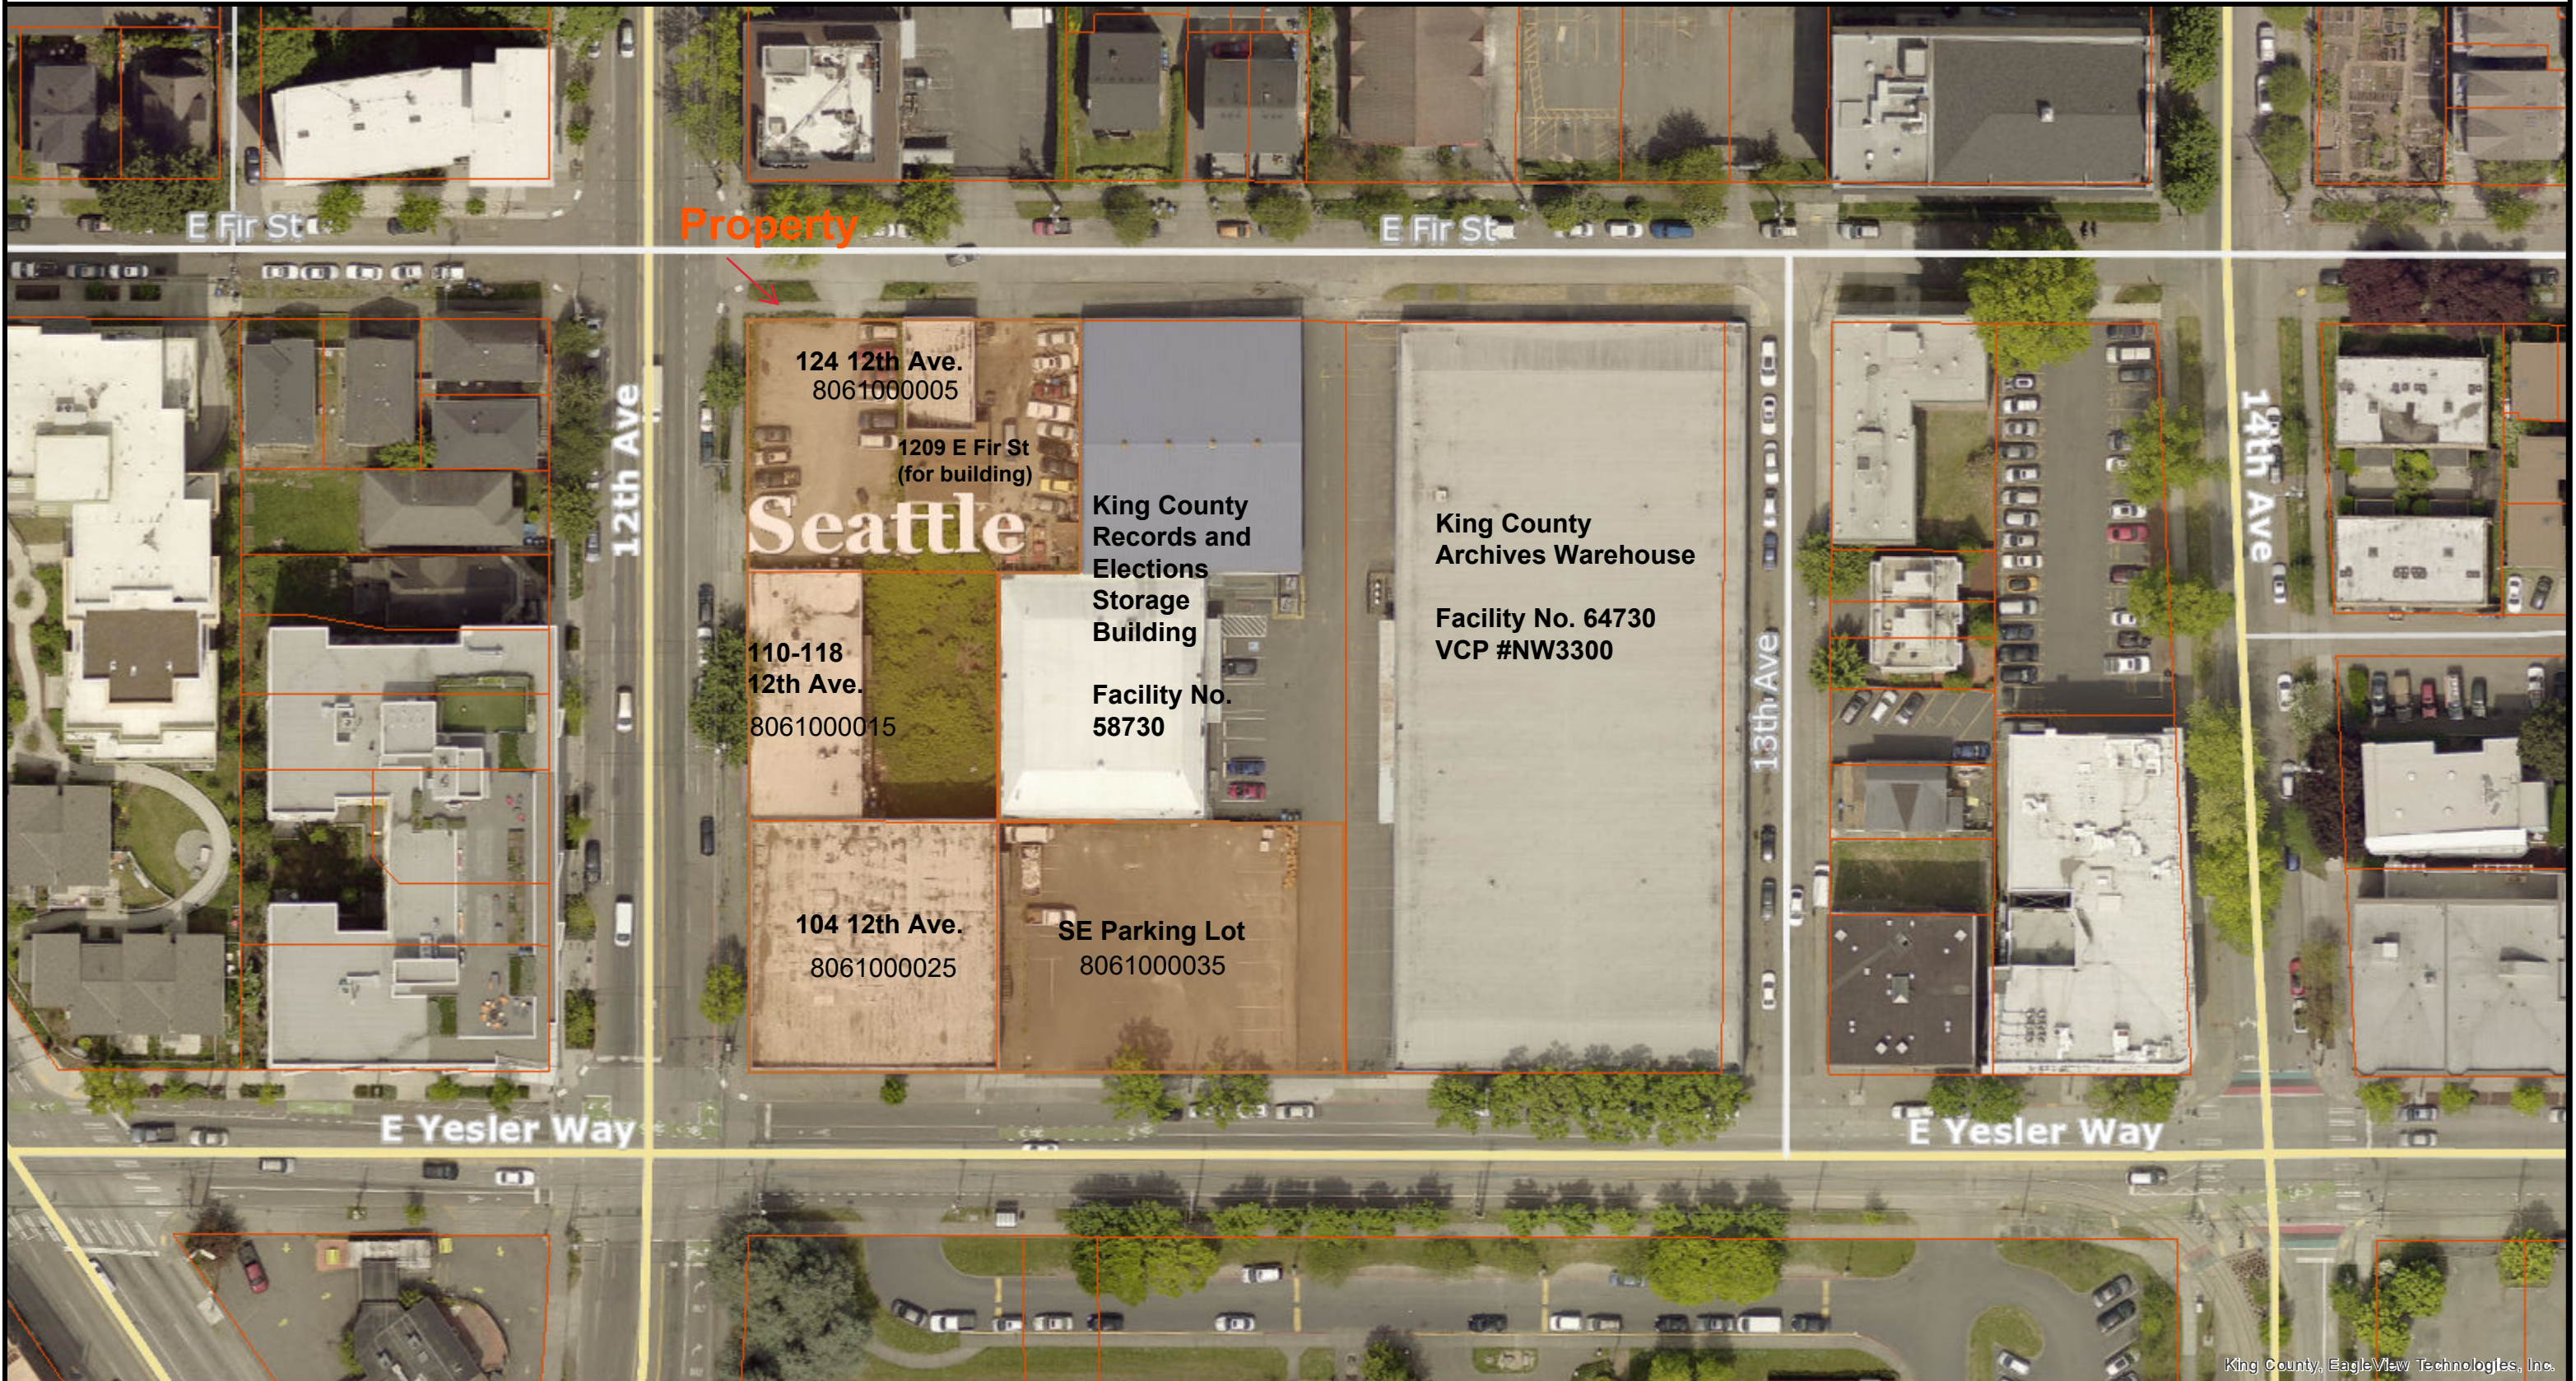
Enclosure A: Figure 2

Base Map is from King County iMAP

Two other cleanup facilities are located adjacent to Property (**Figure 2**):

From about 1907 to 1913, most of the Property was used as a baseball stadium by the Seattle Giants, with grandstands built along East Yesler Way. Subsequent Property uses included **(Figure 2, Figure 3)**:
