OPERATIONS AND MAINTENANCE PLAN

Lenora Building Site

Facility/Site #91413494 and Cleanup Site ID #1802

Project No. 170291 • September 14, 2023

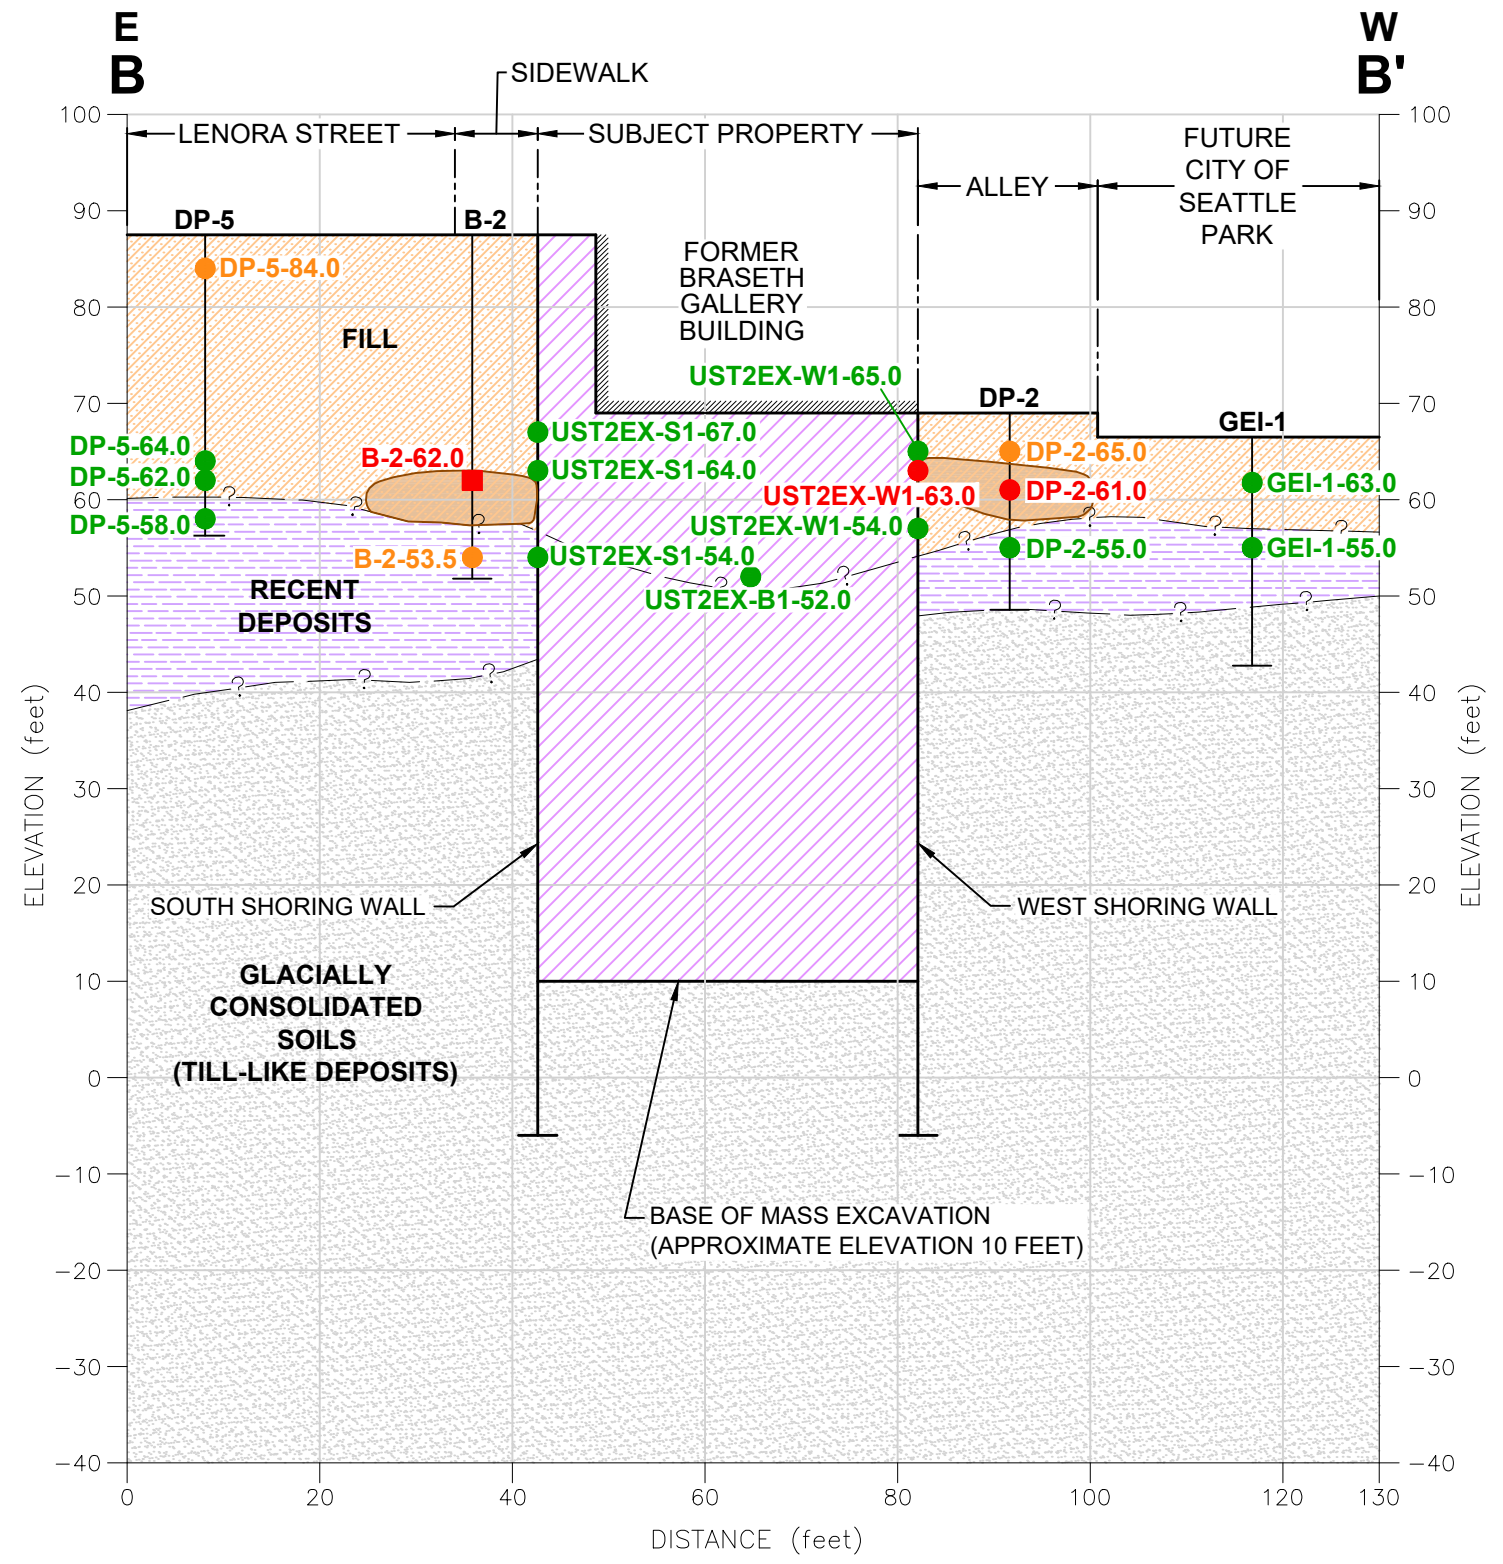
- Soil sample with gasoline- and heavy oil-range hydrocarbons and toluene detections greater than MTCA Method A Cleanup Levels
- Soil sample with MTCA exceedance for diesel- and heavy oil-range hydrocarbons and PAHs
- Soil sample with petroleum hydrocarbons and PAHs detections less than MTCA Method A Cleanup Levels
- Soil sample non-detect for petroleum hydrocarbons and PAHs

- Notes:
1. The subsurface conditions shown are based on interpolation between widely spaced explorations and should be considered approximate; actual subsurface conditions may vary from those shown.
 2. Refer to Figure 7 for location of Cross Section.
 3. This figure is for informational purposes only. It is intended to assist in the identification of features discussed in a related document. Data were compiled from sources as listed in this figure. The data sources do not guarantee these data are accurate or complete. There may have been updates to the data since the publication of this figure.
 4. Figure sourced from GeoEngineers, Cross Section A-A' Figure 6, 2016.
