Engineering and Institutional Controls  
Monitoring and Maintenance Plan

Dakota Creek Industries Site  
Anacortes, Washington

May 2, 2024

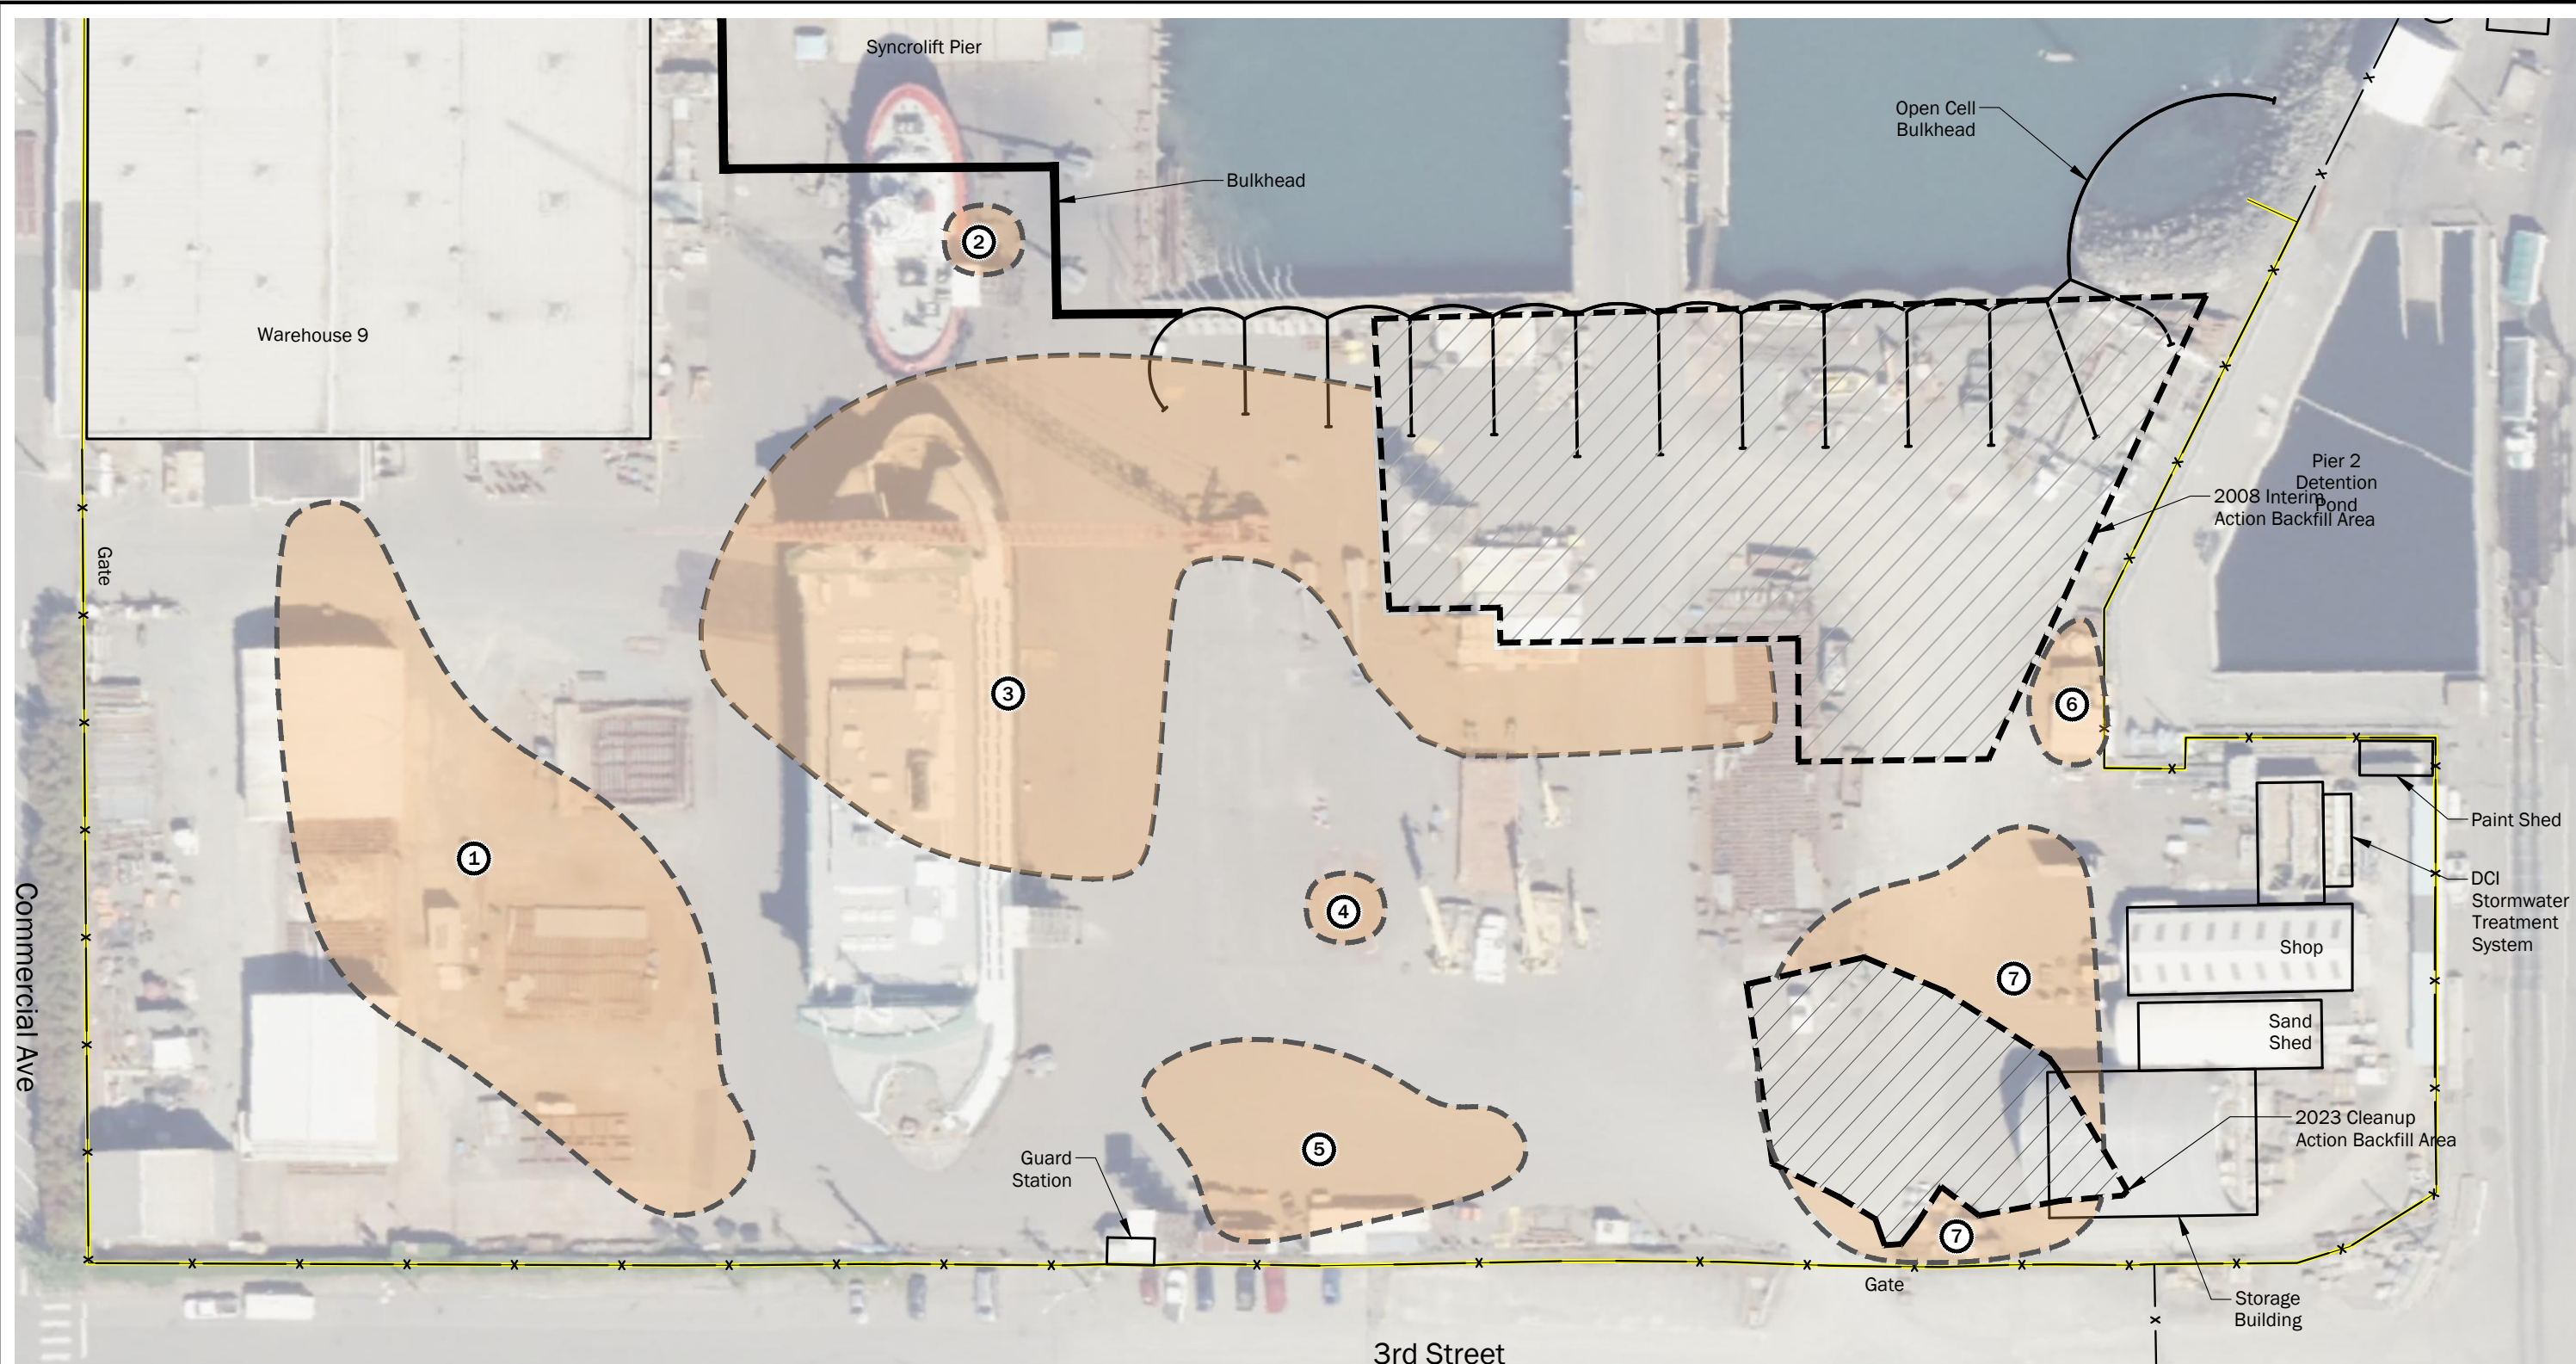
<b>Soil Contamination Summary</b>	
Dakota Creek Industries Anacortes, Washington	
	<b>Figure 5</b>

Legend	
	Dakota Creek Industries (DCI) Property Boundary
	Area of Soil Contamination Based on Previous Site Investigation
	Import Soil Backfill Area
cPAH -	Carcinogenic Polycyclic Aromatic Hydrocarbon
TEQ -	Toxic Equivalent Quotient
bgs -	Below Ground Surface

Site soils are generally comprised of multiple layers of historical fill overlying native marine sediment and glacial deposits. More recently, imported material was placed at the Site as part of the Project Pier 1 Redevelopment activities to expand the shoreline of the Upland Area northward of the historical shoreline. Clean fill material was placed behind the new open cell bulkhead following completion of the interim action dredging in this area. Additionally, clean fill material was placed at the Site to restore the 2023 cleanup action area. Project Pier 1 and 2023 Cleanup Action backfill areas are shown in Figure 5.

Currently, contaminated material in the Upland Area of the Site contains arsenic and nickel, and carcinogenic polycyclic aromatic hydrocarbons (cPAHs) at concentrations greater than the established soil cleanup level. The distribution of Upland Area arsenic and nickel, and cPAH contamination is shown in Figure 5 and is summarized below.

In the event that it becomes necessary to disturb one or more Site control that results in the exposure of soil within the DCI Lease Area, the Port will identify proper soil management procedures prior to initiating the work. These procedures apply to both the areas of contamination identified in Figure 5 and the remaining parts of the DCI Lease Area outside of these areas. Such on-site work should not begin until the Port has reviewed the proposed work and provides authorization to proceed. Proper material handling procedures based on the Port's review of the planned work will be established for soil disturbed in these areas, and as further described below.

As described in Section 2.3, arsenic, nickel and cPAH contamination has been identified in fill soil up to a depth of approximately 13 feet bgs within portions of the DCI Lease Area (see Figure 5). In general, soil and/or demolition debris (asphalt, concrete, etc.) generated from within the materials management area shown in Figure 7 should be segregated, stockpiled and managed as described in Section 5.3.
