From: [Winslow, Frank \(ECY\)](#)
To: ["Lisa Thompson"](#)
Cc: [Suzy Stumpf](#)
Subject: RE: XN0032 - Block 10 Site - Remedial System Operations and Cleanup Objectives
Date: Friday, August 16, 2024 8:44:29 AM
Attachments: [image001.png](#)
[image002.png](#)
[image003.png](#)

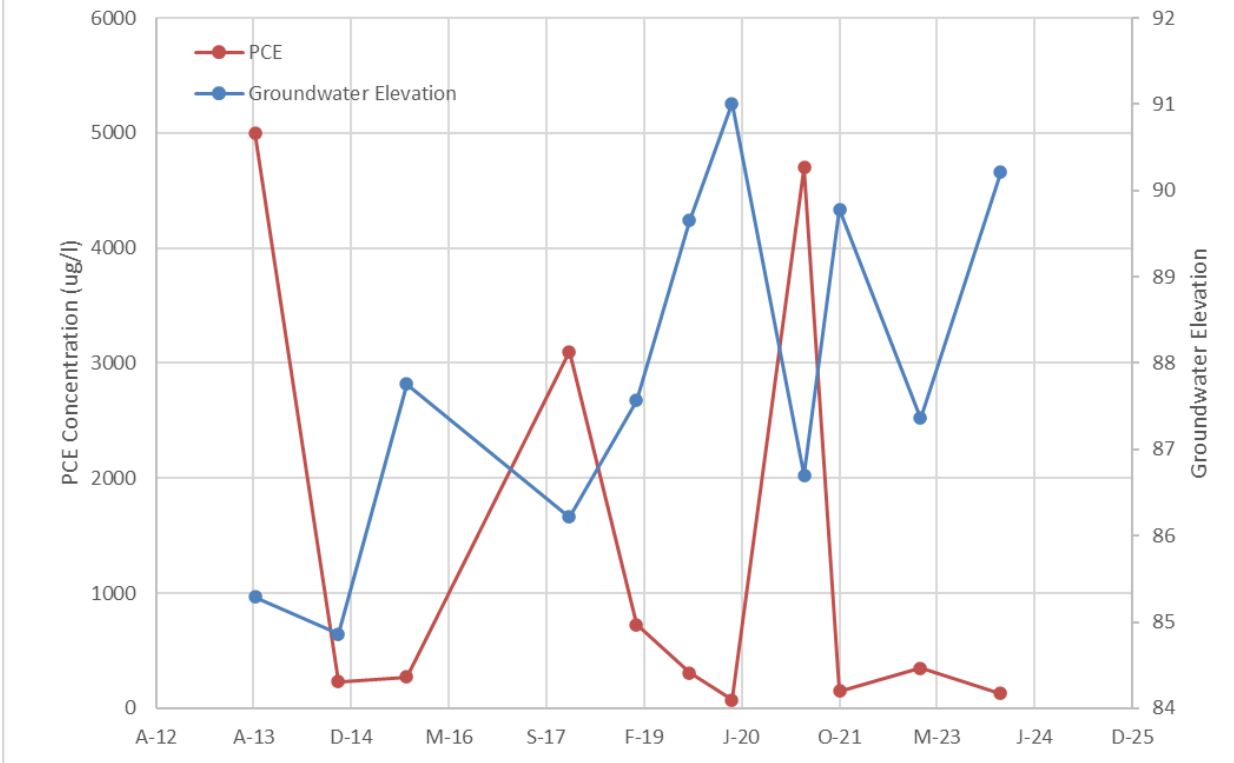
DPE 34: Groundwater Elevation vs PCE Concentration

For the groundwater sampling events prior to May 2023, the downwell pumps were turned off approximately two weeks prior to the event. Prior to turning off the pumps, they were on and cycling when water was present above the pump inlet. There are no flow meters on the individual lines, so it is not possible to record the flow from each individual pump. However, it does appear that the concentrations of PCE and TCE at DPE-34 and DPE-35 increase during times of lower groundwater elevations, see draft charts below.

With respect to the relationship between spiking concentrations and pumping at DPE-34 and DPE-35, my understanding is that Farallon does not believe that any correlation between pump cycling and the elevated concentrations (spikes) observed at DPE-34 and DPE-35 can be drawn. However, I have not seen any charts or data showing pump runtimes from DPE-34 and DE-35. Supporting that conclusion with a data presentation may be appropriate. If the observed spikes are not attributable to specific pumping scenarios, does Farallon have an alternative conceptual model?
