## **Cleanup Action Plan Block 38 West**

**500 through 536 Westlake Avenue North  
Seattle, Washington**

Washington State Department of Ecology  
Shoreline, Washington

December 2024

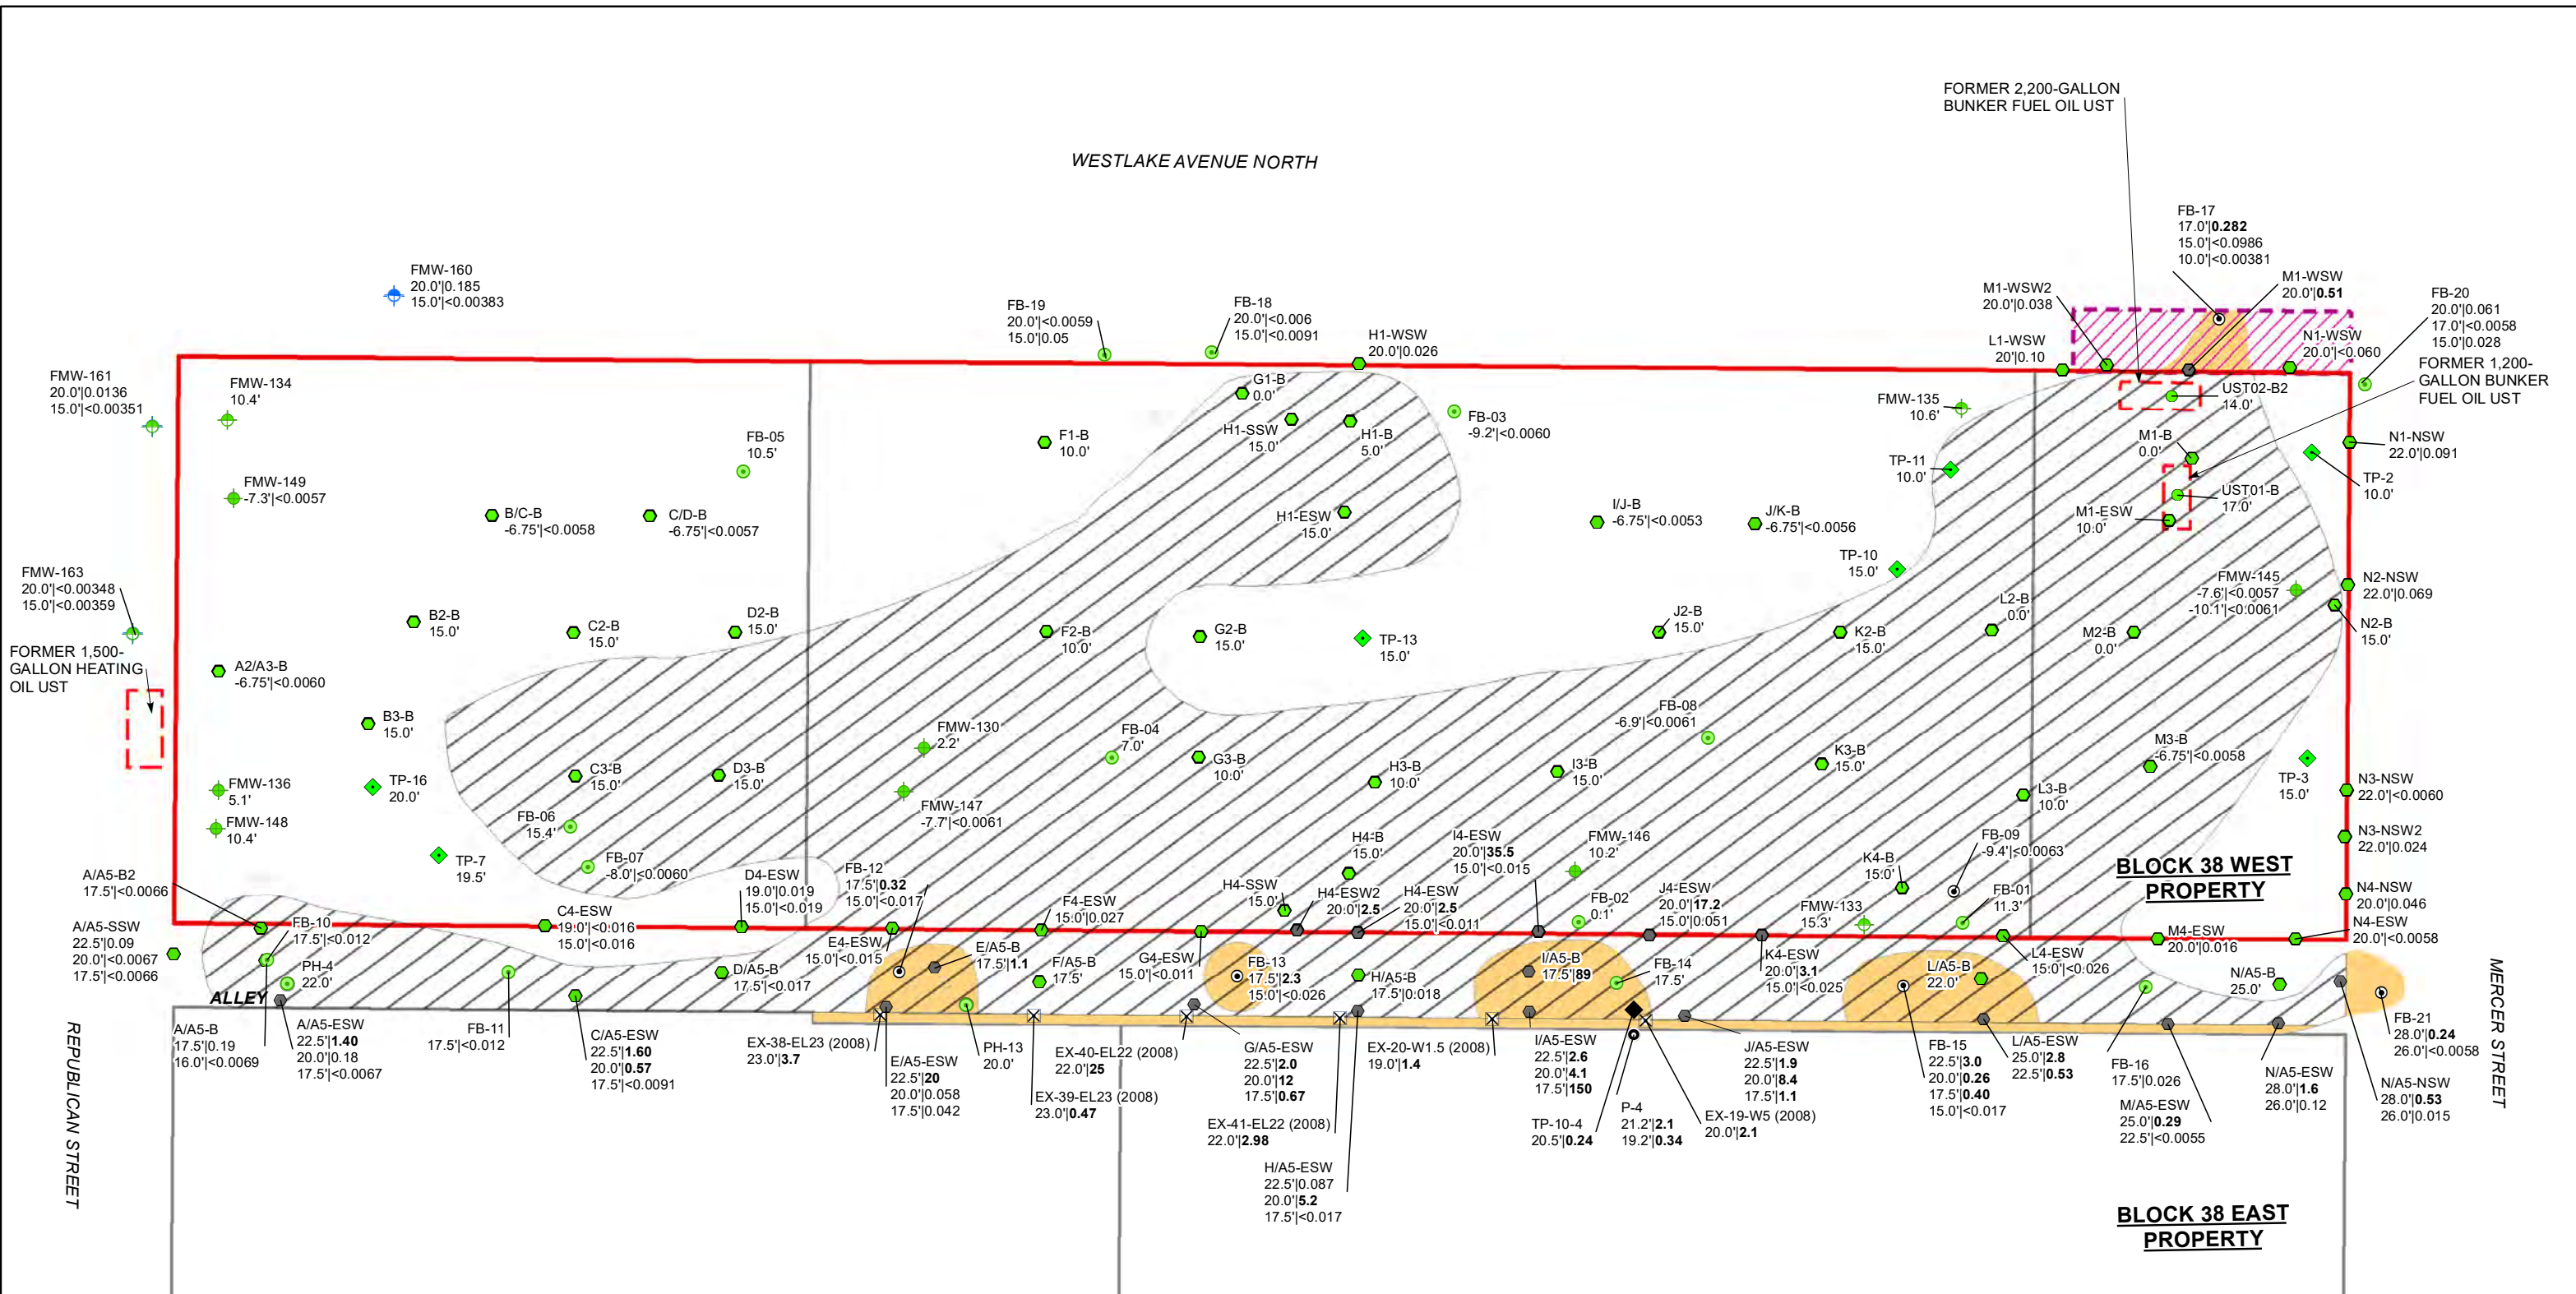
**FIGURE 8**  
 POST INTERIM ACTION  
 SOIL ANALYTICAL RESULTS  
 FOR cPAH TEC  
 BLOCK 38 WEST SITE  
 SEATTLE, WASHINGTON  
 FARALLON PN: 397-019

- DENOTES SAMPLE LOCATION AND ELEVATION IN FEET NAVD88 WHERE cPAHs RESULTS ARE LESS THAN THE CLEANUP LEVEL
- ESTIMATED EXTENT OF SOIL EXCEEDING THE CLEANUP LEVEL REMAINING IN PLACE POST INTERIM ACTIONS OR INACCESSIBLE DUE TO EXISTING UTILITY BANK
- ESTIMATED EXTENT OF SOIL EXCEEDING THE SCREENING LEVEL THAT WAS EXCAVATED AND REMOVED BY INTERIM ACTIONS
- MECHANICAL EQUIPMENT AREA DECOMMISSIONED AND FILLED WITH CDF
- PROPERTY BOUNDARY
- FORMER UNDERGROUND STORAGE TANKS (USTs)
- KING COUNTY PARCEL BOUNDARY

**BOLD** = DENOTES ELEVATION AND CONCENTRATIONS THAT EXCEED THE CLEANUP LEVEL OF 0.19 mg/kg  
 < = DENOTES ANALYTE NOT DETECTED AT OR EXCEEDING THE REPORTING LIMIT LISTED FOR TOTAL TOXIC EQUIVALENT CONCENTRATION OF BENZO(A)PYRENE (mg/kg)

As documented in the RI/FFS, analytical results of performance soil sampling indicates that soil containing total DRO+ORO and cPAHs at concentrations exceeding cleanup levels remains in localized areas within the alley area, a limited portion of the Mercer Street right-of-way, and near the northwestern boundary of the Block 38 West Property (Figures 4 through 8). Confirmation samples collected on the Block 38 West Property indicate all soil with detectable concentrations of COCs have been removed.

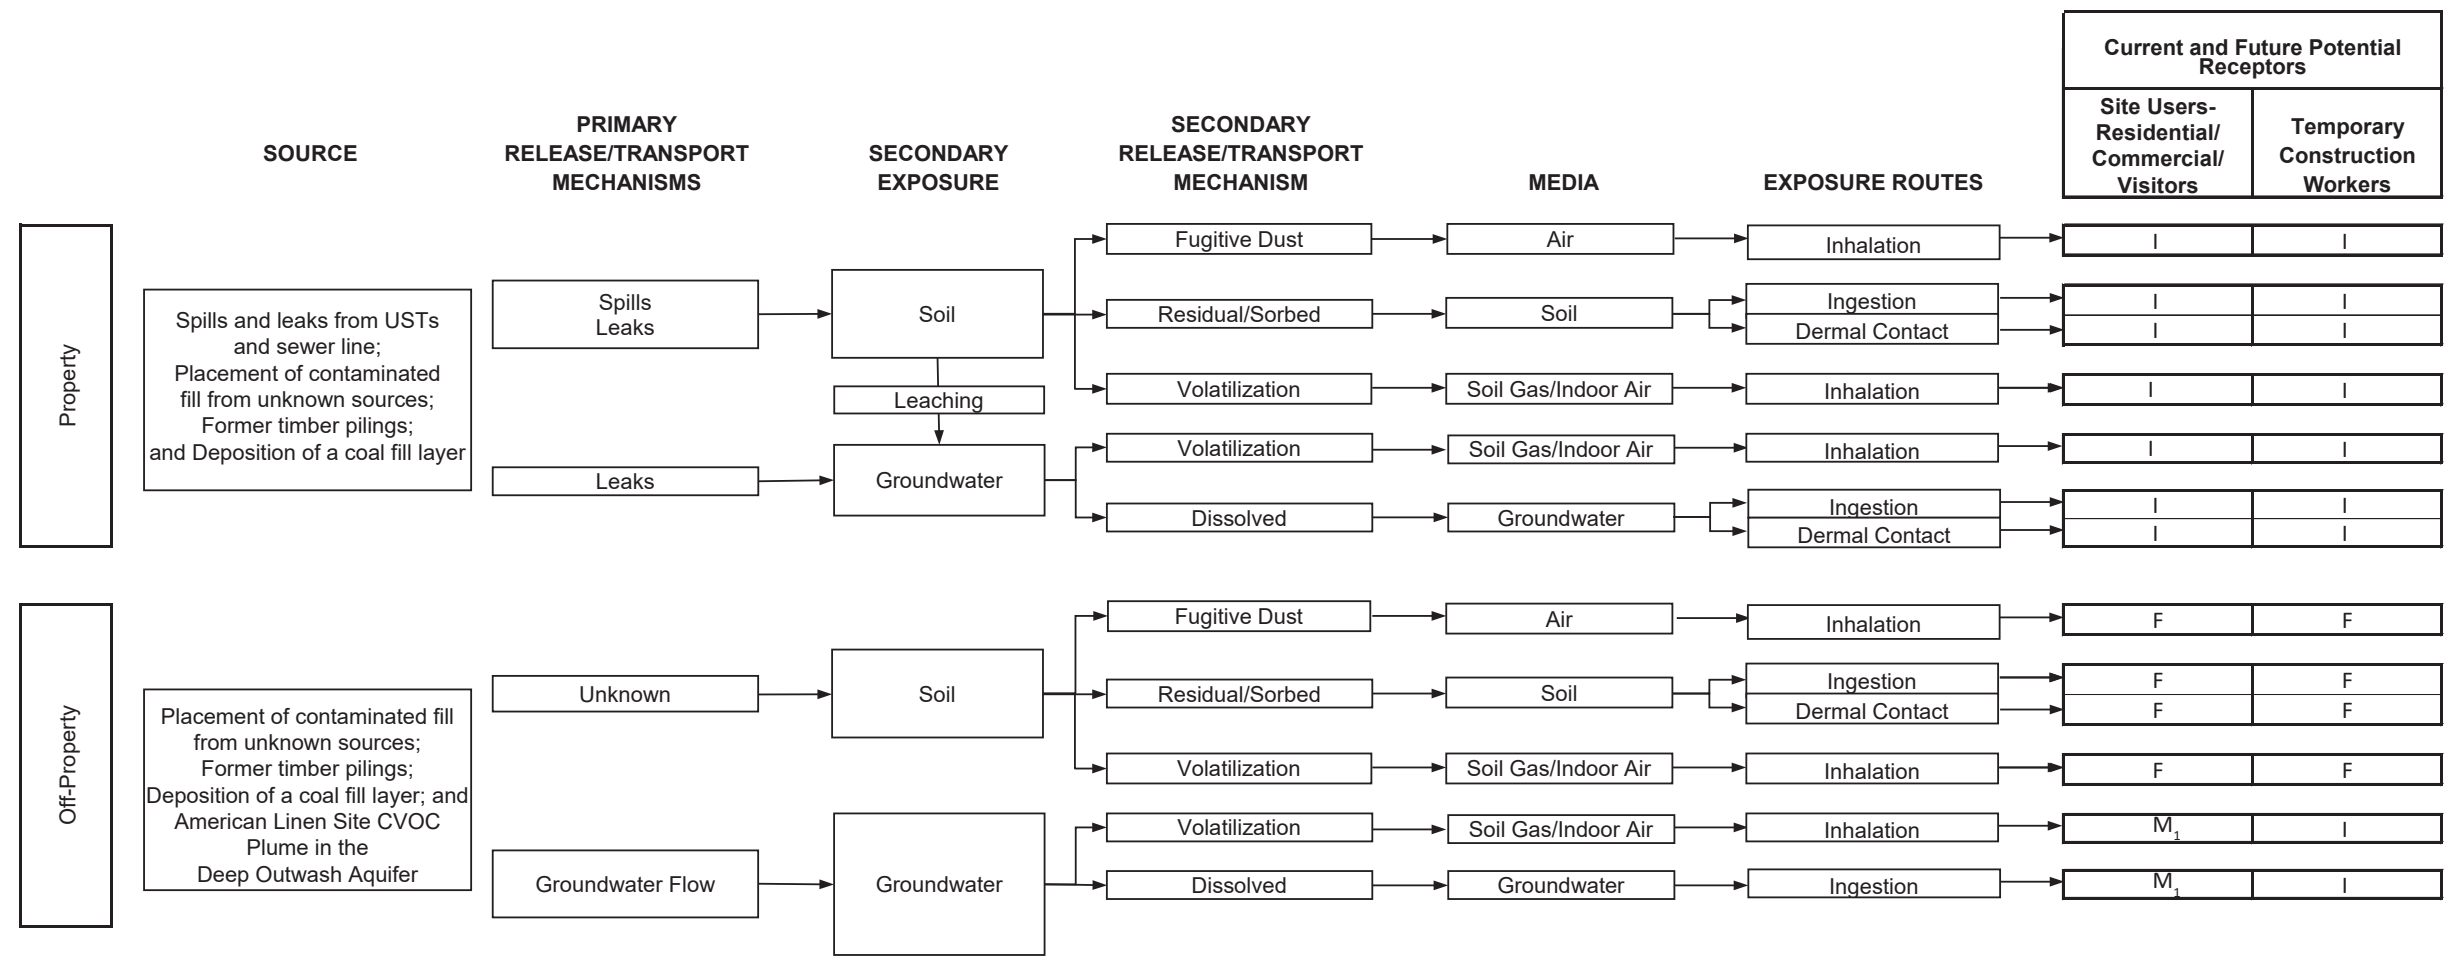
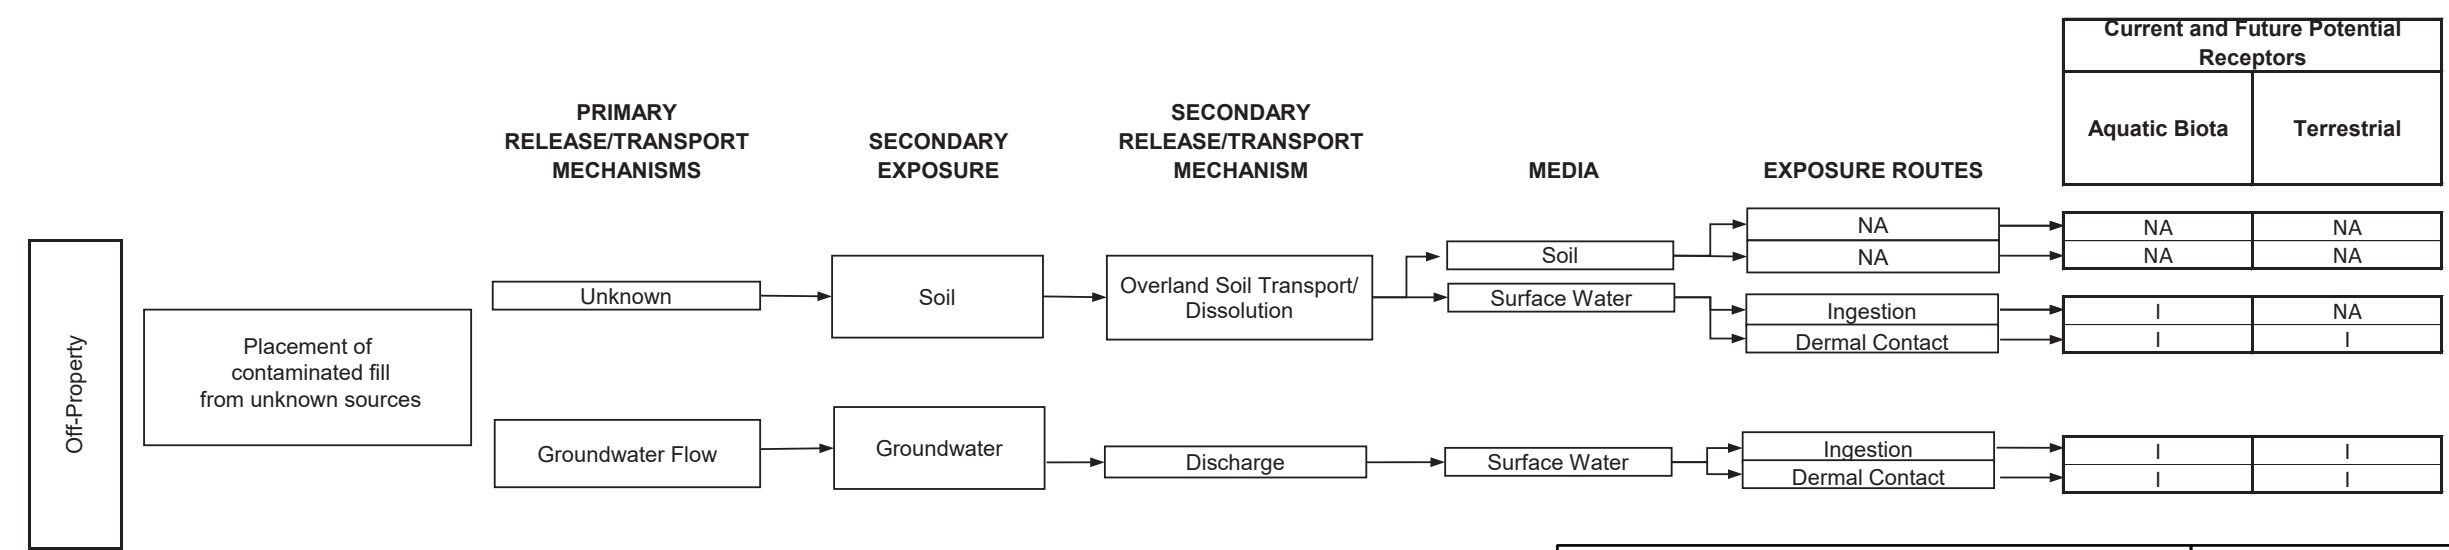
HUMAN HEALTH RISK CONCEPTUAL SITE MODEL

I = Incomplete Pathway  
 C = Complete Current Pathway  
 M = Complete pathway currently on Property mitigated by presence of vapor barrier and concrete floor  
 M<sub>1</sub> = Pathway is incomplete based on the COCs for the Block 38 West Site.  
 However the pathway is potentially complete based on the presence of the American Linen Site CVOC Plume adjacent to the Block 38 West Site.  
 F = Currently Incomplete, Potentially Complete Pathway in Future  
 NA = not applicable

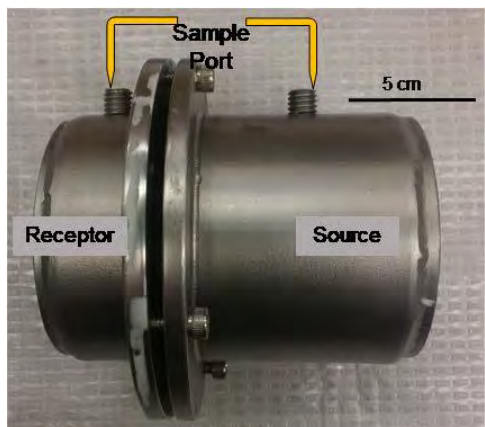
**Figure 1: Double Compartment Cell**

The diffusion testing setup used stainless steel double-compartment cells (Figure 1), such that source and receptor volumes were separated by the Drago Wrap membrane. The cell was screwed together, with the membrane secured using two Viton rings (Figure 2) to prevent the loss of contaminant at the connection between each compartment and the membrane. Both the source and receptor were filled with double deionized (DDI) water, and a septum was inserted into the sampling ports to prevent losses. A stock solution of contaminants was added to the source compartment to form a dilute aqueous solution with a known concentration. Before assembly, and after disassembly, the mass of the membrane was recorded.

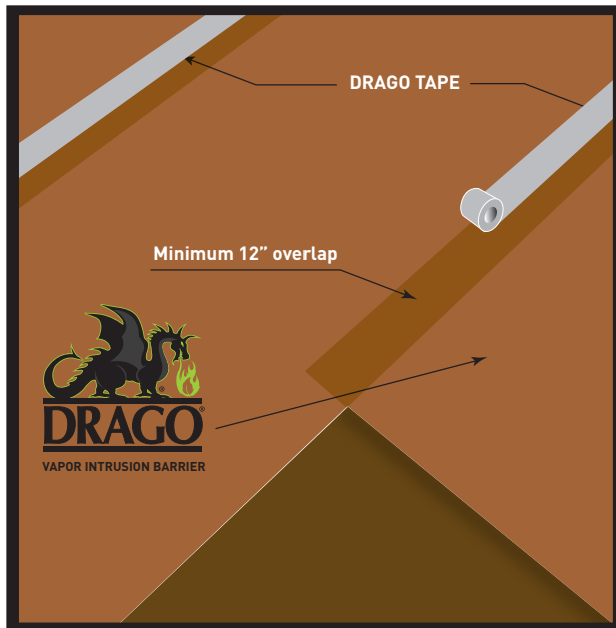
Fig.1: UNDER-SLAB INSTALLATION

2. Unroll Drago Wrap over the area where the slab is to be placed. Drago Wrap should completely cover the concrete placement area. All joints/seams should be overlapped a minimum of 12 inches and taped using Drago® Tape. (Fig. 1). If additional protection is needed, install DragoTack™ Tape in between the overlapped seam in combination with Drago Tape on top of the seam.

**NOTE: The area of adhesion should be free from dust, dirt, moisture, and frost to allow maximum adhesion of the pressure-sensitive tape. Ensure that all seams are taped with applied pressure to allow for maximum and continuous adhesion of the pressure-sensitive Drago Tape. Adhesives should be installed above 40°F. In temperatures below 40°F, take extra care to remove moisture/frost from the area of adhesion.**

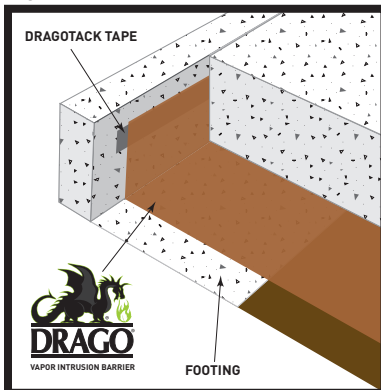
Fig.2a: SEAL TO PERIMETER WALL

- a. Make sure area of adhesion is free of dust, dirt, debris, moisture, and frost to allow maximum adhesion.
- b. Remove release liner on one side and stick to desired surface.
- c. When ready to apply Drago Wrap, remove the exposed release liner and press firmly against DragoTack Tape to secure.
- d. If a mechanical seal is needed, fasten a termination bar over the top of the Drago Wrap inline with the DragoTack Tape.

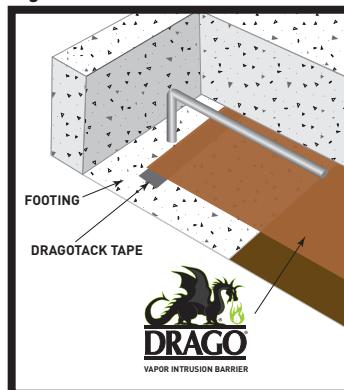
Fig. 2b: SEAL TO FOOTING

**NOTE: If sealing to the footing, the footing should receive a hand float finish to allow for maximum adhesion.**

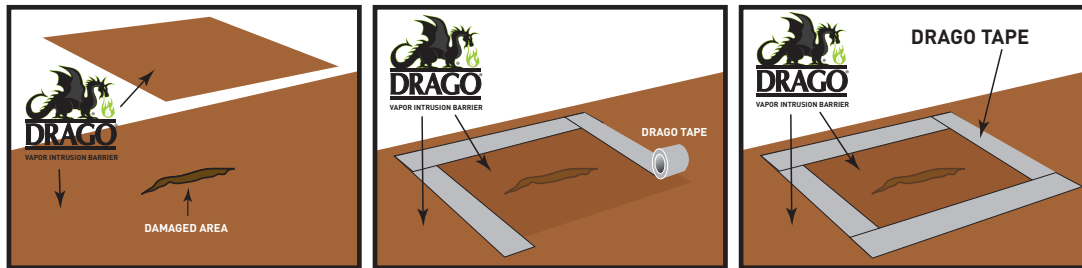
Fig. 3: SEALING DAMAGED AREAS

4. In the event that Drago Wrap is damaged during or after installation, repairs must be made. Cut a piece of Drago Wrap to a size and shape that covers any damage by a minimum of 6 inches in all directions. Clean all adhesion areas of dust, dirt, moisture, and frost. Tape down all edges using Drago Tape. (Fig. 3)

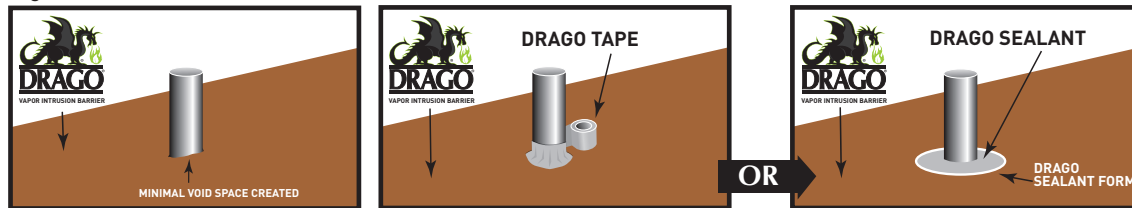
Fig. 4a: PIPE PENETRATION SEALING

5. **IMPORTANT: ALL PENETRATIONS MUST BE SEALED.** All pipe, ducting, rebar, and block outs should be sealed using Drago Wrap, Drago Tape, and/or Drago® Sealant and Drago® Sealant Form. (Fig. 4a). Drago accessories should be sealed directly to the penetrations.

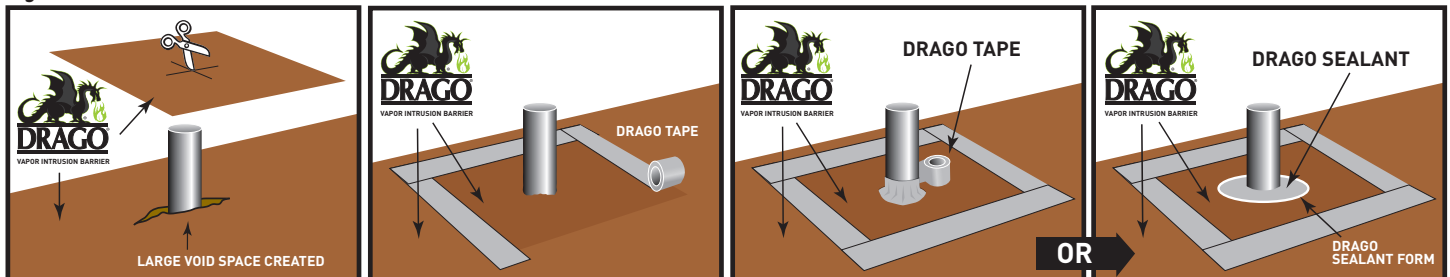
Fig. 4b: DETAIL PATCH FOR PIPE PENETRATION SEALING

- a. Install Drago Wrap around pipe penetrations by slitting/cutting material as needed. Try to minimize void space created.
- b. If Drago Wrap is close to pipe and void space is minimized, proceed to step d.
- c. If void space exists, then
  - i. Cut a detail patch to a size and shape that creates a 6-inch overlap on all edges around the void space at the base of the pipe.
  - ii. Cut an "X" slightly smaller than the size of the pipe diameter in the center of the detail patch and slide tightly over pipe.
  - iii. Tape the edges of the detail patch using Drago Tape.
- d. Seal around the base of the pipe using Drago Tape and/or Drago Sealant and Drago Sealant Form.
  - i. If Drago Sealant is used to seal around pipe, make sure Drago Wrap is flush with the base of the penetration prior to pouring Drago Sealant.

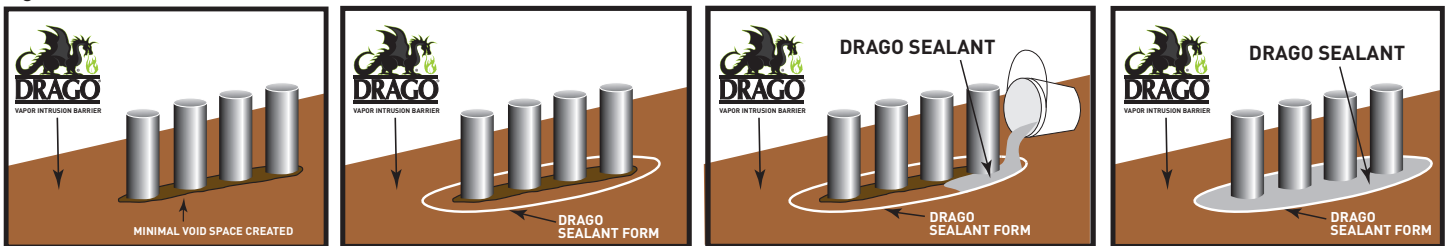
Fig. 5: MULTIPLE PIPE PENETRATION SEALING

- Cut a hole in Drago Wrap such that the membrane fits over and around the base of the pipes as closely as possible, ensuring that it is flush with the base of the penetrations.
- Install Drago Sealant Form continuously around the entire perimeter of the group of penetrations and at least 1 inch beyond the terminating edge of Drago Wrap.
- Pour Drago Sealant inside of Drago Sealant Form to create a seal around the penetrations.
- If the void space between Drago Wrap and the penetrations is not minimized and/or the base course allows for too much drainage of sealant, a second coat of Drago Sealant may need to be poured after the first application has cured.

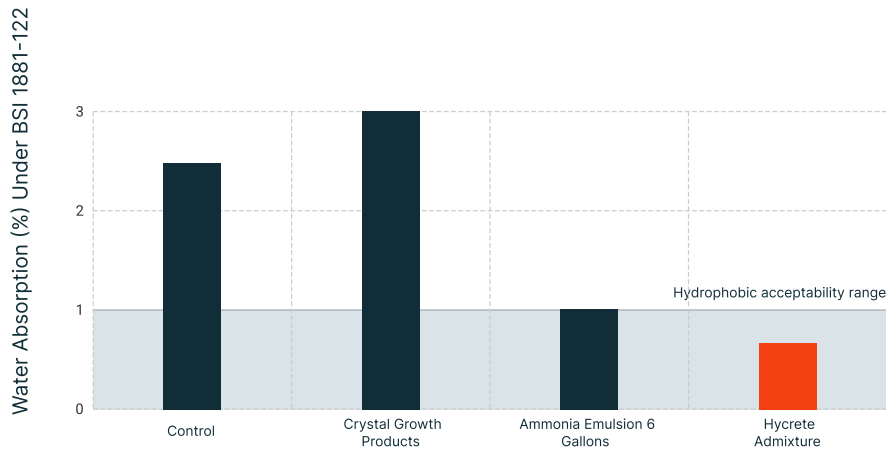
**WATERPROOFING PERFORMANCE**

South Carolina independent Lab Testing: 40/60 Structural Mix, 0.40 W/C 611  
 Type I-II Cement Polycarboxylate Superplasticizer

Water absorption	BSI 1881-122	Less than 1% absorption
Permeability/hydrostatic pressure	DIN 1048 BS EN 12390-8	Passes DIN 1048; up to 70% reduction in permeability
Crack healing	ASTM C597	Concrete with Hycrete fosters faster and 100% complete healing compared to untreated control
Set time	ASTM C403	Set neutral
Drying shrinkage	ASTM C157	Neutral to the control
Slump	ASTM C143	Neutral
Workability	N/A	Excellent
Effect on concrete color	N/A	None
Compressive strength	ASTM C39	Water/cement ratios may need to be lowered to account for possible, minor strength decreases associated with some materials. Perform trial mixes.
Potable water	NSF/ANSI 61	Approved for use in potable water tanks 50,000 gallons or greater and pipes 84" in diameter and greater
Adhesion	ASTM C1583, ASTM C1072, ASTM D3359	Neutral; no adverse effect on bond with concrete
