Port of Friday Harbor
Albert Jensen and Sons Boatyard and Marina
Eelgrass and Macroalgae Survey
June 3, 2020

The Port of Friday Harbor is proposing an emergency maintenance and repair project to replace the main walkway float and travel-lift pier of the Jensen's and Sons Boatyard and Marina located in the south end of Friday Harbor (Figures 1 and 2). The Port has determined that these structures are at imminent risk of failure, which poses a safety hazard and risks spreading creosote-treated wood fragments throughout the intertidal and subtidal areas around Jensen's marine infrastructure. The main walkway float will be replaced with a fully grated walkway with encapsulated floats and will be positioned in the same footprint as the existing walkway. The float is secured by 15 creosote-treated timber piling that are severely deteriorated or broken. These piling will all be removed be replaced with 7 12-inch steel piling. The piling that support the travel lift pier are also severely deteriorated and will be repaired by installing a fiberglass jacket around the pile and filling it with grout to encapsulate the creosote-treated timber piling. These emergency repairs will restore the i

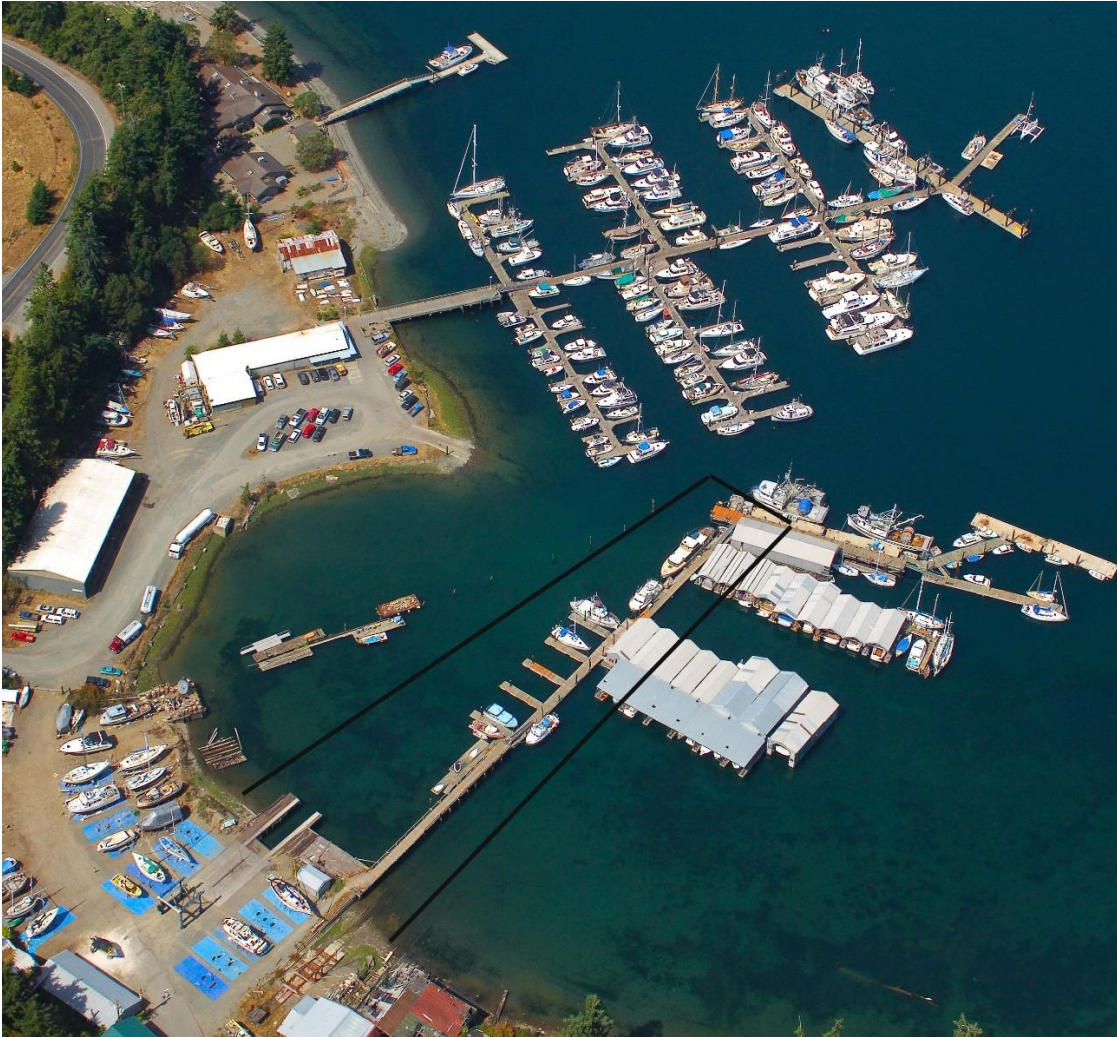
Figure 2. Jensen's and outline of survey area. Ecology aerial photograph August 15, 2006.

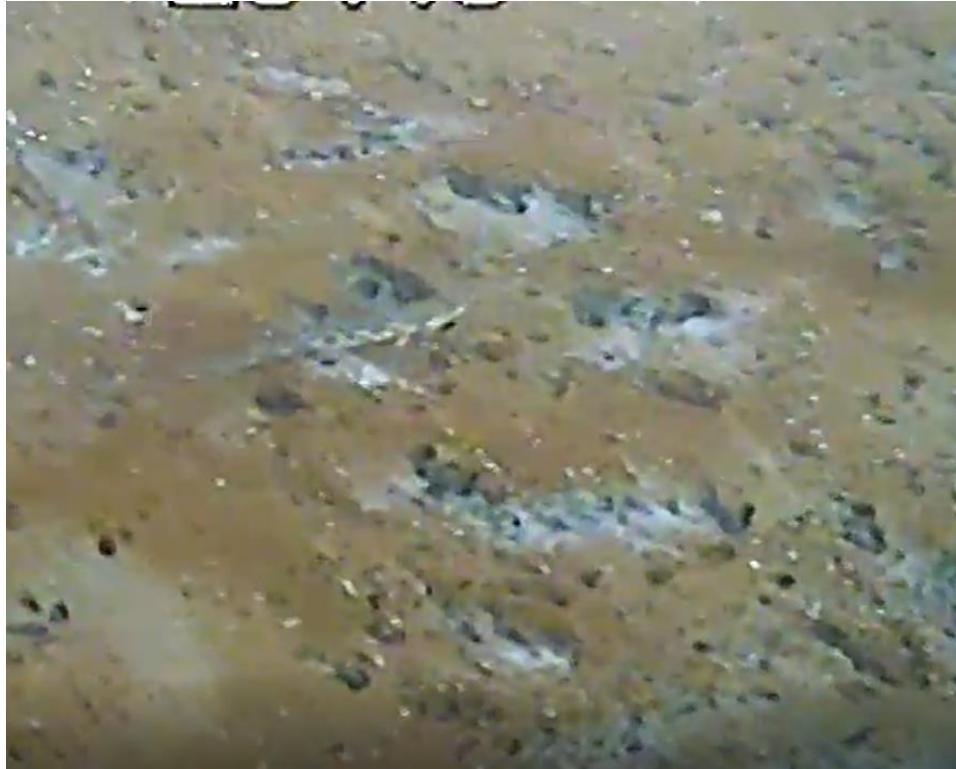
Figure 4. Below MLLW, the sediment is primarily mud covered with periphyton.

The seafloor in the walkway float replacement area is composed of mud (silt mixed with organic detritus) which is covered with periphyton, a mix of micro-algae such as diatoms, bacteria, and microscopic organisms (Figure 4). Small patches of the green alga *Ulva* were observed throughout the survey area (Figure 5). Blades of brown algae such as *Saccharina* were observed scatter in the study area, these blades did not appear to be attached to rocks, it is possible that these blades have drifted into the area and settled onto the bottom.

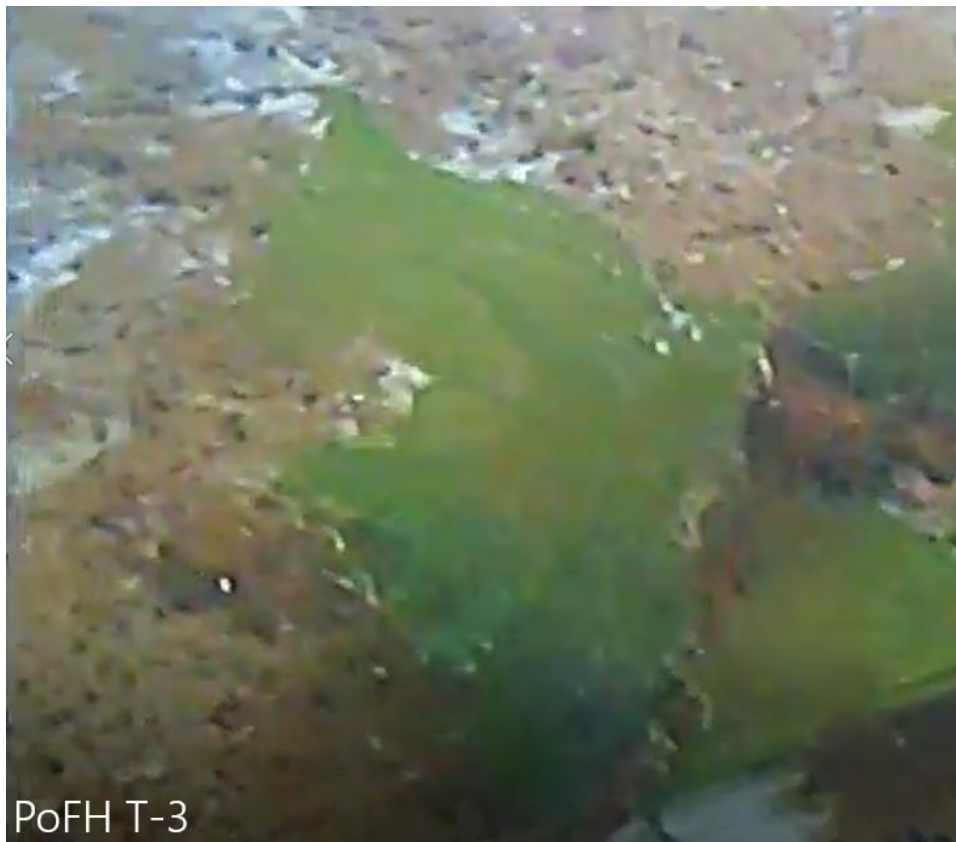
Figure 5. The green alga *Ulva* was observed growing in patches throughout the study area.

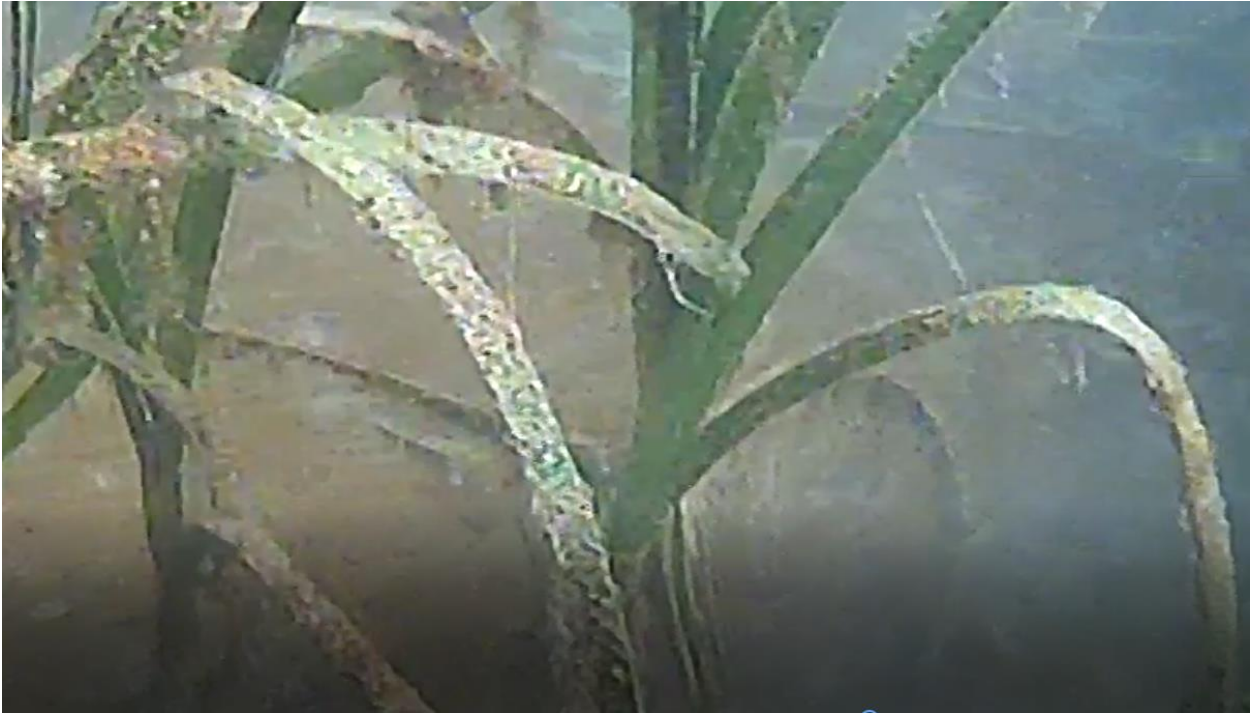
Figure 6. The native eelgrass *Zostera marina* was observed in two small patches in the study area.

Two small patches of the native eelgrass *Zostera marina* were observed at the water depth of approximately -7 feet MLLW (Figure 3). The eelgrass shoots were distributed in clumps within the patches. One patch is located to the west of the walkway float with an irregular shape

approximately 12 feet by 6 feet and has a density of 35.2 shoots per square meter. The second patch is east of the walkway float between the rows of boathouses and has the density of 46.8 shoots per square meter (Figure 6).

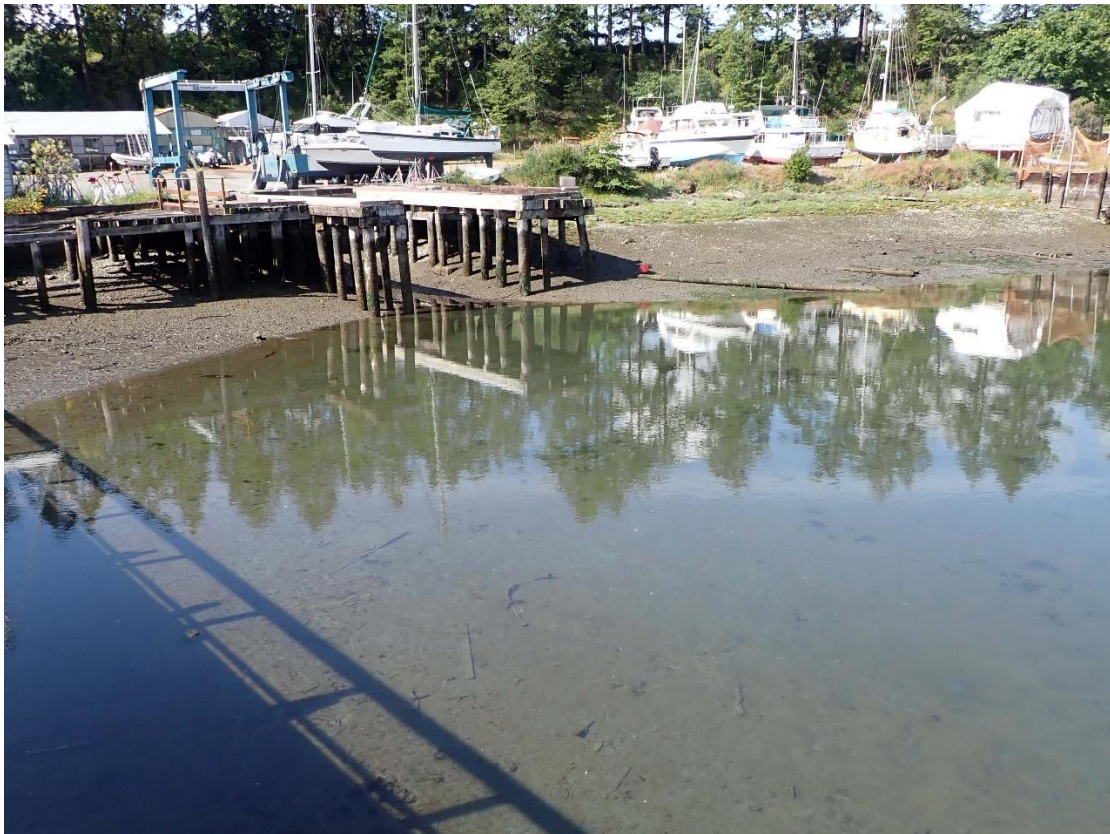
Figure 7. The travel lift area is located over the upper intertidal area with silt mixed with gravel. Tide = -0.5 MLLW.

The travel lift pier is positioned over the upper intertidal area from approximately elevation from 0 feet to +8 feet MLLW (Figure 7). The sediment consists of silt mixed with gravel. The marine vegetation is very sparse with some rockweed (*Fucus*) attached to the large gravel and *Ulva*. Pickleweed (*Salicornia depressa*) is present along the Ordinary High Water Line (OHWL) (Figure 8). The seafloor under the travel lift pier and in the open space between the piers is bare of sediment. A derelict pier is located to the east of the pier and sediment under the derelict is bare.

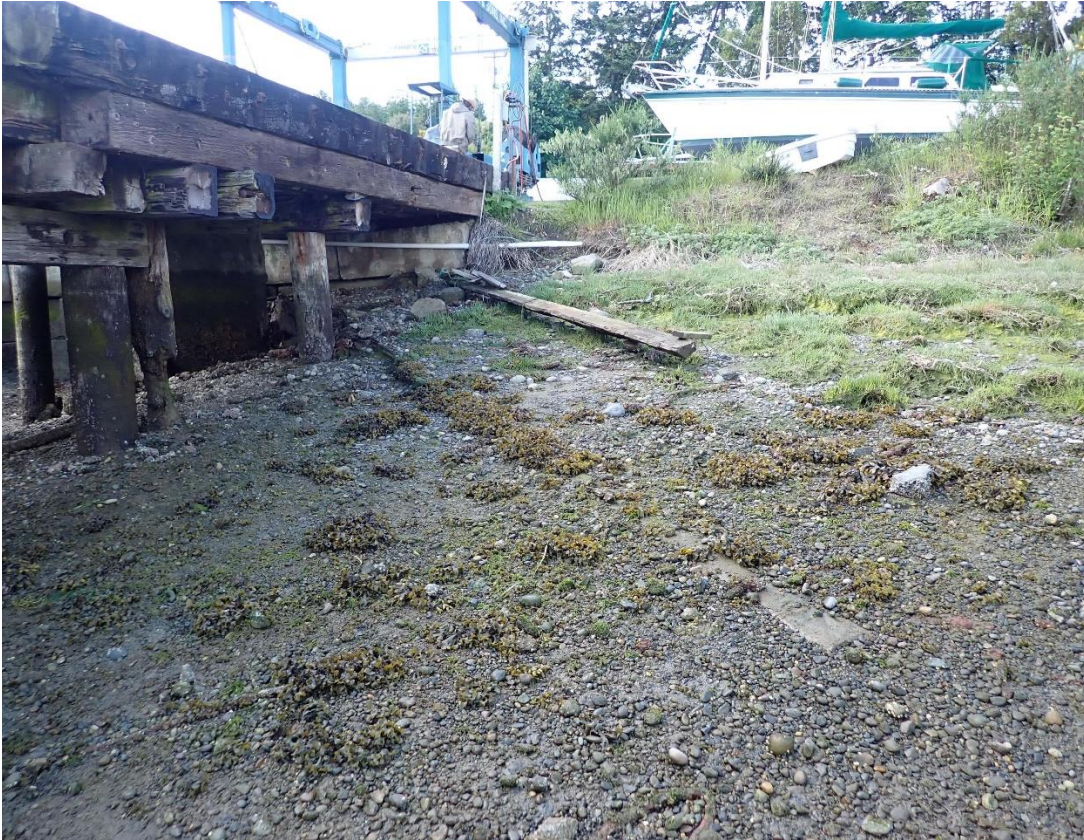
Figure 8. The brown alga *Fucus* is growing attached to large gravel to the west of the travel lift pier. Pickleweed is growing along the OHWL.

The seafloor in the project area is primarily mud covered with periphyton below MLLW. Landward of MLLW, the seafloor is bare mud. The brown alga *Fucus* was observed attached to large gravel at the upper intertidal zone to the west of the travel lift and pickleweed is present along the OHWL. The green alga *Ulva* was observed in patches throughout the study area. Two small patches of the native eelgrass *Zostera marina* are present at -7 feet MLLW; one patch is located to the east of the main walkway and another patch is located to the east of the walkway in the fairway between the boathouses.
