**Re: No Further Action with Environmental Covenant for the
Following Site:**

- **Facility/Site Name:** The Auto Technician
- **Facility/Site Address:** 7418 Greenwood Avenue North,
Seattle, 98103
- **Facility Site ID:** 49454698
- **Cleanup Site ID:** 17029
- **Technical Assistance Program No.:** P-NW2831

COMPLIANCE MONITORING PLAN
GREENWOOD AVENUE PROPERTY
7418 GREENWOOD AVENUE NORTH
SEATTLE, WASHINGTON

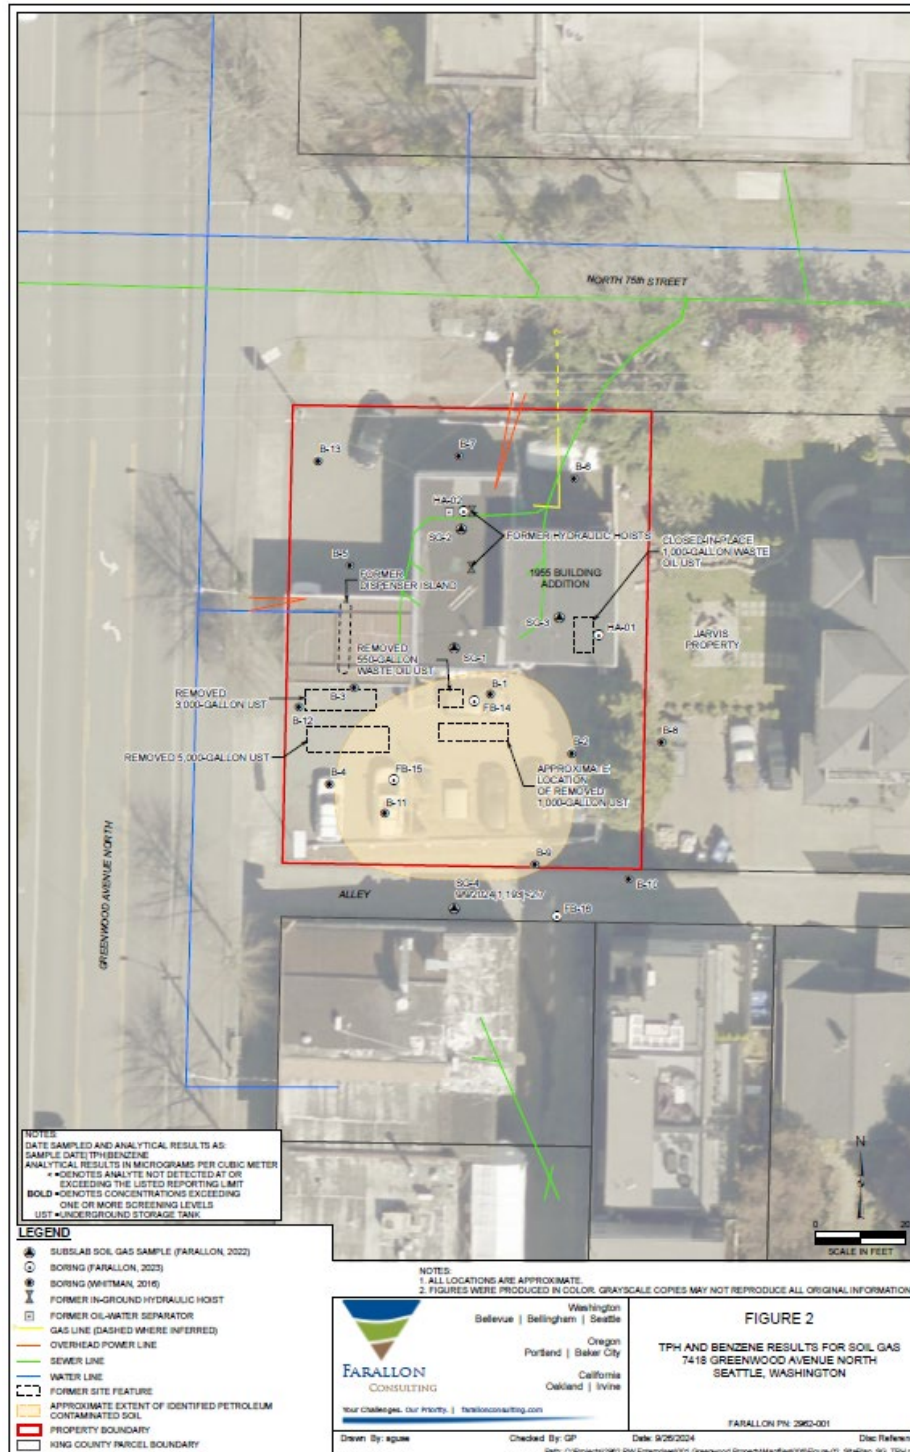
Figure 2: Property Map and Extent of Petroleum Contaminated Soil

Source: *Soil Gas Assessment Summary Report*, Farallon Consulting LLC., October 23, 2024.

- The areal and vertical extent of petroleum contaminated soil (PCS) remaining at the Site is shown on Figures 2. It has been adequately demonstrated that removal and/or treatment of PCS is not technically feasible or practicable.
- Institutional and engineering controls will limit direct contact with residual PCS and soil leaching to groundwater at the Site. An impervious surface is in place over the remaining PCS with concentrations of COCs exceeding CULs.
 - Environmental Covenant: The impacted area, and any necessary safety protocols to address concerns with the soil direct contact exposure pathway, are detailed in Environmental Covenant No. 20250415000555 dated April 15, 2025 with King County.
