**CONSTRUCTION REPORT  
EAST LINED AREA PARTIAL CLOSURE**

**HIDDEN VALLEY LANDFILL**

**PIERCE COUNTY, WASHINGTON**

**Construction Report  
East Lined Area Partial Closure  
Hidden Valley Landfill  
Pierce County, Washington**

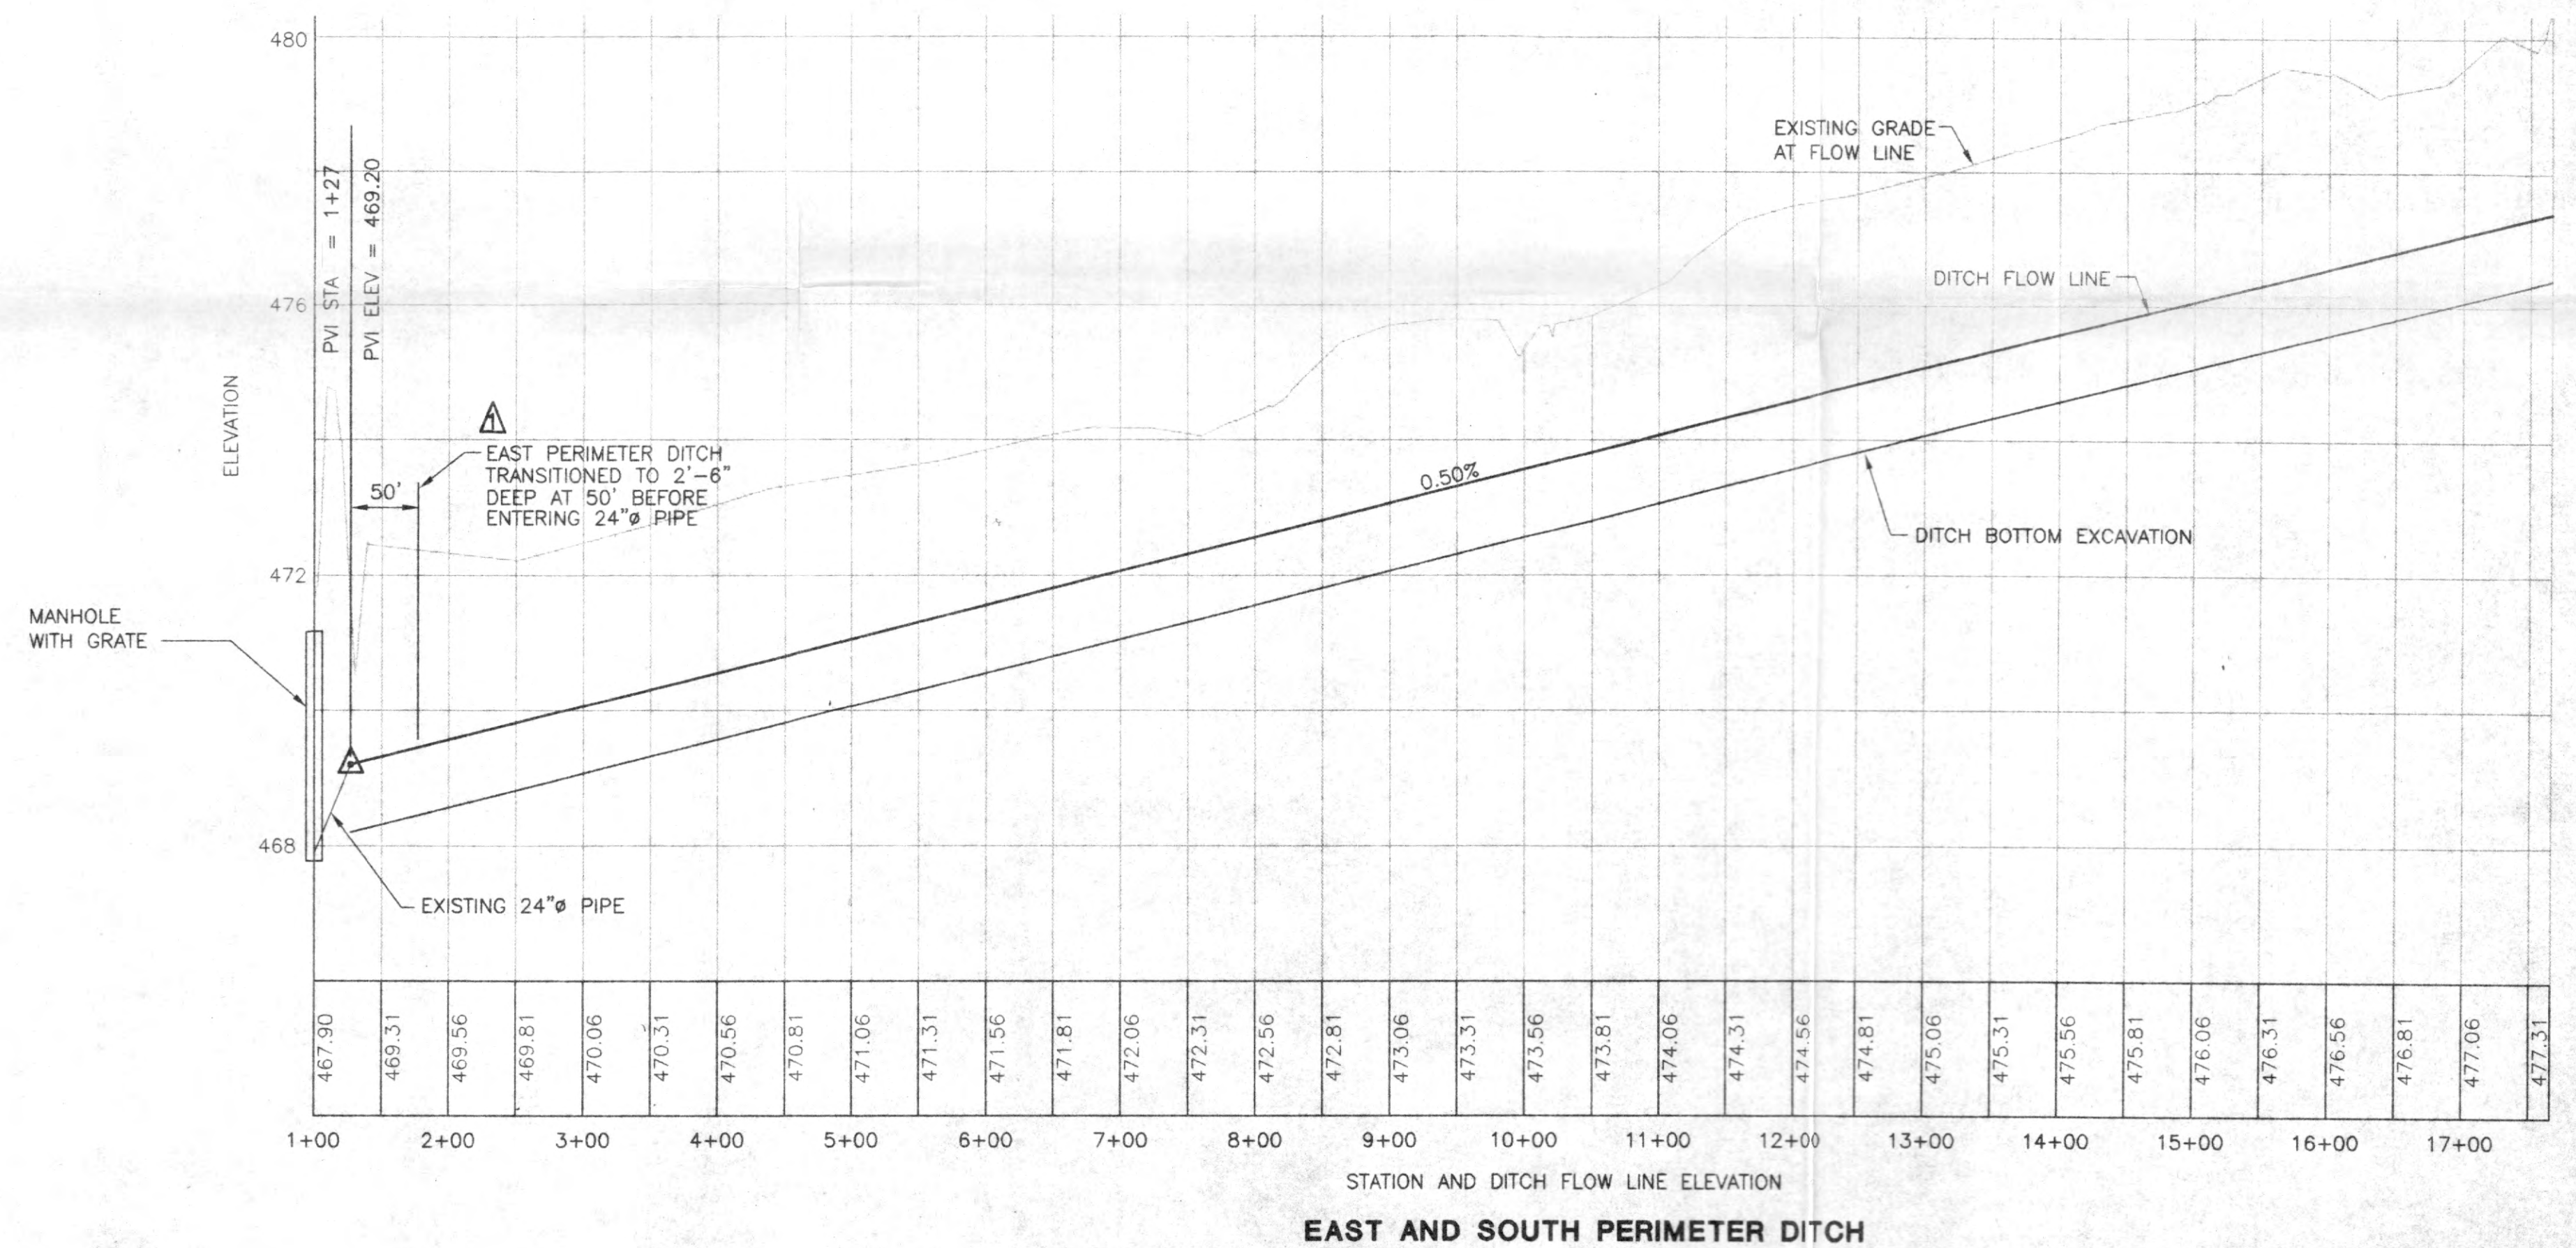
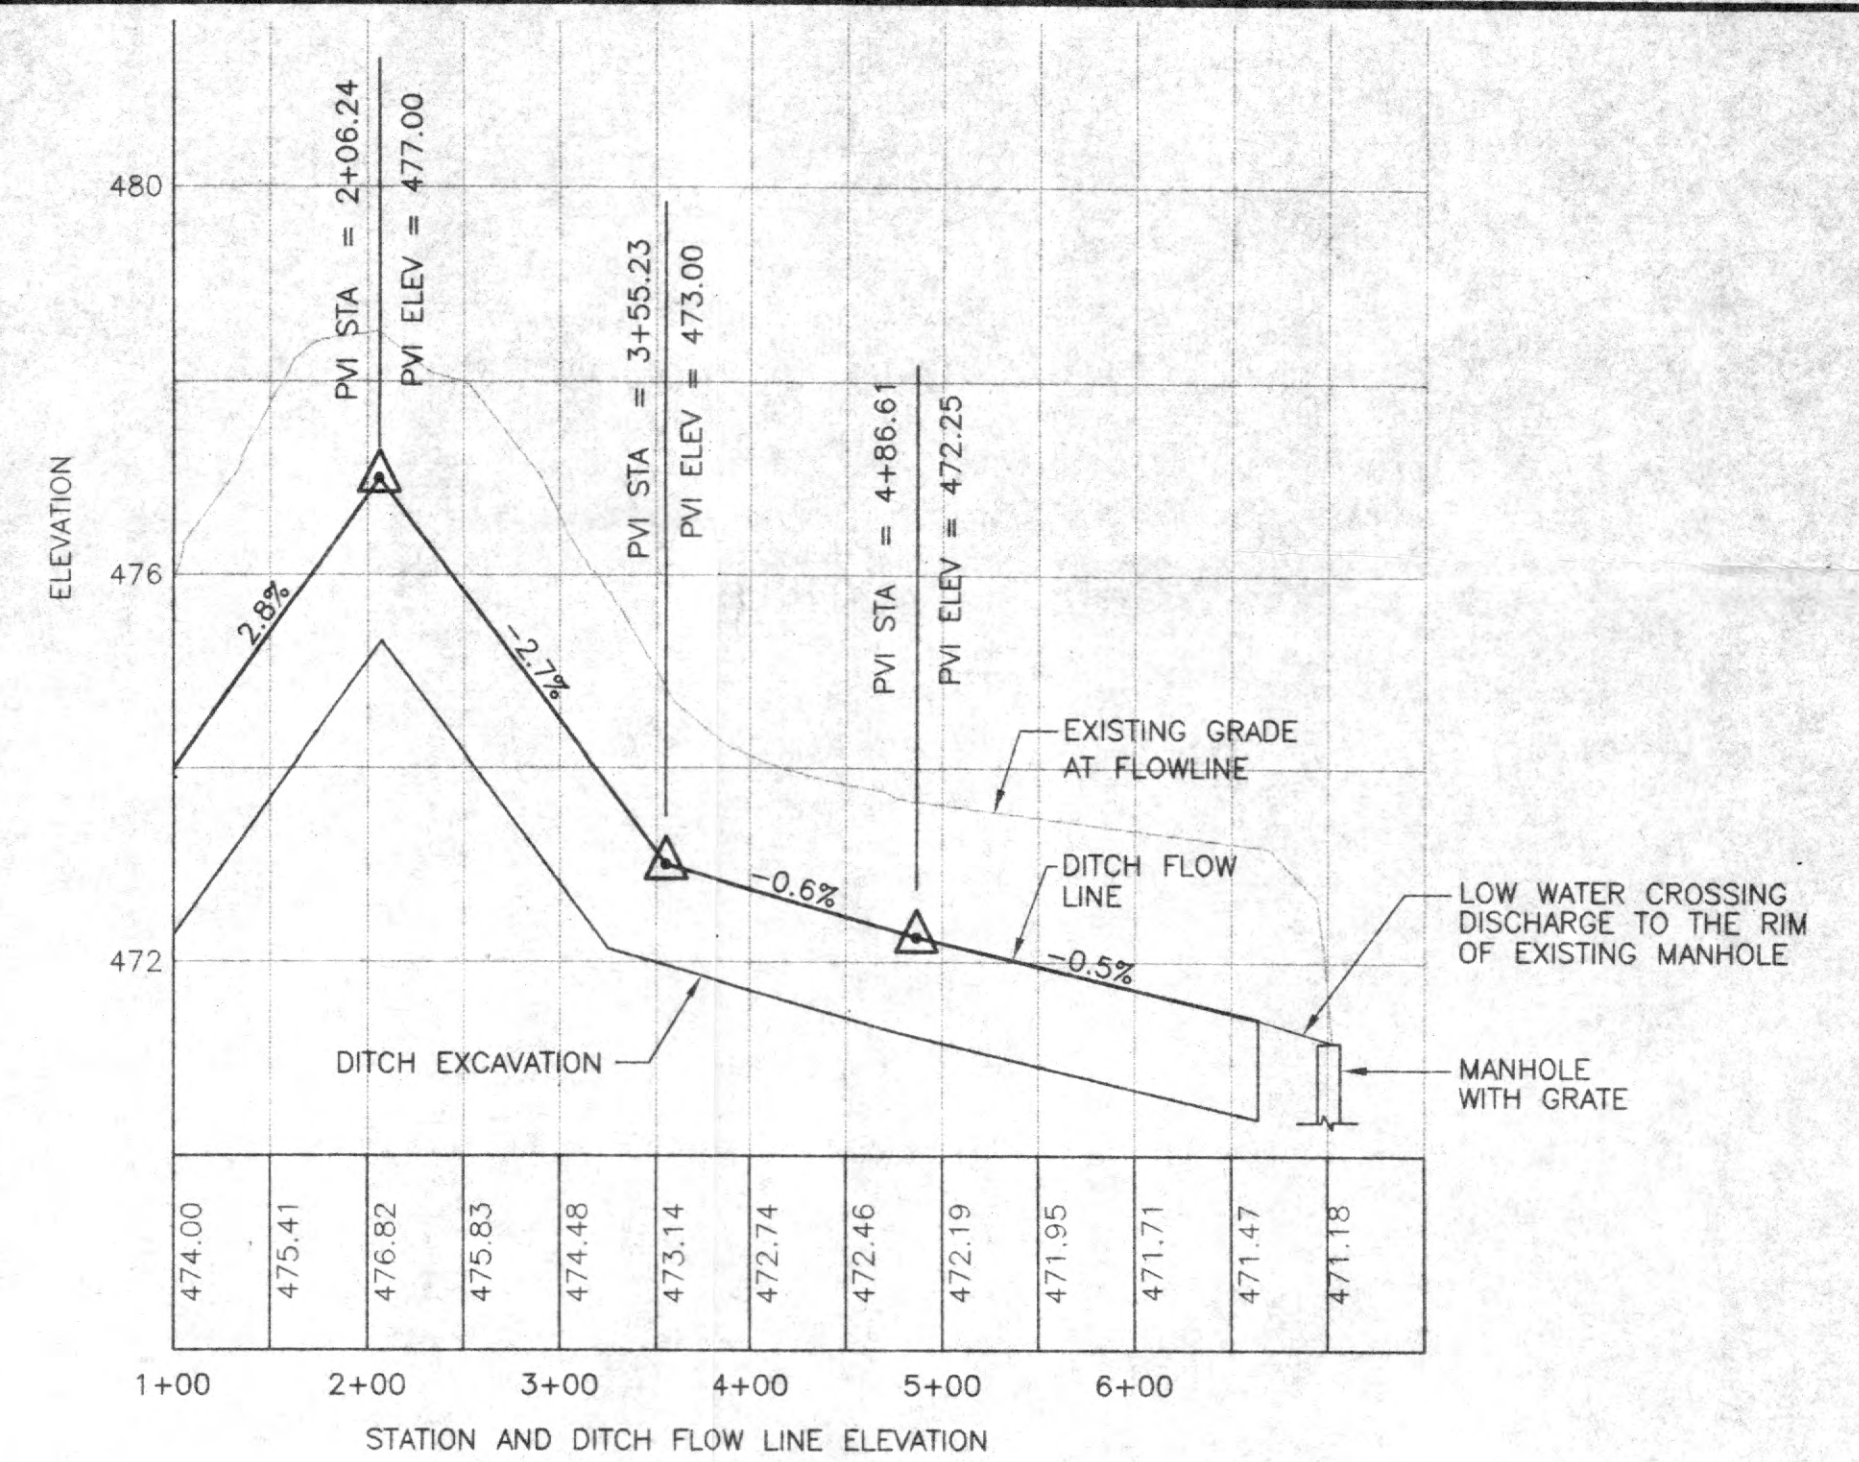
DRAWING NO.  
**4**  
PROJECT NO.  
202-005.061

**EAST LINED AREA PARTIAL CLOSURE  
PERIMETER DITCH PROFILES**

NOTE: FOR PERIMETER DITCH FLOW LINE ELEVATION, SEE PROFILE, DWG. 4.

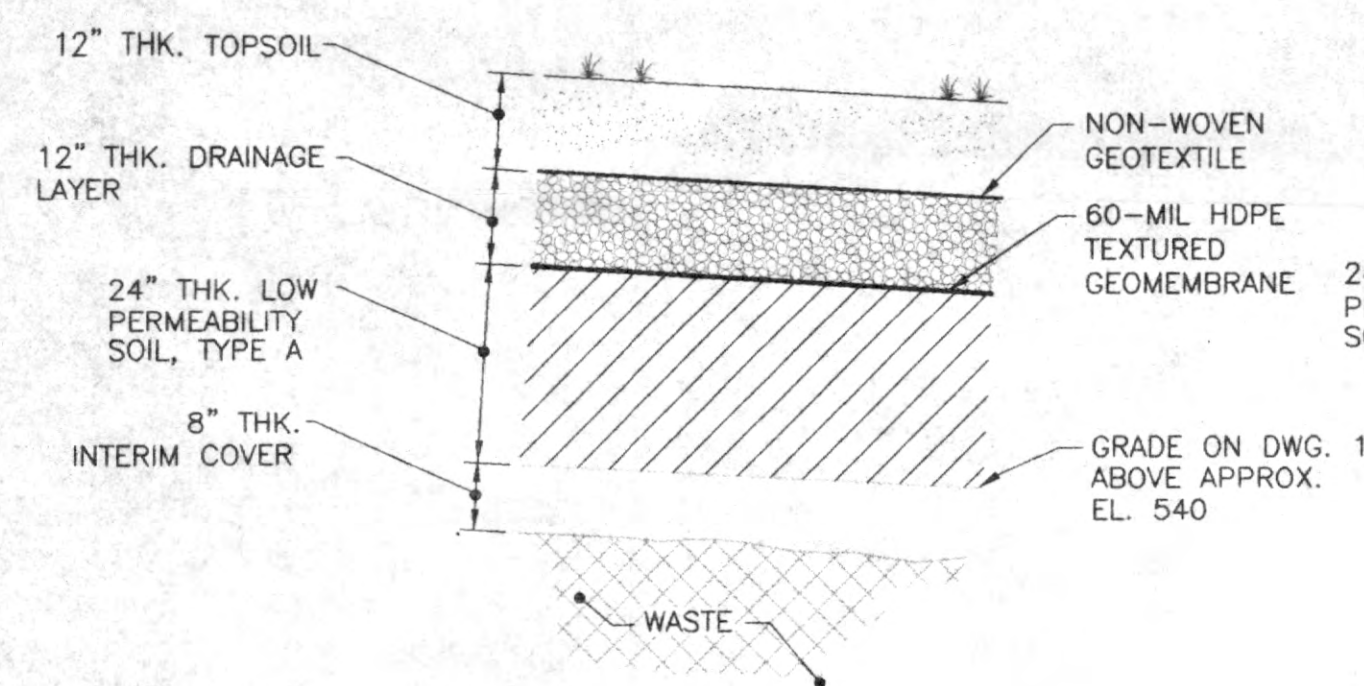
DETAIL

TYPE 1 FINAL COVER

SCALE: 1" = 2'

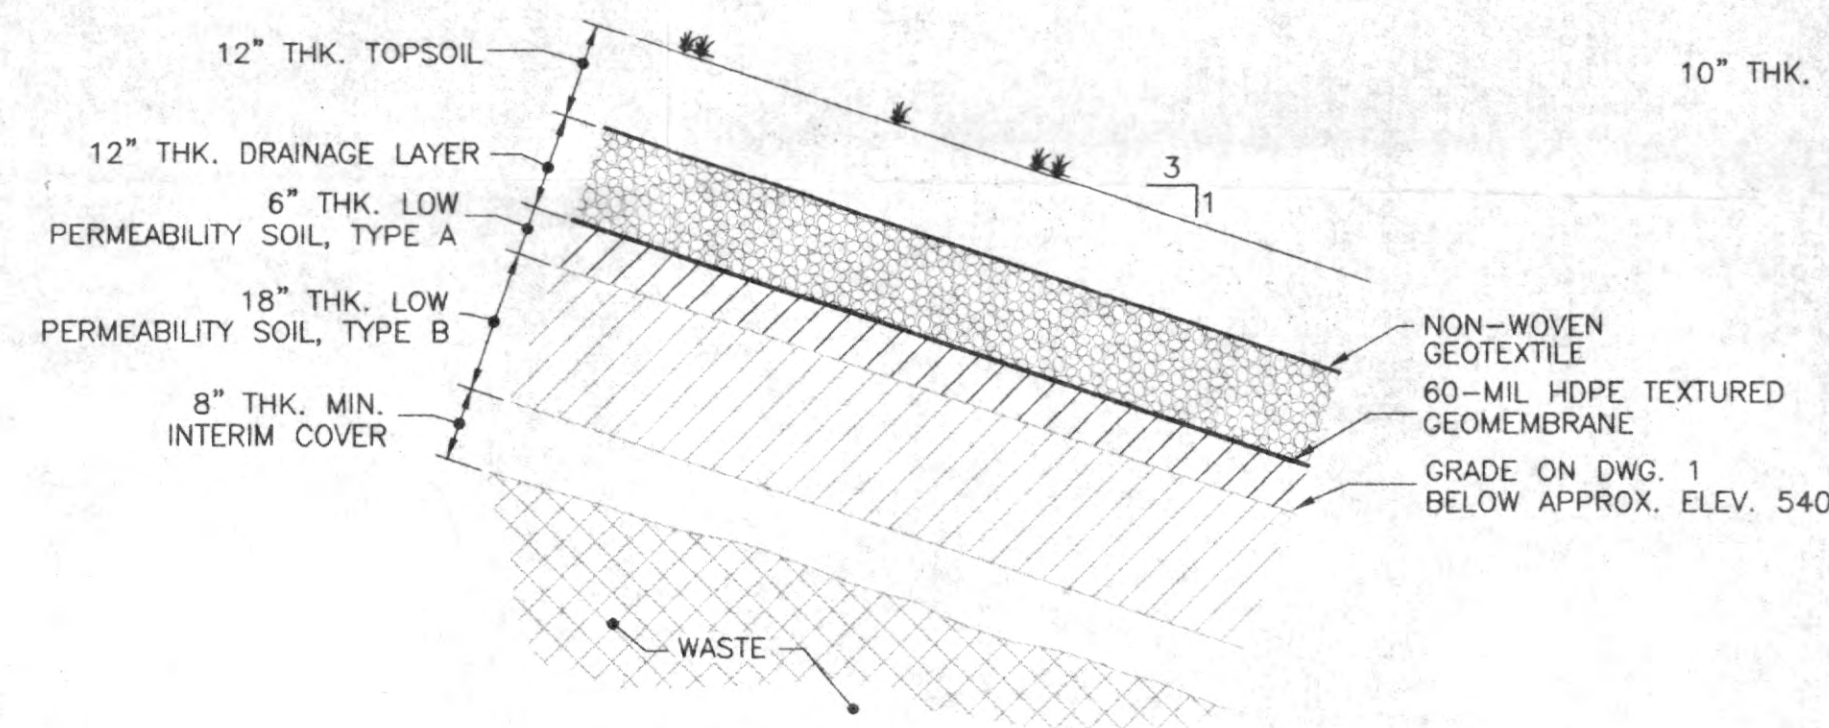
DETAIL

TYPE 2 FINAL COVER

SCALE: 1" = 2'

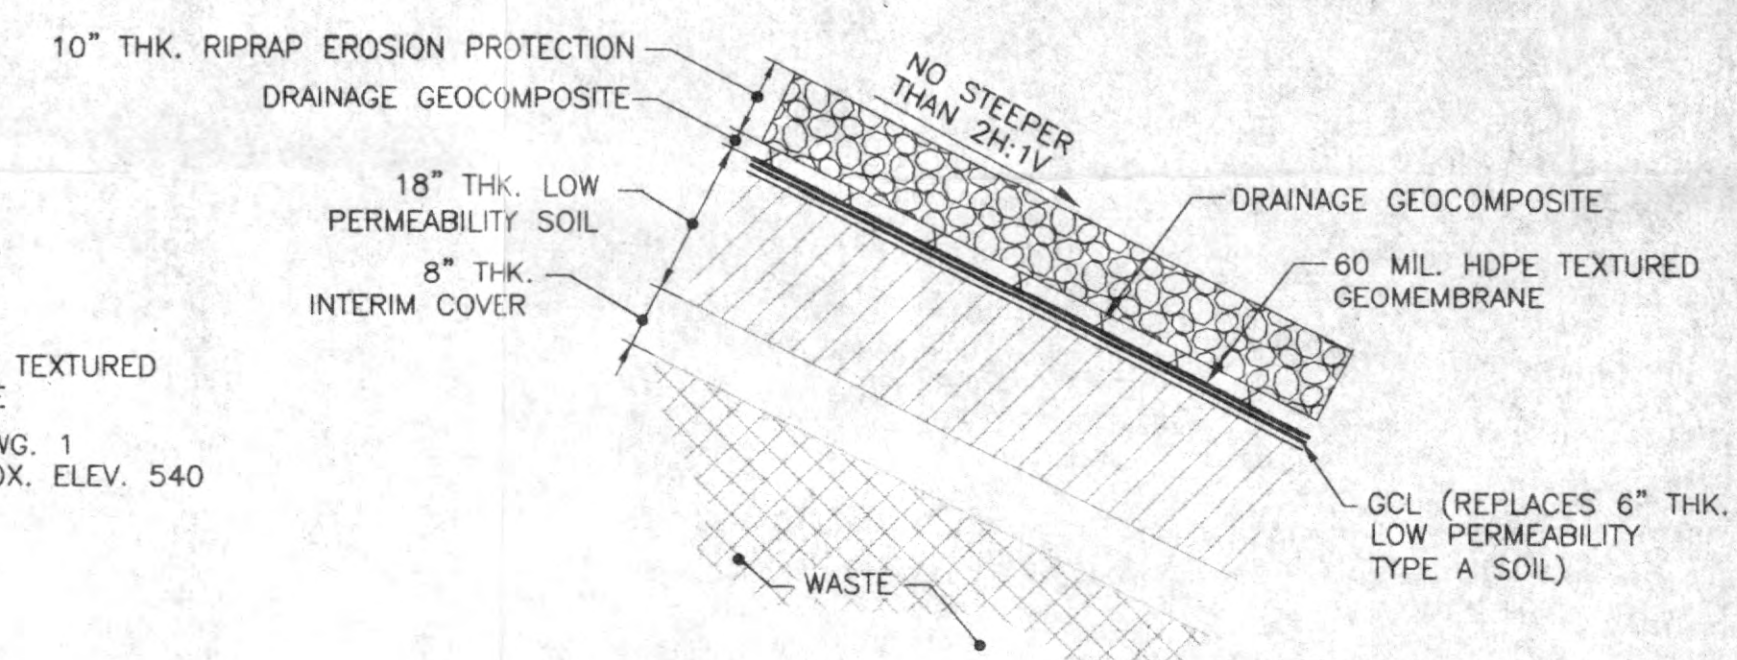
DETAIL

TYPE 3 FINAL COVER

SCALE: 1" = 2'

A GCL was installed with the Type 3 cover system, below the access roadway and to form a diversion flap in the drainage layer. The GCL in the Type 3 cover system and access roadway replaces the Type A low-permeability cover soil in the composite barrier system. The GCL was selected to provide an equivalent material to the Type A low-permeability cover soil; however, could be installed through the ditch lines where compaction

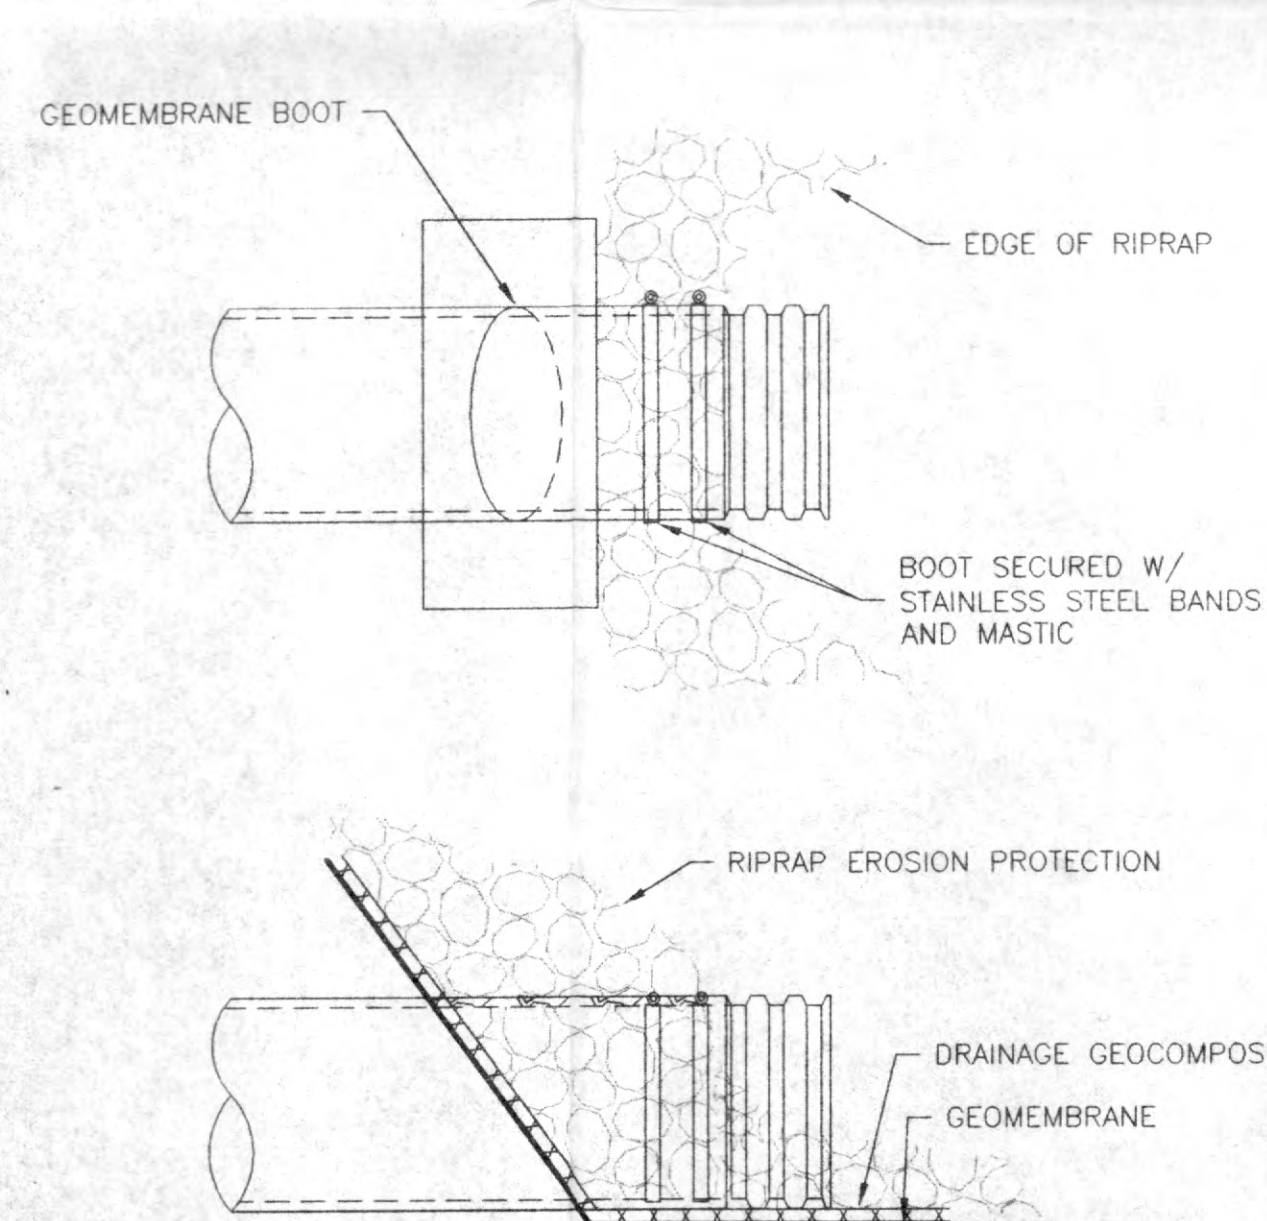
**DEBRIS BARRIER DETAIL 1**  
N.T.S.

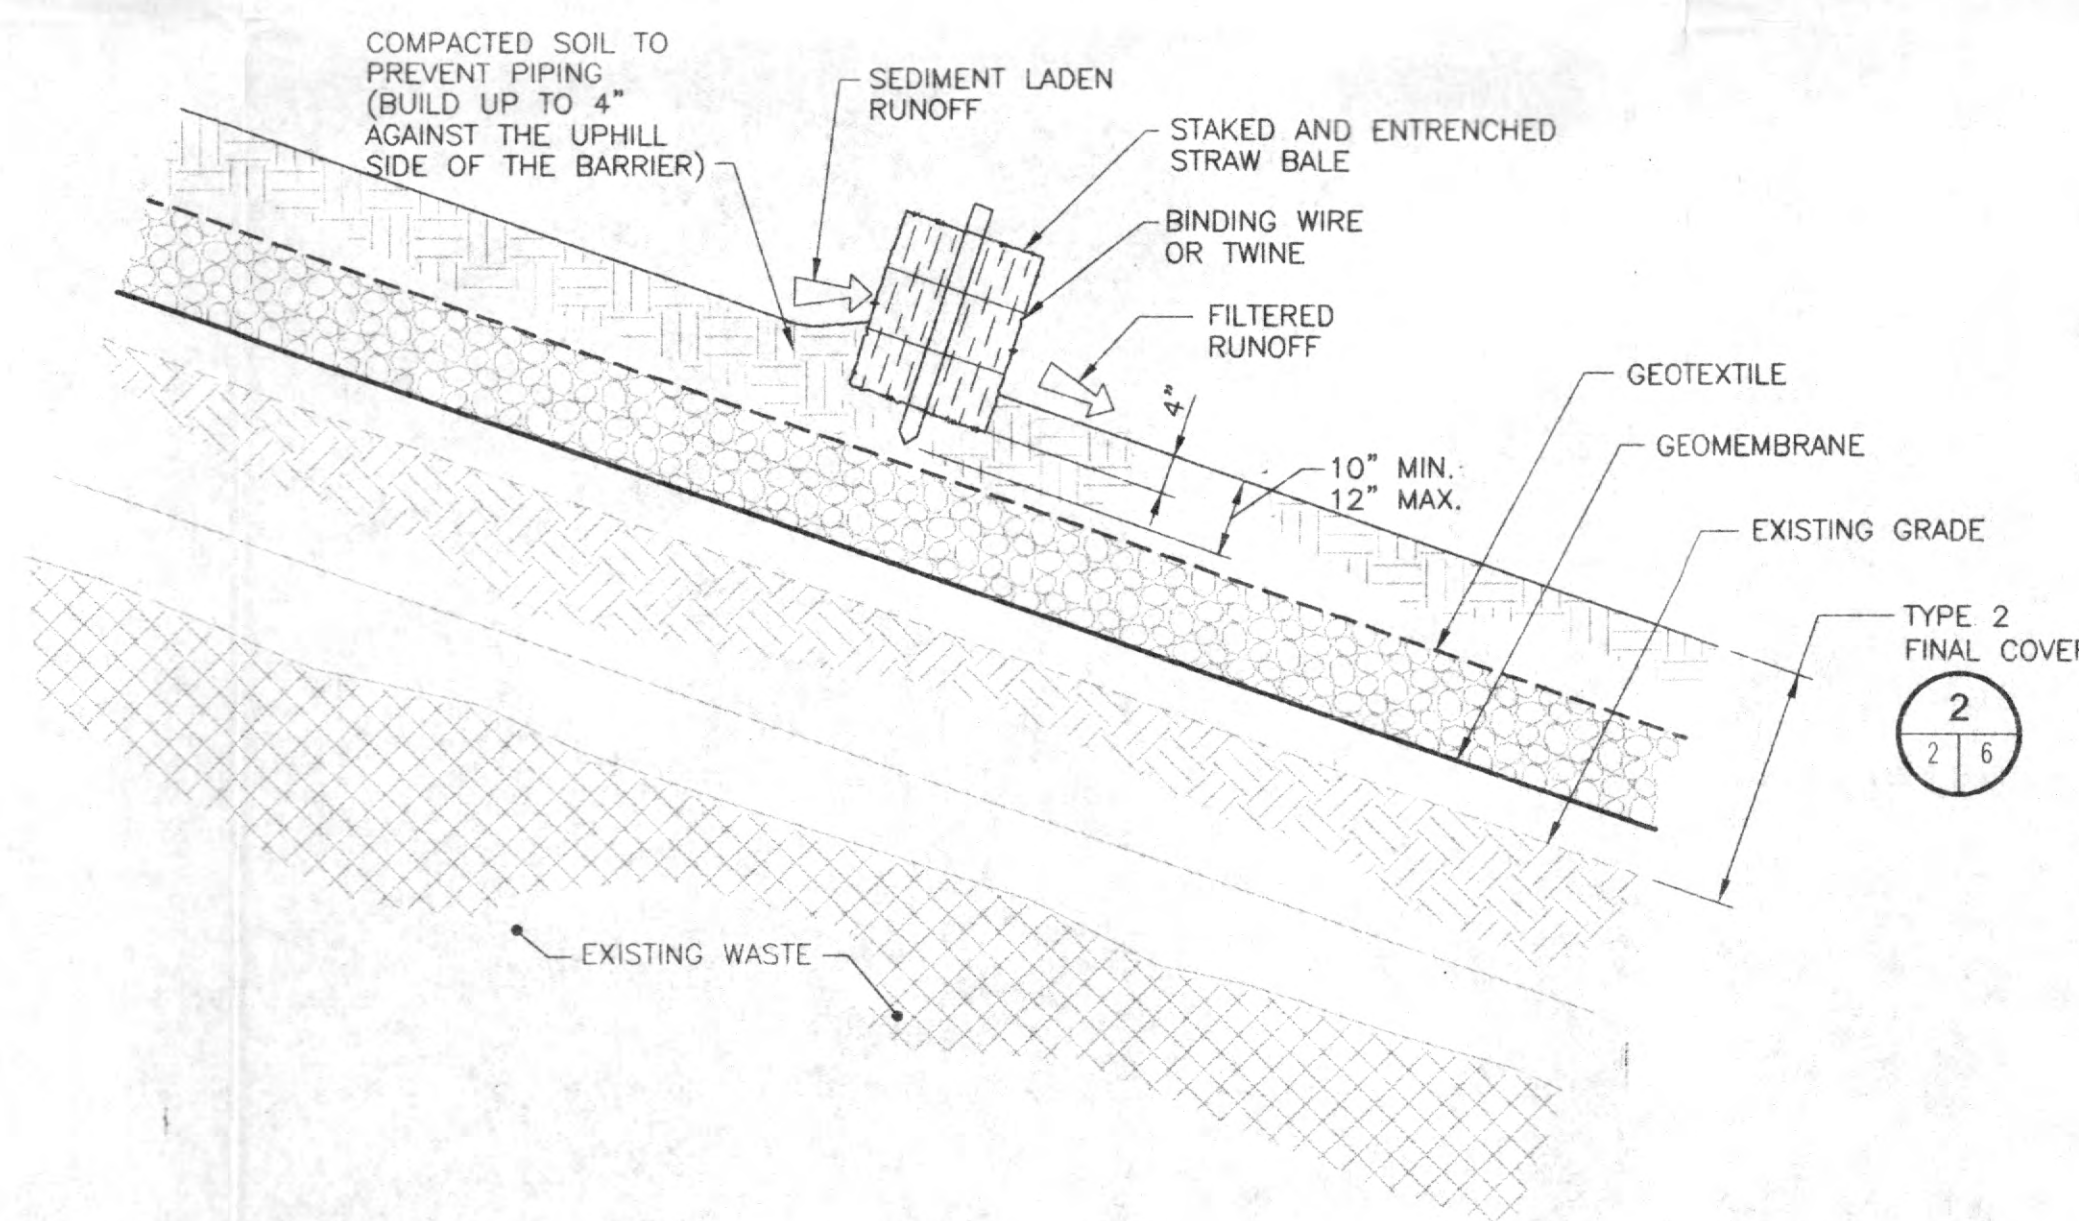
**STRAW BALE BARRIER INSTALLATION SECTION C**  
N.T.S.

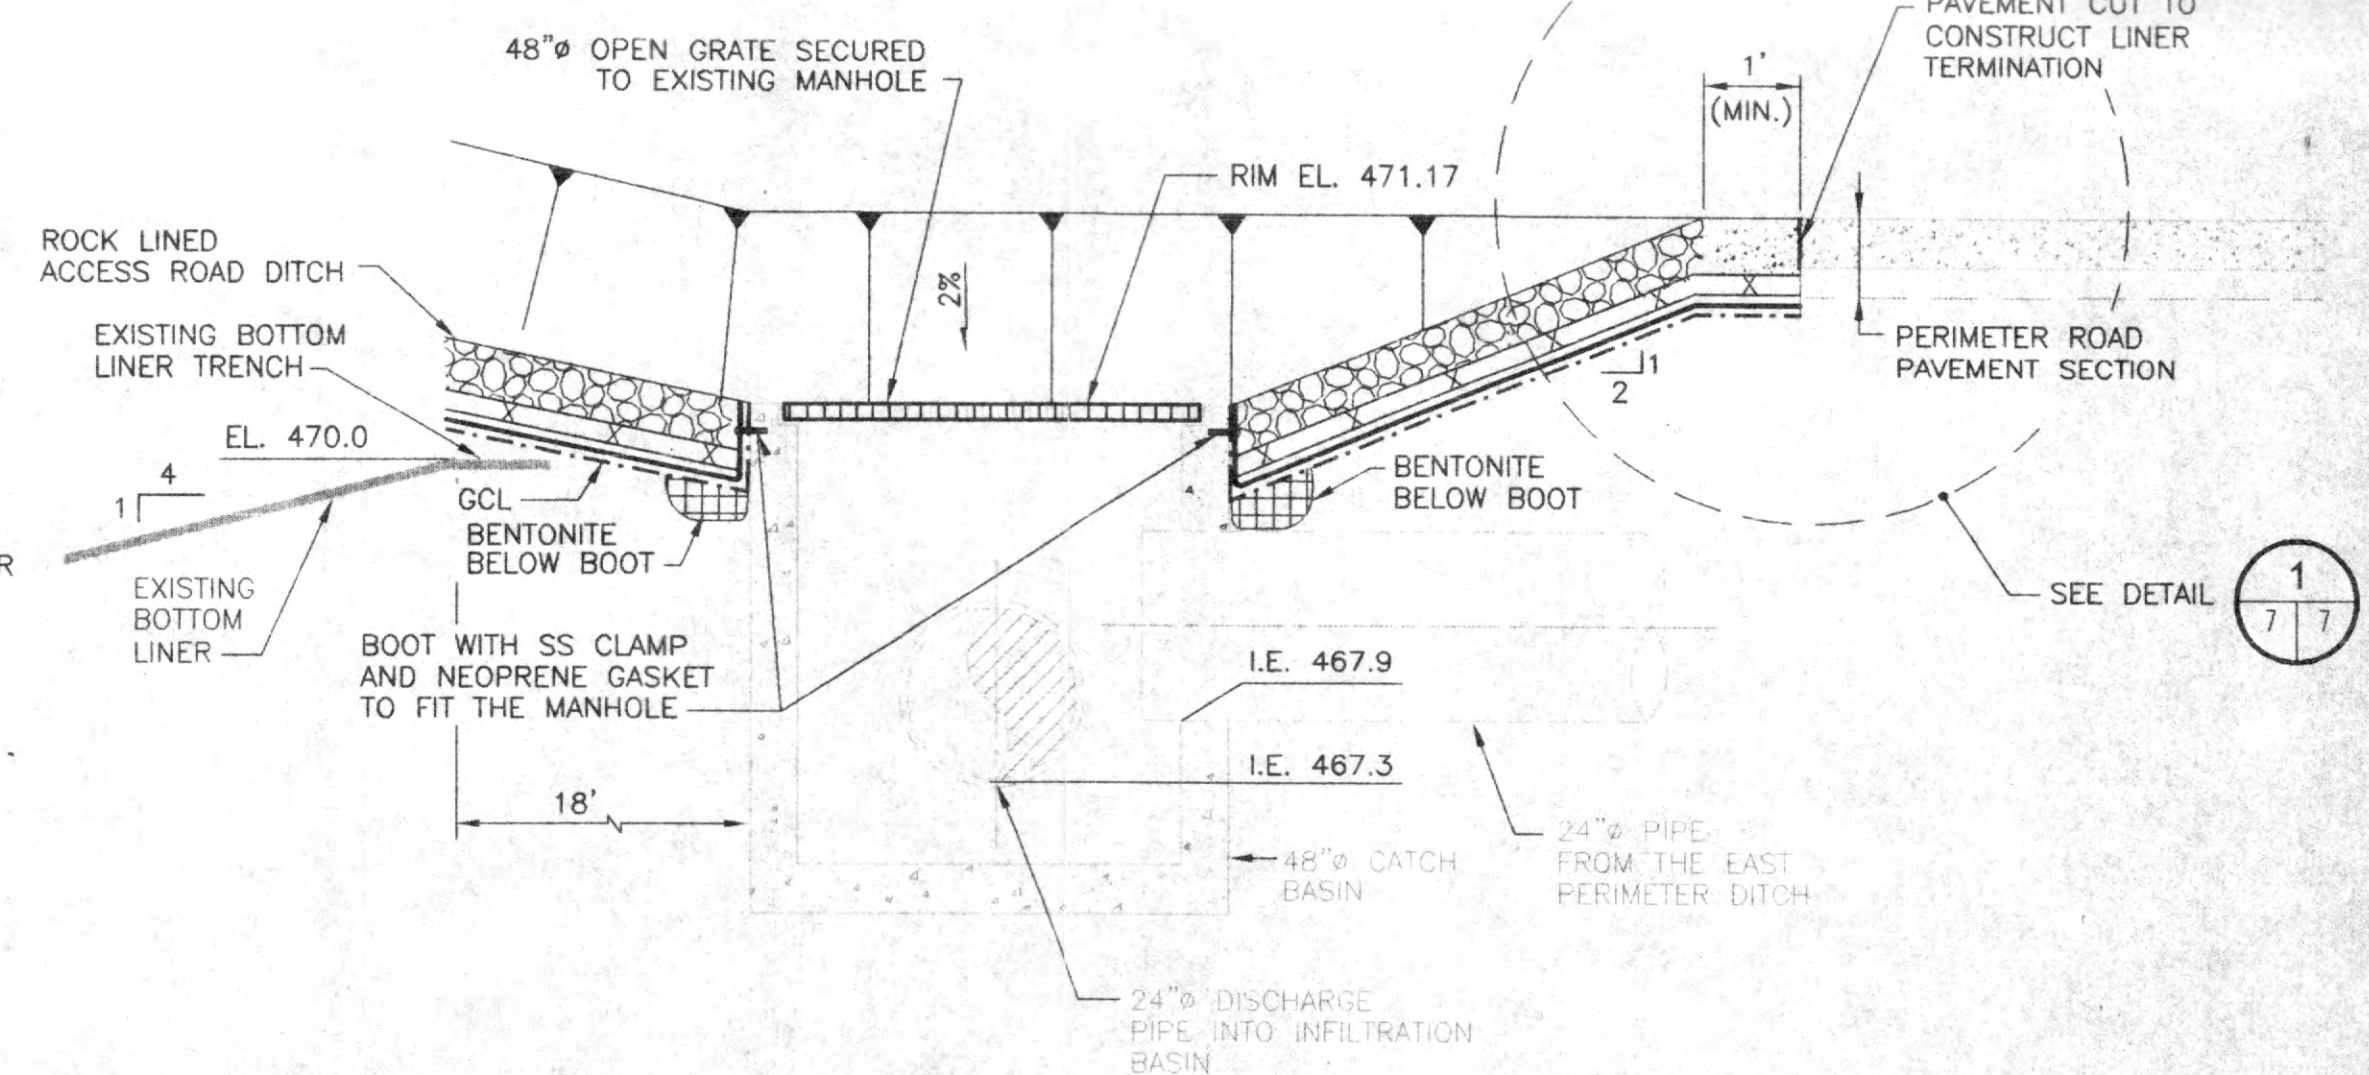
**SECTION D**  
SCALE: 1" = 2'

**GRATE INSTALLATION AND SIDE SLOPE CONSTRUCTION AT EXIST. MANHOLE**

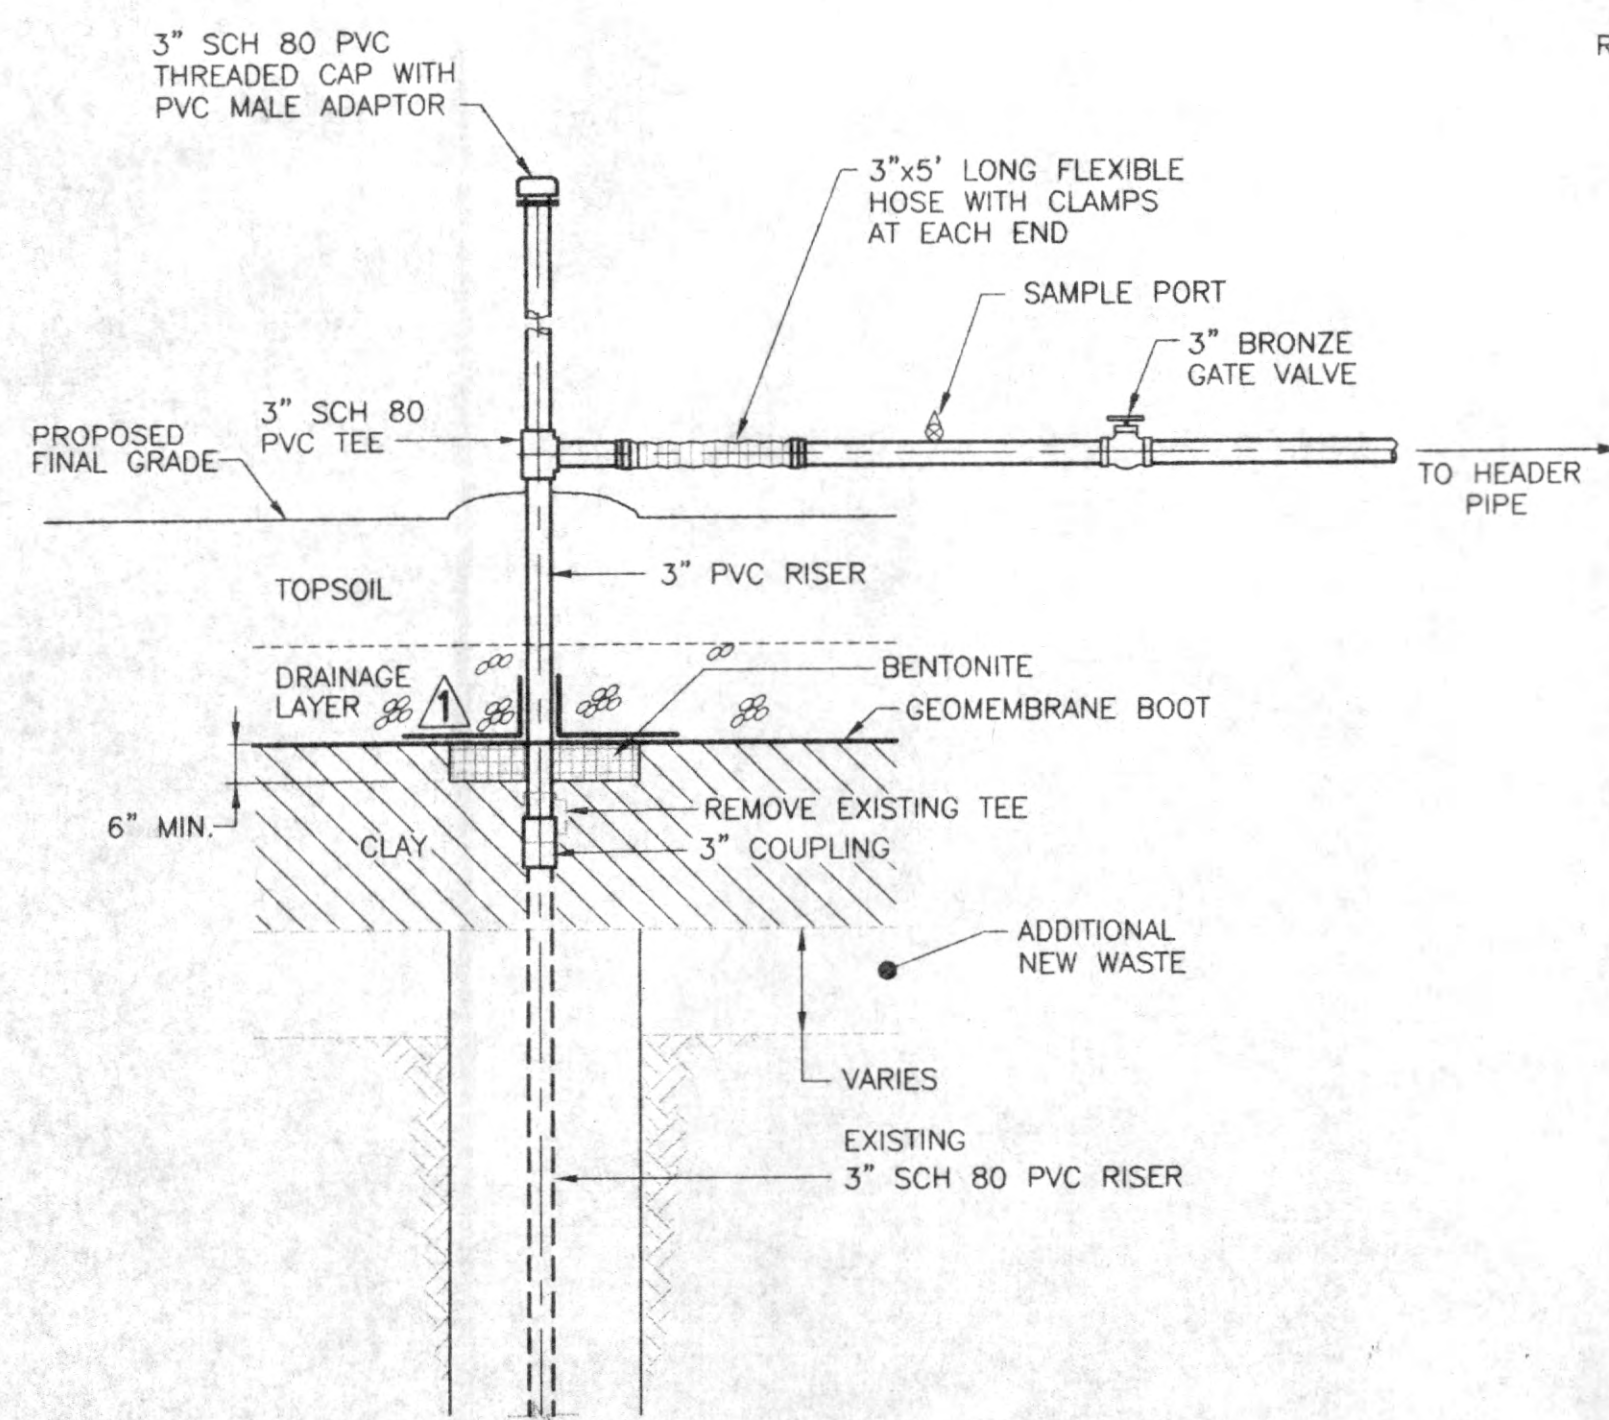
WELL EXTENSION  
DETAIL 2  
N.T.S.

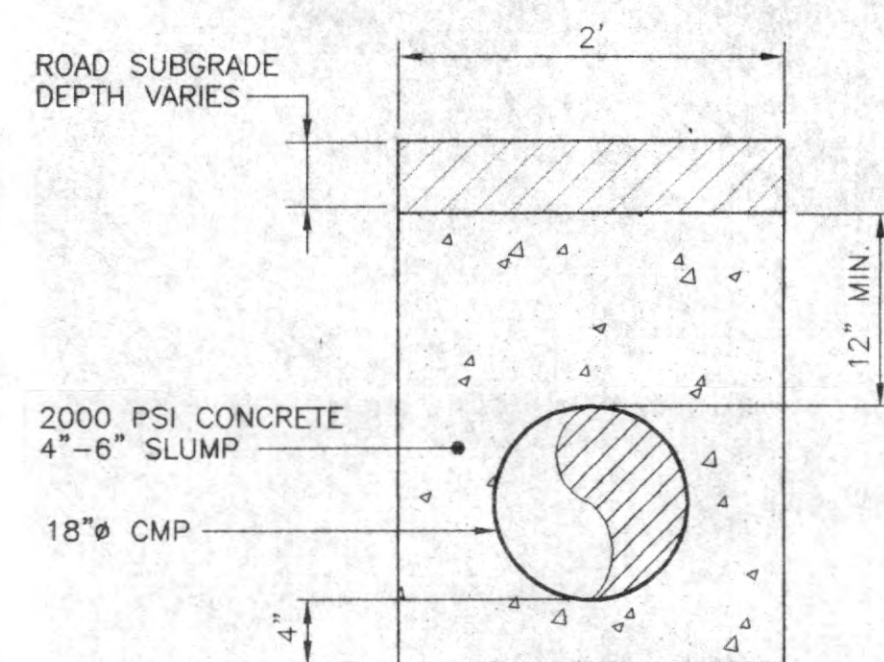
GAS HEADER CULVERT  
SECTION A  
SCALE: 1" = 1'

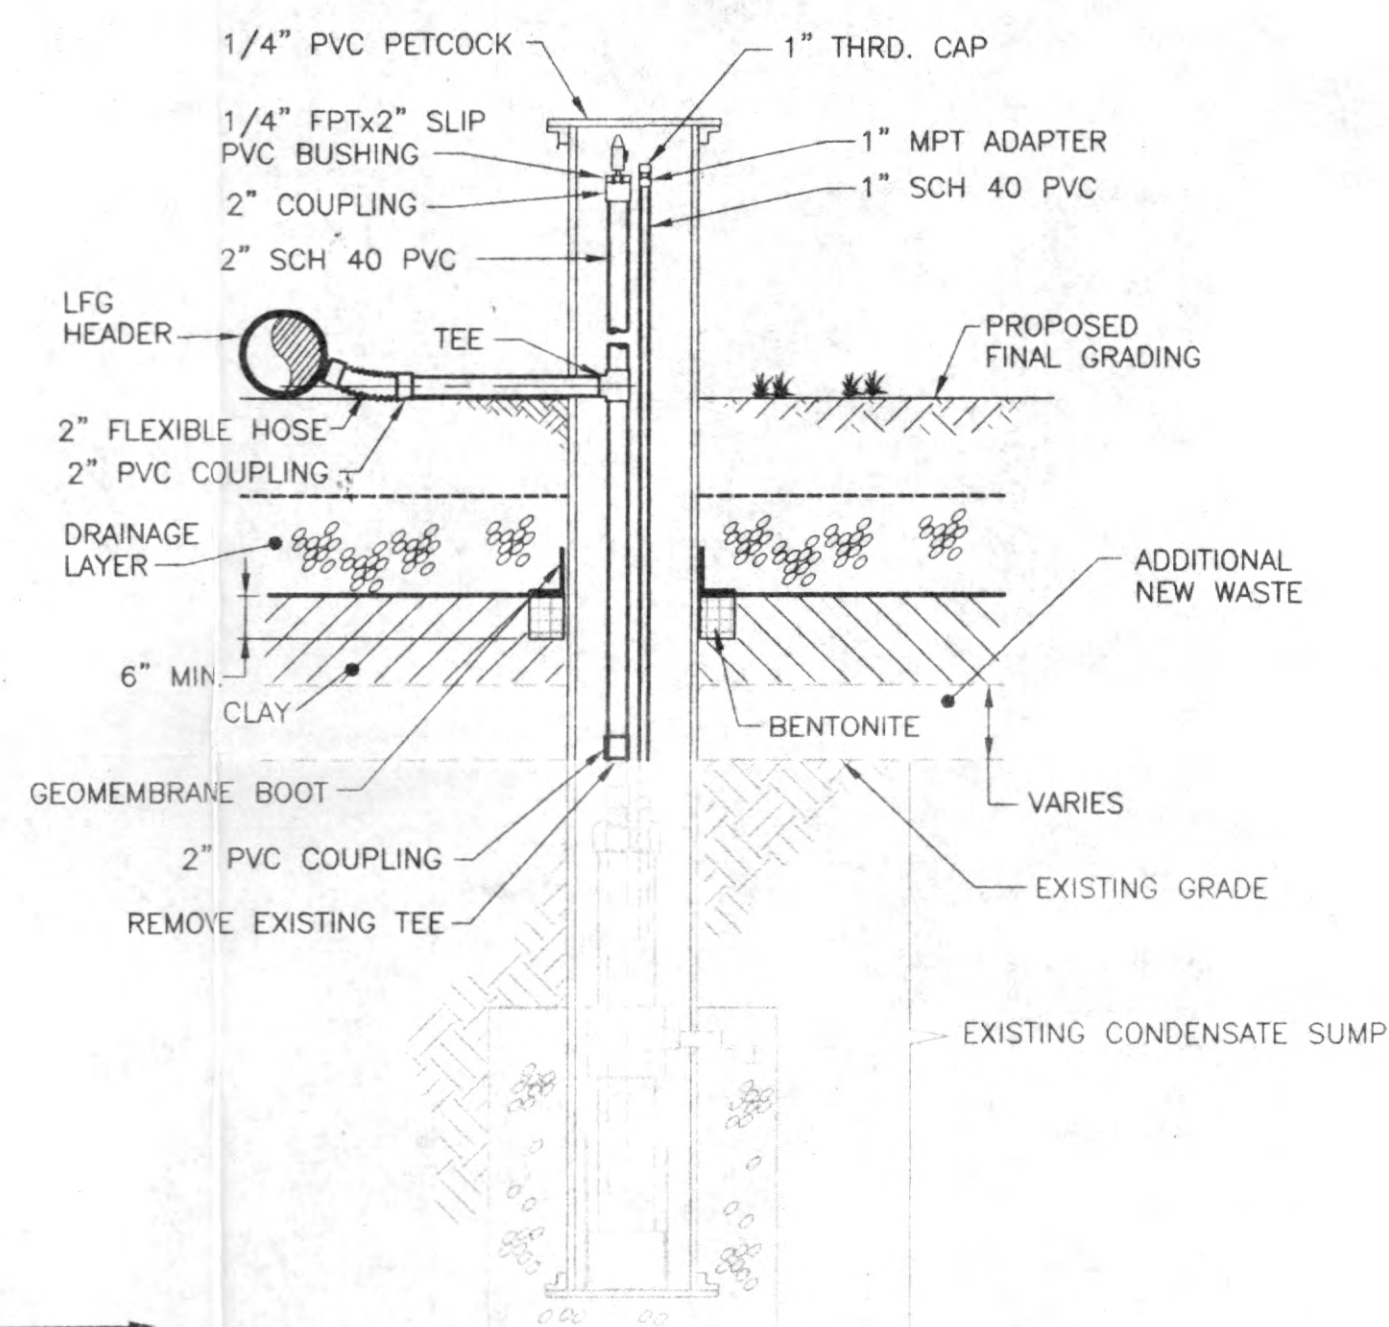
CONDENSATE DRAIN EXTENSION  
DETAIL 3  
SCALE: 1" = 2'

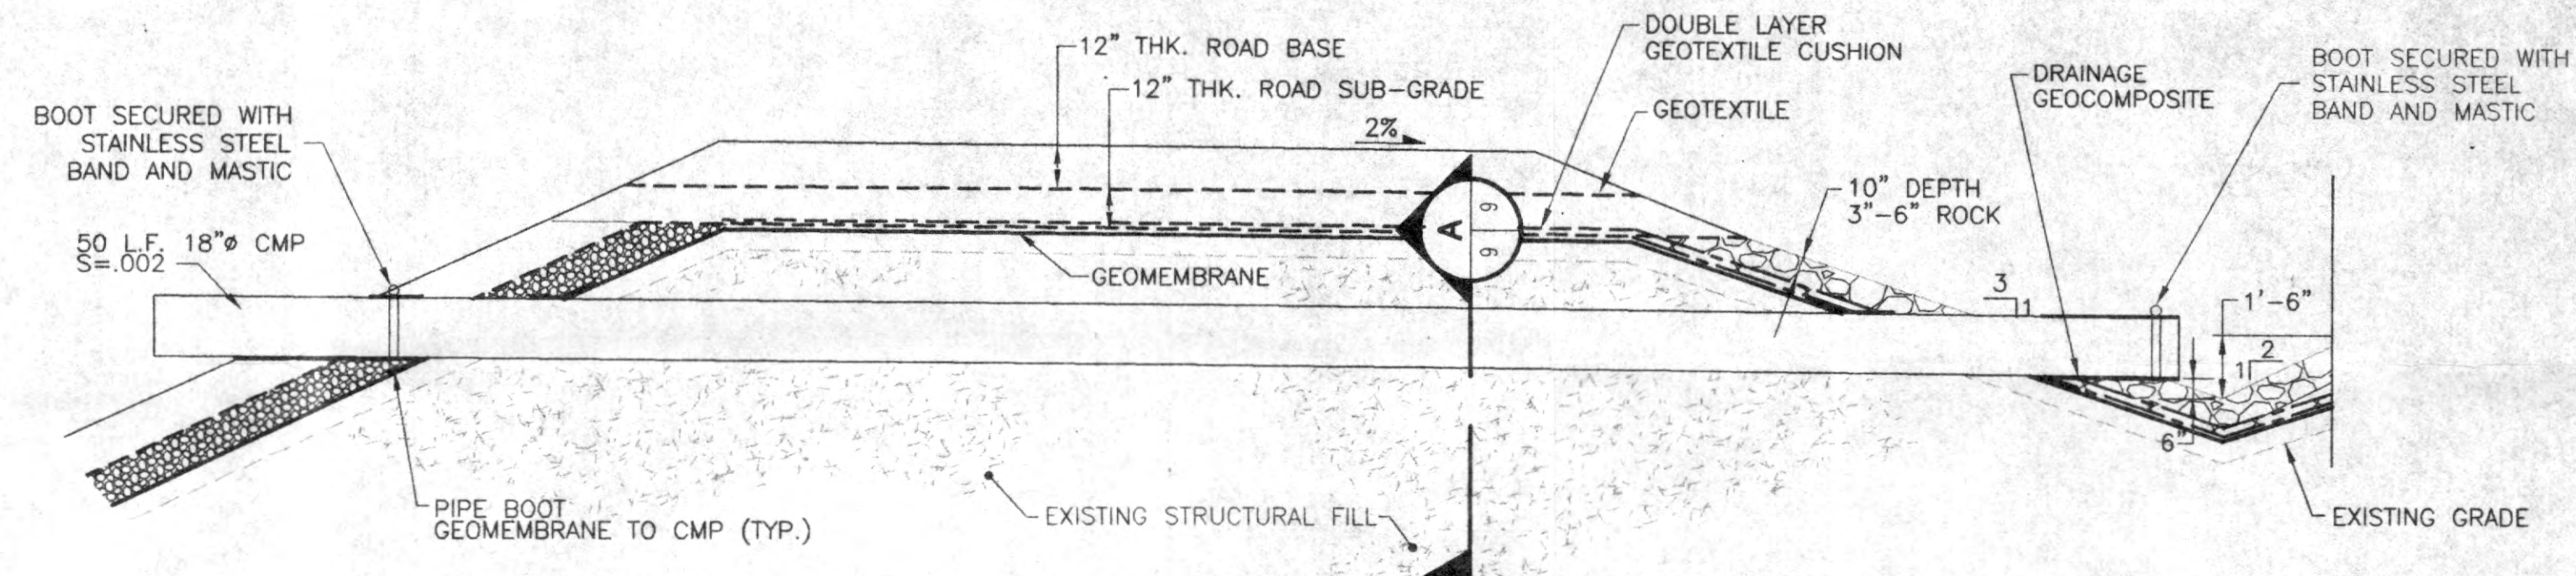
GAS HEADER CULVERT  
SECTION B  
SCALE: 1" = 4'
