**CONSTRUCTION REPORT  
EAST LINED AREA PARTIAL CLOSURE**

**HIDDEN VALLEY LANDFILL**

**PIERCE COUNTY, WASHINGTON**

**Construction Report  
East Lined Area Partial Closure  
Hidden Valley Landfill  
Pierce County, Washington**

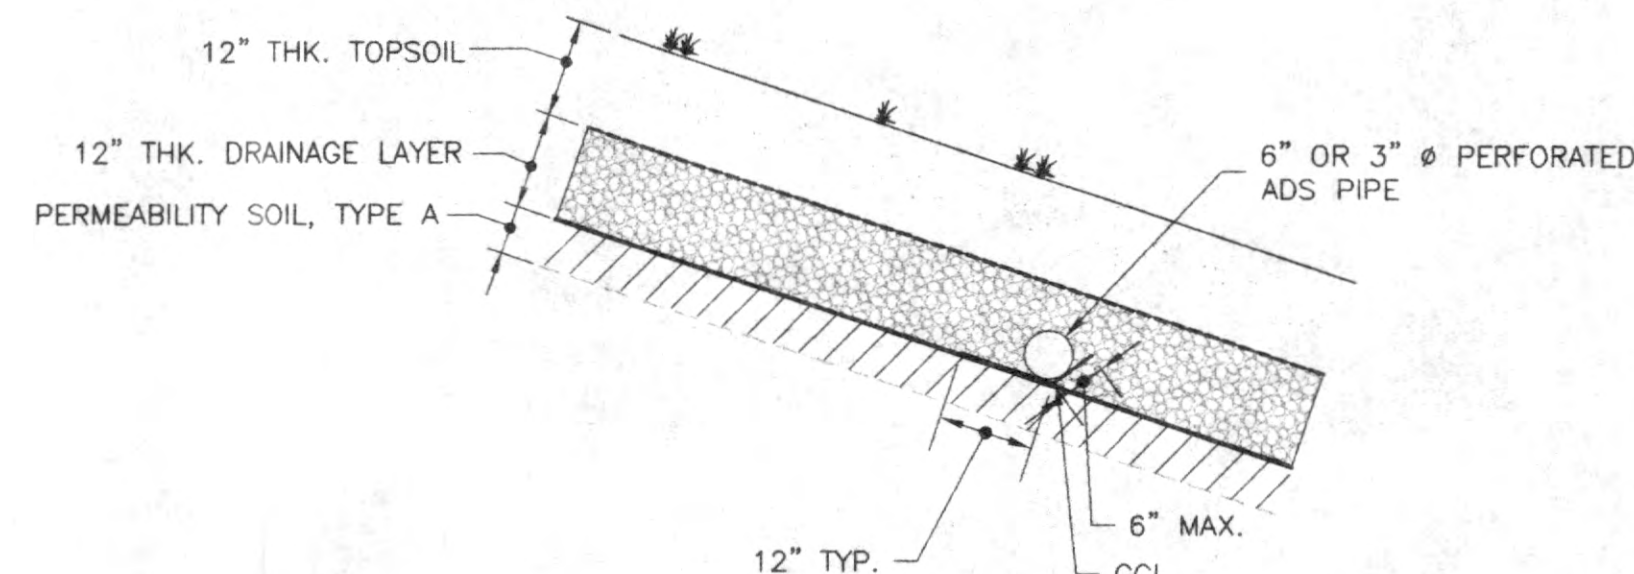
DRAIN PIPE DETAIL  
DETAIL D  
SCALE: 1" = 2'

An drainage pipe system was installed in the drainage layer to increase surface water percolation from this layer. By providing this added drainage, pore pressure in the drainage layer is reduced and this reduction in pore pressure reduces the potential for slope failure.

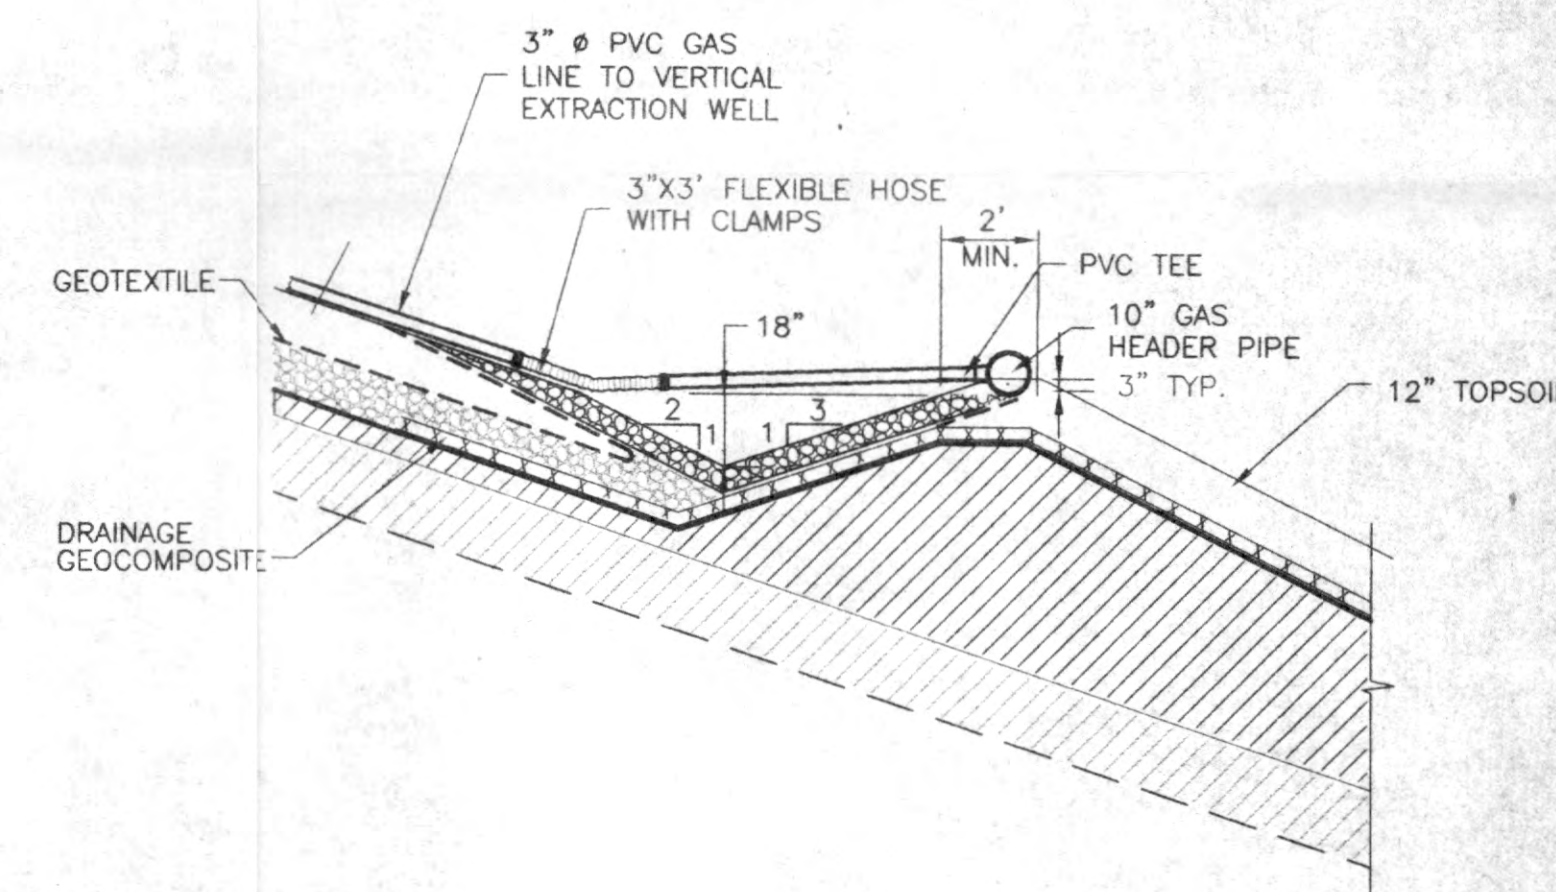
GAS HEADER DITCH CROSSING  
DETAIL 4  
SCALE: 1" = 4'

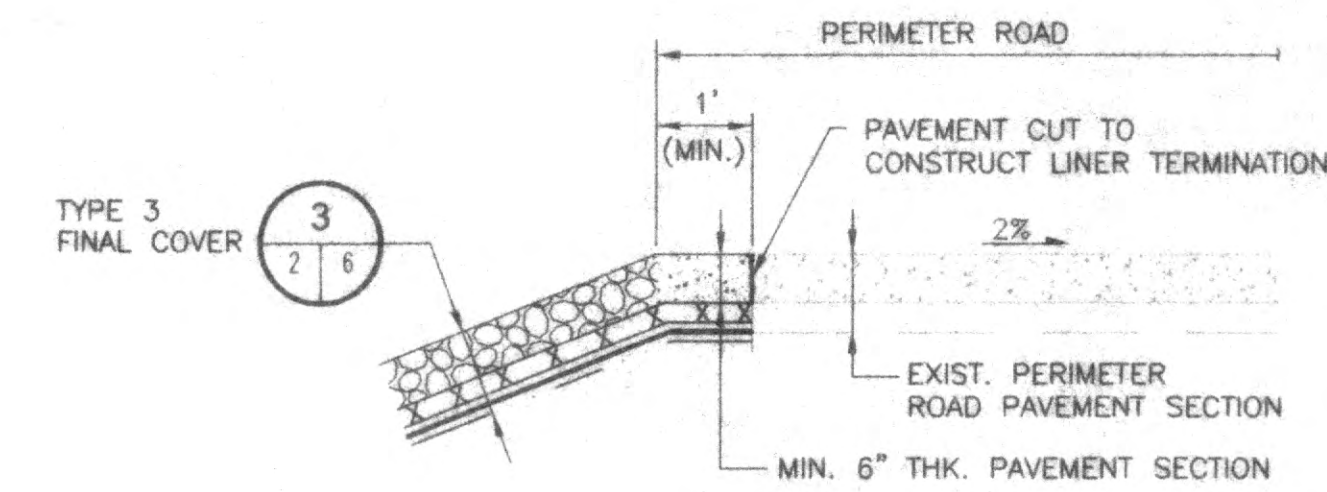
SOUTH / EAST PERIMETER ROAD

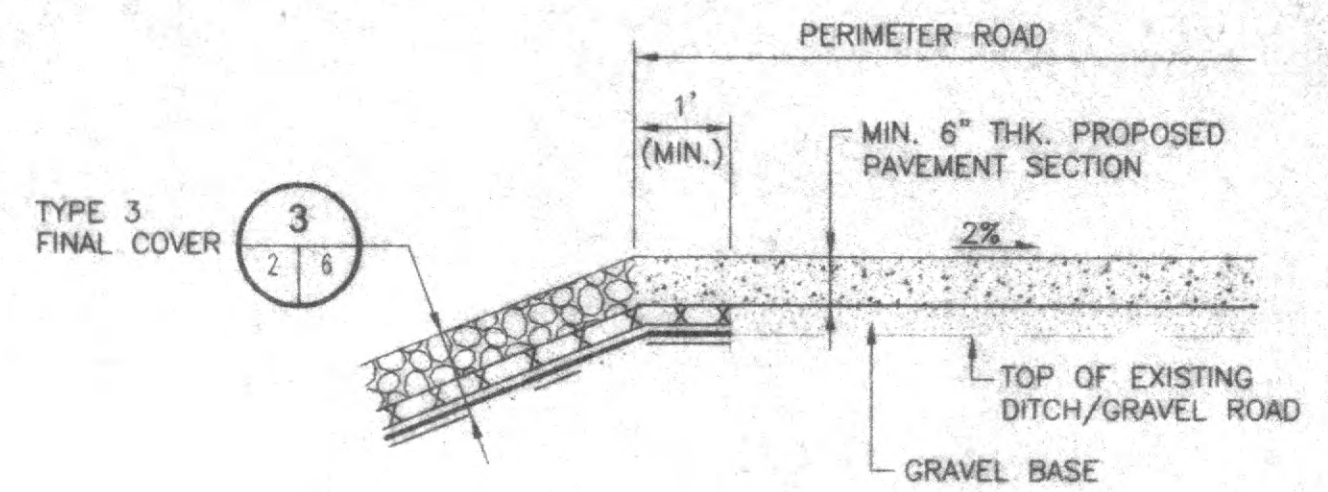
DETAIL 1  
SCALE: 1" = 2'

NORTH PERIMETER ROAD

FINAL COVER TERMINATION

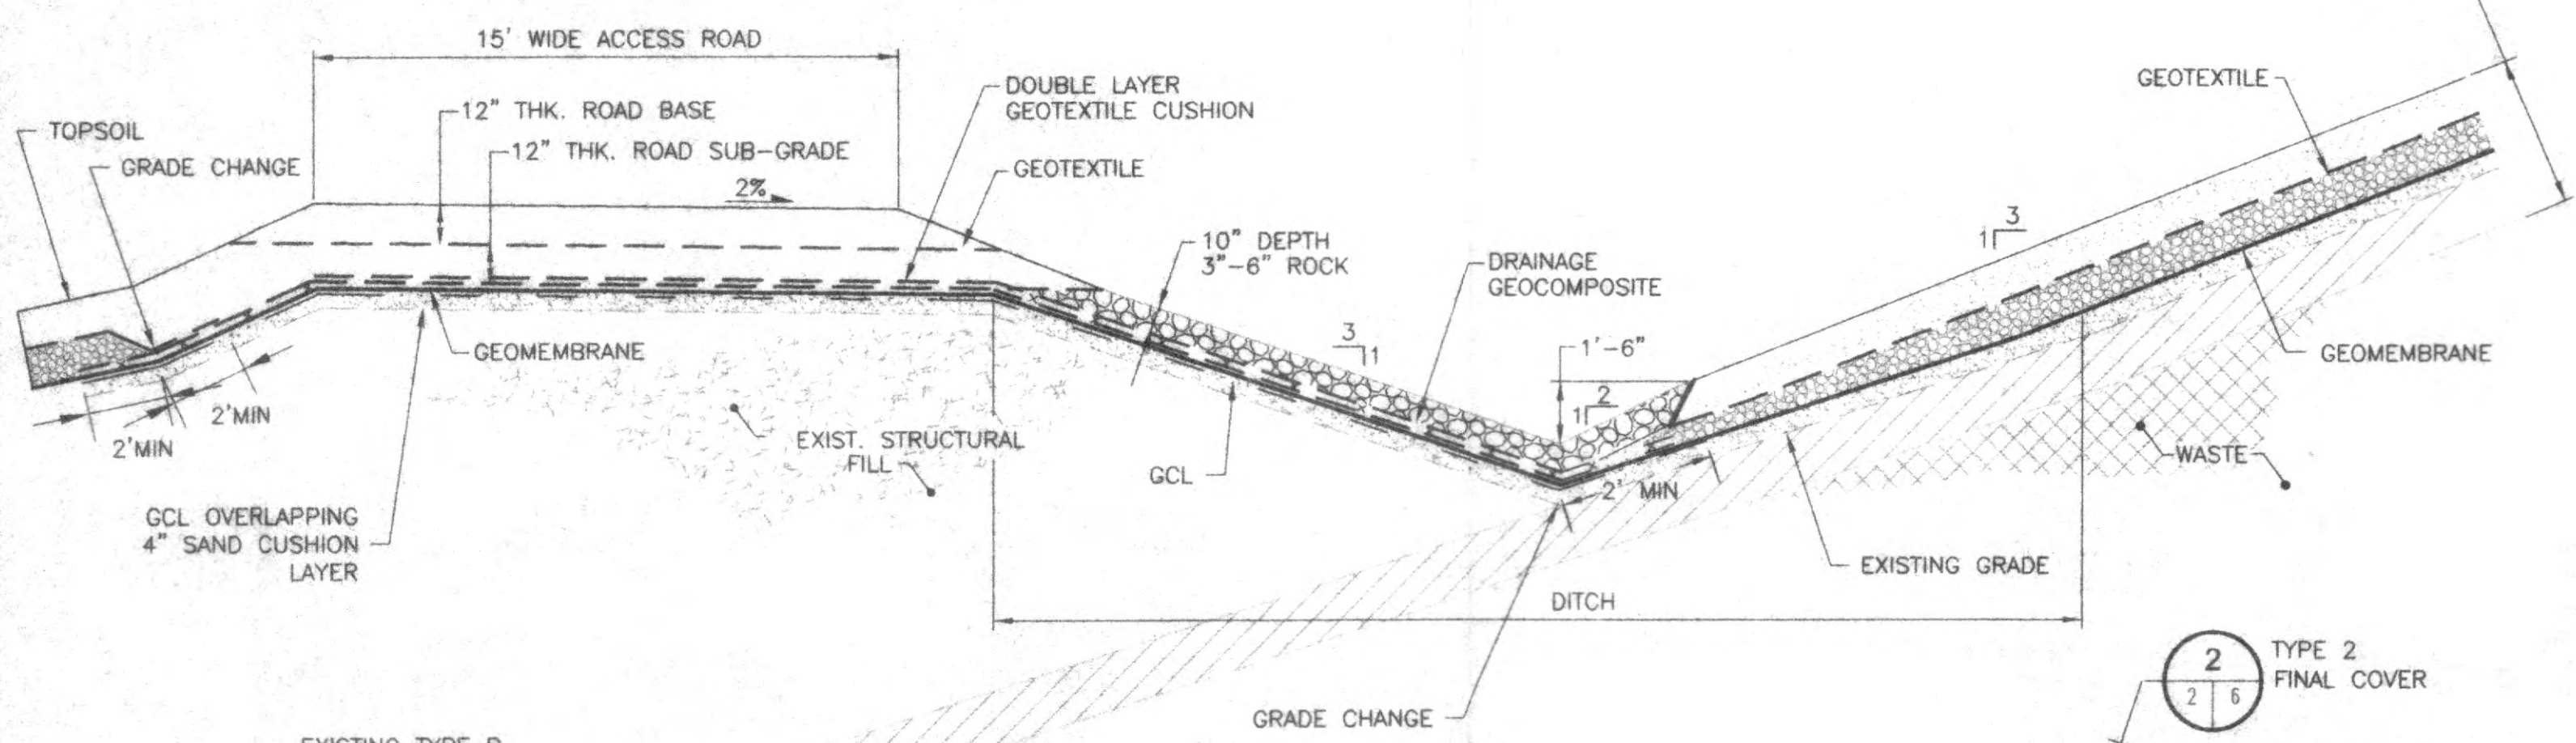
SECTION B  
SCALE: 1" = 4'

ACCESS ROAD AND ROAD SIDE DITCH

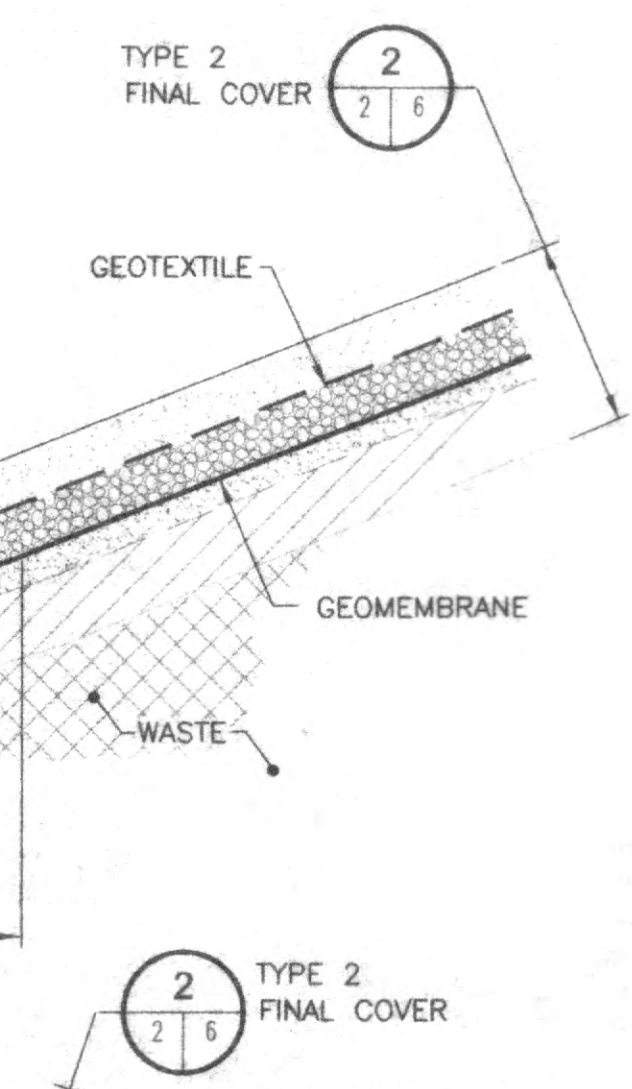
SECTION C  
SCALE: 1" = 4'

TYPICAL TIE-IN WITH NORTH PERIMETER ROAD

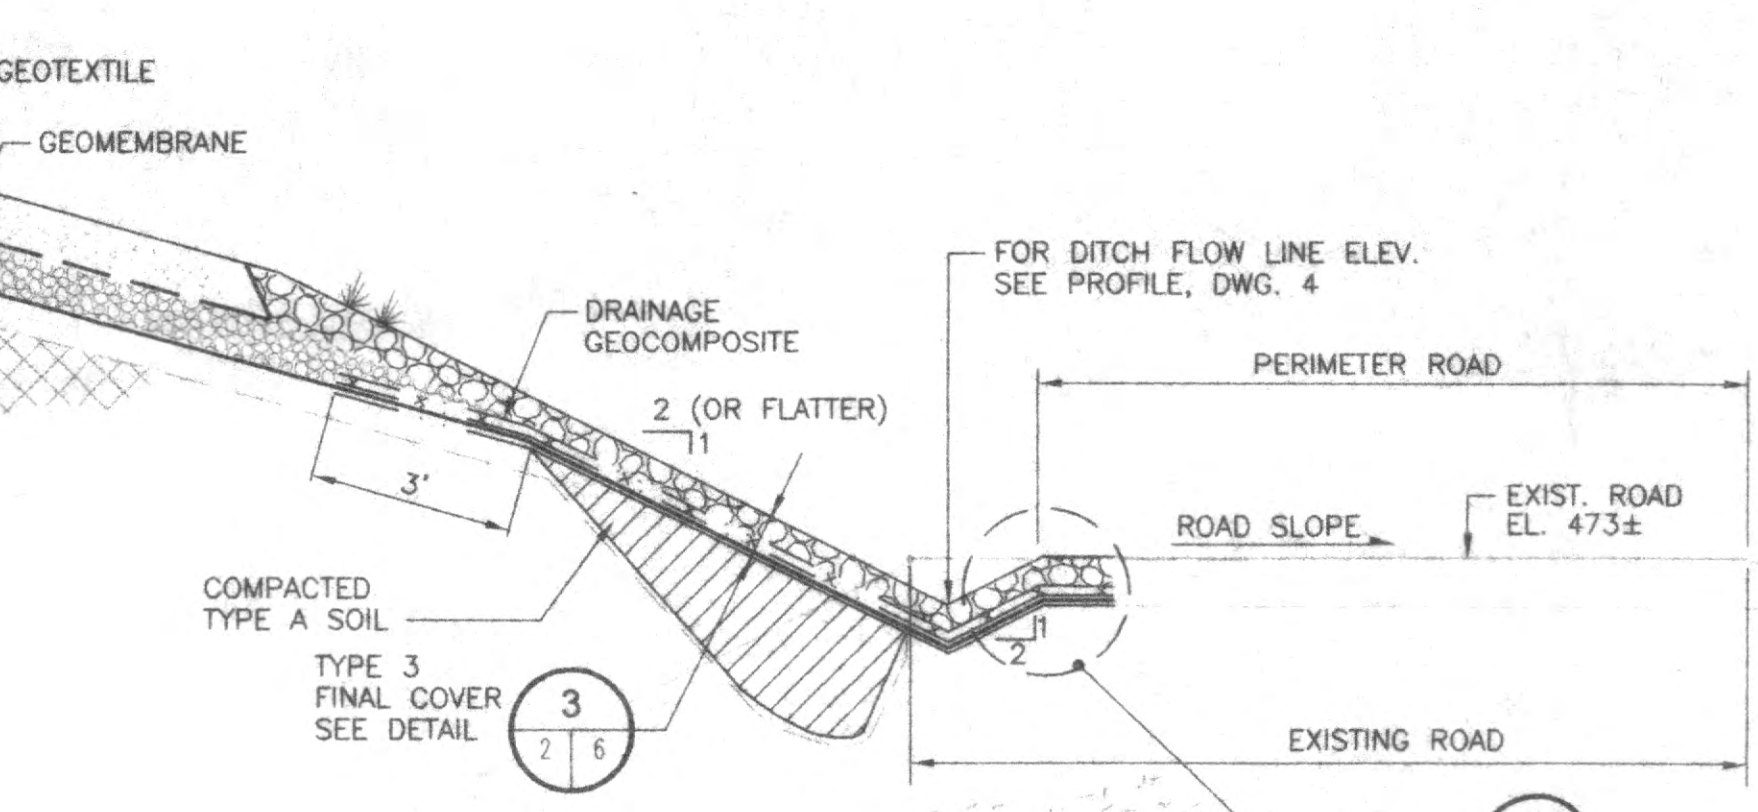
SECTION D  
SCALE: 1" = 4'

TYPICAL TIE-IN WITH SOUTH & EAST PERIMETER ROAD

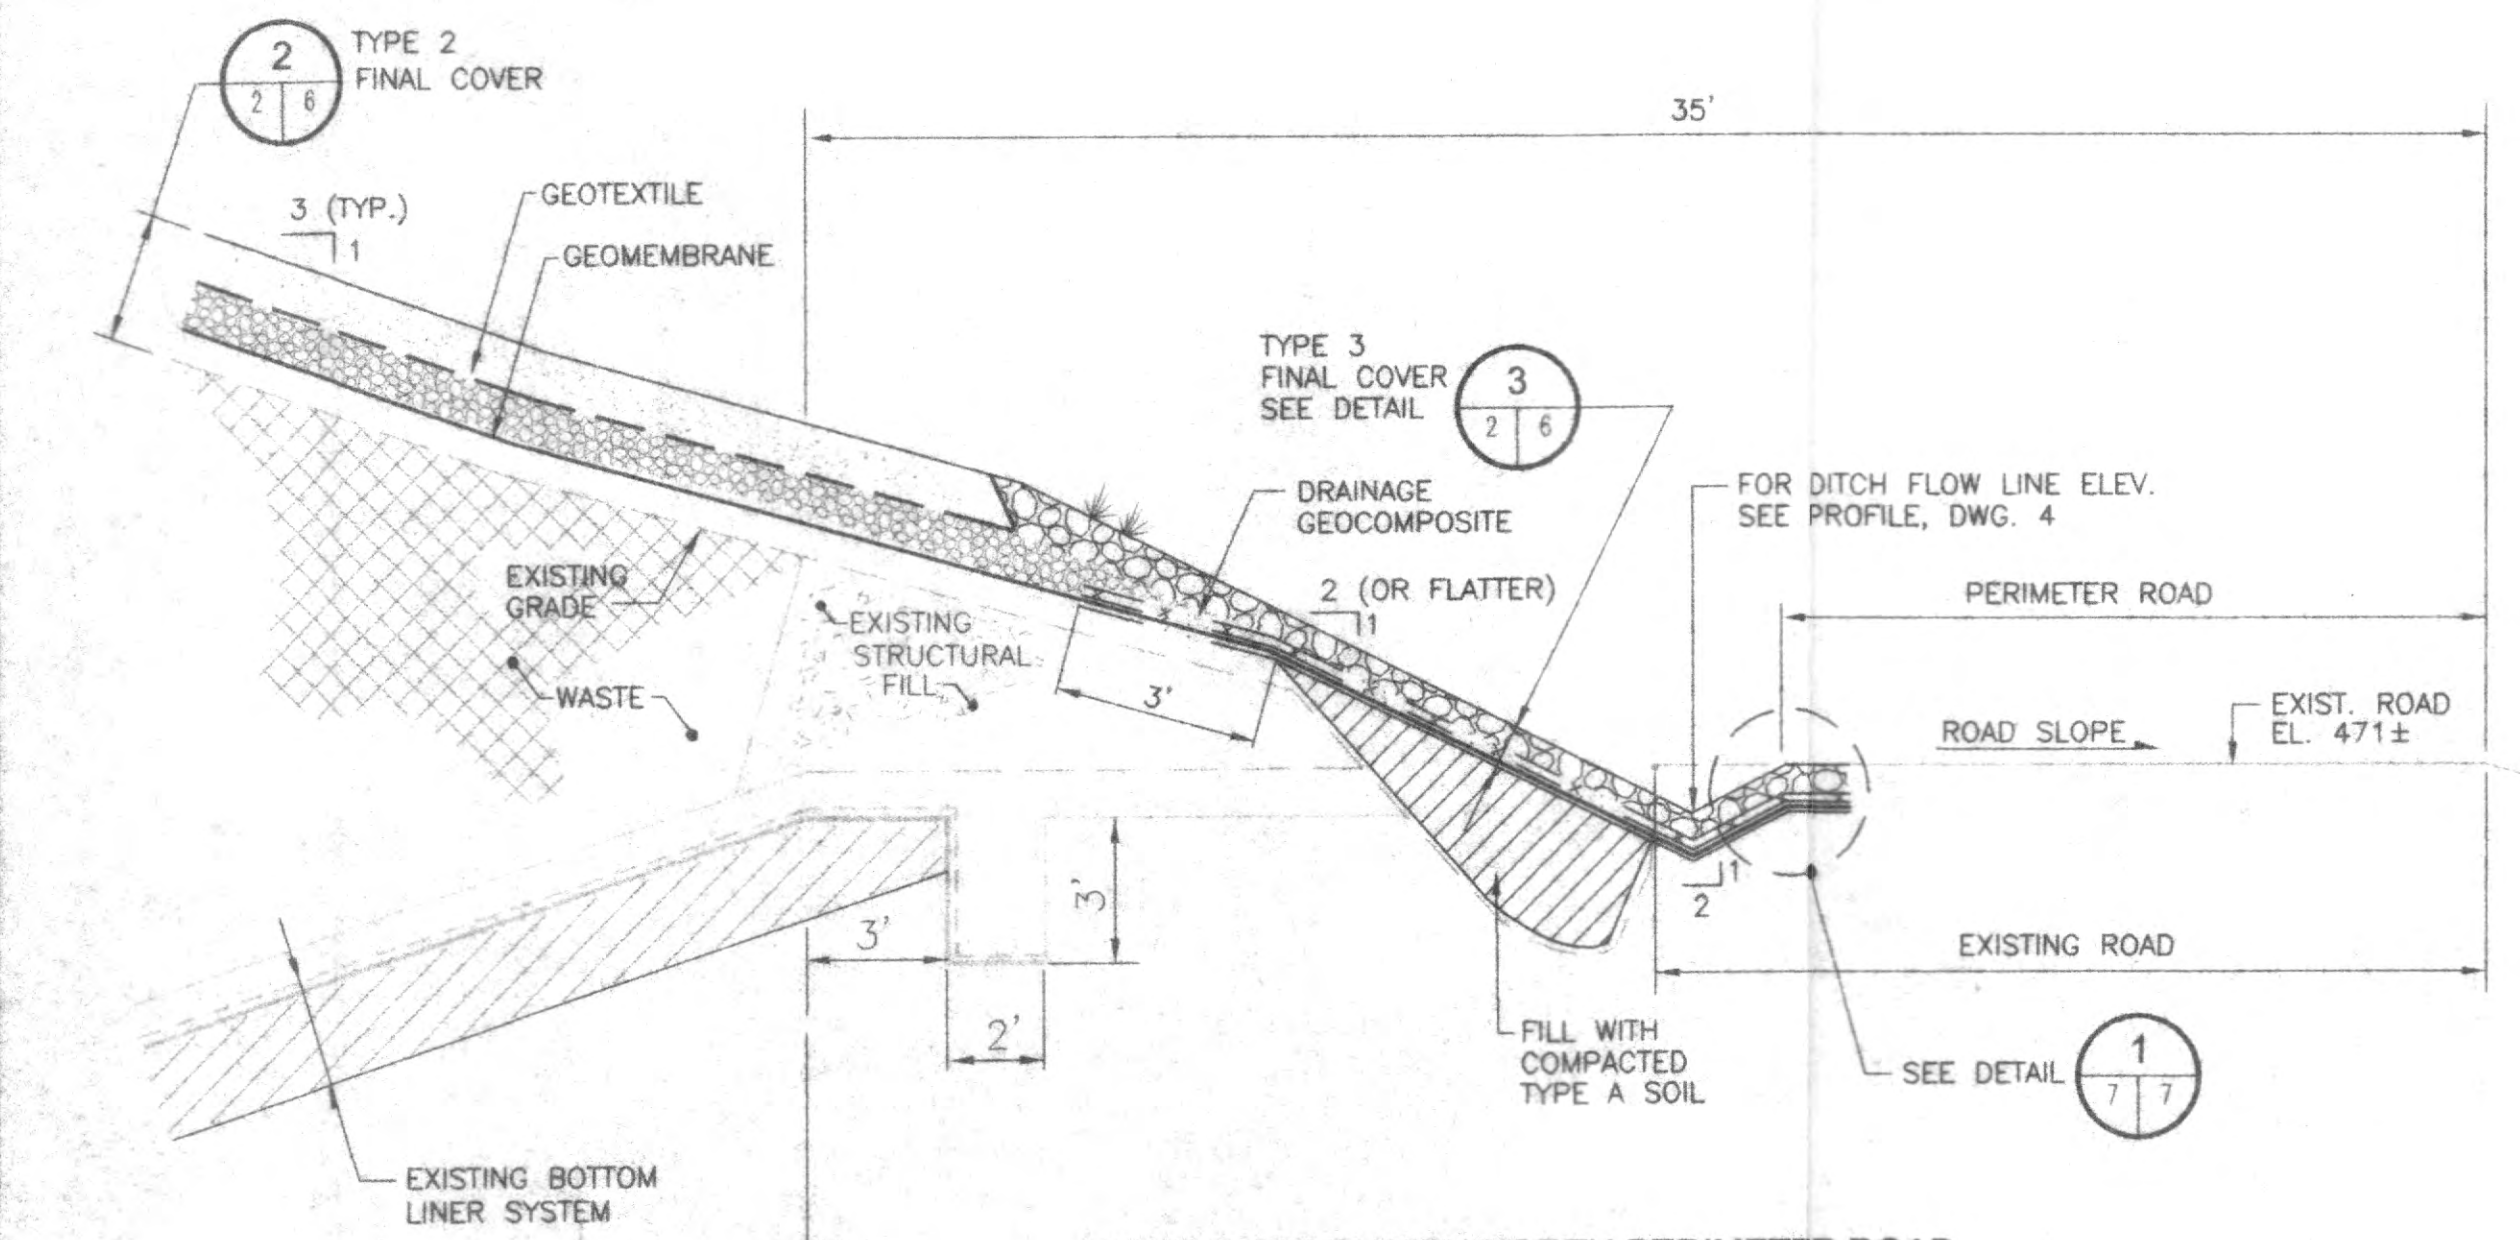
SECTION C  
SCALE: 1" = 4'

TYPICAL TIE-IN WITH NORTH PERIMETER ROAD

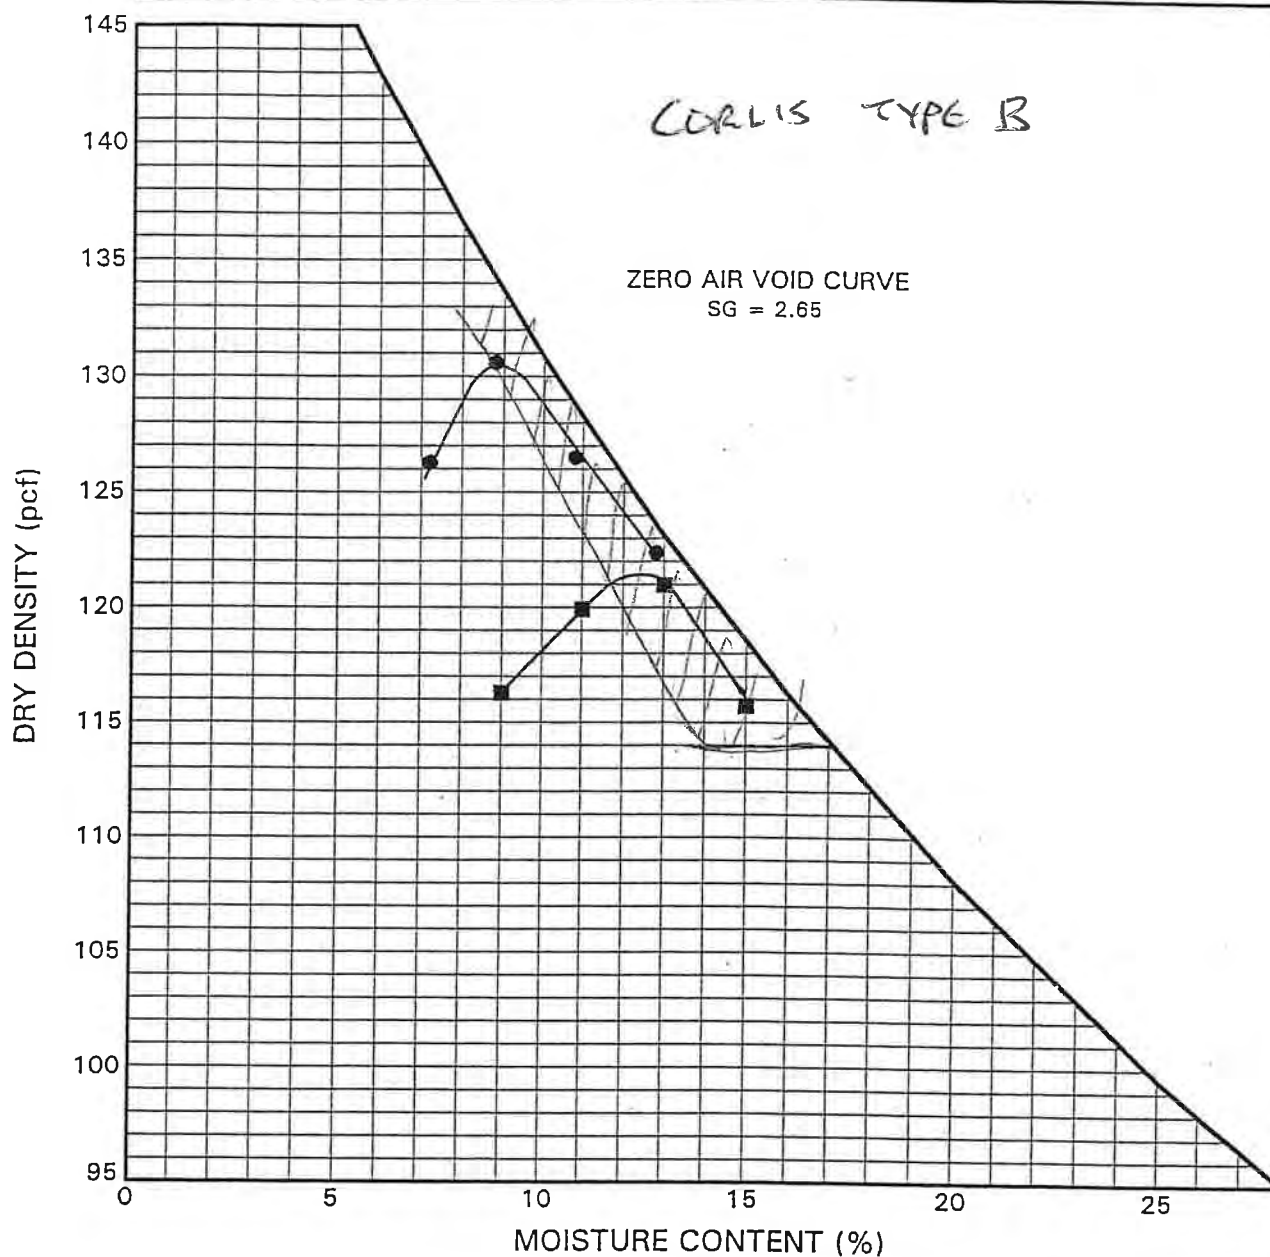
SAMPLE	DEPTH (feet)	CLASSIFICATION
CORBMOD		(SM) Dark grayish brown, silty SAND with gravel.
CORBSTD		(SM) Dark grayish brown, silty SAND with gravel.

SAMPLE:	CORBMOD,	CORBSTD,	
TEST METHOD:	ASTM D 1557	ASTM D 698	
MAXIMUM DRY DENSITY (pcf):	130.6	121.2	
OPTIMUM MOISTURE CONTENT (%):	8.8	12.5	
INITIAL MOISTURE CONTENT (%):	4.8	4.8

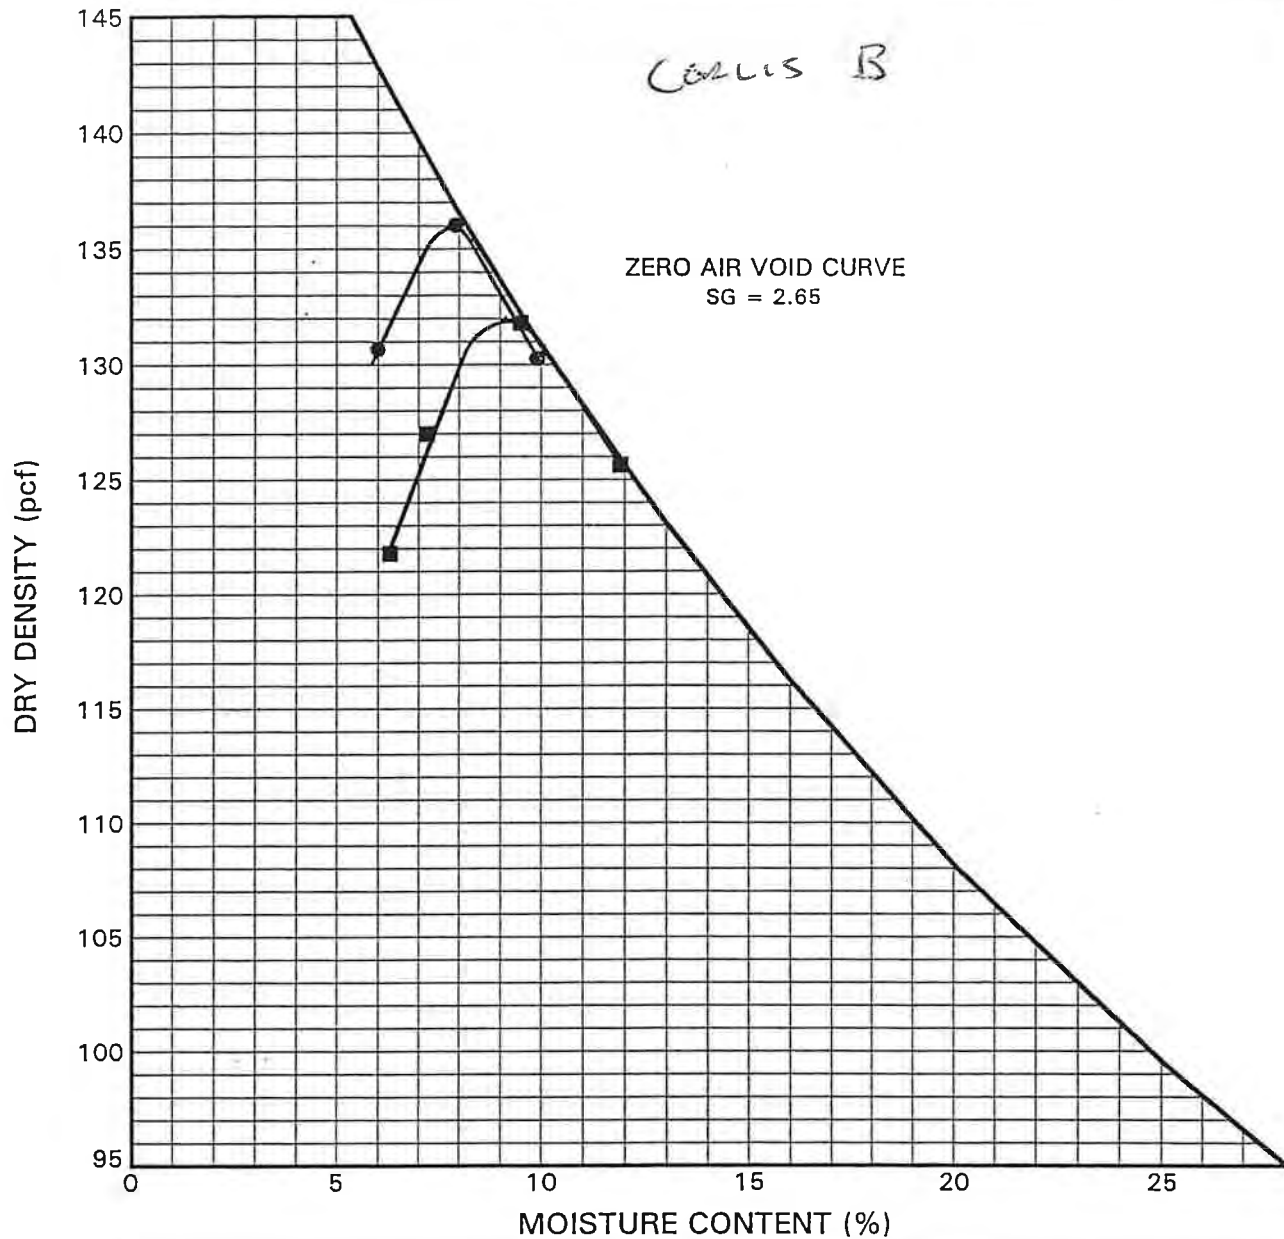
SAMPLE	DEPTH (feet)	CLASSIFICATION
COR2BMOD		(SM) Dark brown, silty SAND with gravel.
COR2BSTD		(SM) Dark brown, silty SAND with gravel.

SAMPLE:	COR2BMOD,	COR2BSTD,	
TEST METHOD:	ASTM D 1557	ASTM D 1557	
MAXIMUM DRY DENSITY (pcf):	136.0	131.8	
OPTIMUM MOISTURE CONTENT (%):	7.9	9.5	
INITIAL MOISTURE CONTENT (%):	7.9	7.9

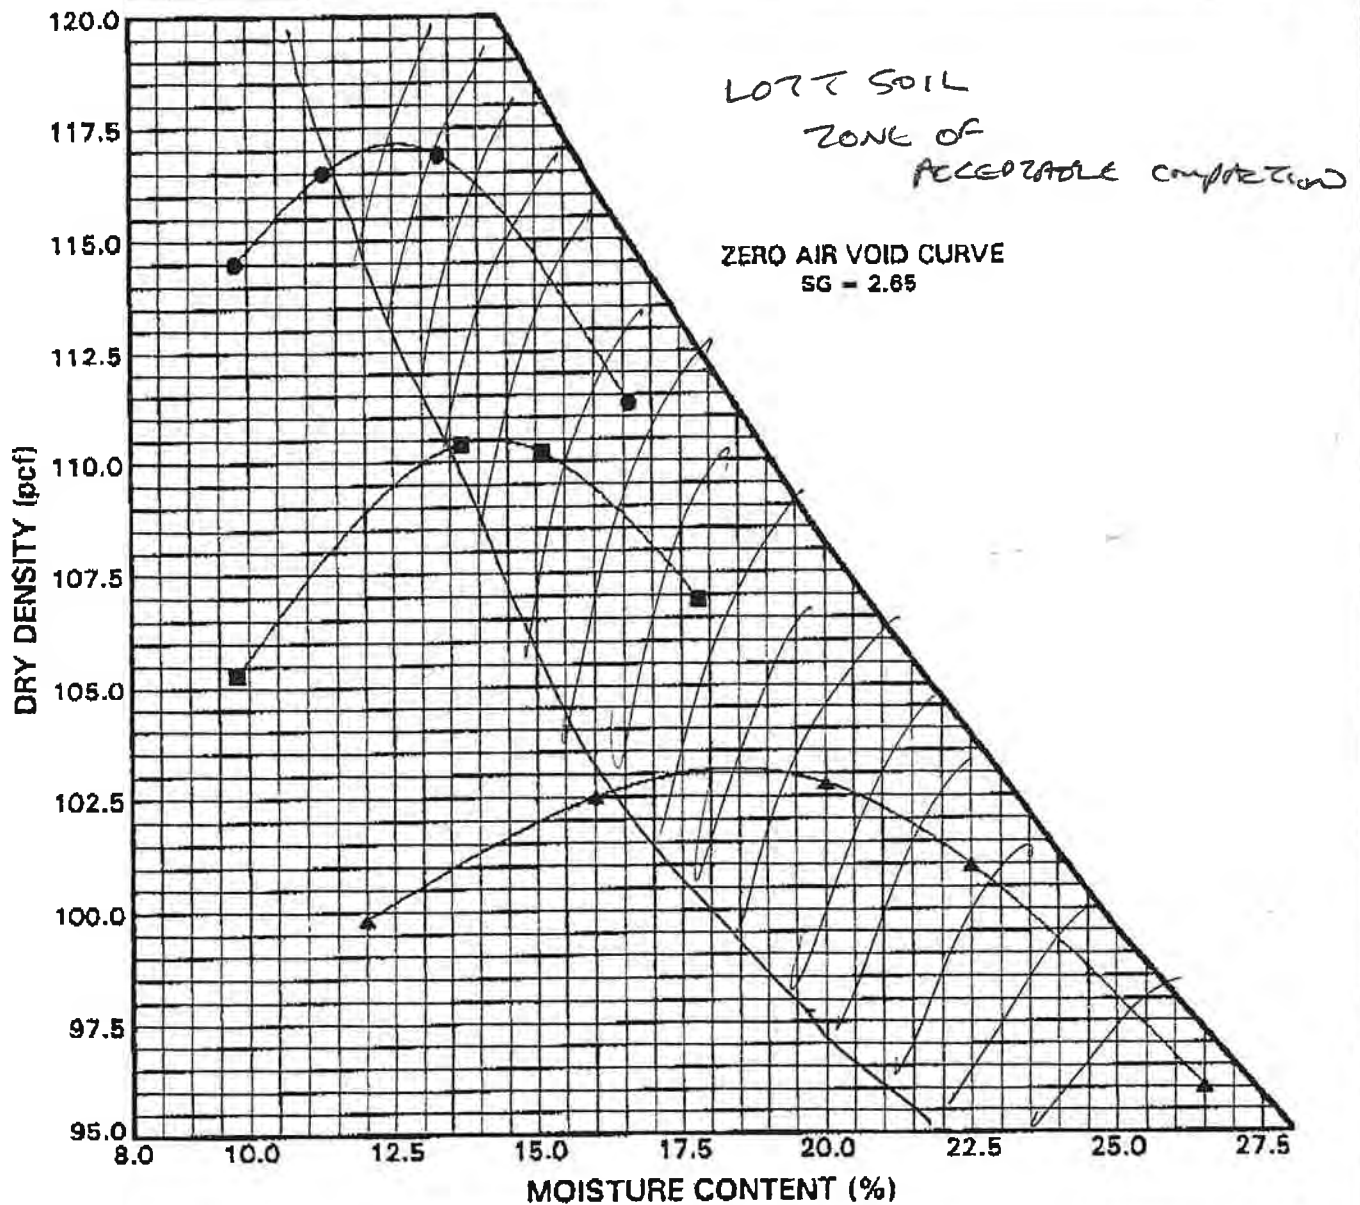
SAMPLE	DEPTH (feet)	CLASSIFICATION
S-3MOD		(GM) Very dark brown, silty GRAVEL with sand
S-3STD		(GM) Very dark brown, silty GRAVEL with sand
S-4		(GM) Very dark brown, silty GRAVEL with sand (LOTT Soil)

SAMPLE:	S-3MOD,	S-3STD,	S-4,
TEST METHOD:	ASTM D 1557	ASTM D 698	Low Energy
MAXIMUM DRY DENSITY (pcf):	117.2	110.5	103.1
OPTIMUM MOISTURE CONTENT (%):	12.5	14.3	18.5
INITIAL MOISTURE CONTENT (%):	12.2	12.2	20.0

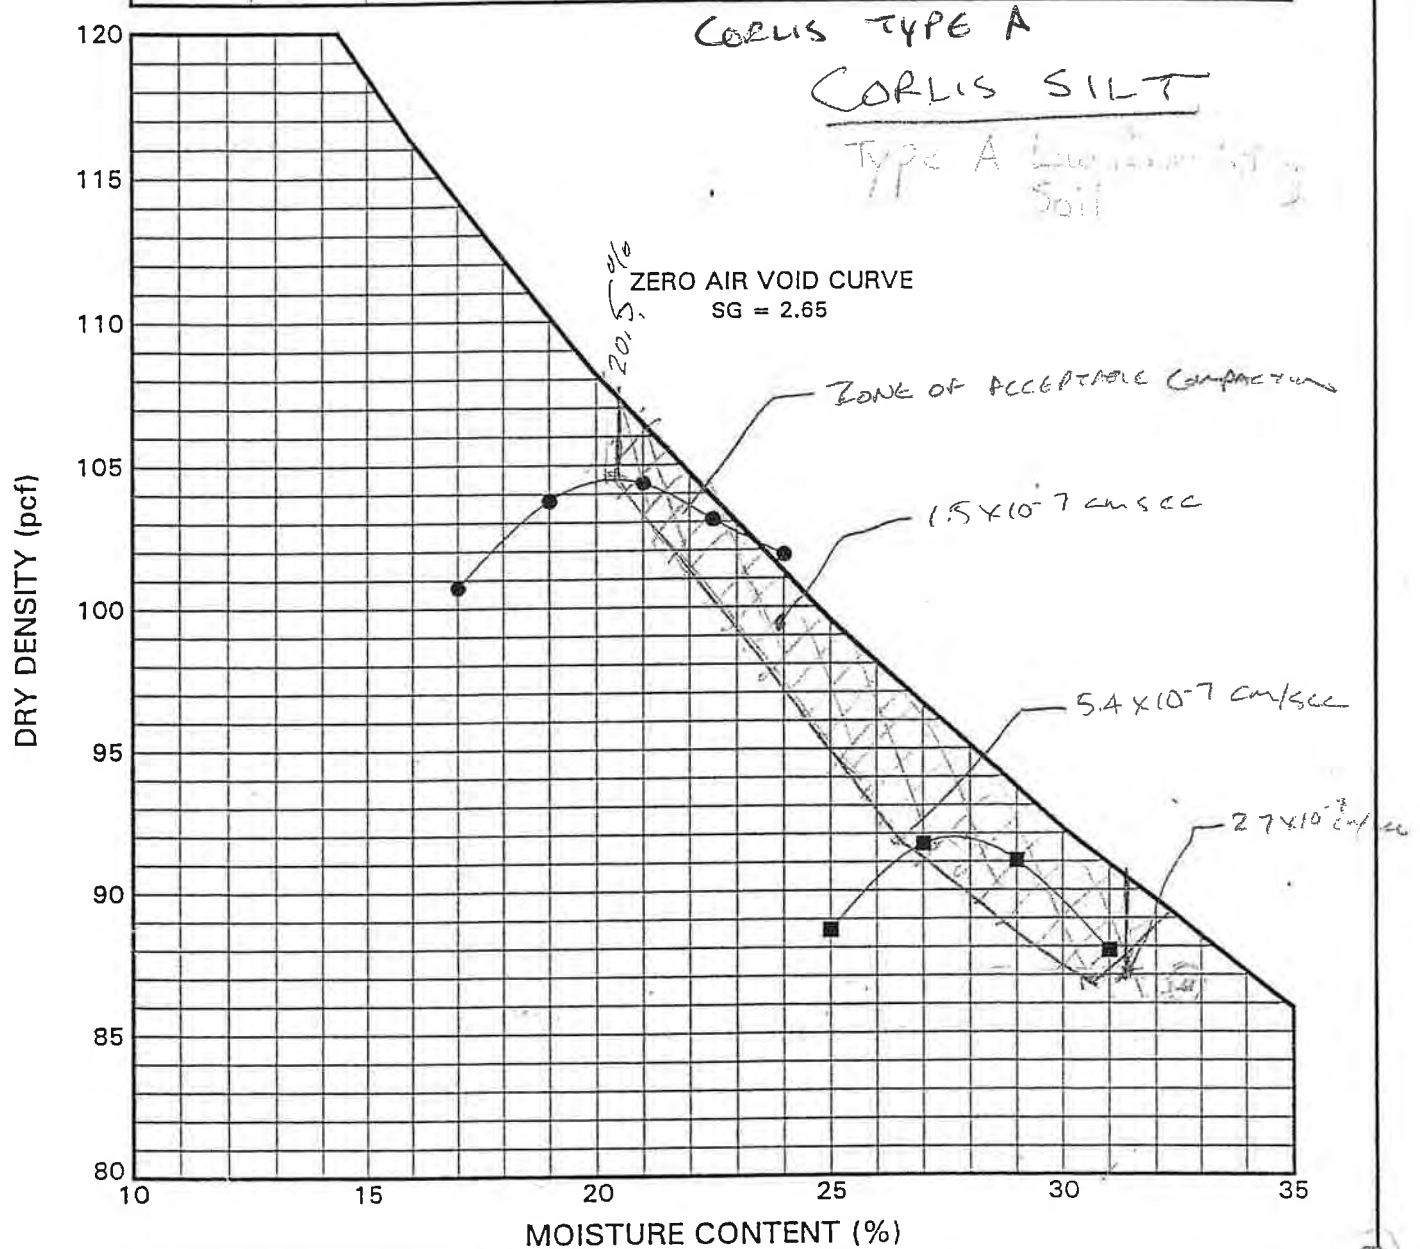
SAMPLE	DEPTH (feet)	CLASSIFICATION
S-1MOD		(CH) Olive Brown, Fat CLAY with sand.
S-1STD		(CH) Olive brown, Fat CLAY with sand.

SAMPLE:	S-1MOD,	S-1STD,	
TEST METHOD:	ASTM D 1557	ASTM D 698	
MAXIMUM DRY DENSITY (pcf):	104.5	91.9	<del>104.5</del>
OPTIMUM MOISTURE CONTENT (%):	20.5	27.5	<del>20.5</del>
INITIAL MOISTURE CONTENT (%):	58.9	58.9

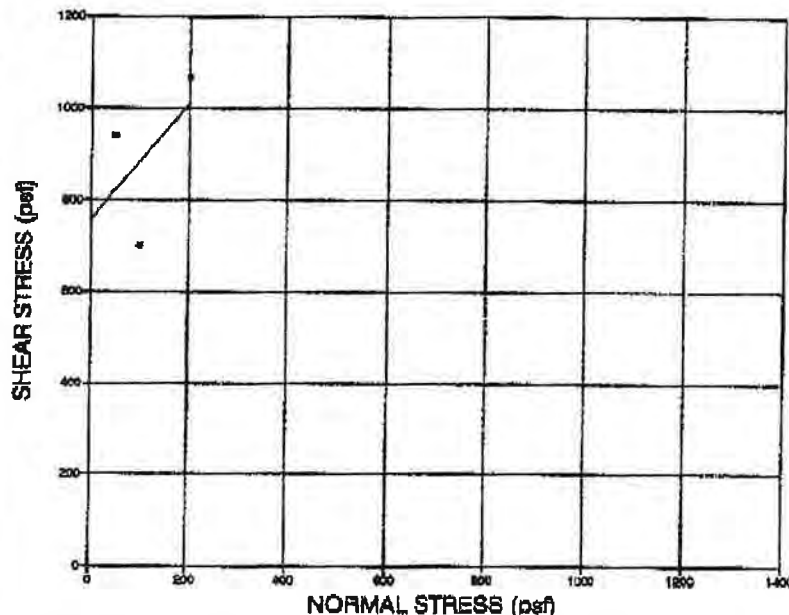
Test Point	Normal Stress		Shear Stress psf
	psi	psf	
1.	0.3	50	940
2.	0.7	100	700
3.	1.4	200	1070

Adhesion: 760 psf  
Friction Angle: 52 degrees  
Displ. Rate: 0.040 in./min.

**STRENGTH ENVELOPE**

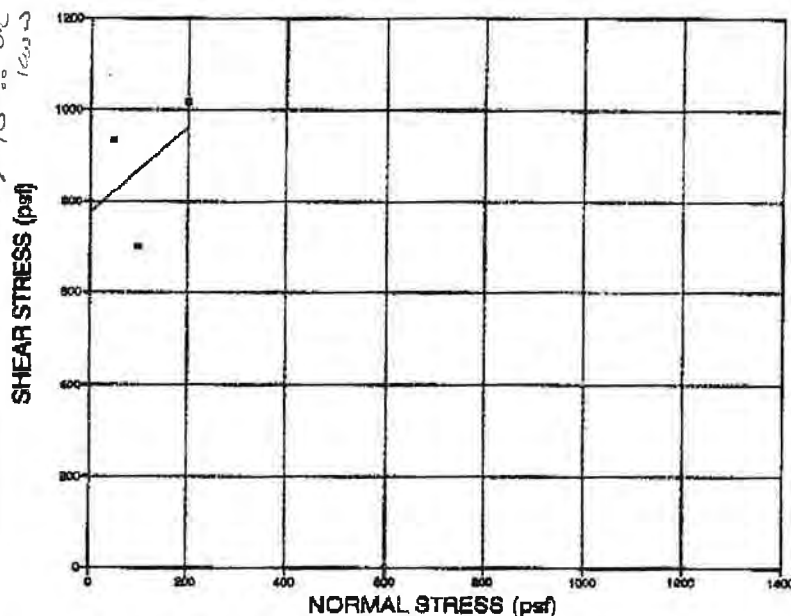
Test Point	Normal Stress		Shear Stress psf
	psi	psf	
1.	0.3	50	930
2.	0.7	100	700
3.	1.4	200	1020

Adhesion: 780 psf  
Friction Angle: 43 degrees  
Displ. Rate: 0.040 in./min.

**NOTE:** The Friction Angle and Adhesion (or Cohesion) results given here are based upon a mathematically determined "best fit" line. Further interpretation should be conducted by a qualified professional experienced in geosynthetic and geotechnical engineering.

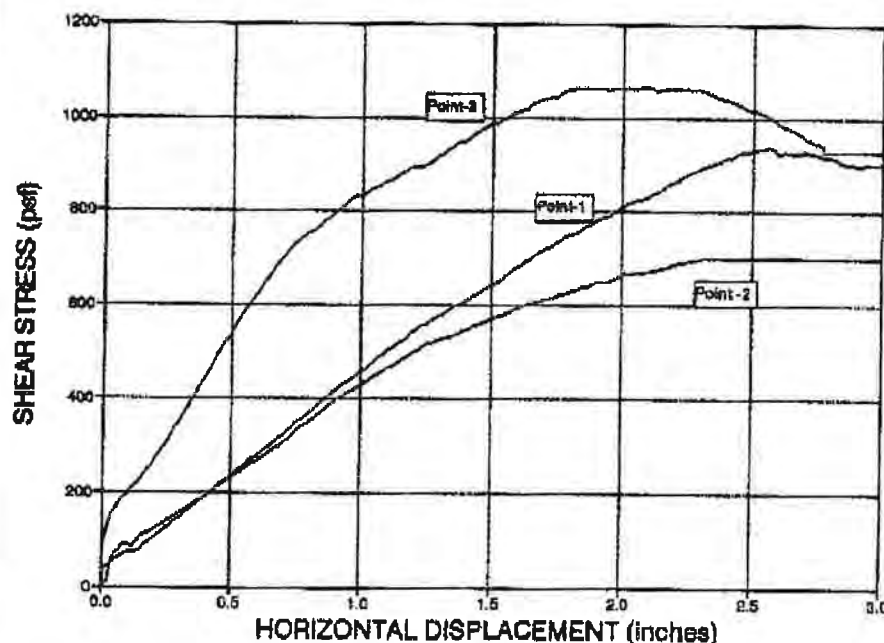
**DISPLACEMENT  
vs SHEAR STRESS**

Test Point	Normal Stress	
	psi	psf
1.	0.3	50
2.	0.7	100
3.	1.4	200

1. The "gap" between shear boxes was set at 80 mil (2.0 mm).
2. The test specimens were flooded during testing unless noted.
3. High Normal Stress (>5psi) was applied using air pressure.
4. Low Normal Stress (<5 psi) was applied using dead weights.
5. The tests were terminated 3.0" displacement unless noted.
6. Tests were performed in general accordance with ASTM procedure D 5321-92 Method A using a Brainard-Kilman LG-112 direct shear machine with an effective area of 12 in. x 12 in. (Machine A)

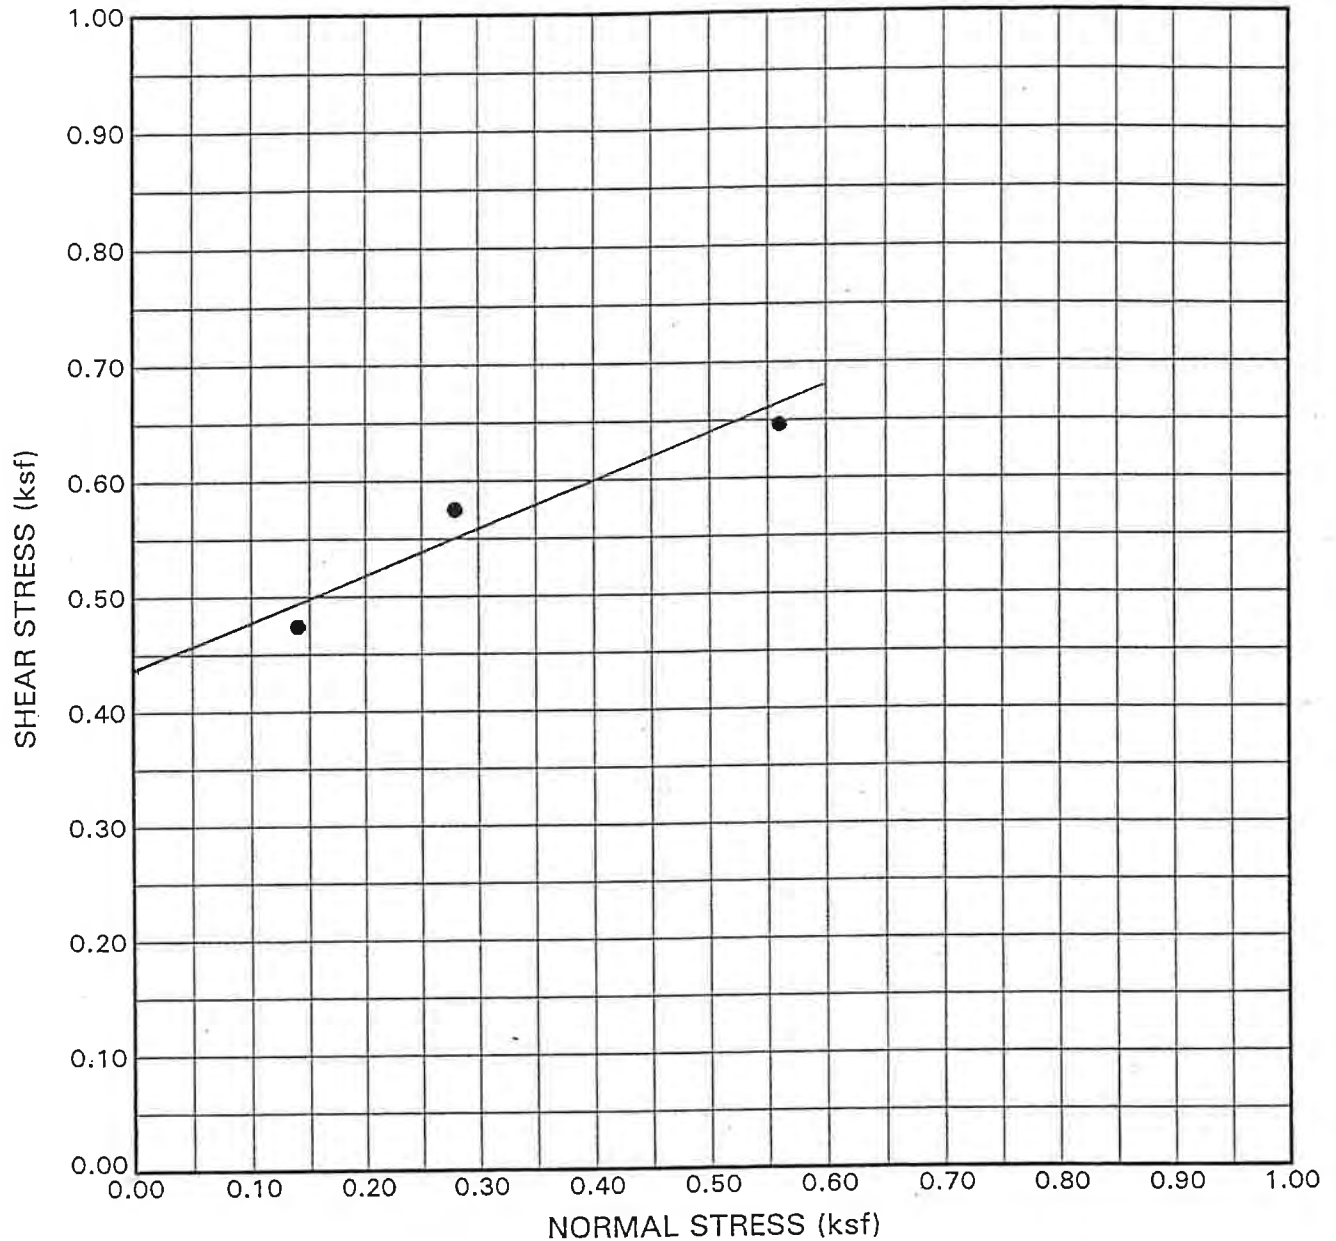
FIGURE: 3

SAMPLE		DEPTH (feet)	CLASSIFICATION
S-1	<i>TYPE A</i>		(CH) Olive brown, Fat CLAY with sand.
TEST CONDITIONS:		Peak values plotted for remolded specimens.

FRICTION ANGLE (degrees)	21
APPARENT COHESION (psf)	440
AVERAGE DRY DENSITY (pcf)	87.3
AVERAGE WATER CONTENT (%)	31.5
