**CONSTRUCTION REPORT  
EAST LINED AREA PARTIAL CLOSURE**

**HIDDEN VALLEY LANDFILL**

**PIERCE COUNTY, WASHINGTON**

**Construction Report  
East Lined Area Partial Closure  
Hidden Valley Landfill  
Pierce County, Washington**

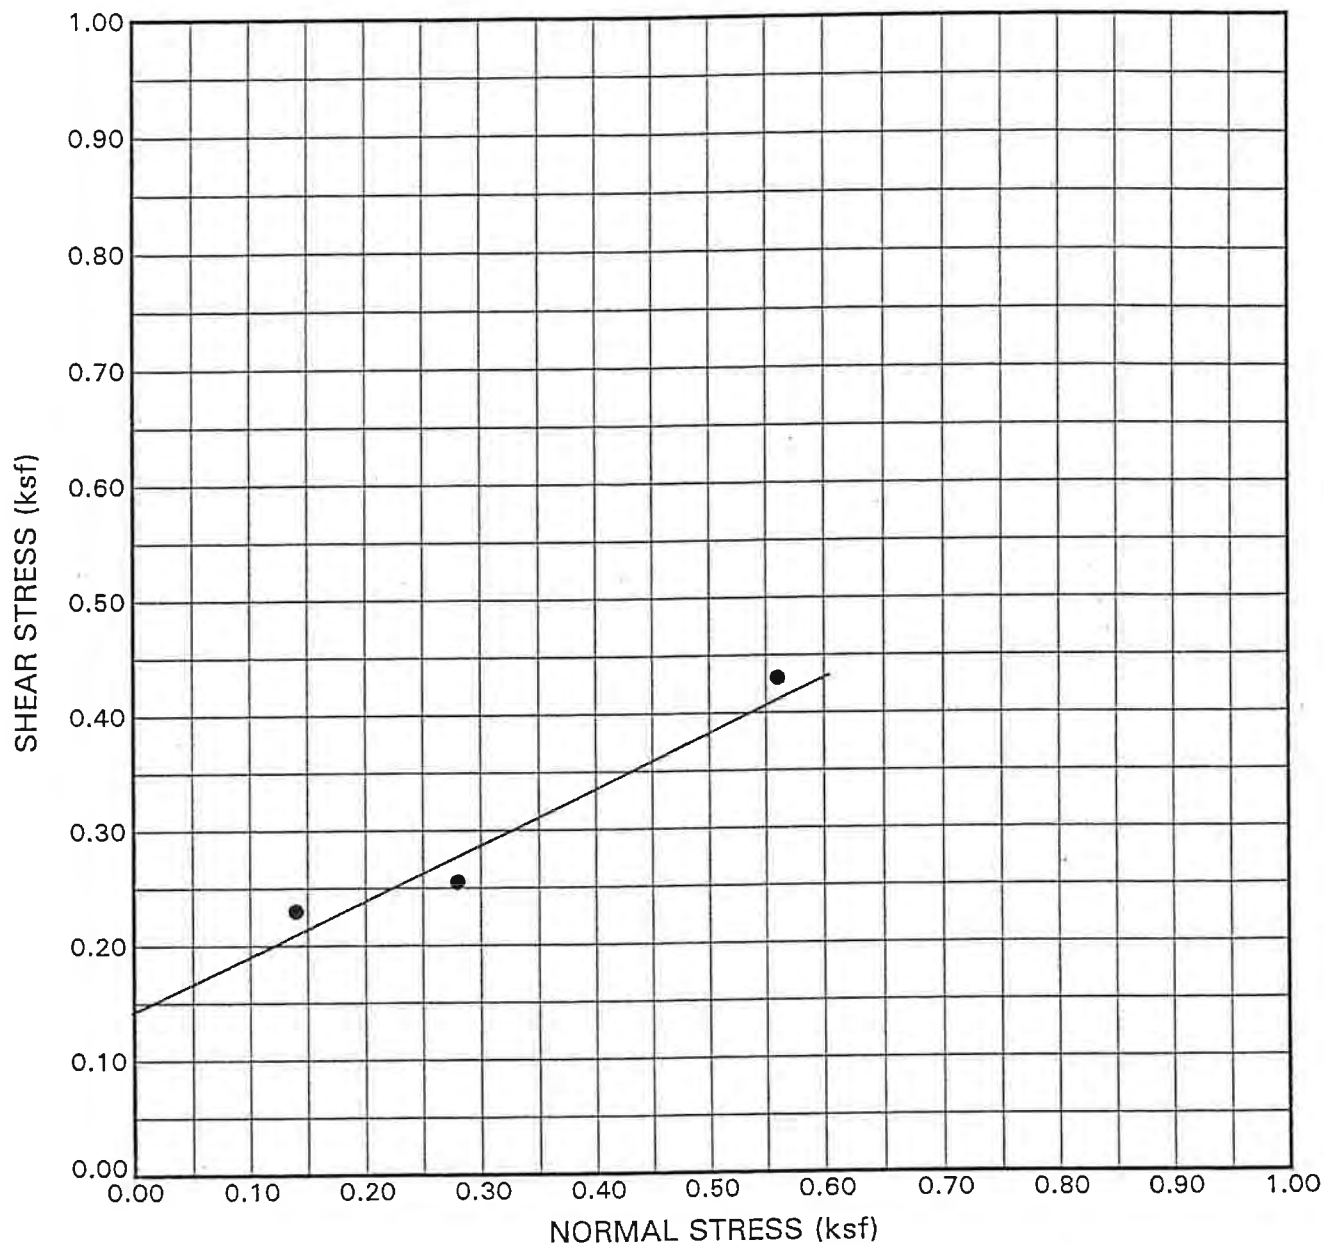
FIGURE: 4

SAMPLE	DEPTH (feet)	CLASSIFICATION
S-1R	TYPE A	(CH) Olive brown, Fat CLAY with sand.
TEST CONDITIONS: Approximate residual values obtained by re-testing failed sample.

FRICTION ANGLE (degrees)	26
APPARENT COHESION (psf)	140
AVERAGE DRY DENSITY (pcf)	87.3
AVERAGE WATER CONTENT (%)	31.5

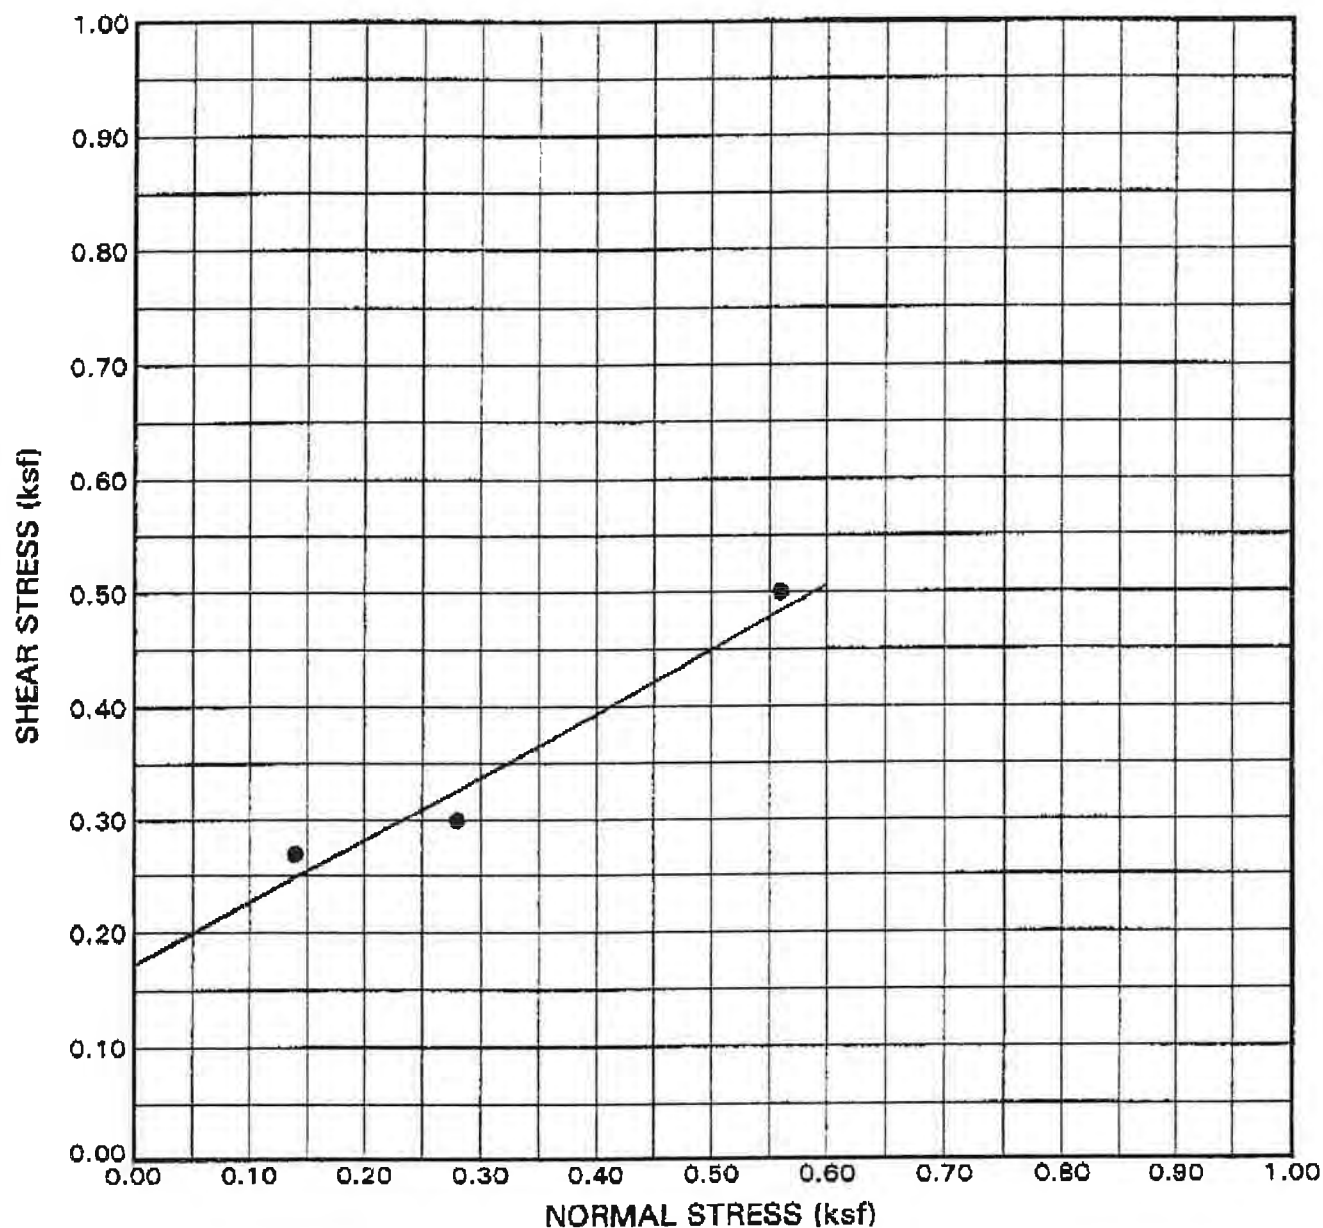
SAMPLE	DEPTH (feet)	CLASSIFICATION
S-4 <i>Type B</i>		(GM) Very dark brown, silty GRAVEL with sand (LOTT Soil)
TEST CONDITIONS: Specimens remolded to match field density and moisture content.

FRICTION ANGLE (degrees)	30
APPARENT COHESION (psf)	170
AVERAGE DRY DENSITY (pcf)	88.7
AVERAGE WATER CONTENT (%)	20.9

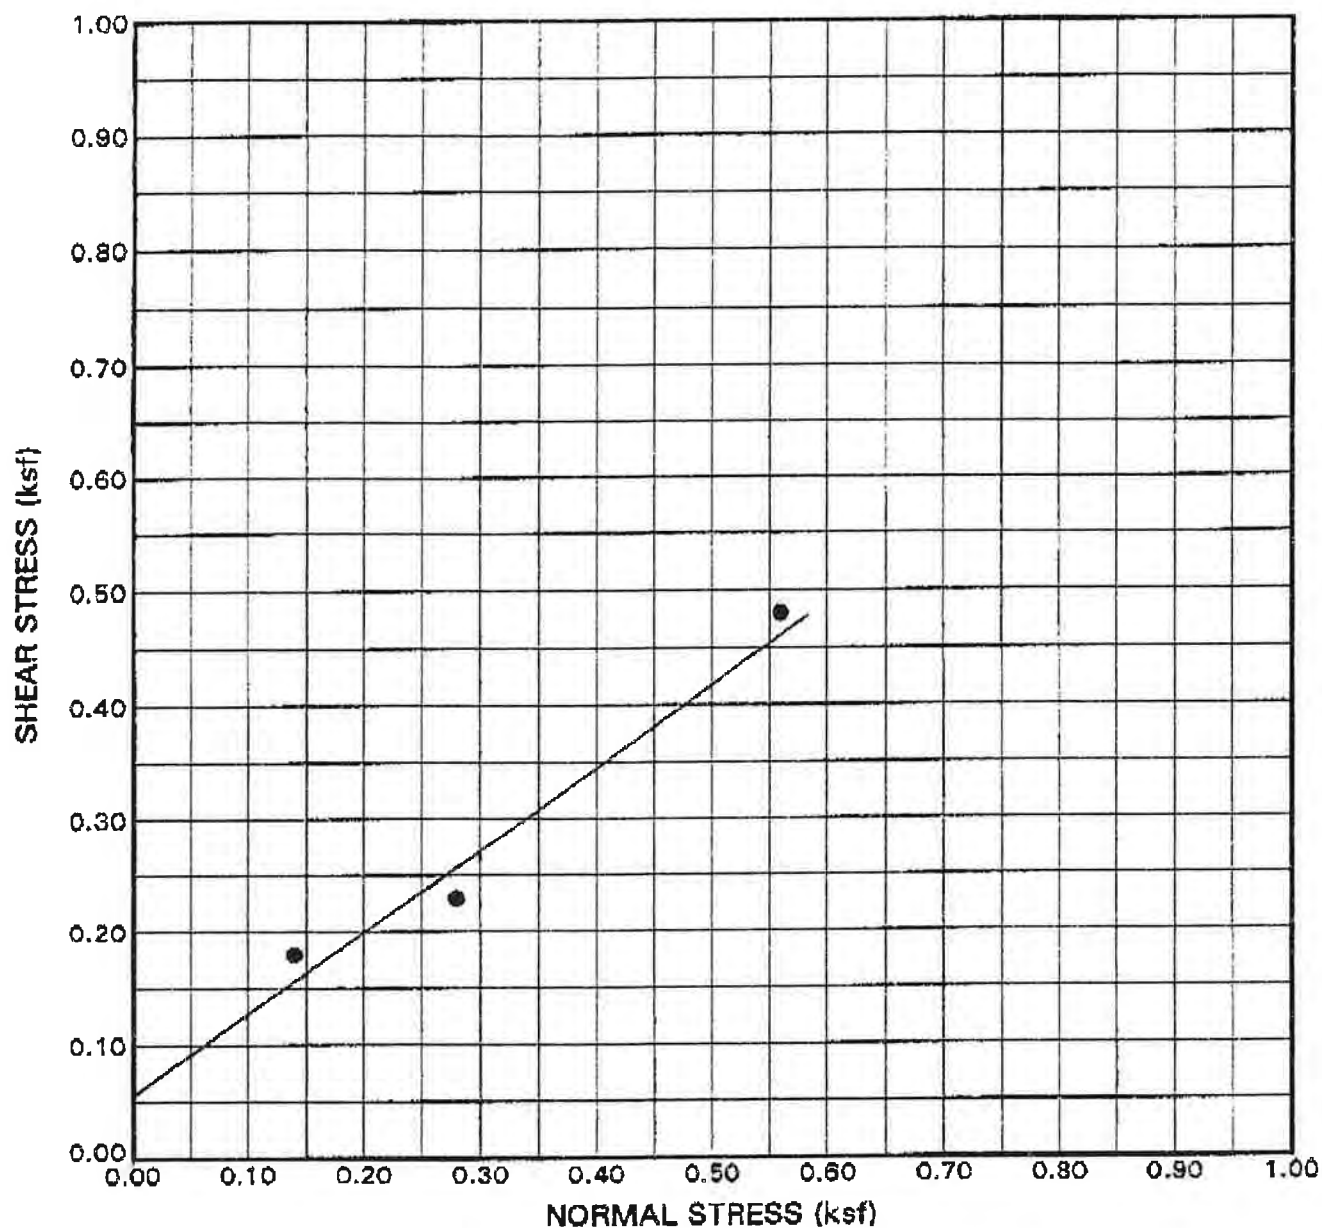
SAMPLE	DEPTH (feet)	CLASSIFICATION
S-4R TYPE B		(GM) Very dark brown, silty GRAVEL with sand.
TEST CONDITIONS: Residual shear conducted on previously sheared remolded samples.

FRICTION ANGLE (degrees)	36
APPARENT COHESION (psf)	60
AVERAGE DRY DENSITY (pcf)	88.7
AVERAGE WATER CONTENT (%)	20.9

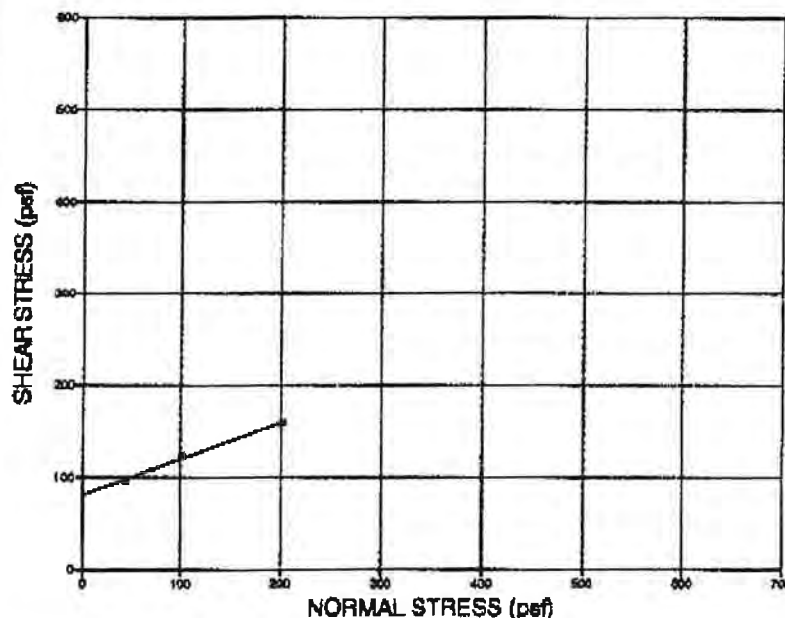
Friction Angle: 22 degrees

Displ. Rate: 0.200 in./min.

### STRENGTH ENVELOPE

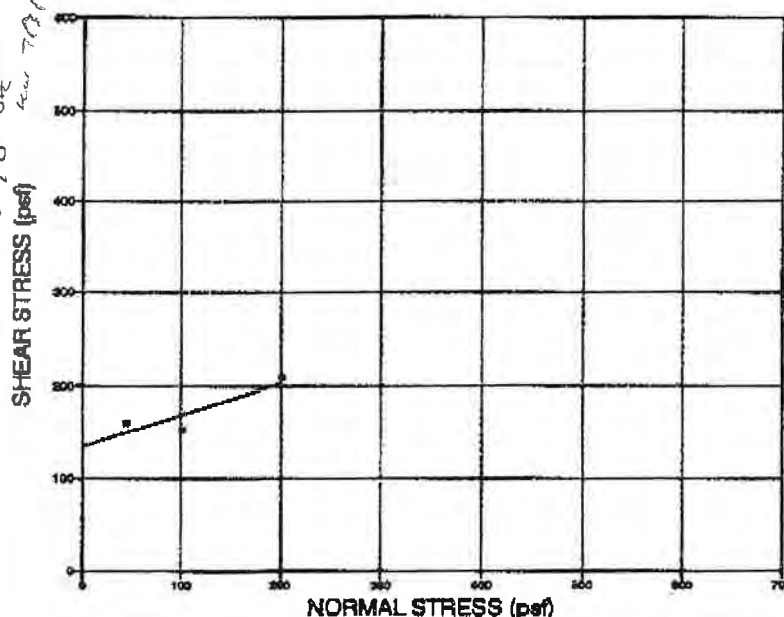
Friction Angle: 19 degrees

Displ. Rate: 0.200 in./min.

**NOTE:** The Friction Angle and Adhesion (or Cohesion) results given here are based upon a mathematically determined 'best fit' line. Further interpretation should be conducted by a qualified professional experienced in geosynthetic and geotechnical engineering.

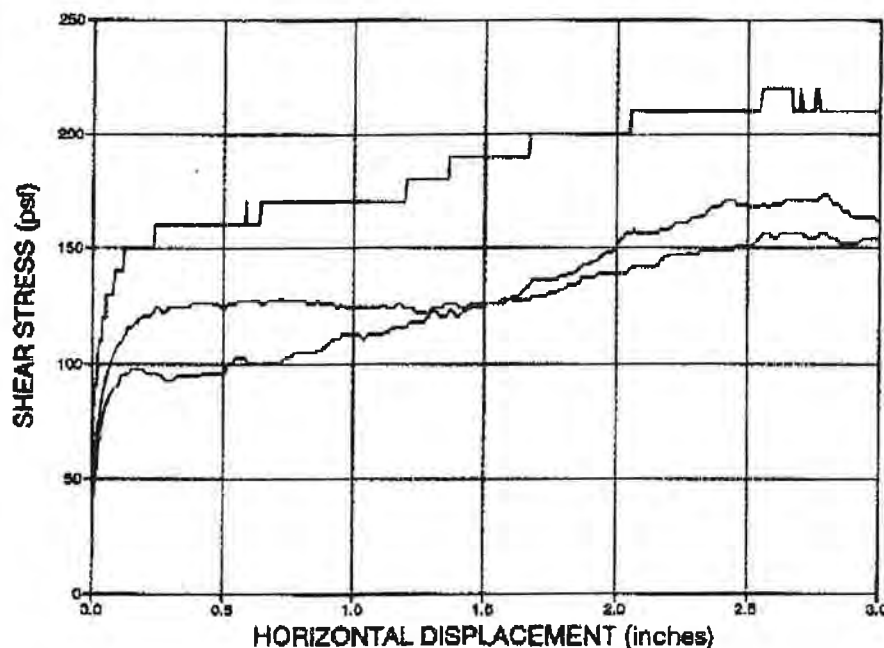
Final Moisture Content:

1.	2.	3.
37.9	41.1	39.2

1. The "gap" between shear boxes was set at 80 mil (2.0 mm).
2. The test specimens were flooded during testing unless noted.
3. High Normal Stress (>5psi) was applied using air pressure.
4. Low Normal Stress (<5 psi) was applied using dead weights
5. The tests were terminated 3.0" displacement unless noted.
6. Tests were performed in general accordance with ASTM procedure D 5321-92 Method B using a Brainard-Kilman LG-112 direct shear machine with an effective area of 12 in. x 12 in. (Machine C)

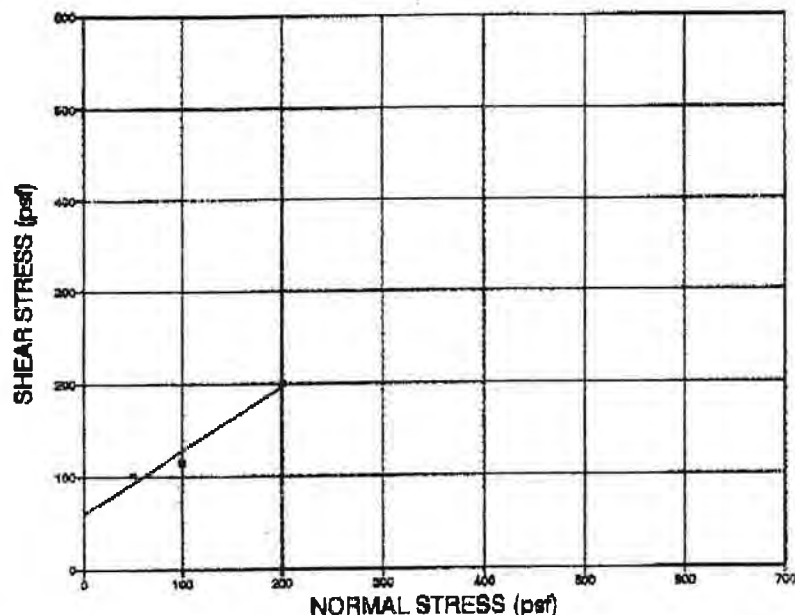
Friction Angle: 34 degrees

Displ. Rate: 0.200 in./min.

**STRENGTH ENVELOPE**

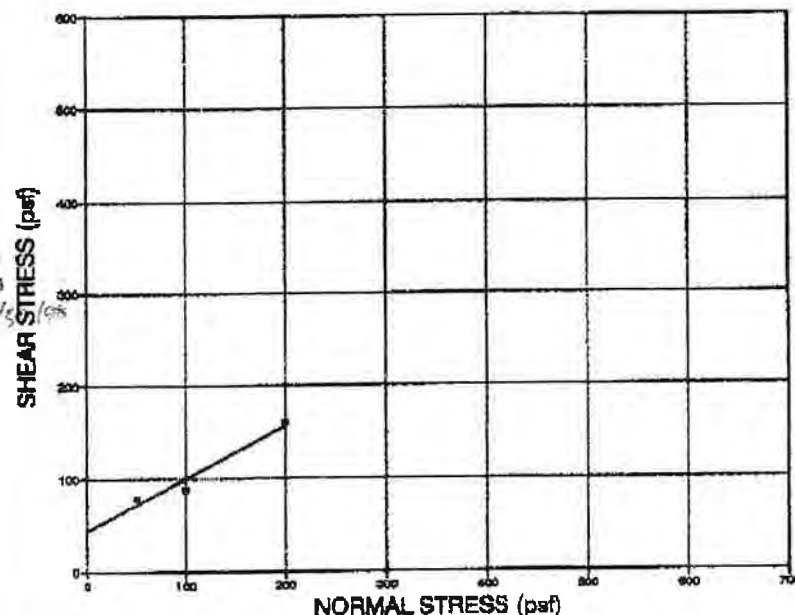
Friction Angle: 29 degrees

Displ. Rate: 0.200 in./min.

**NOTE:** The Friction Angle and Adhesion (or Cohesion) results given here are based upon a mathematically determined "best fit" line. Further interpretation should be conducted by a qualified professional experienced in geosynthetic and geotechnical engineering.

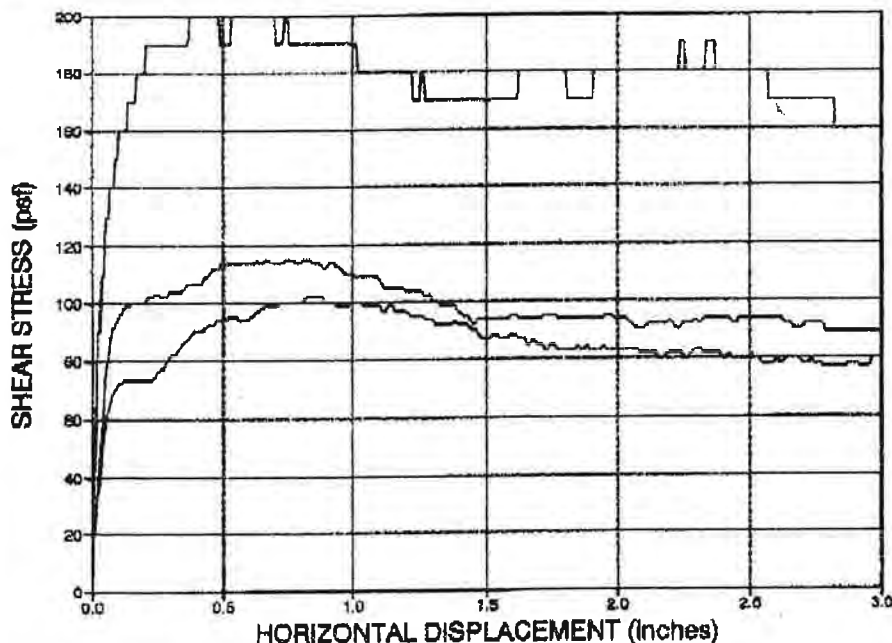
### DISPLACEMENT vs SHEAR STRESS

Test Point	Normal Stress	
	psi	psf
1.	0.3	50
2.	0.7	100
3.	1.4	200

1. The "gap" between shear boxes was set at 80 mil (2.0 mm).
2. The test specimens were flooded during testing unless noted.
3. High Normal Stress > 5 psi (34 kPa) was applied using air pressure.
4. Low Normal Stress < 5 psi (34 kPa) was applied using dead weights.
5. The tests were terminated 3.0" (75 mm) displacement unless noted.
6. Tests were performed in general accordance with ASTM procedure D 5321-92 Method A using a Brainard-Kilman LG-112 direct shear machine with an effective area of 12 x 12 in. (300 x 300 mm).

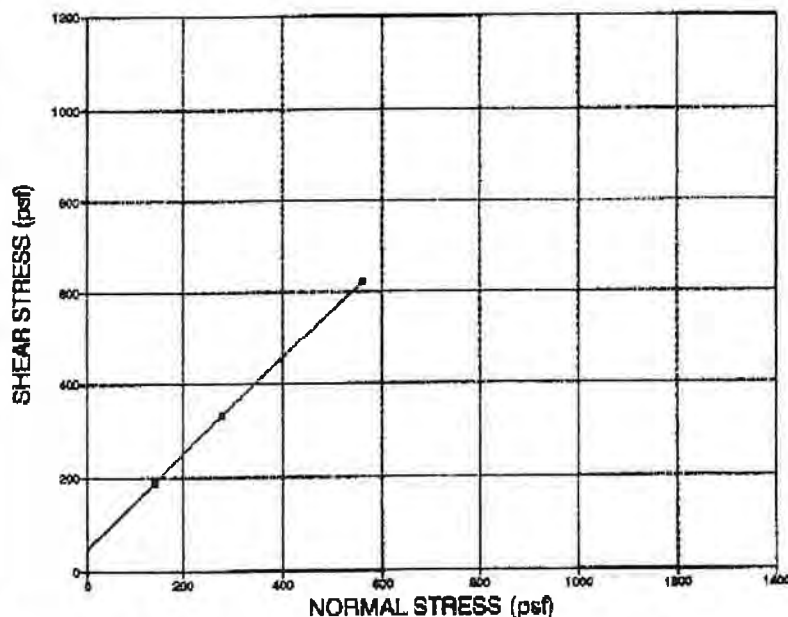
Friction Angle: 48 degrees

Displ. Rate: 0.040 in./min.

### STRENGTH ENVELOPE

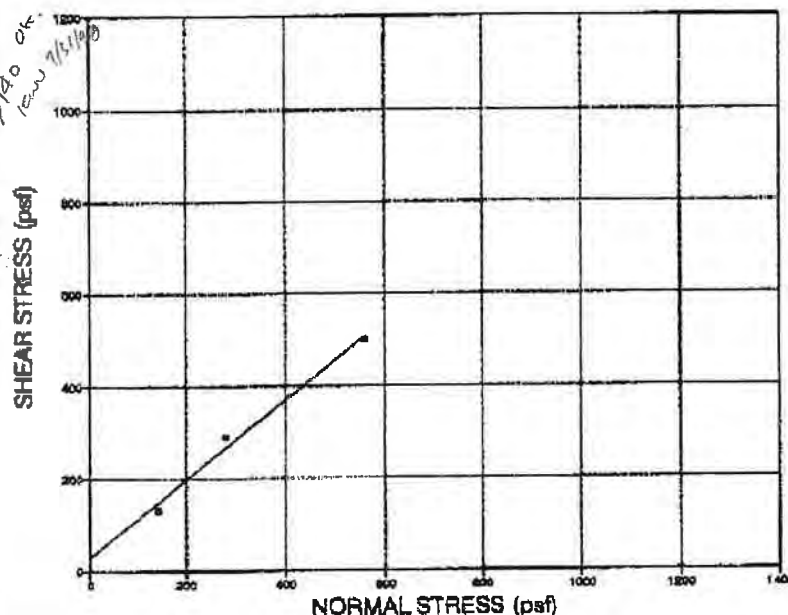
Friction Angle: 41 degrees

Displ. Rate: 0.040 in./min.

**NOTE:** The Friction Angle and Adhesion (or Cohesion) results given here are based upon a mathematically determined "best fit" line. Further interpretation should be conducted by a qualified professional experienced in geosynthetic and geotechnical engineering.

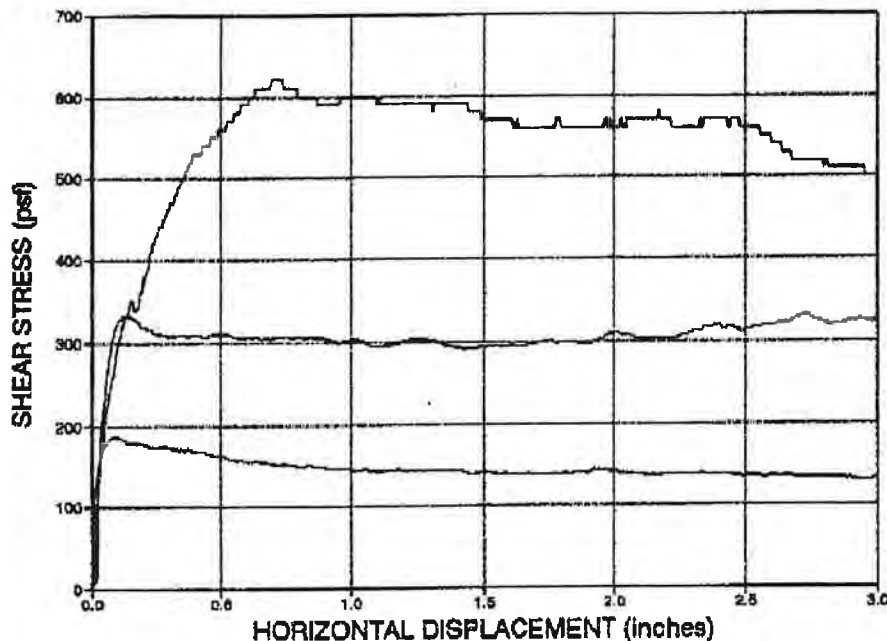
Final Moisture Content:

1.	2.	3.
38.7	35.7	36.7

1. The "gap" between shear boxes was set at 80 mil (2.0 mm).
2. The test specimens were flooded during testing unless noted.
3. High Normal Stress (>5psi) was applied using air pressure.
4. Low Normal Stress (<5 psi) was applied using dead weights
5. The tests were terminated 3.0" displacement unless noted.
6. Tests were performed in general accordance with ASTM procedure D 5321-92 Method B using a Brainard-Kilman LG-112 direct shear machine with an effective area of 12 in. x 12 in. (Machine A)

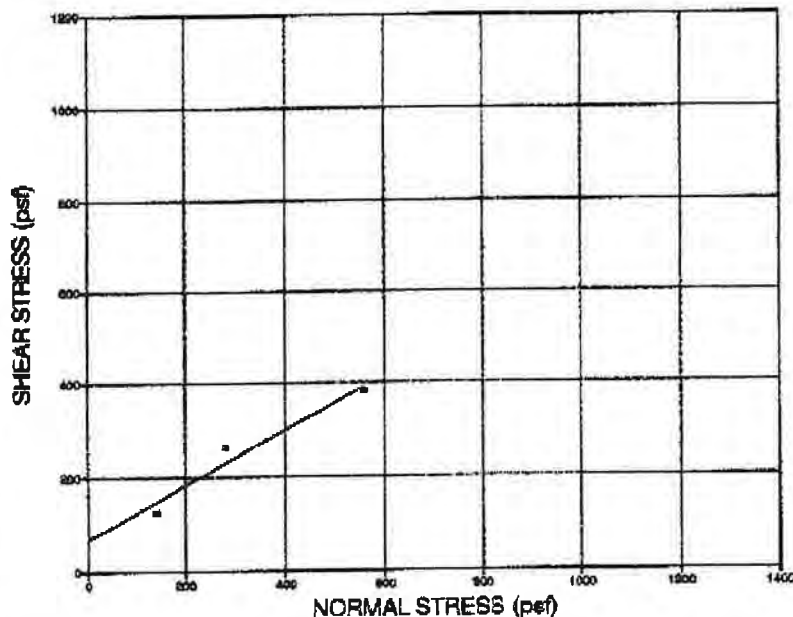
Test Point	Normal Stress		Shear Stress
	psi	psf	psf
1.	1.0	140	130
2.	1.9	280	260
3.	3.9	560	380

Adhesion: 70 psf  
 Friction Angle: 30 degrees  
 Displ. Rate: 0.040 in./min.

**STRENGTH ENVELOPE**

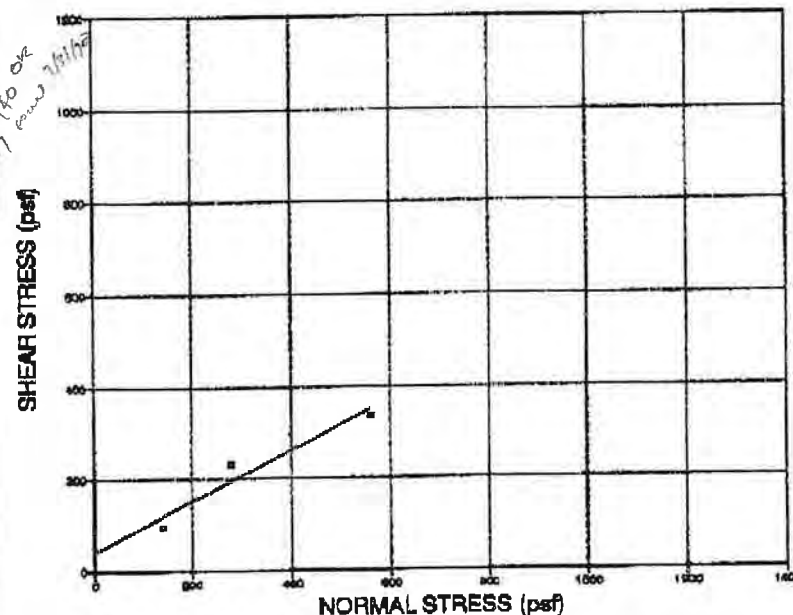
Minimum Shear Stress

Test Point	Normal Stress		Shear Stress
	psi	psf	psf
1.	1.0	140	100
2.	1.9	280	230
3.	3.9	560	340

Adhesion: 40 psf  
 Friction Angle: 29 degrees  
 Displ. Rate: 0.040 in./min.

**NOTE:** The Friction Angle and Adhesion (or Cohesion) results given here are based upon a mathematically determined "best fit" line. Further interpretation should be conducted by a qualified professional experienced in geosynthetic and geotechnical engineering.

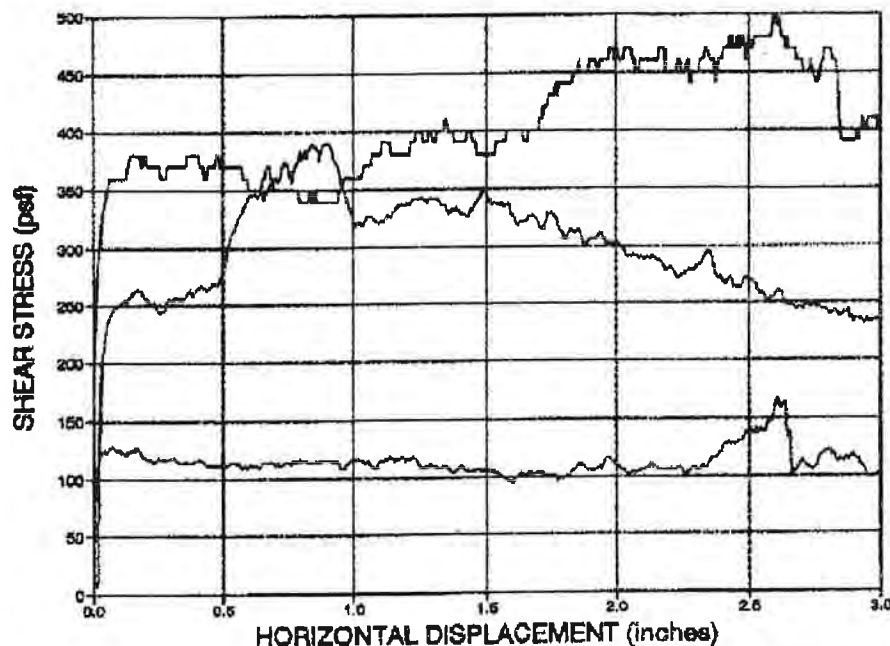
Final Moisture Content:

1.	2.	3.
43.0	38.5	39.8

1. The "gap" between shear boxes was set at 80 mil (2.0 mm).
2. The test specimens were flooded during testing unless noted.
3. High Normal Stress (>5psi) was applied using air pressure.
4. Low Normal Stress (<5 psi) was applied using dead weights
5. The tests were terminated 3.0" displacement unless noted.
6. Tests were performed in general accordance with ASTM procedure D 5321-92 Method B using a Brainard-Kilman LG-112 direct shear machine with an effective area of 12 in. x 12 in. (Machine A)

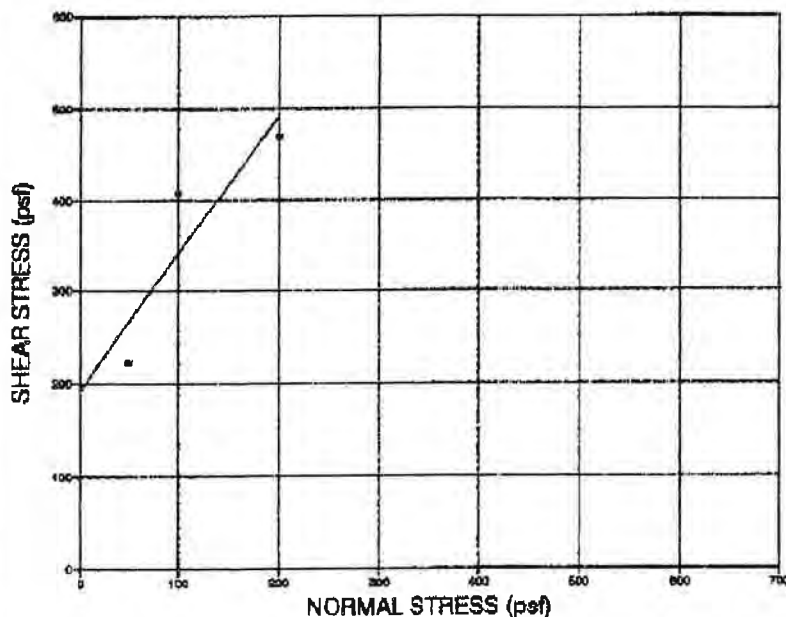
Friction Angle: 56 degrees

Displ. Rate: 0.040 in./min.

### STRENGTH ENVELOPE

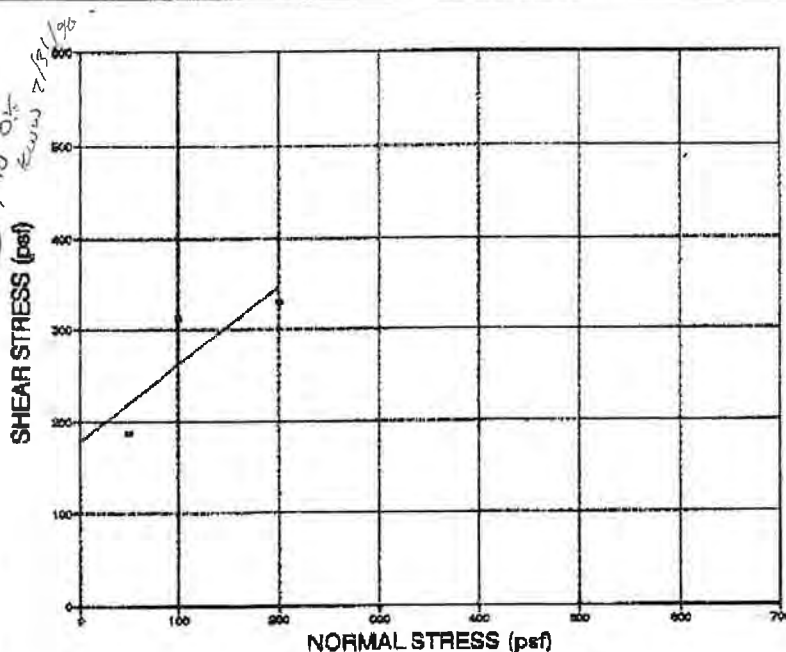
Friction Angle: 40 degrees

Displ. Rate: 0.040 in./min.

NOTE: GRAPH NOT TO SCALE

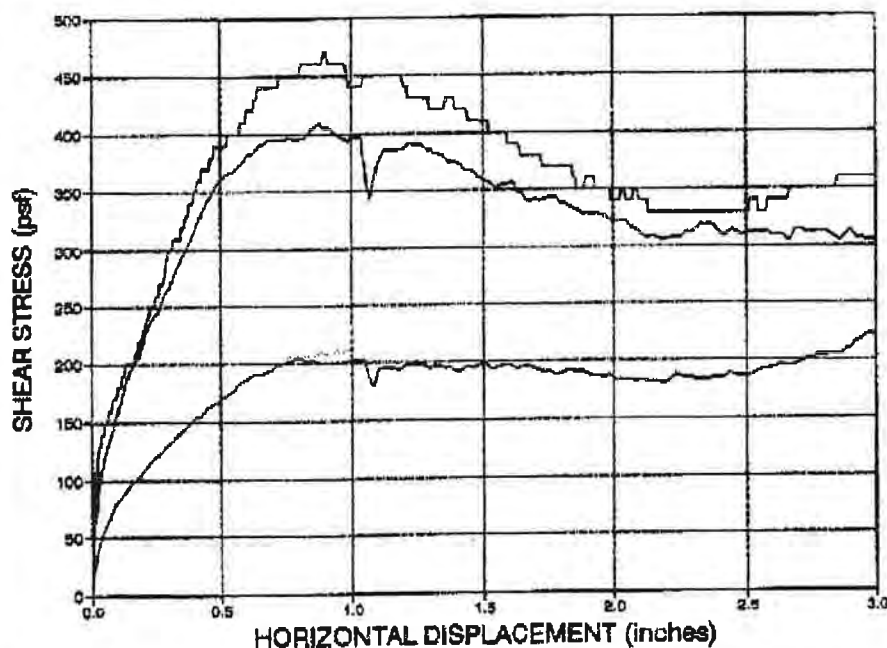
**DISPLACEMENT  
vs SHEAR STRESS**

Test Point	Normal Stress	
	psf	psf
1.	0.3	50
2.	0.7	100
3.	1.4	200

1. The "gap" between shear boxes was set at 80 mil (2.0 mm).
2. The test specimens were flooded during testing unless noted.
3. High Normal Stress (>5psi) was applied using air pressure.
4. Low Normal Stress (<5 psi) was applied using dead weights
5. The tests were terminated 3.0" displacement unless noted.
6. Tests were performed in general accordance with ASTM procedure D 5321-92 Method A using a Brainard-Kilman LG-112 direct shear machine with an effective area of 12 in. x 12 in. (Machine A)

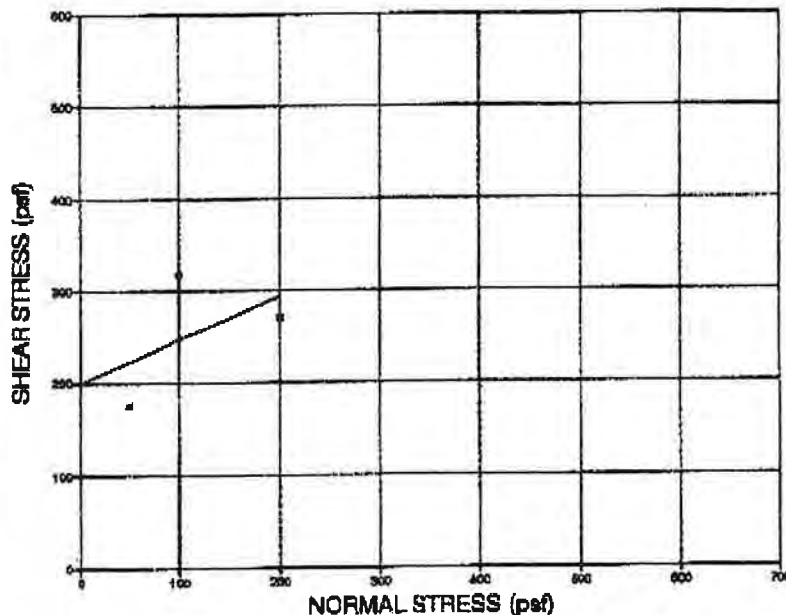
Friction Angle: 25 degrees

Displ. Rate: 0.040 in./min.

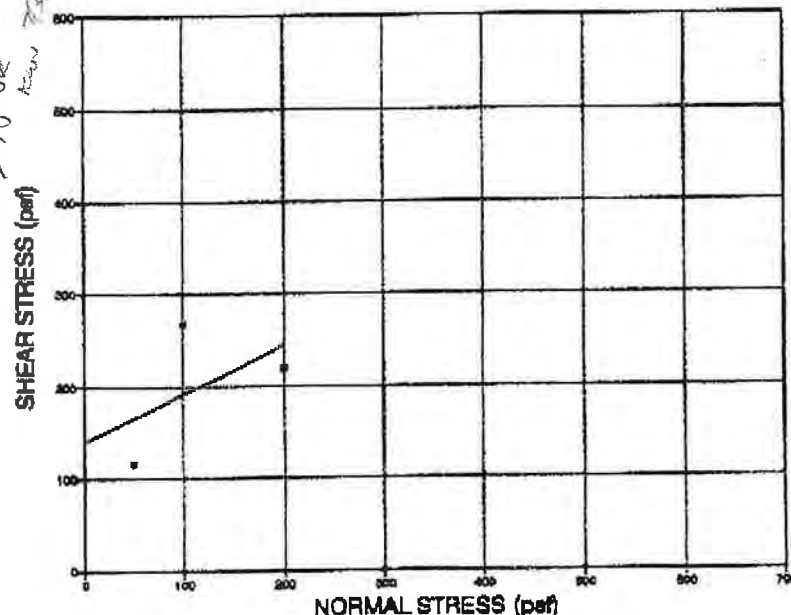
### STRENGTH ENVELOPE

Friction Angle: 28 degrees

Displ. Rate: 0.040 in./min.

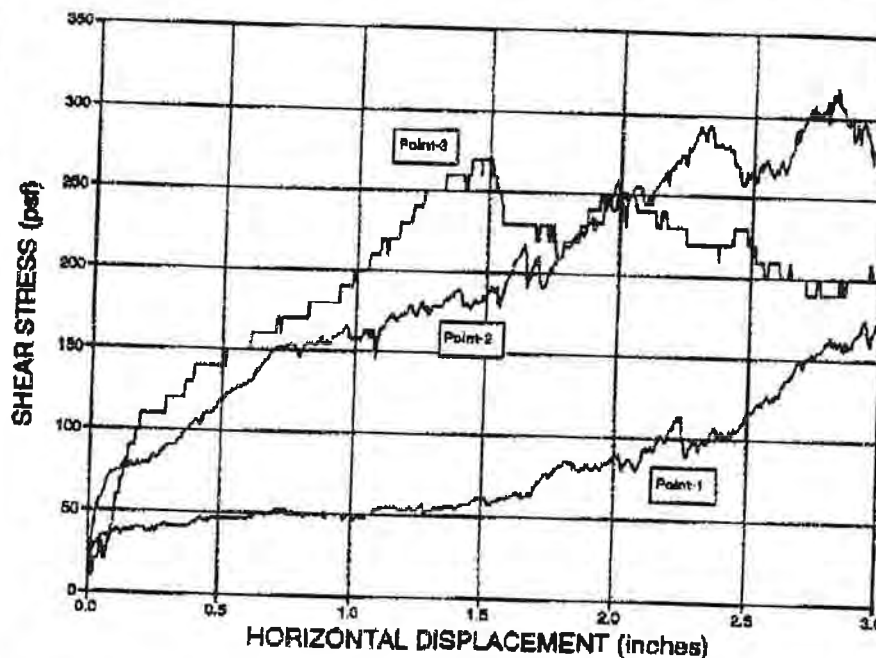
### MOISTURE/DENSITY DATA

Initial Moisture Content:  
0%

Initial Dry Density:  
109.5 pcf

1. The "gap" between shear boxes was set at 80 mil (2.0 mm).
2. The test specimens were flooded during testing unless noted.
3. High Normal Stress (>5psi) was applied using air pressure.
4. Low Normal Stress (<5 psi) was applied using dead weights
5. The tests were terminated 3.0" displacement unless noted.
6. Tests were performed in general accordance with ASTM procedure D 5321-92 Method B using a Brinard-Kilman LG-112 direct shear machine with an effective area of 12 in. x 12 in. (Machine A)

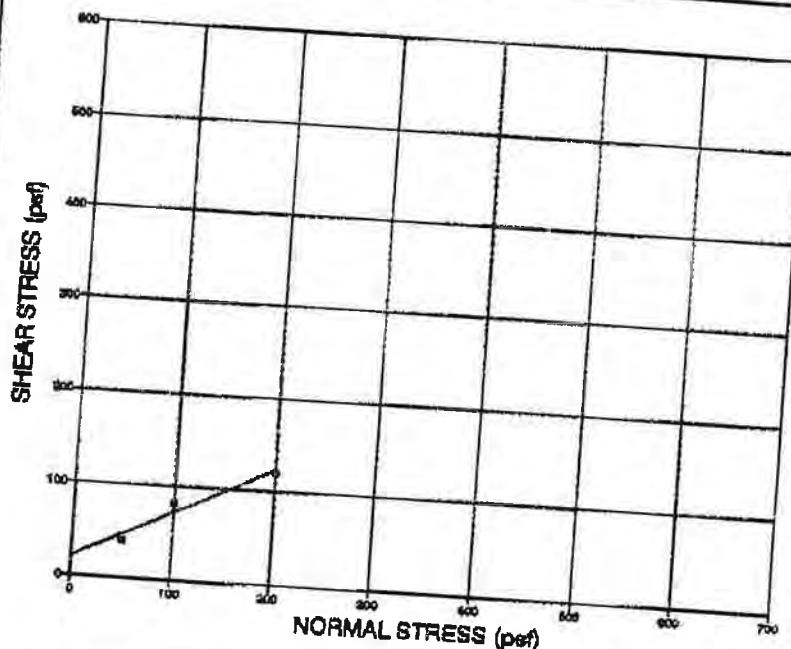
Adhesion: 20 psf  
 Friction Angle: 27 degrees  
 Displ. Rate: 0.040 in./min.

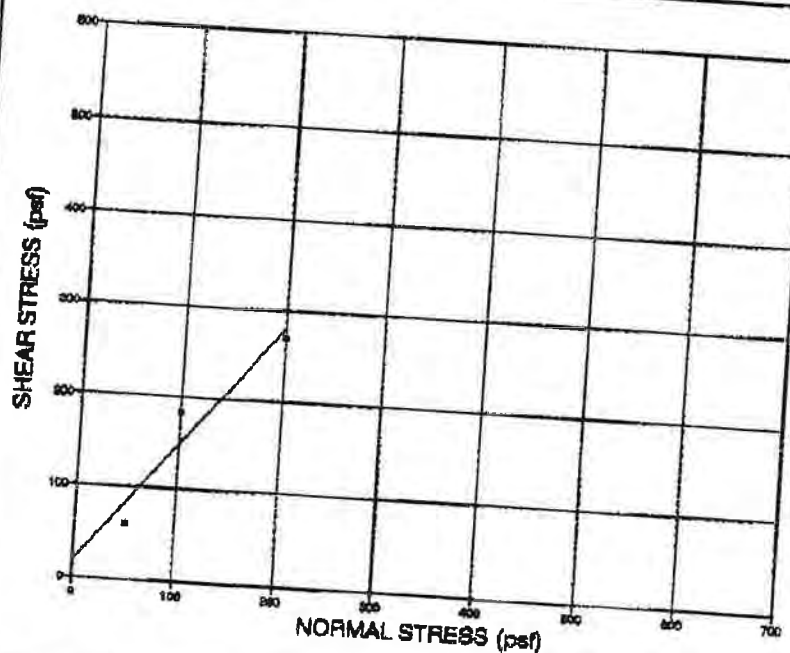
**STRENGTH ENVELOPE****HIGH STRAIN (1.5 in.)**

Test Point	Normal Stress		Shear Stress
	psf	psf	
1.	0.3	50	60
2.	0.7	100	180
3.	1.4	200	270

Adhesion: 20 psf  
 Friction Angle: 53 degrees  
 Displ. Rate: 0.040 in./min.
