**Southwest Closure Area  
Construction Report  
Hidden Valley Landfill  
Pierce County, Washington**

Prepared for  
Land Recovery Inc.  
December 31, 1992

Prepared by  
EMCON Northwest, Inc.  
18912 North Creek Parkway, Suite 100  
Bothell, Washington 98011

Construction Report  
Southwest Closure  
Hidden Valley Landfill

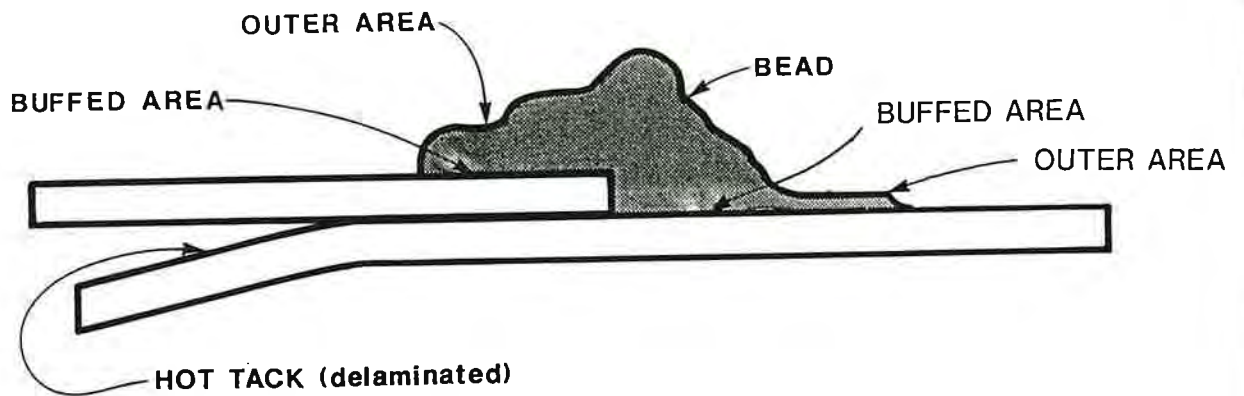
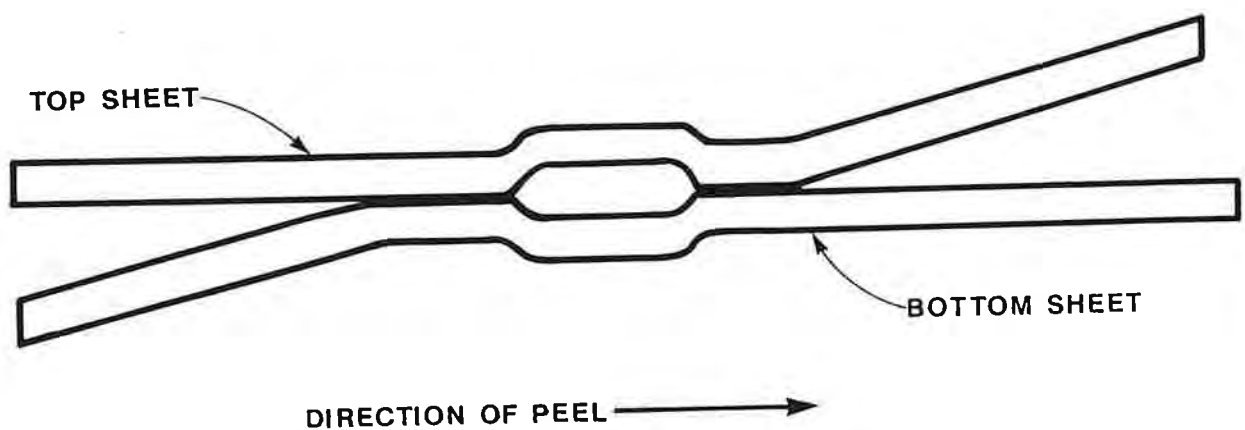
### EXTRUSION WELD

### HOT WEDGE OR FUSION WELD

The deployment process began by unrolling the geomembrane rolls and cutting panels to required dimensions. Following deployment, geomembrane panels were welded using primarily the hot wedge welding process. However, the extrusion welding process was also used. In areas where the hot wedge welder could not be utilized, the seam was welded using the extrusion welding technique. Extrusion welding was typically used for destructive test repairs, gas well boots, and intersecting weld locations or corners. Figure 3 shows cross-sections of both seam welding techniques.

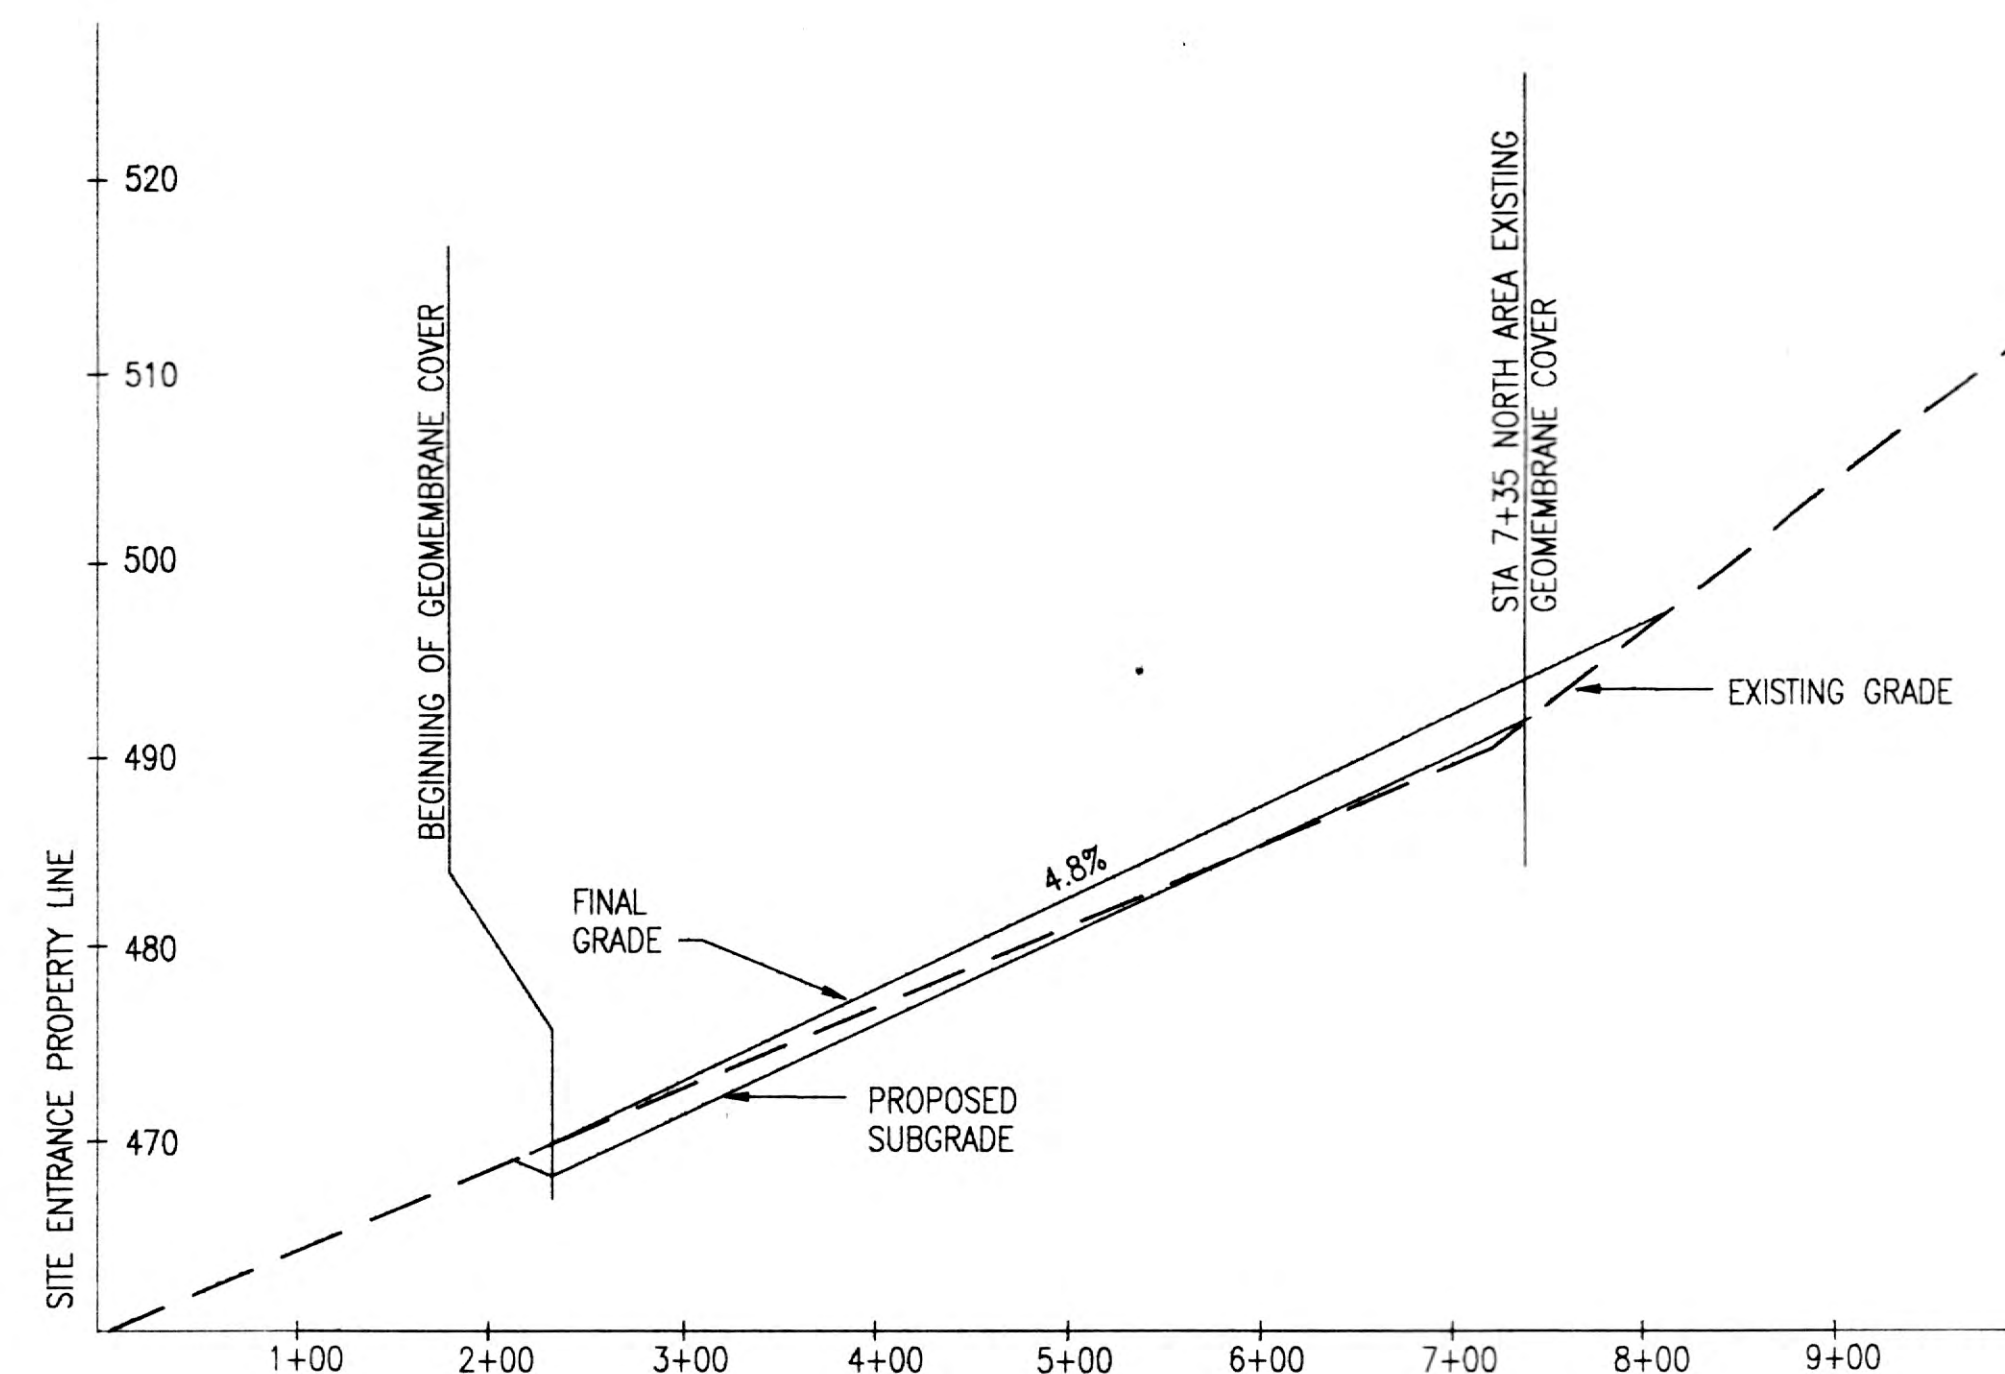
ENTRANCE ROAD PROFILE

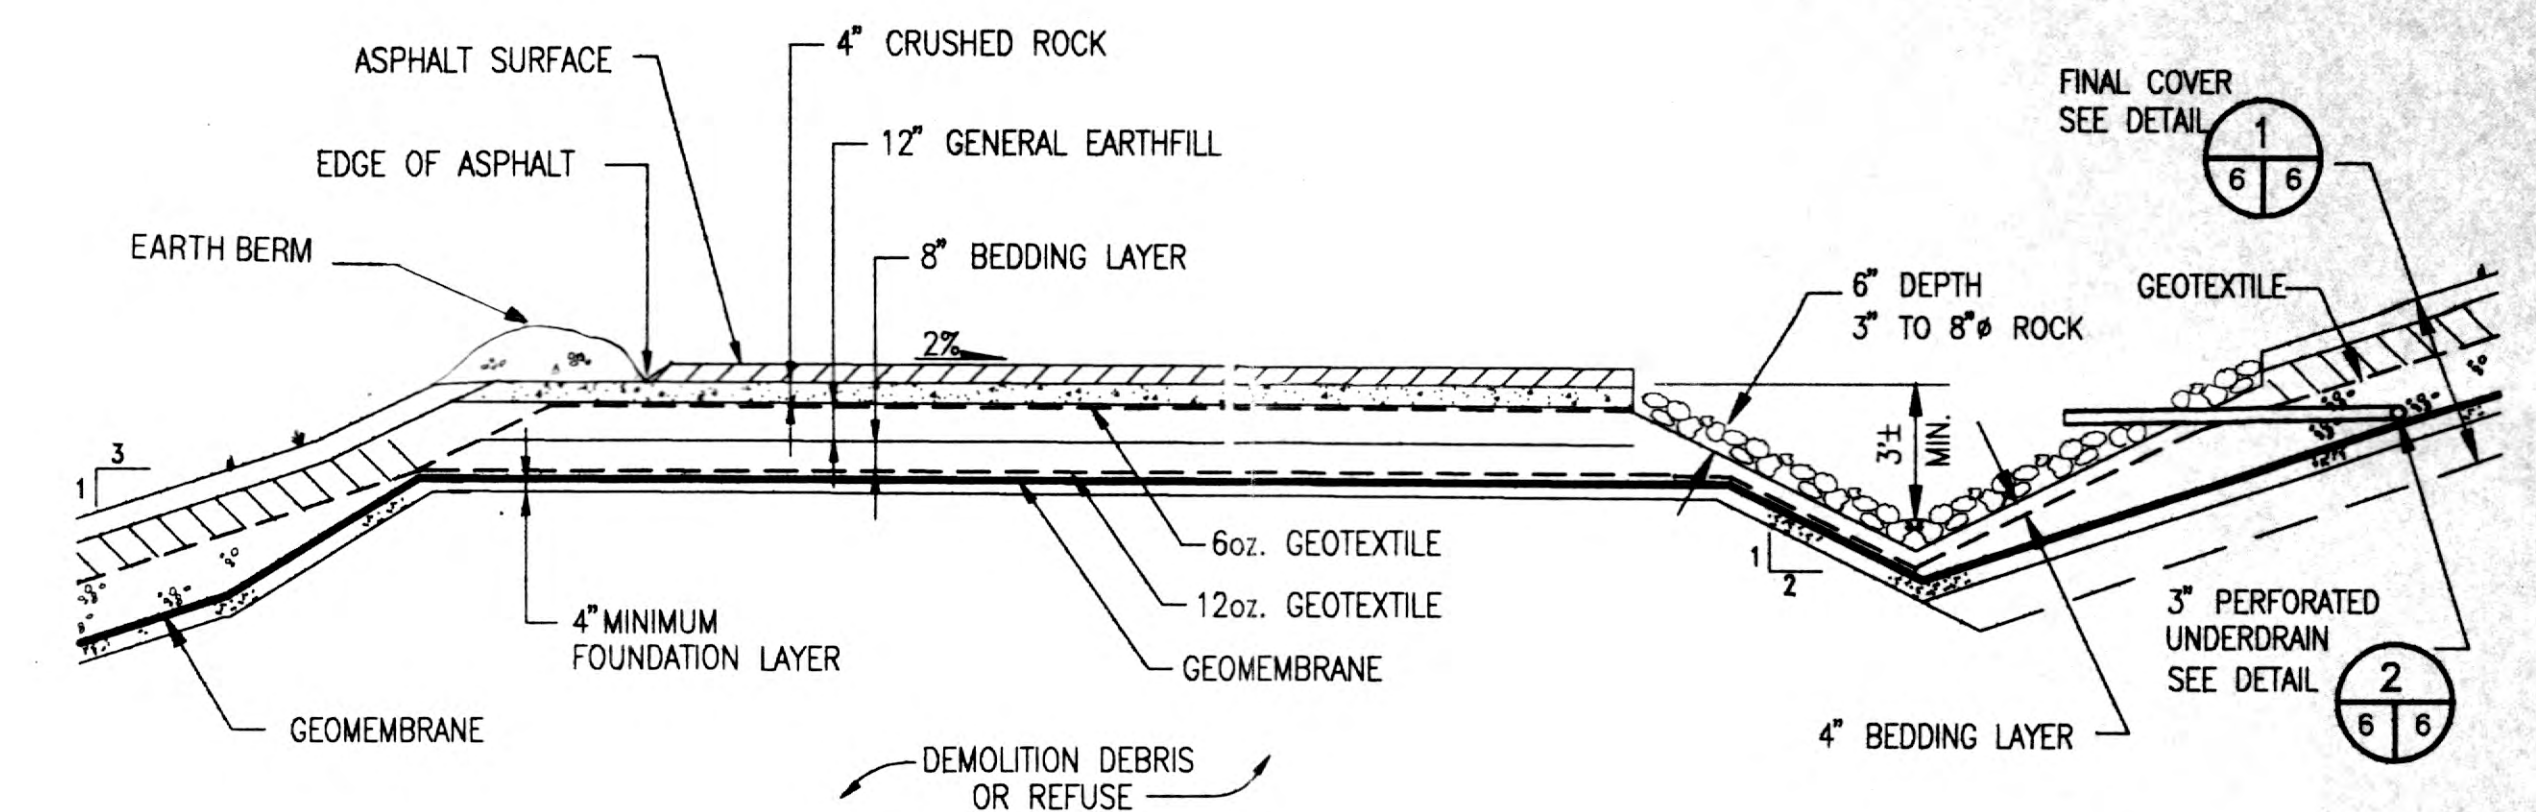
ENTRANCE ROAD  
SECTION B

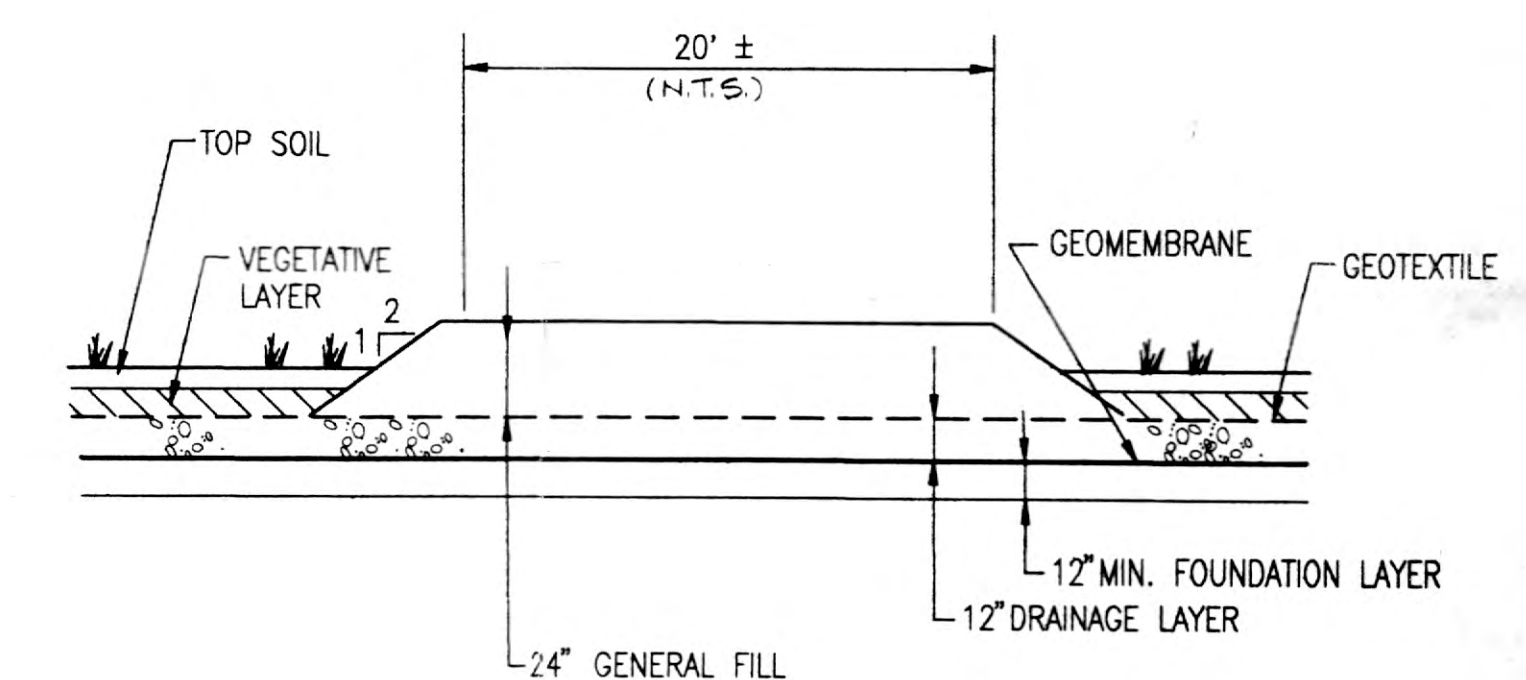
TOP SLOPE MAINTENANCE ROAD  
SECTION C

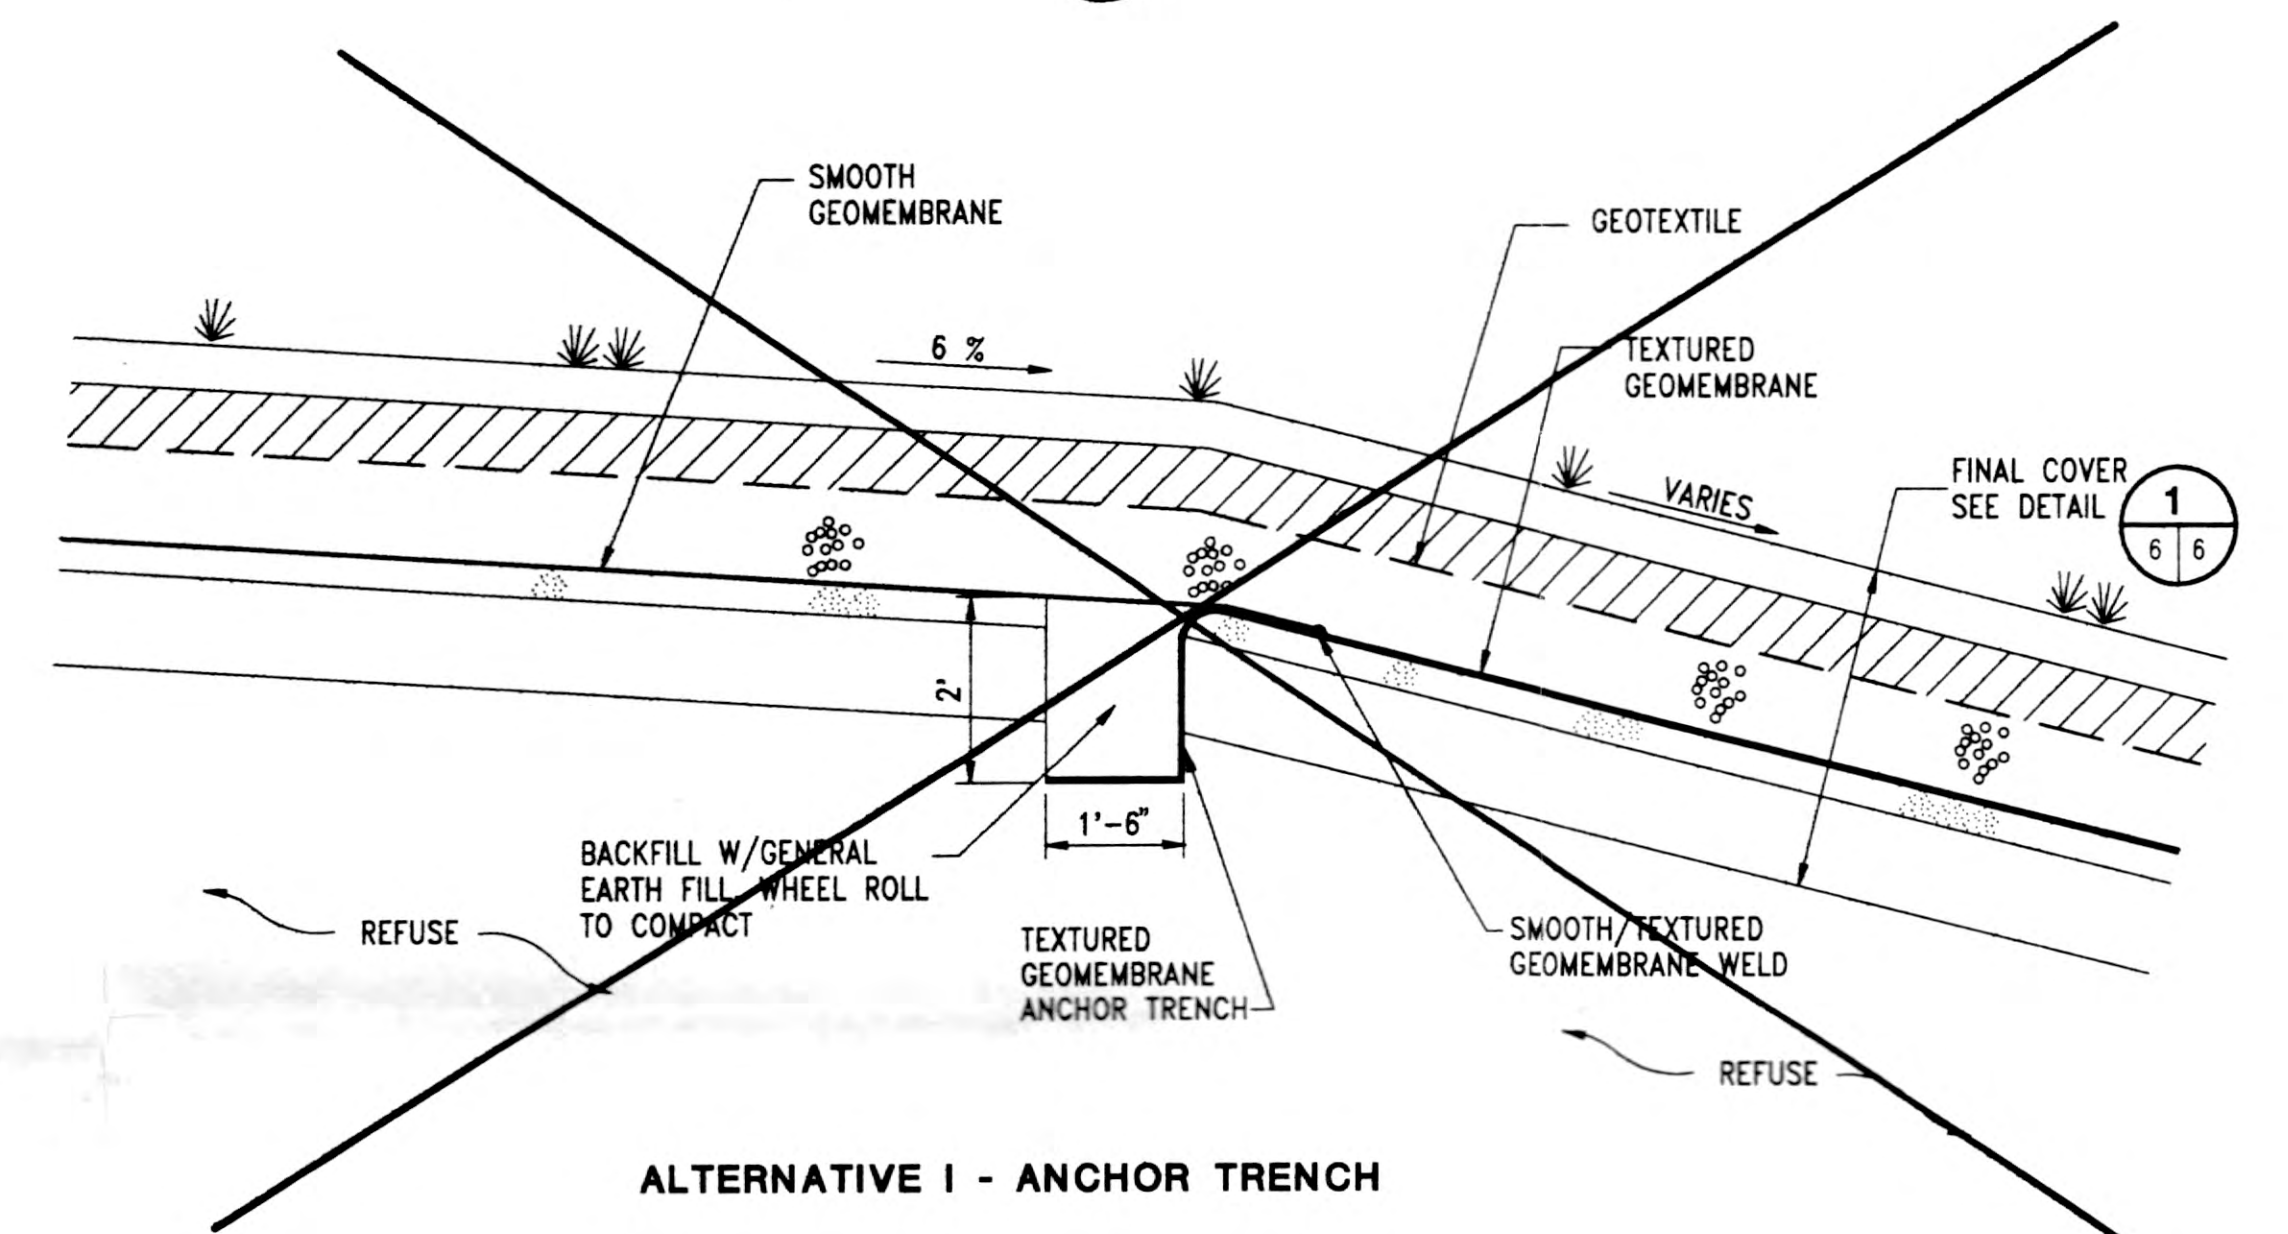
**ALTERNATIVE I - ANCHOR TRENCH**

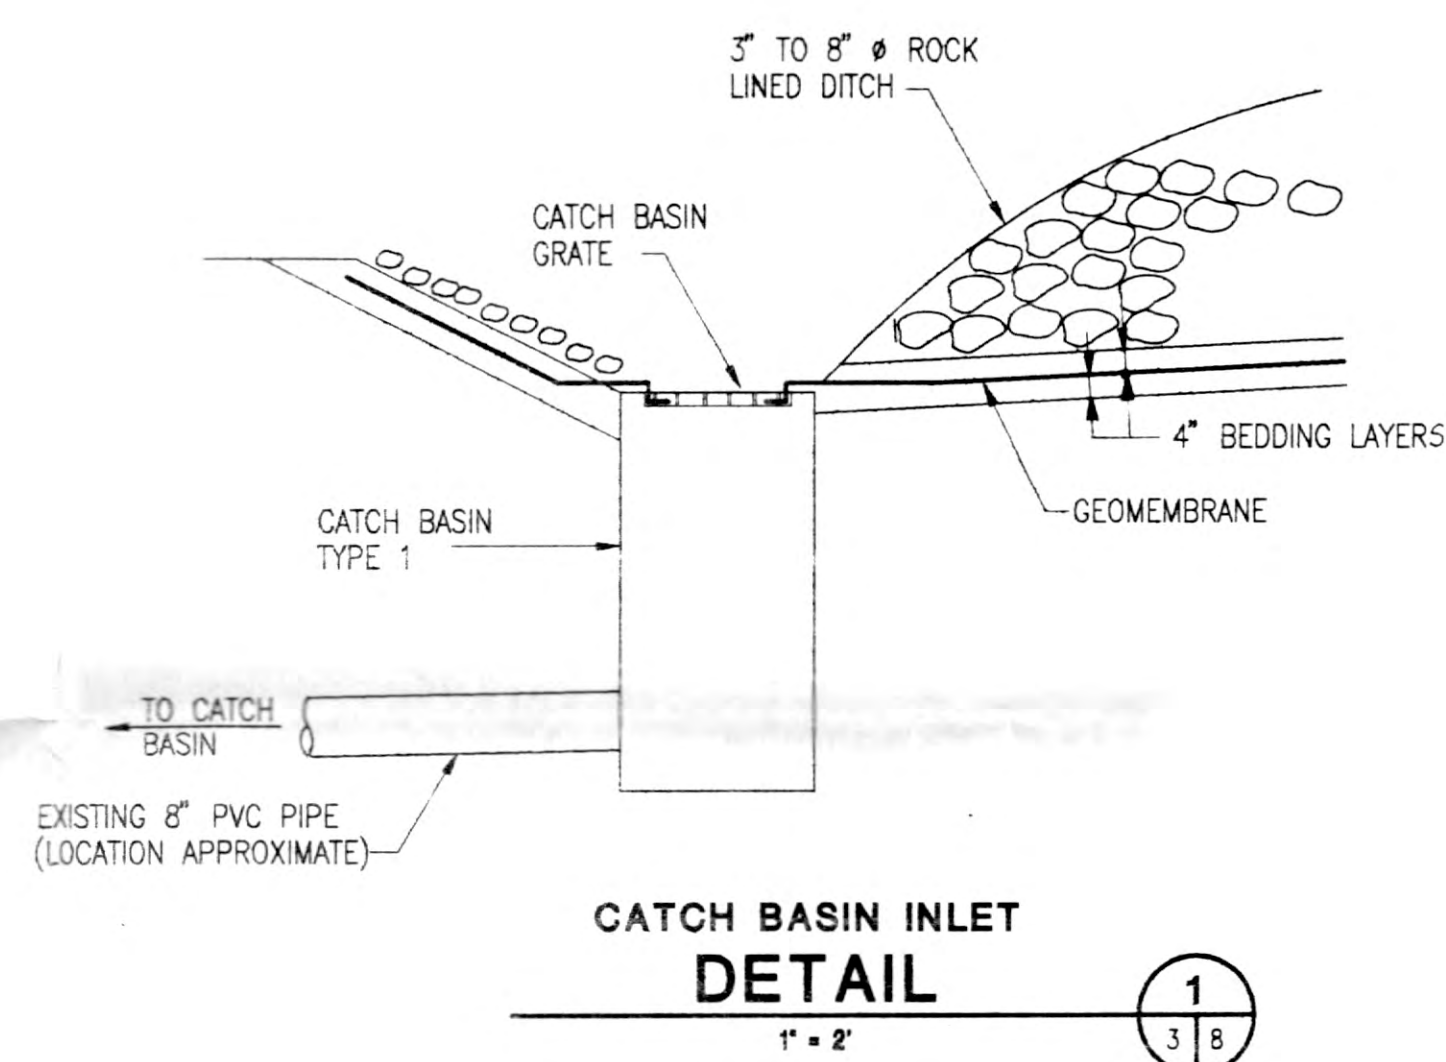
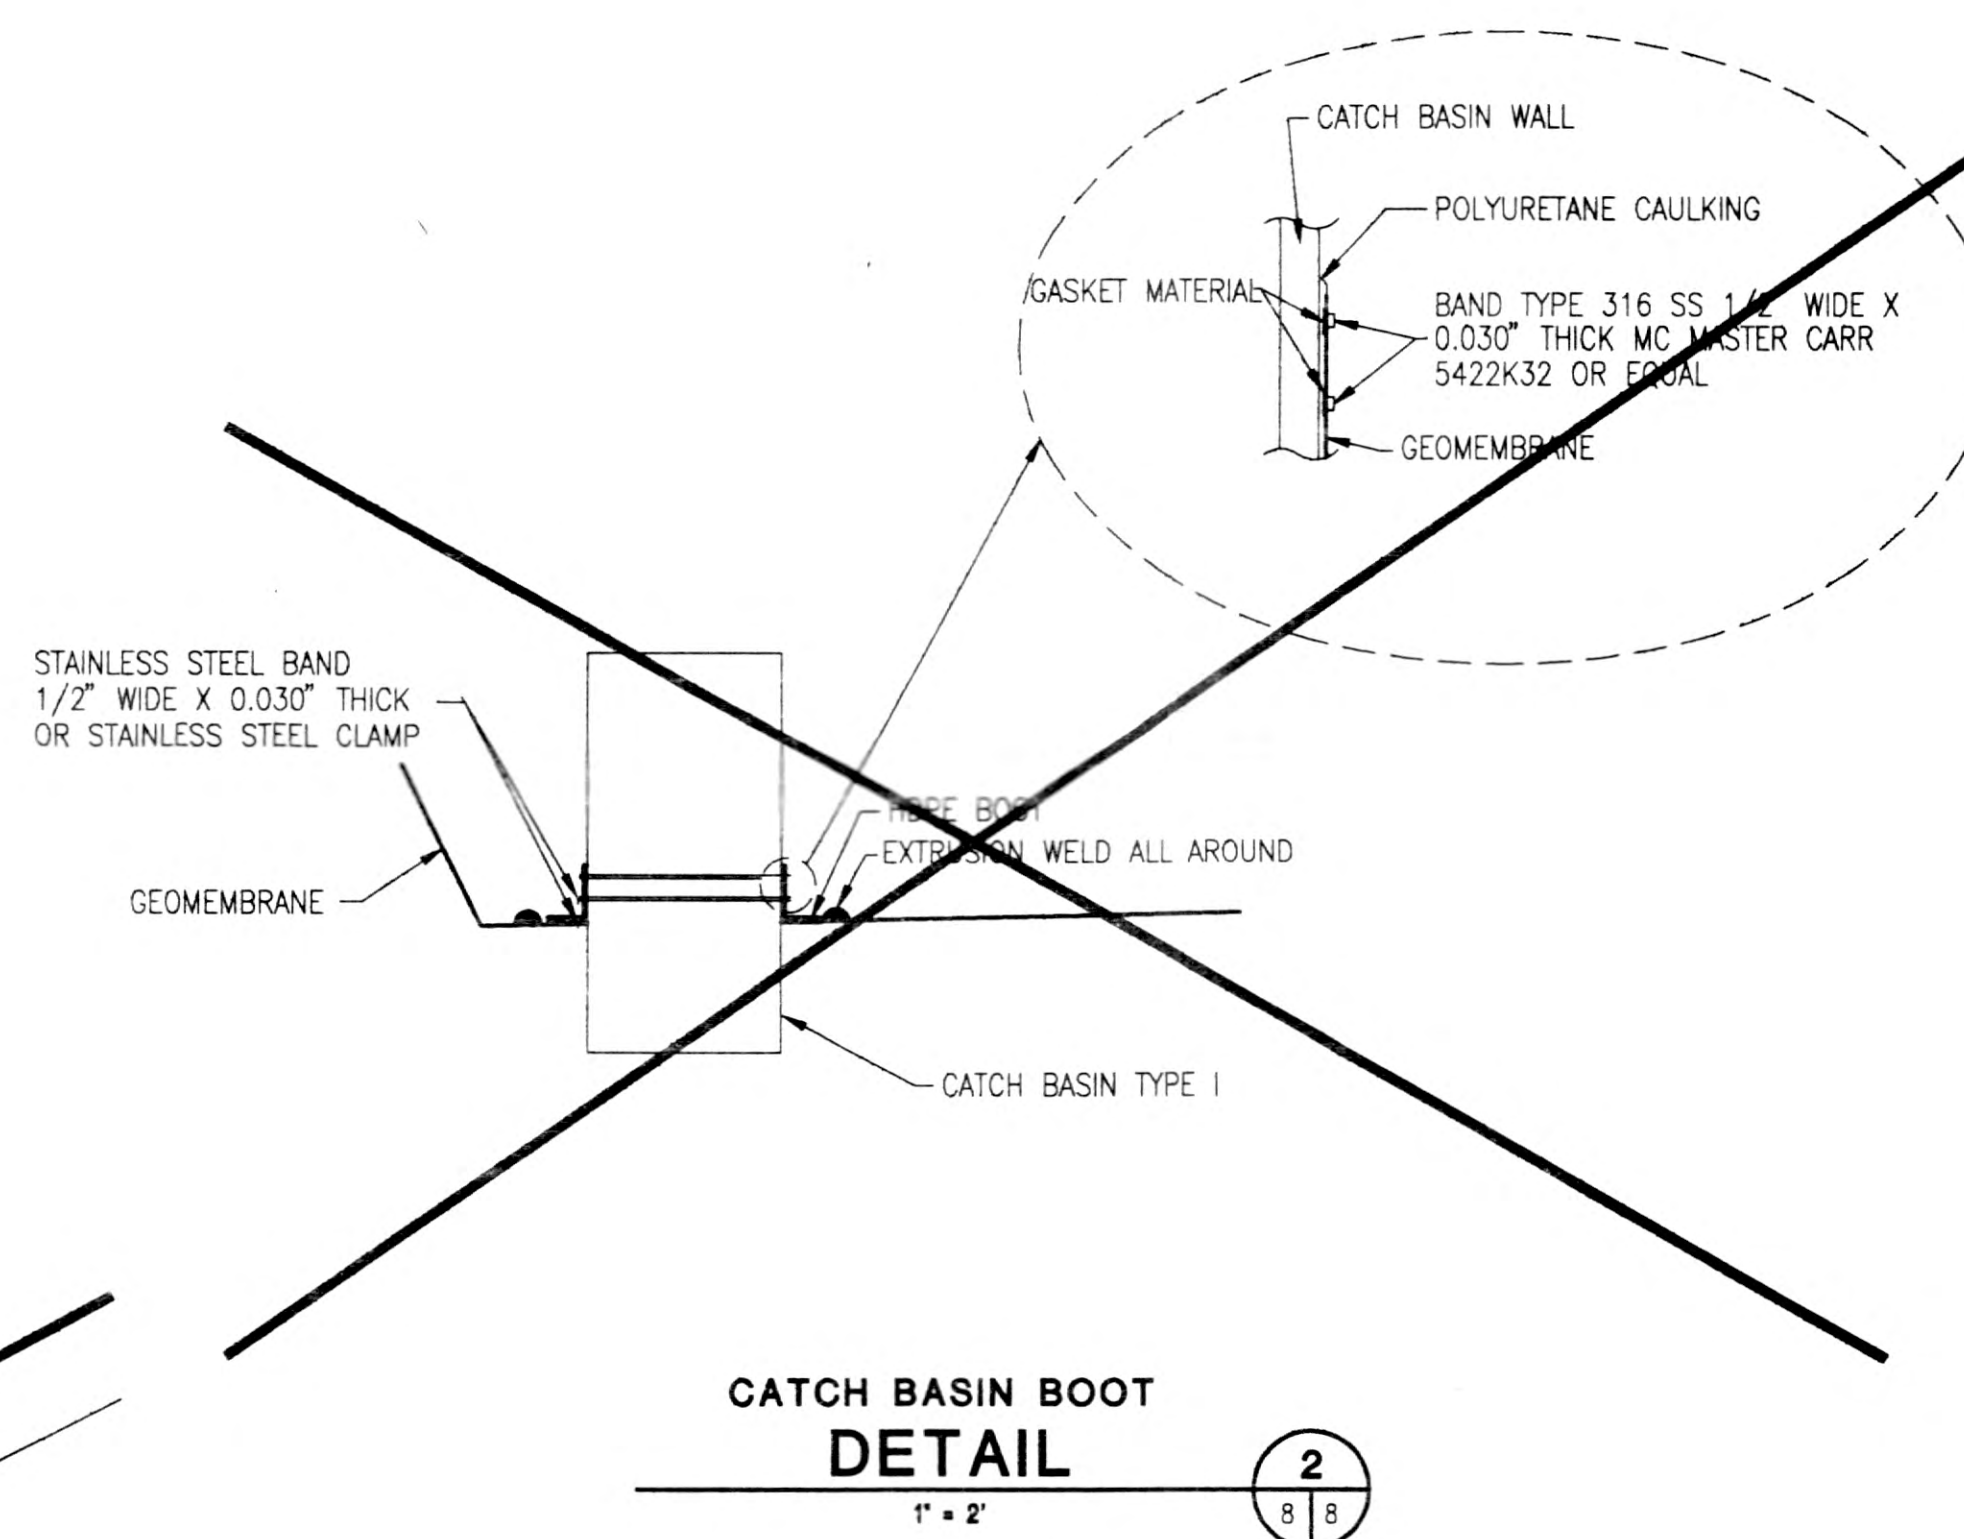
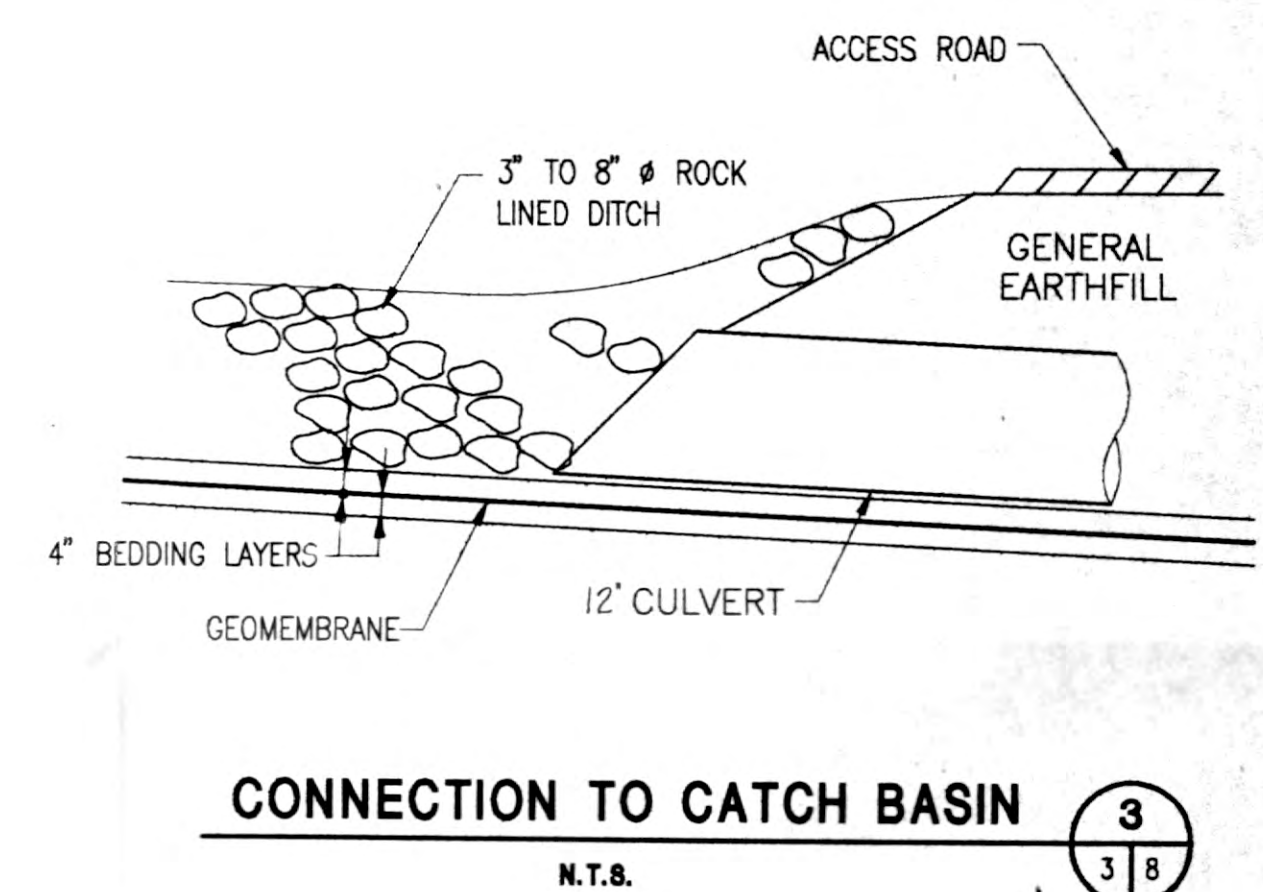
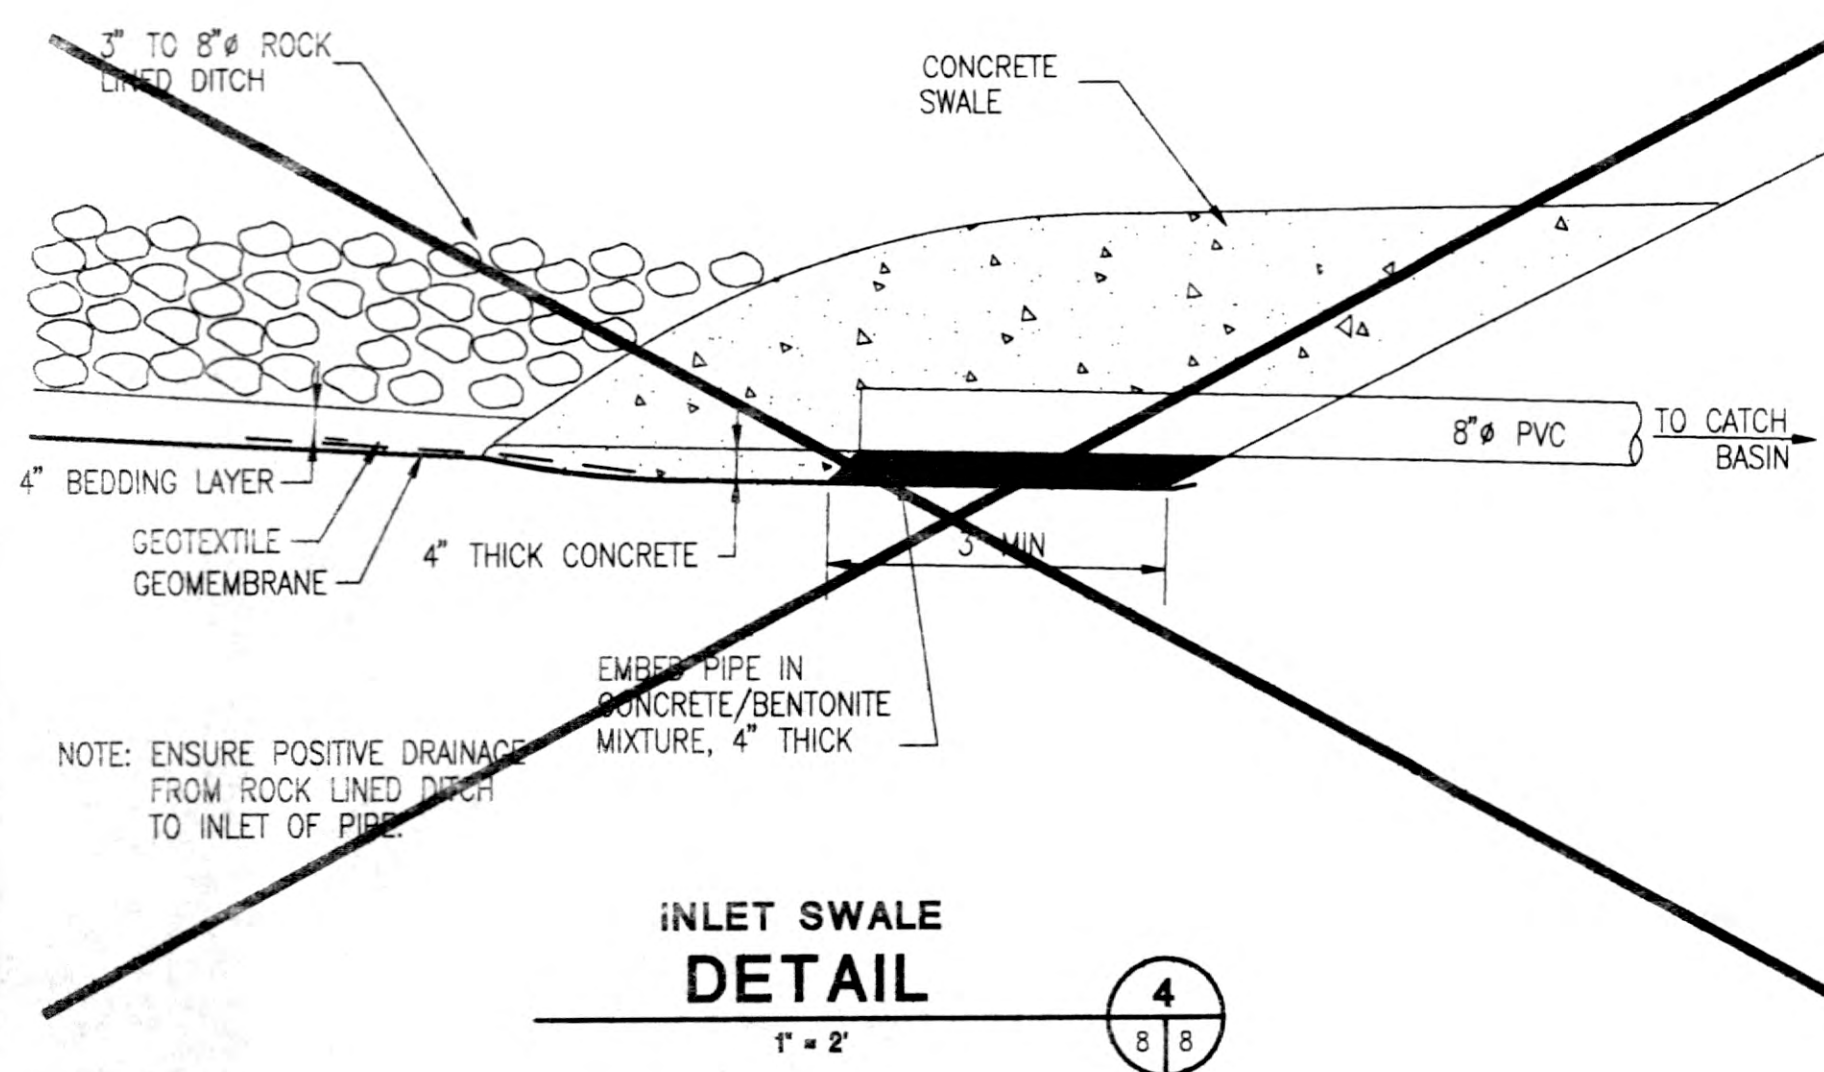
DRAWING NO  
**7**  
PROJECT NO  
70201.50

LAND RECOVERY, INC.  
HIDDEN VALLEY LANDFILL  
PIERCE COUNTY, WASHINGTON  
**SOUTHWEST CLOSURE COVER DETAILS**

NOTE: GEOMEMBRANE AND GEOTEXTILE WORK SHOWN ON THIS DRAWING BY GEOSYNTHETIC CONTRACTOR; ALL OTHER WORK BY LAND RECOVERY, INC.
