**Southwest Closure Area  
Construction Report  
Hidden Valley Landfill  
Pierce County, Washington**

Prepared for  
Land Recovery Inc.  
December 31, 1992

Prepared by  
EMCON Northwest, Inc.  
18912 North Creek Parkway, Suite 100  
Bothell, Washington 98011

Construction Report  
Southwest Closure  
Hidden Valley Landfill

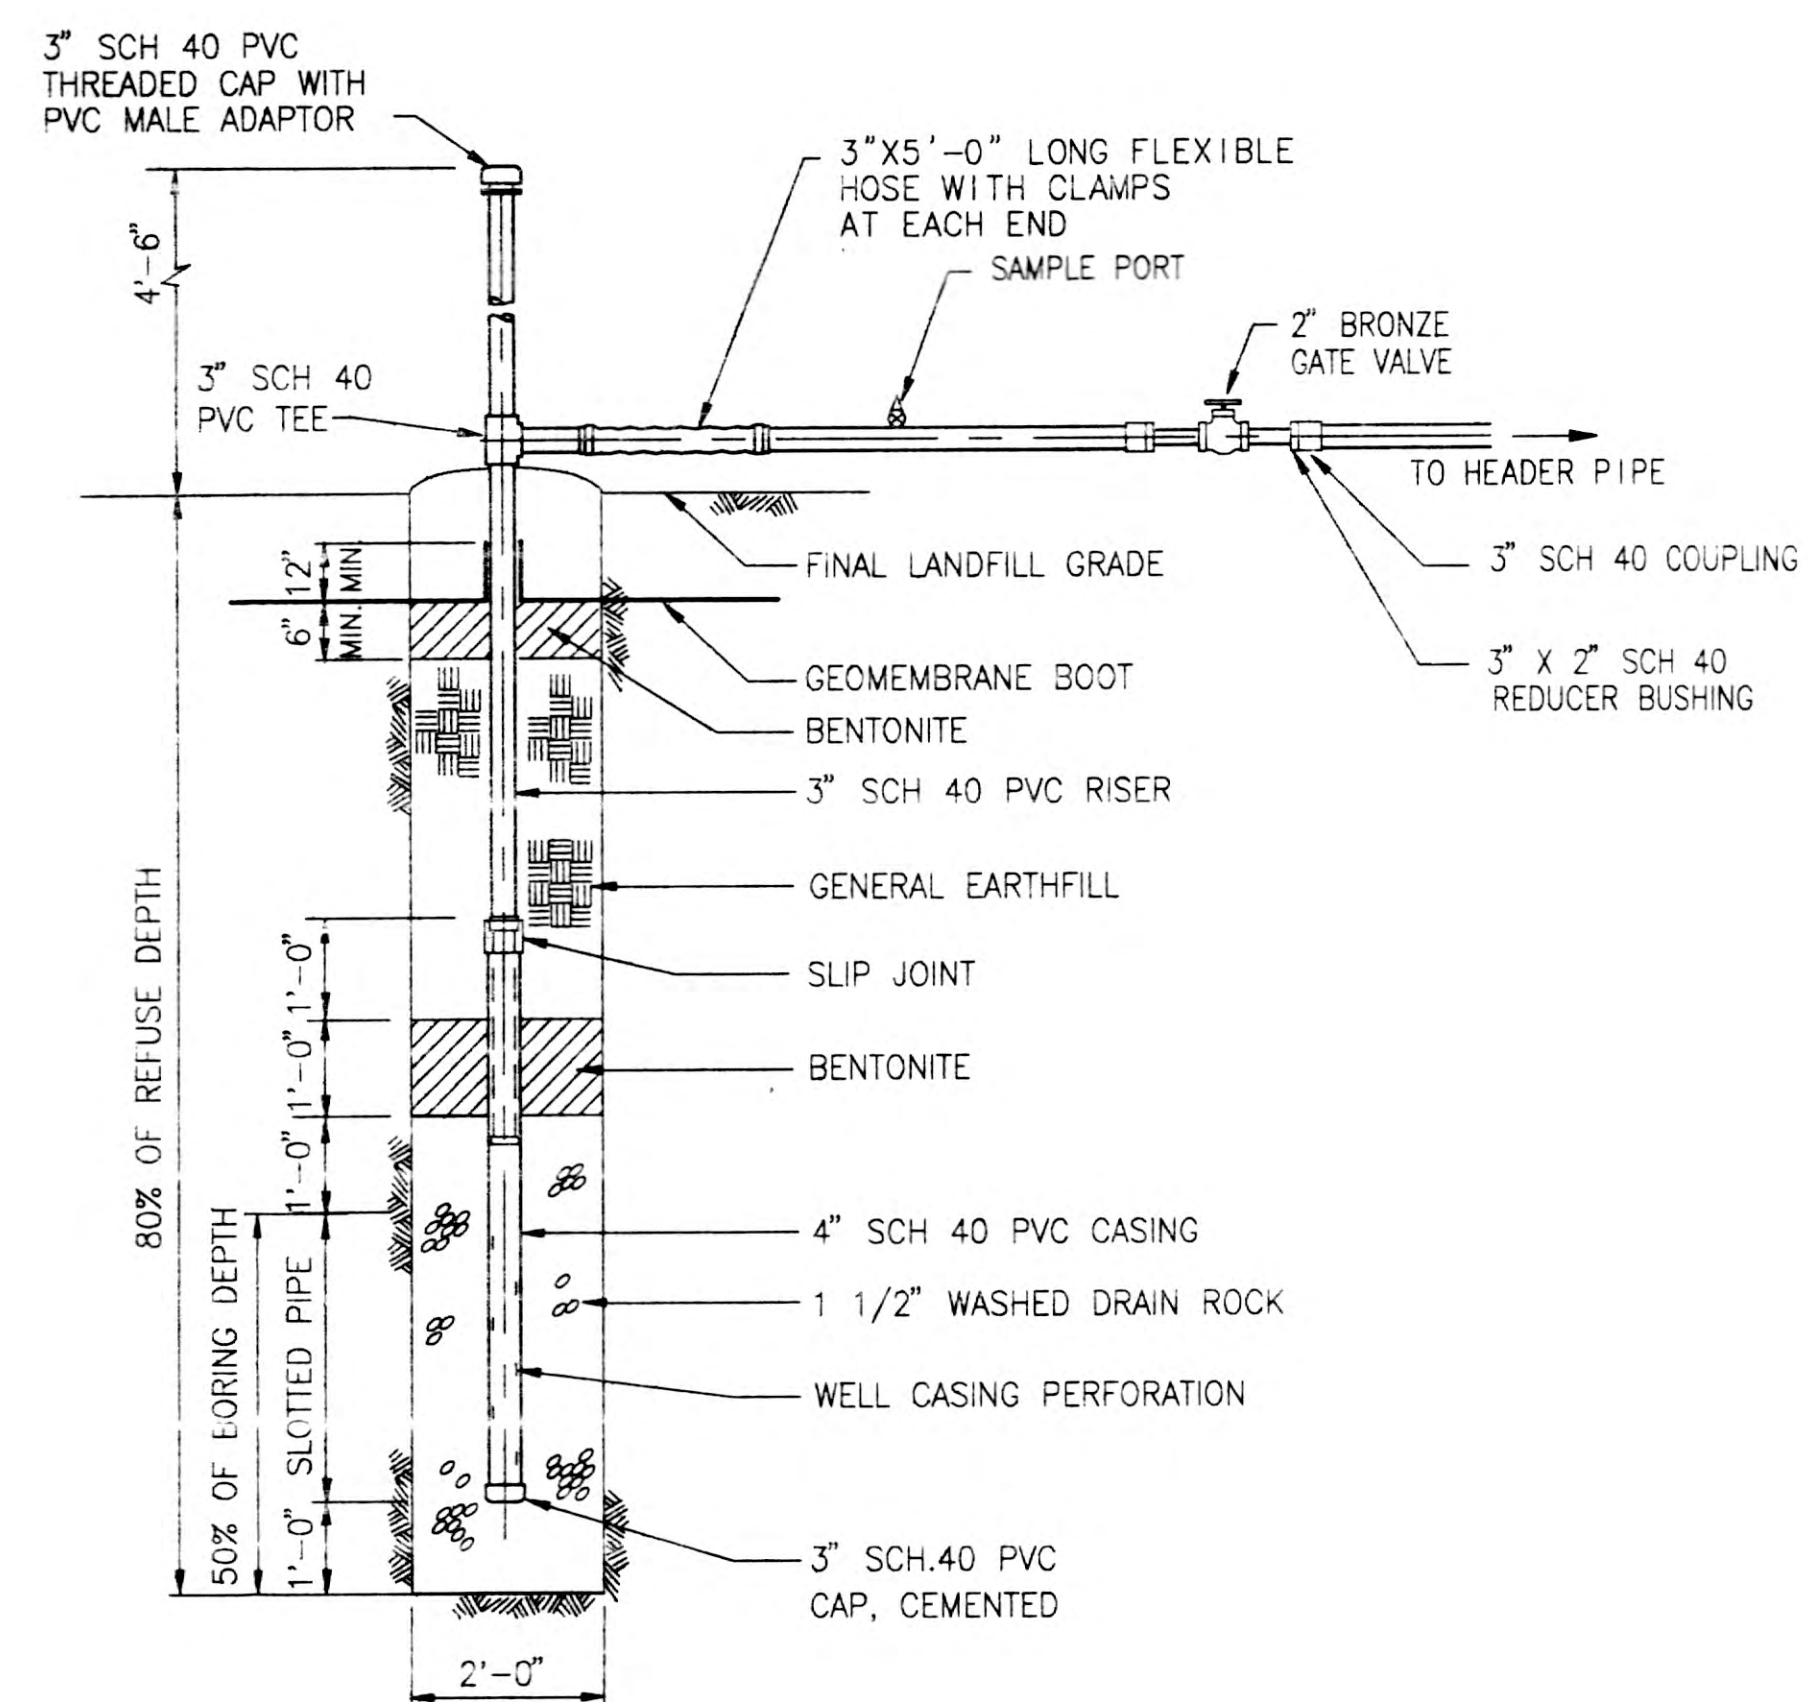
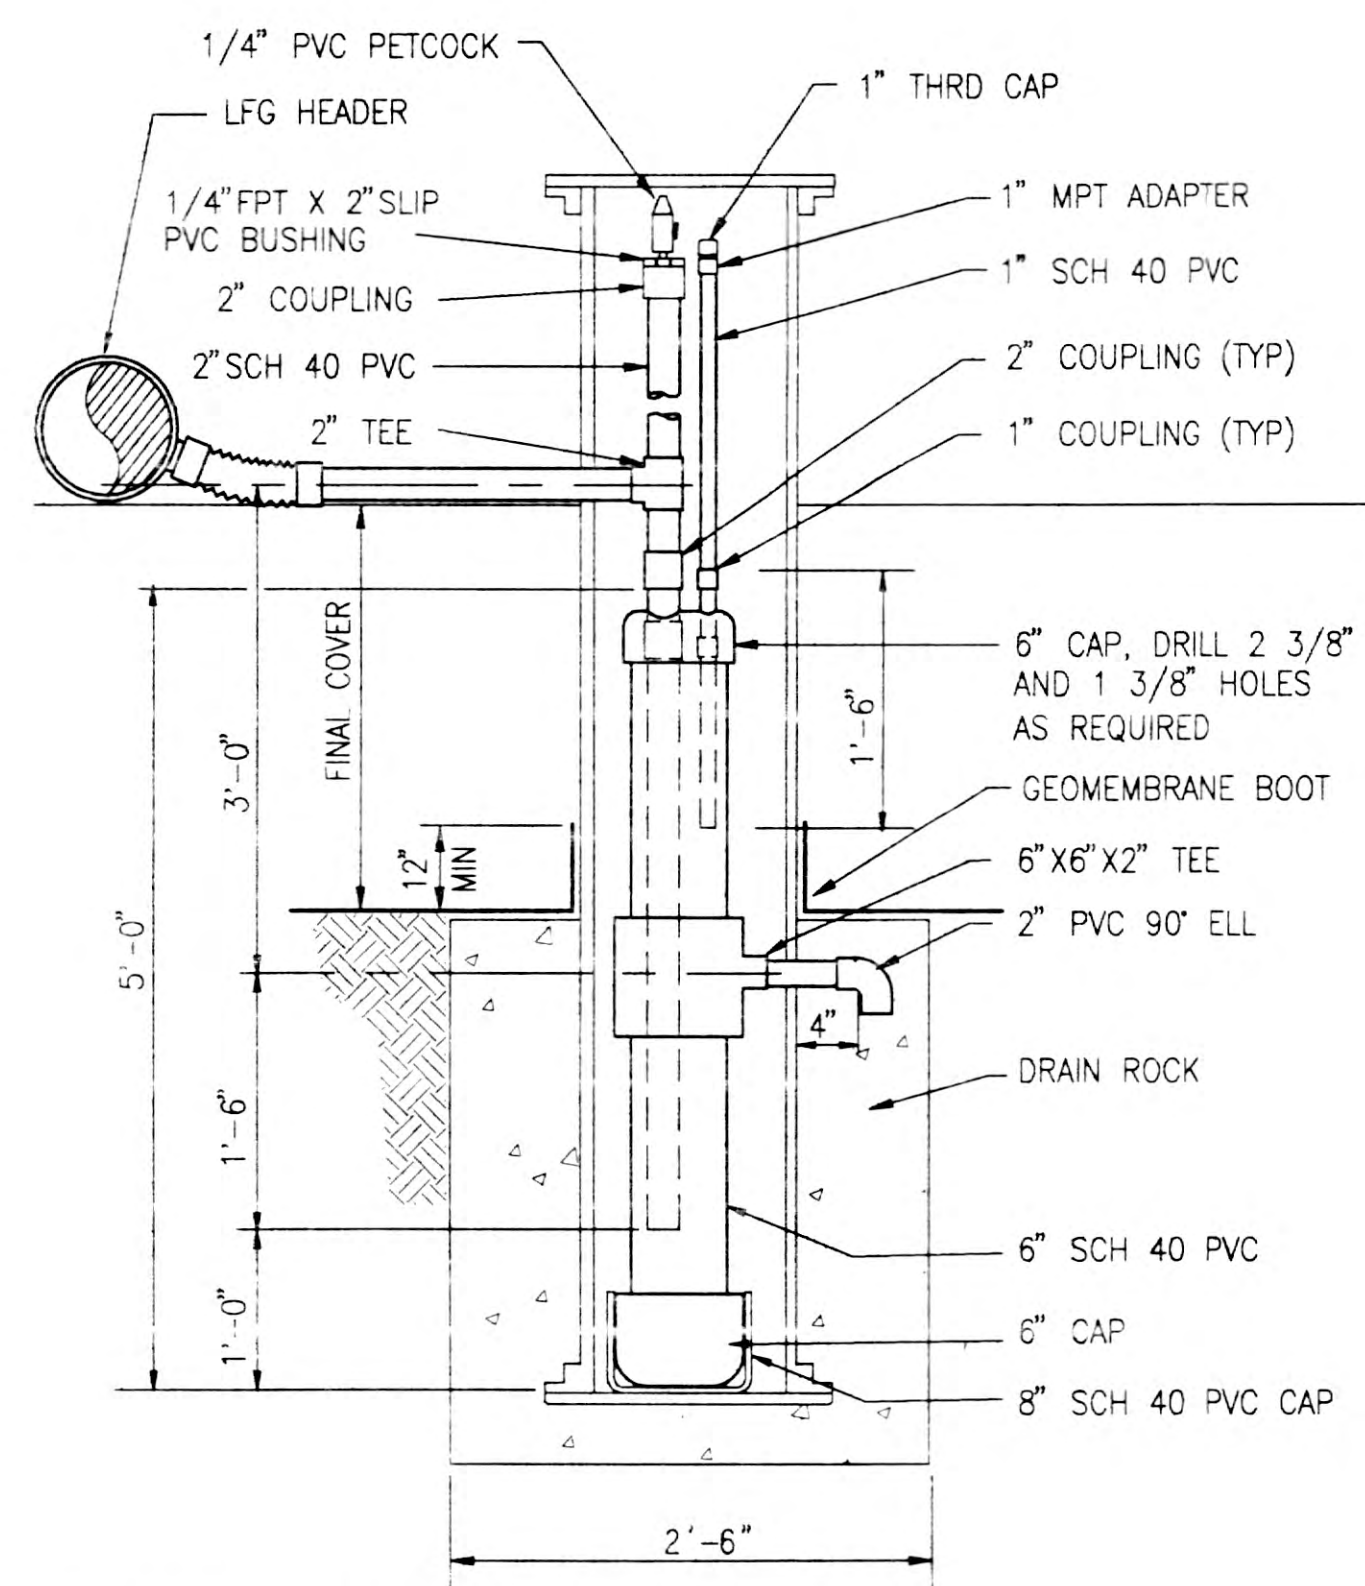
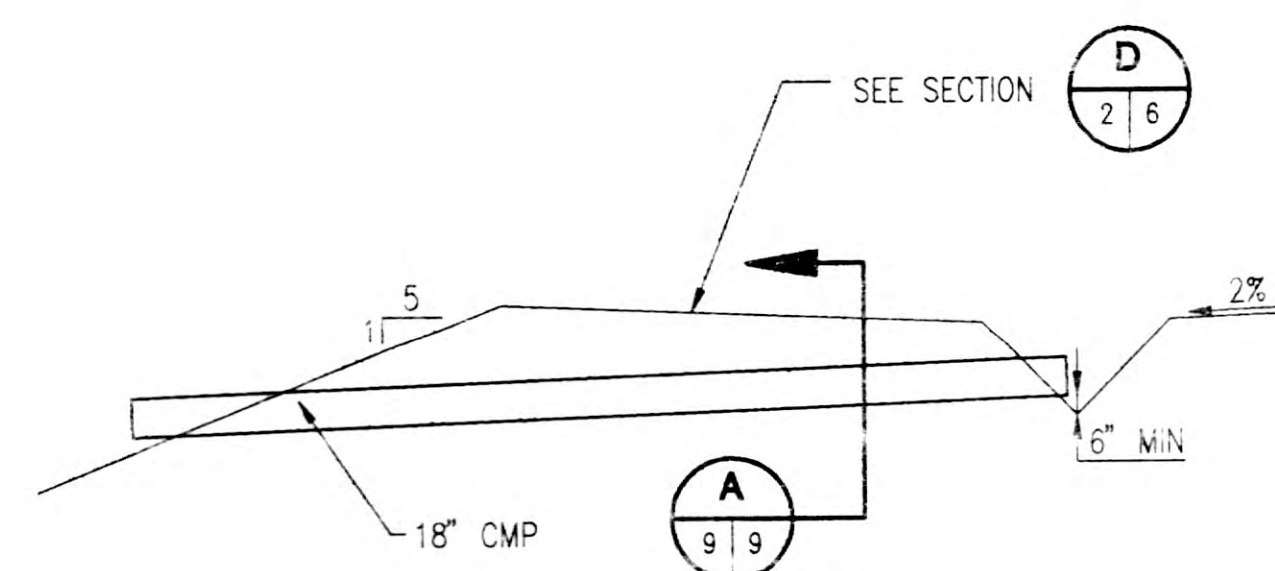
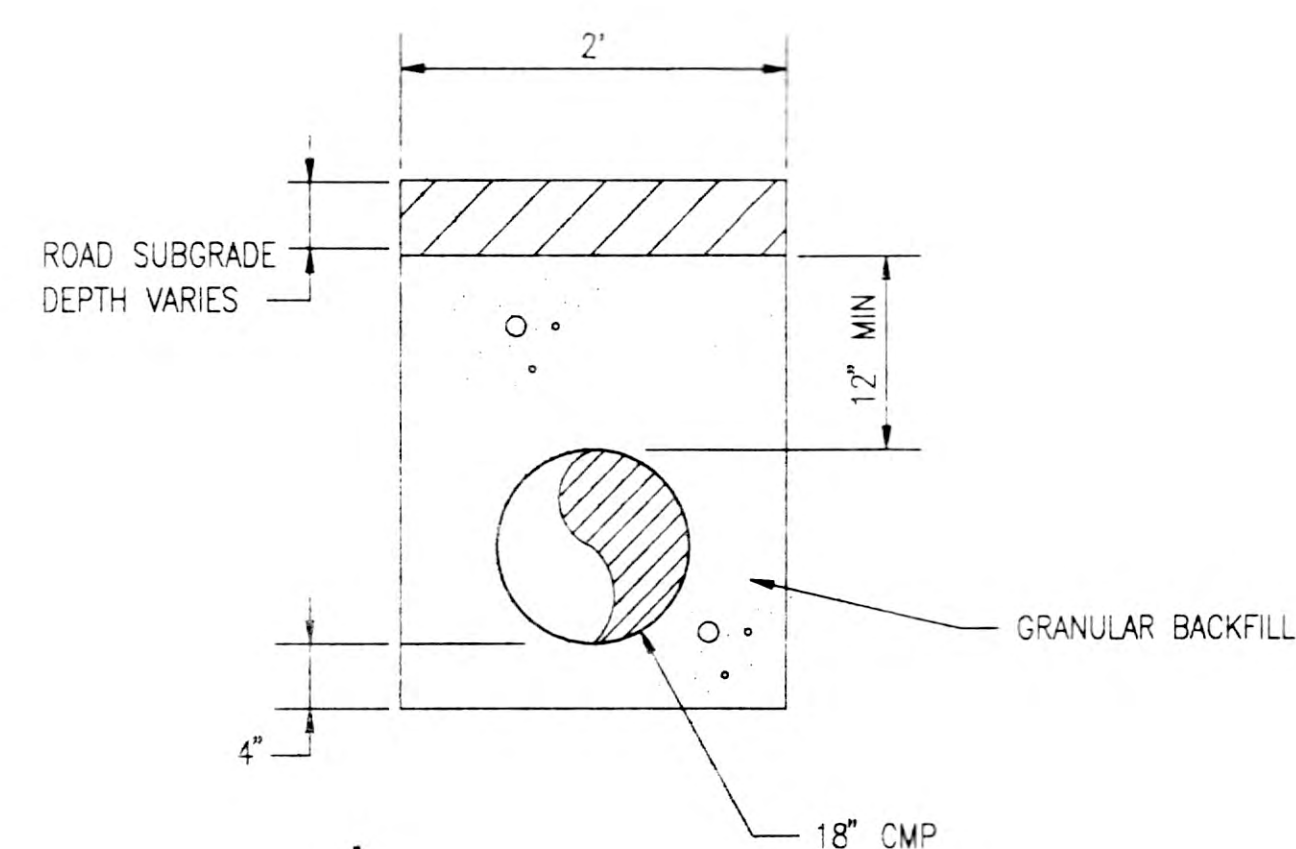
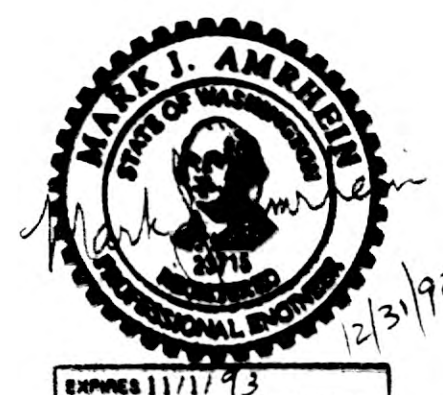
DRAWING NO. 8  
PROJECT NO. T0201.50

**SOUTHWEST CLOSURE COVER DETAILS**

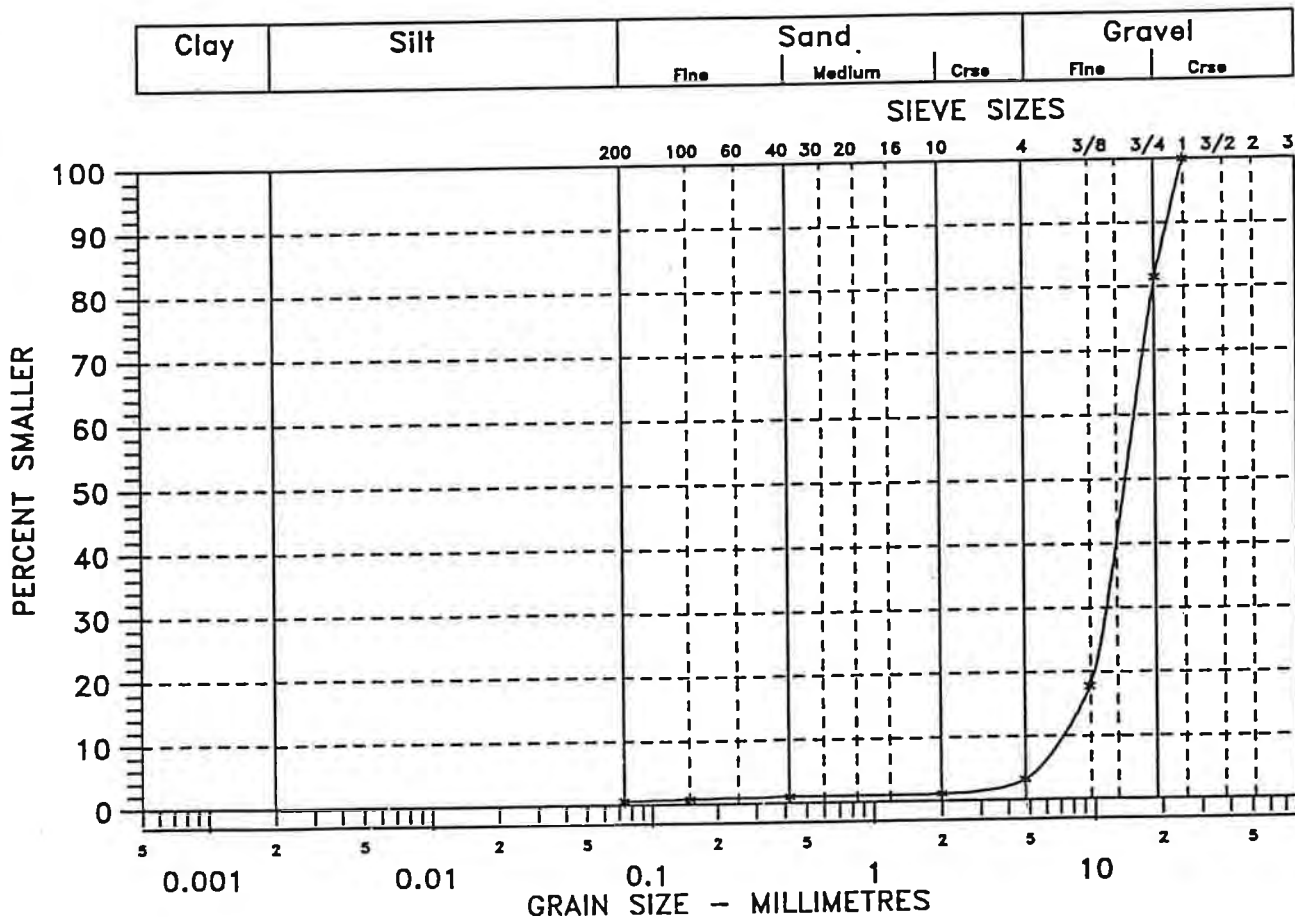
## GRAIN SIZE DISTRIBUTION

Project: Hidden Valley Landfill Closure  
 Client: Emcon Northwest  
 Project Number: 90113  
 Date Tested: 7/22/92  
 Remarks: Gray GRAVEL with trace of sand  
           and silt (GP)

Test Hole Number: ---  
 Sample Number: DR-1  
 Depth: ---  
 Sample Description:  
     Gravel: 96.8  
     Sand: 2.6  
     Silt: 0.6  
     Clay: ---

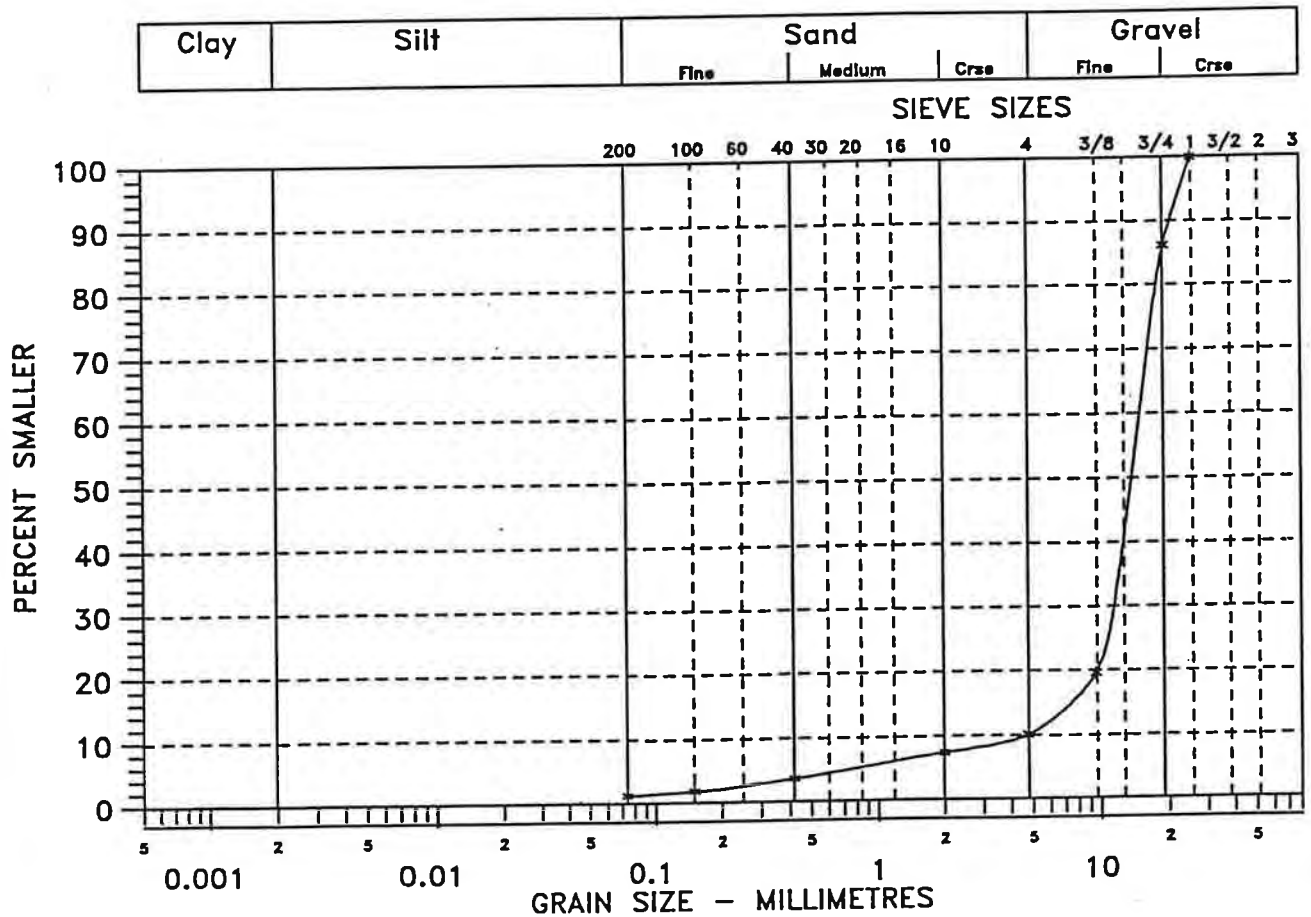
## GRAIN SIZE DISTRIBUTION

Remarks: Gray GRAVEL with some sand and  
trace of silt (GW)

Sample Number: DR-2

Gravel: 89.9

Sand: 8.9

Silt: 1.2

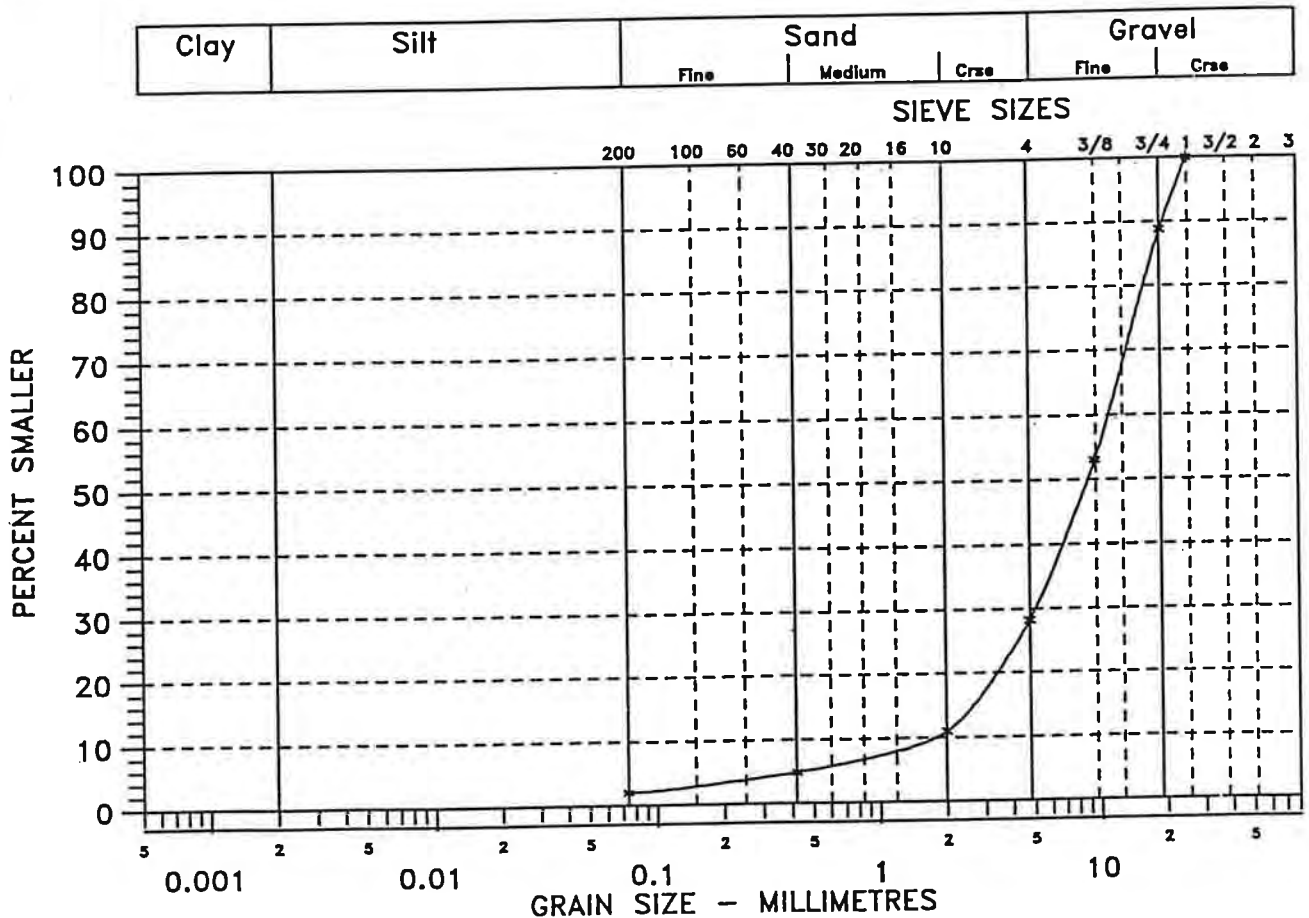
# HONG WEST & ASSOCIATES GRAIN SIZE DISTRIBUTION

Project: Hidden Valley Landfill Closure  
 Client: Emcon Northwest  
 Project Number: 90113  
 Date Tested: 8/28/92  
 Remarks: Grayish brown, GRAVEL with some  
sand and trace of silt (GW)

Test Hole Number: --  
 Sample Number: DR-1  
 Depth: --  
 Sample Description:  
 Gravel: 89.0  
 Sand: 9.0  
 Silt: 2.0  
 Clay:

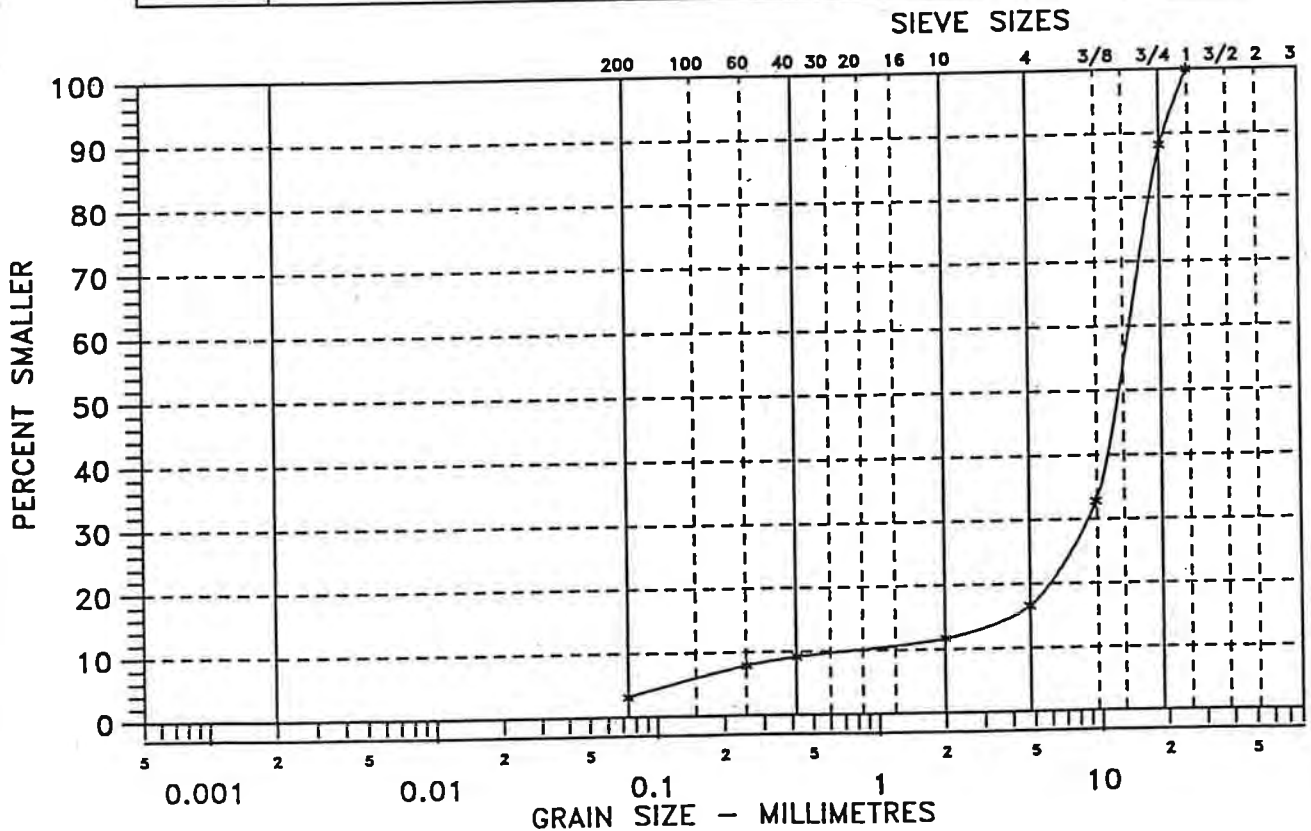
# HONG WEST & ASSOCIATES GRAIN SIZE DISTRIBUTION

Project: Hidden Valley Landfill Closure  
 Client: Emcon Northwest  
 Project Number: 90113  
 Date Tested: 8/21/92  
 Remarks: Gray, sandy GRAVEL with  
           trace of silt (GP)

Test Hole Number: ---  
 Sample Number: DR-2  
 Depth: ---  
 Sample Description:  
 Gravel: 83.4  
 Sand: 13.5  
 Silt: 3.1  
 Clay: ---

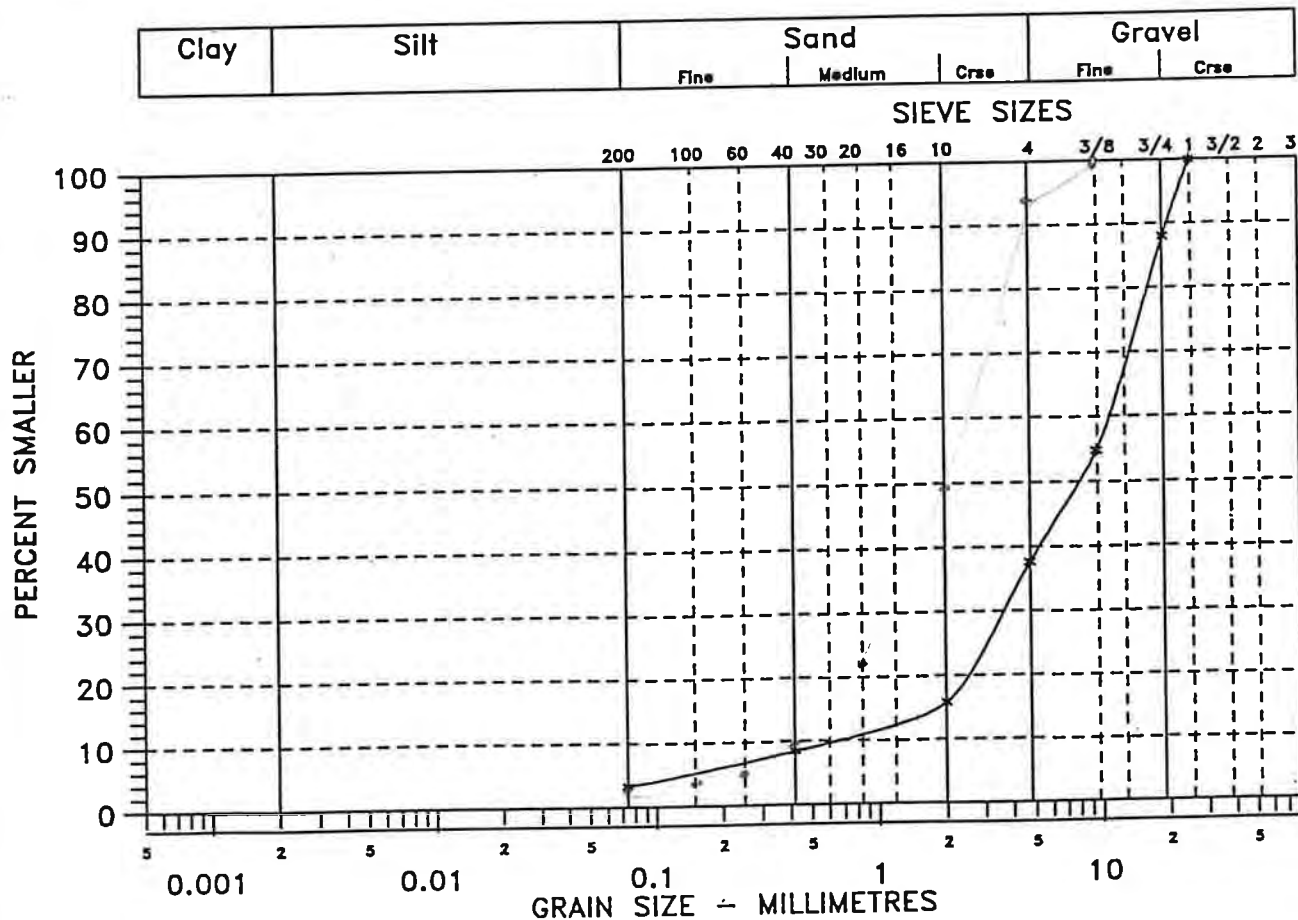
## GRAIN SIZE DISTRIBUTION

Remarks: Grayish brown, sandy GRAVEL with  
trace of silt (GW)

PERMEABILITY: K= 3.7x10<sup>-2</sup> cm/sec

Sample Number: DR-3

Gravel: 84.2

Sand: 12.5

Silt: 3.3

<b>SAMPLE NO.</b>	<b>PERMEABILITY CM/SEC</b>
TOP-1	$5.0 \times 10^{-5}$
TOP-2	$1.6 \times 10^{-4}$
TOP-3	$1.4 \times 10^{-4}$
DR-3	$3.7 \times 10^{-2}$
DR-4	$2.4 \times 10^{-2}$
VEG-1	$3.8 \times 10^{-2}$
VEG-3	$1.9 \times 10^{-2}$

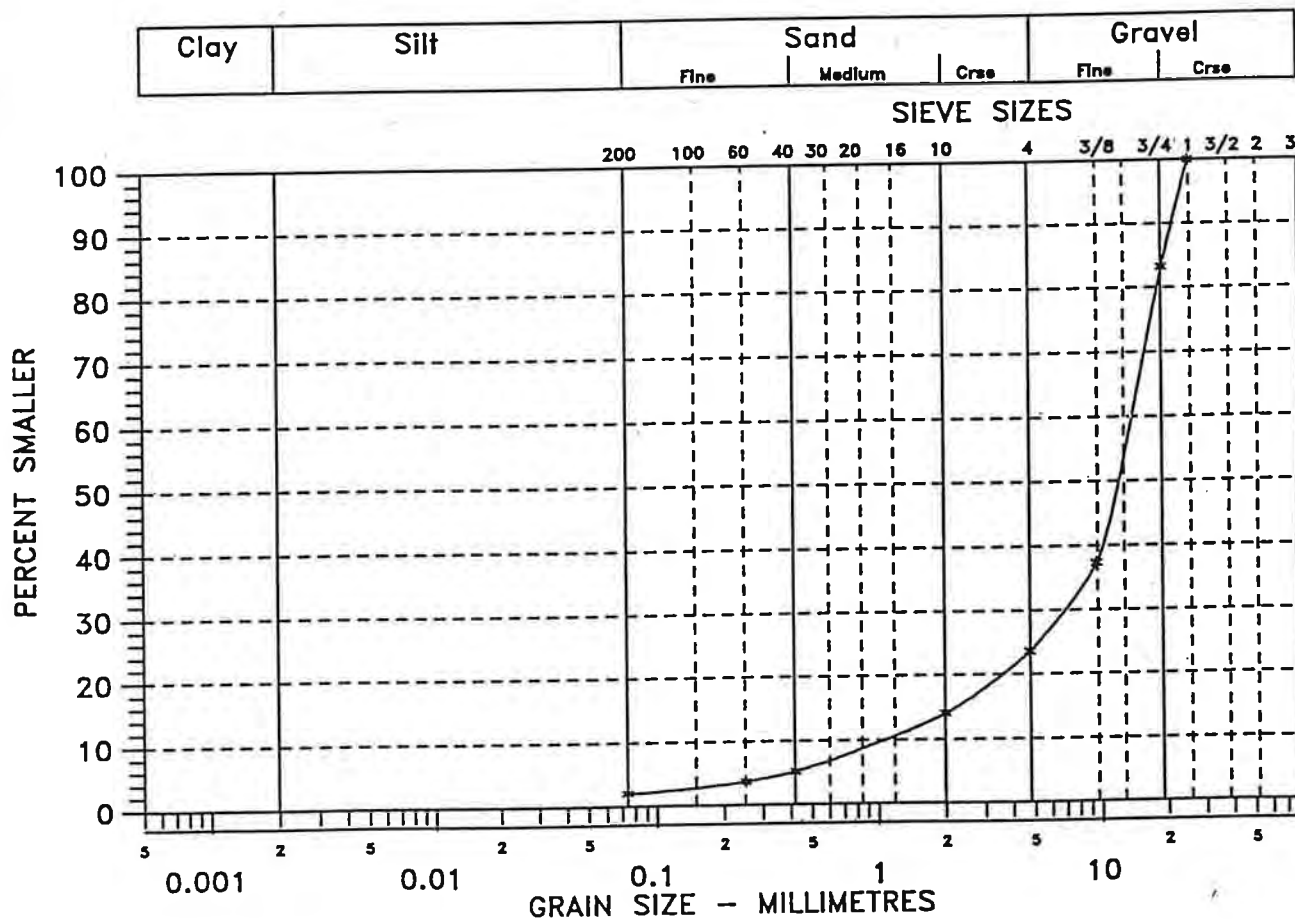
# HONG WEST & ASSOCIATES GRAIN SIZE DISTRIBUTION

Remarks: Grayish brown, sandy GRAVEL with  
trace of silt (GP)

PERMEABILITY: K= 2.4x10<sup>-2</sup> cm/sec

Sample Number: DR-4

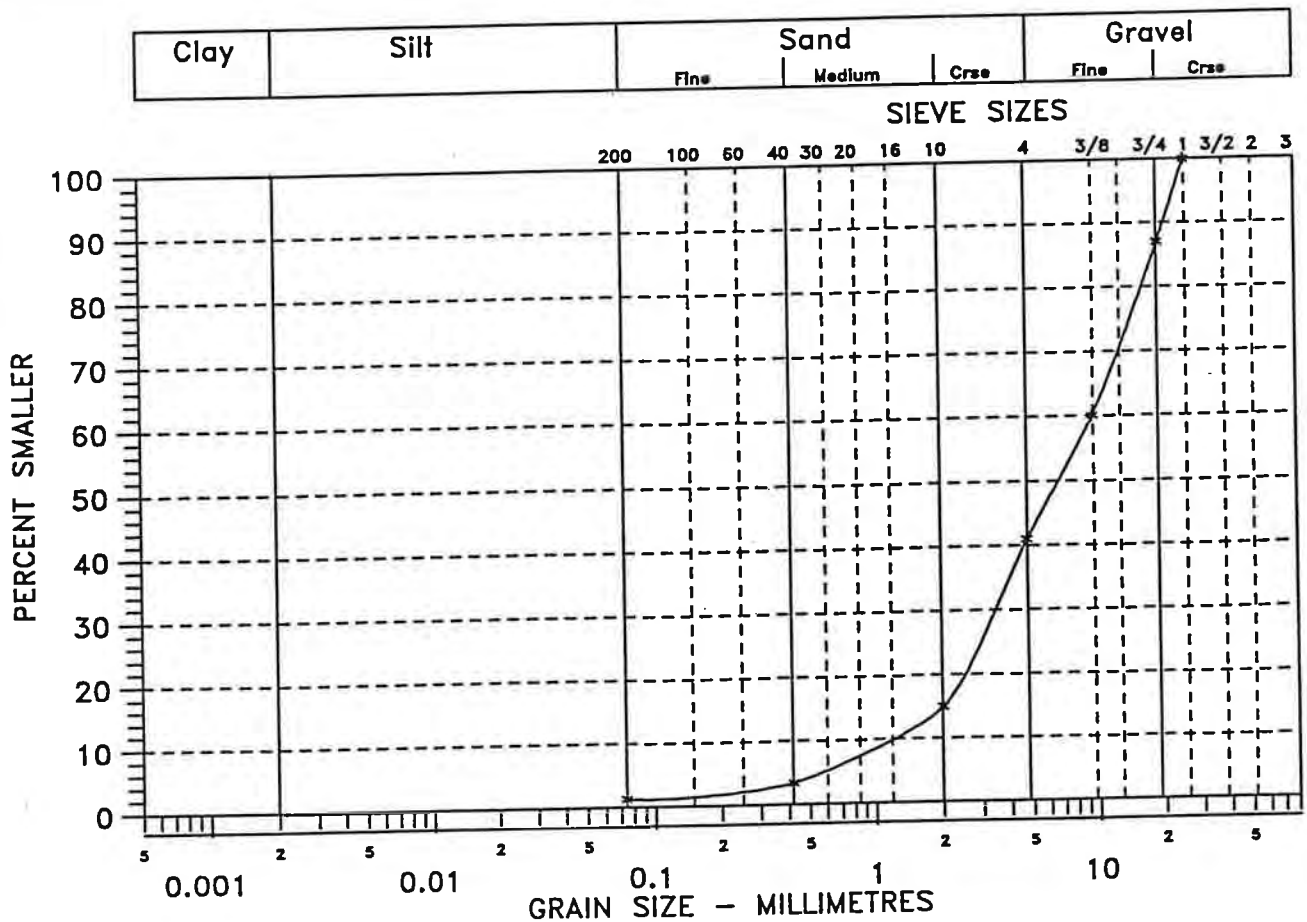
# HONG WEST & ASSOCIATES GRAIN SIZE DISTRIBUTION

Project: Hidden Valley Landfill Closure  
 Client: Emcon Northwest  
 Project Number: 90113  
 Date Tested: 8/28/92  
 Remarks: Grayish brown, sandy GRAVEL with  
           trace of silt (GP)

Test Hole Number: ---  
 Sample Number: DR-6  
 Depth: ---  
 Sample Description:  
     Gravel: 85.0  
     Sand: 13.7  
     Silt: 1.3  
     Clay: ---

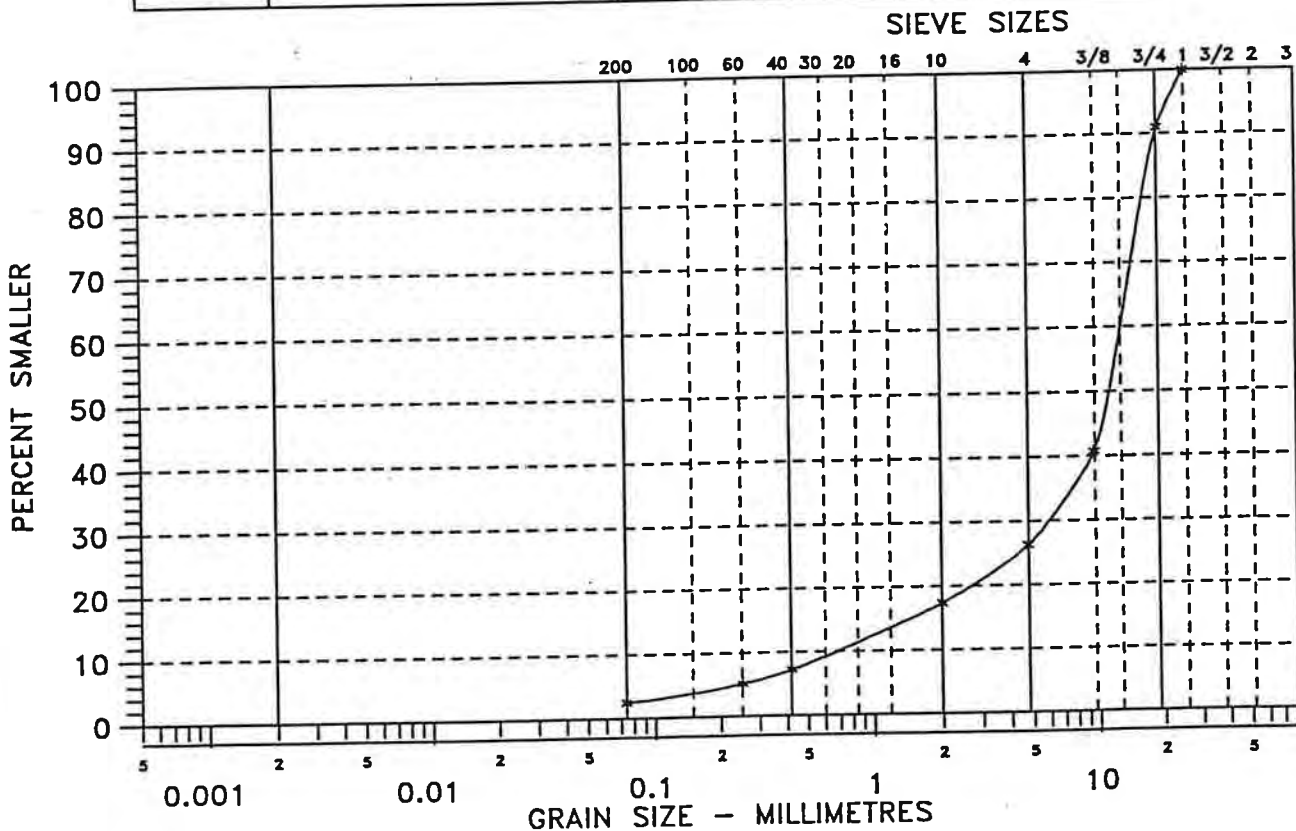
## GRAIN SIZE DISTRIBUTION

Test Hole Number: --  
 Sample Number: DR-7  
 Depth: --  
 Sample Description:  
     Gravel: 73.7  
     Sand: 23.8  
     Silt: 2.5  
     Clay:

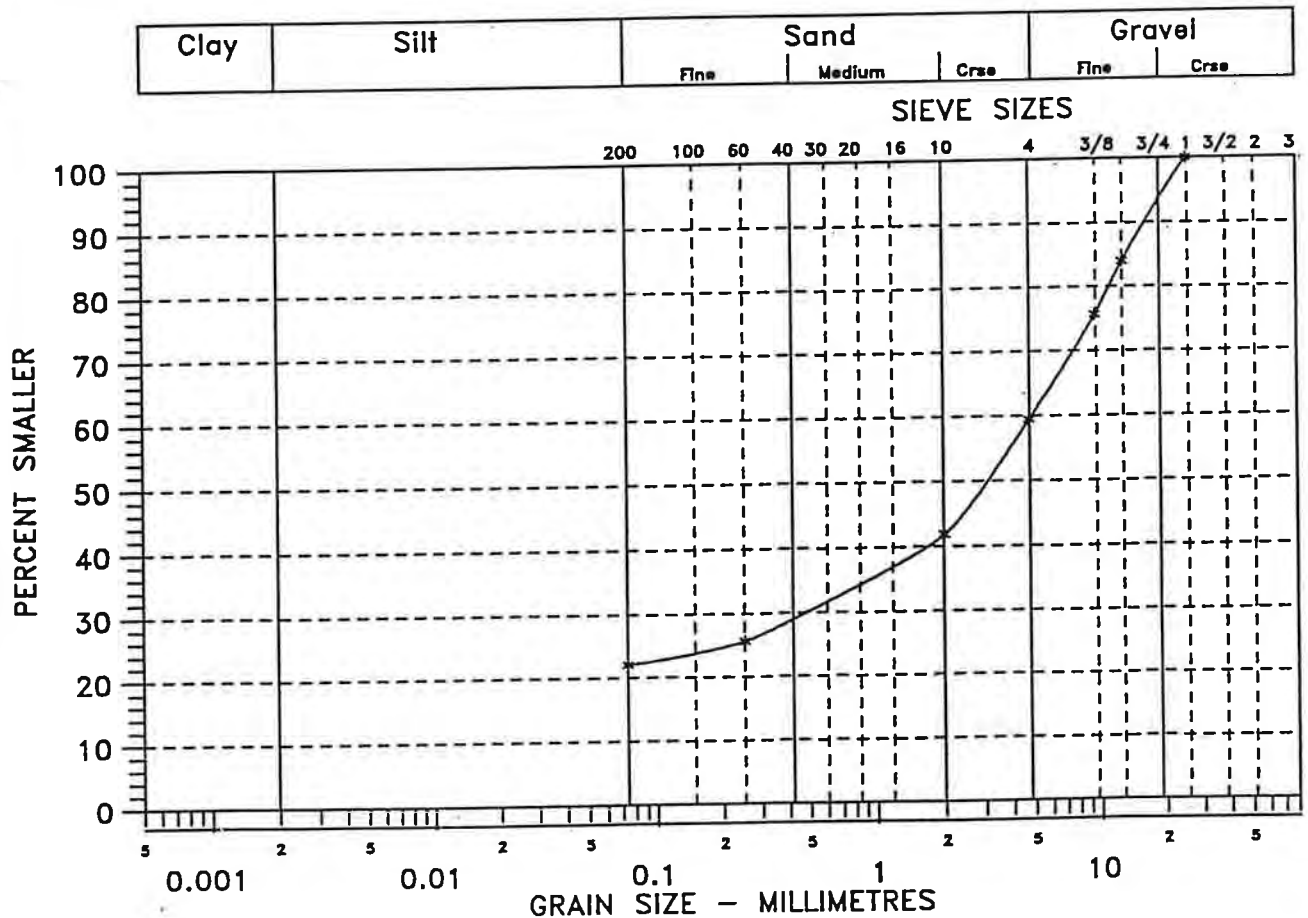
## GRAIN SIZE DISTRIBUTION

Project: Hidden Valley Landfill Closure  
 Client: Emcon Northwest  
 Project Number: 90113  
 Date Tested: 8/31/92  
 Remarks: Light brown, very sandy, silty  
GRAVEL (GM)  
PERMEABILITY: K= 5.0x10<sup>-5</sup> cm/sec  
DRY DENSITY: 95.5 pcf

Test Hole Number: --  
 Sample Number: TOP-1  
 Depth: --  
 Sample Description:  
 Gravel: 40.6  
 Sand: 37.3  
 Silt: 22.1  
 Clay: --

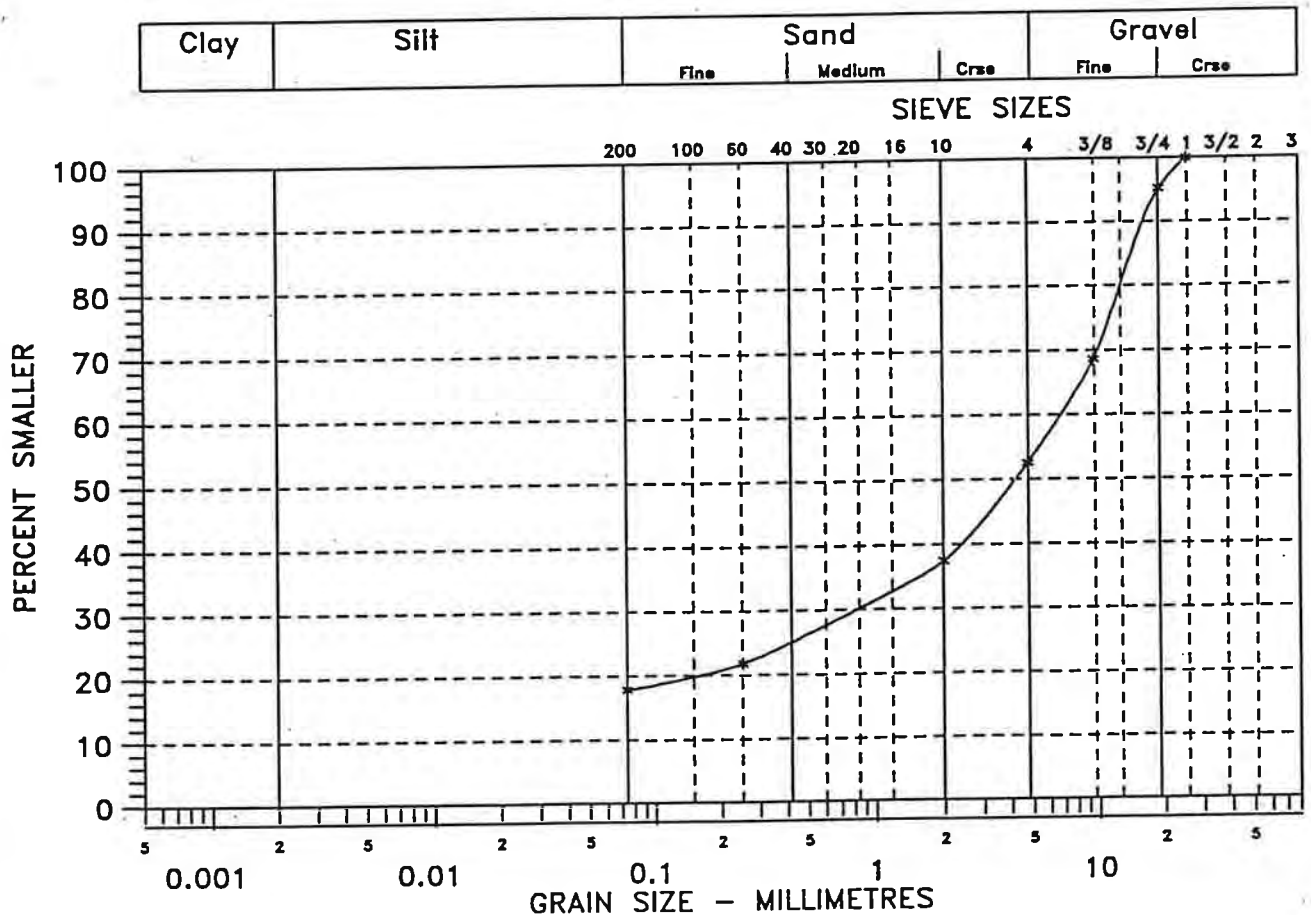
## GRAIN SIZE DISTRIBUTION

Project: Hidden Valley Landfill Closure  
 Client: Emcon Northwest  
 Project Number: 90113  
 Date Tested: 8/31/92  
 Remarks: Light brown, sandy, silty  
GRAVEL (GM)  
PERMEABILITY:  $K = 1.6 \times 10^{-4}$  cm/sec  
DRY DENSITY: 92.7 pcf

Test Hole Number: --  
 Sample Number: TOP-2  
 Depth: --  
 Sample Description:  
 Gravel: 47.5  
 Sand: 34.6  
 Silt: 17.9  
 Clay:

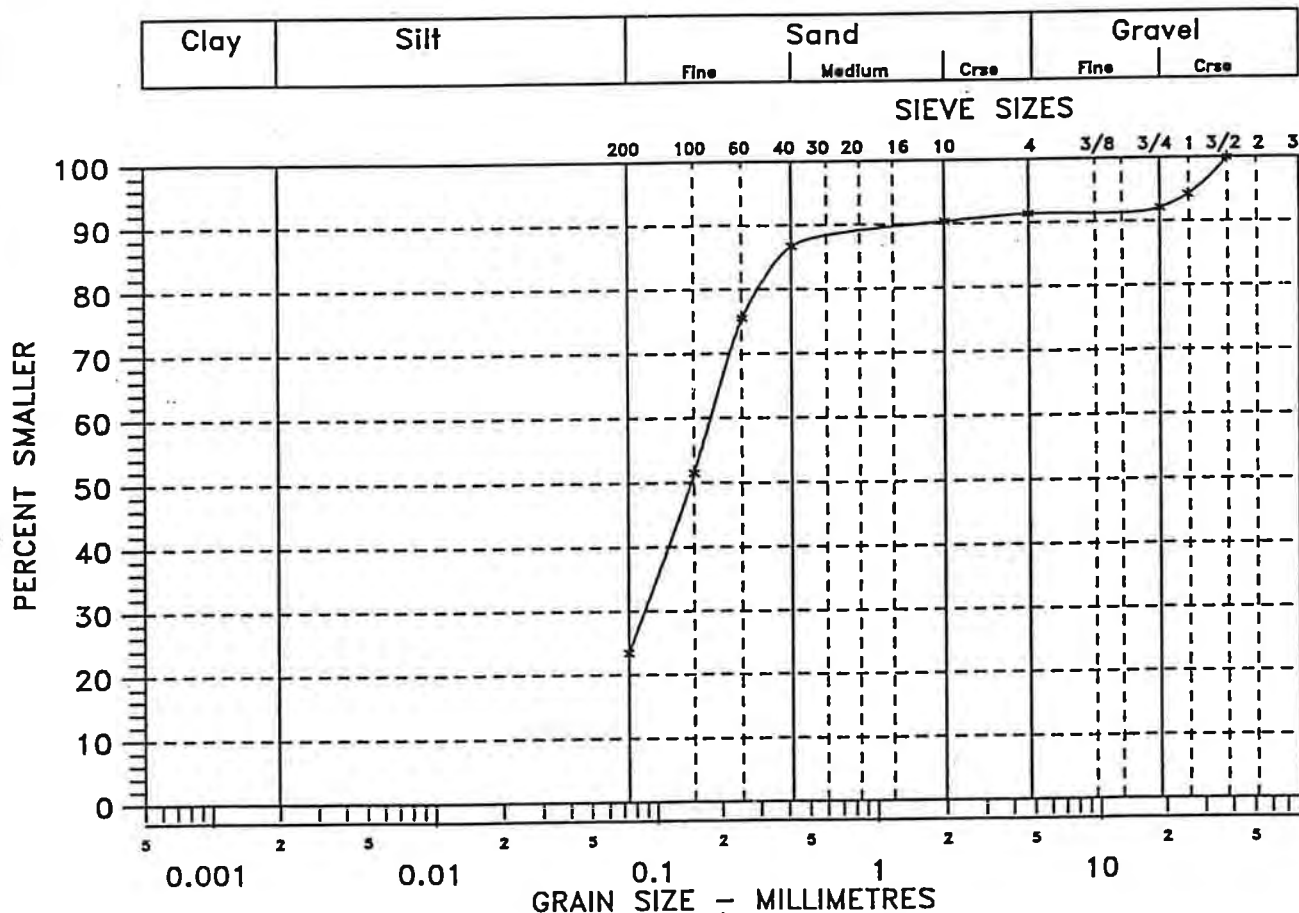
# HONG WEST & ASSOCIATES GRAIN SIZE DISTRIBUTION

Project: Hidden Valley Landfill Closure  
 Client: Emcon Northwest  
 Project Number: 90113  
 Date Tested: 7/18/92  
 Remarks: Olive gray, silty SAND with some  
gravel (SM)

Test Hole Number: --  
 Sample Number: BED-1  
 Depth: --  
 Sample Description:  
 Gravel: 8.6  
 Sand: 68.0  
 Silt: 23.4  
 Clay:

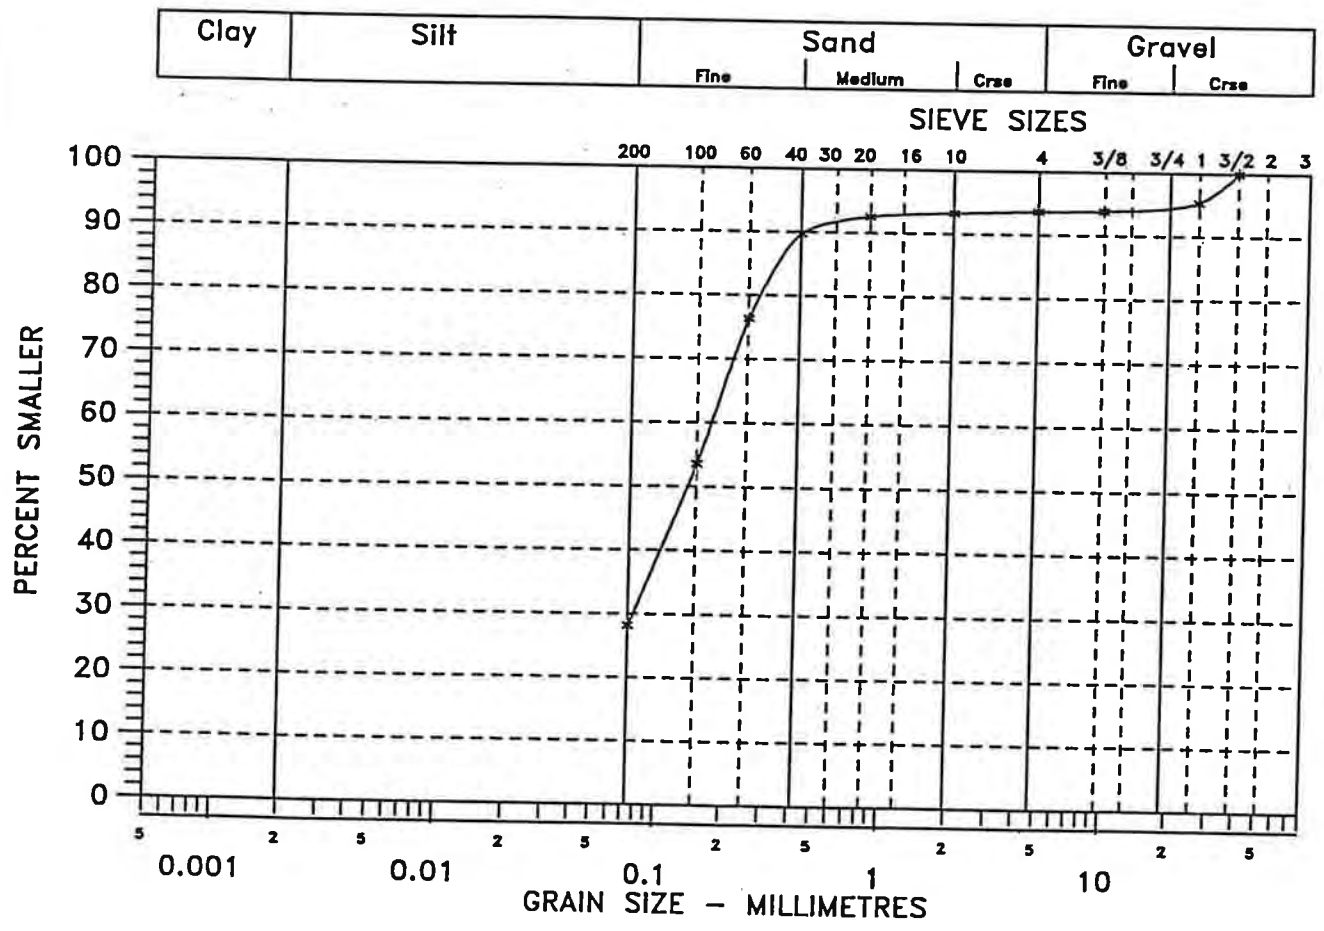
# HONG WEST & ASSOCIATES GRAIN SIZE DISTRIBUTION

Project: Hidden Valley Landfill Closure  
 Client: Emcon Northwest  
 Project Number: 90113  
 Date Tested: 7/21/92  
 Remarks: Olive brown, silty SAND with some  
gravel (SM)

Test Hole Number: ---  
 Sample Number: BED-2  
 Depth: ---  
 Sample Description:  
 Gravel: 6.3  
 Sand: 65.6  
 Silt: 28.1  
 Clay: ---
