**Southwest Closure Area  
Construction Report  
Hidden Valley Landfill  
Pierce County, Washington**

Prepared for  
Land Recovery Inc.  
December 31, 1992

Prepared by  
EMCON Northwest, Inc.  
18912 North Creek Parkway, Suite 100  
Bothell, Washington 98011

Construction Report  
Southwest Closure  
Hidden Valley Landfill

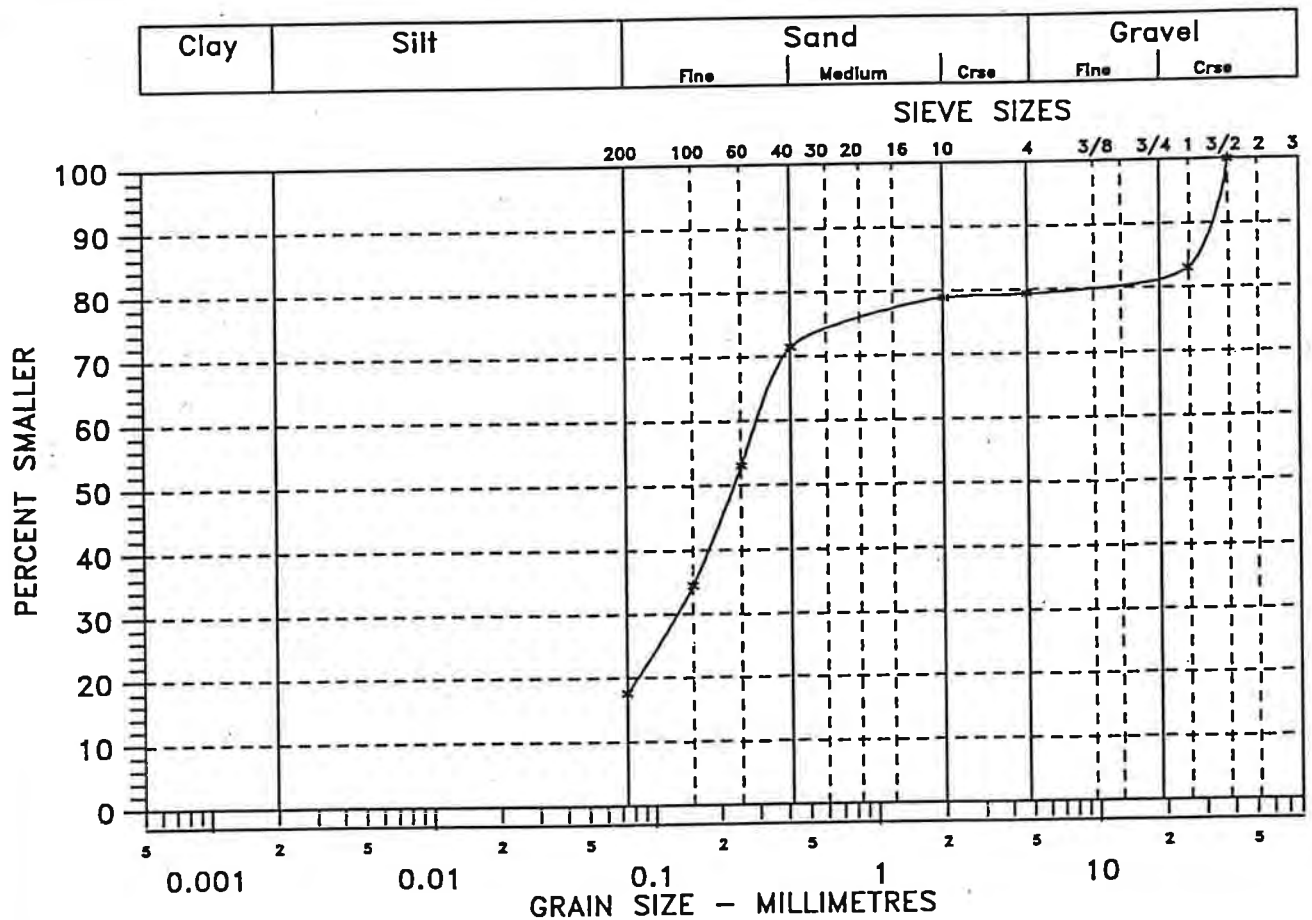
## GRAIN SIZE DISTRIBUTION

Project: Hidden Valley Landfill Closure  
 Client: Emcon Northwest  
 Project Number: 90113  
 Date Tested: 7/18/92  
 Remarks: Very dark grayish brown, gravelly,  
           silty SAND (SM)

Test Hole Number: ---  
 Sample Number: BED-3  
 Depth: ---  
 Sample Description:  
 Gravel: 20.7  
 Sand: 61.7  
 Silt: 17.6  
 Clay: ---

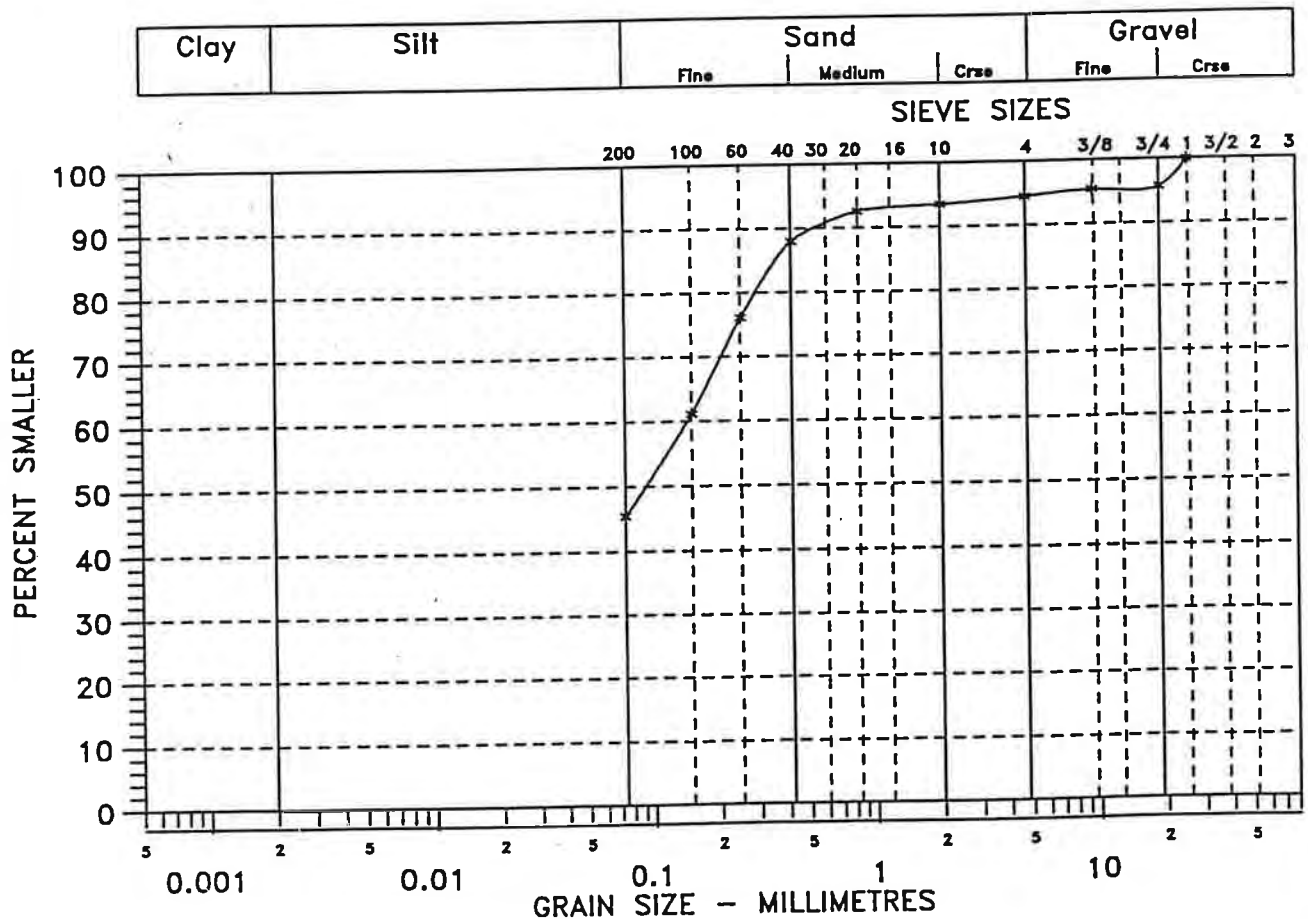
# HONG WEST & ASSOCIATES GRAIN SIZE DISTRIBUTION

Project: Hidden Valley Landfill Closure  
 Client: Emcon Northwest  
 Project Number: 90113  
 Date Tested: 7/21/92  
 Remarks: Dark brown, very silty SAND with  
           some gravel (SM)

Test Hole Number: --  
 Sample Number: BED-4  
 Depth: --  
 Sample Description:  
     Gravel: 5.5  
     Sand: 49.1  
     Silt: 45.4  
     Clay:

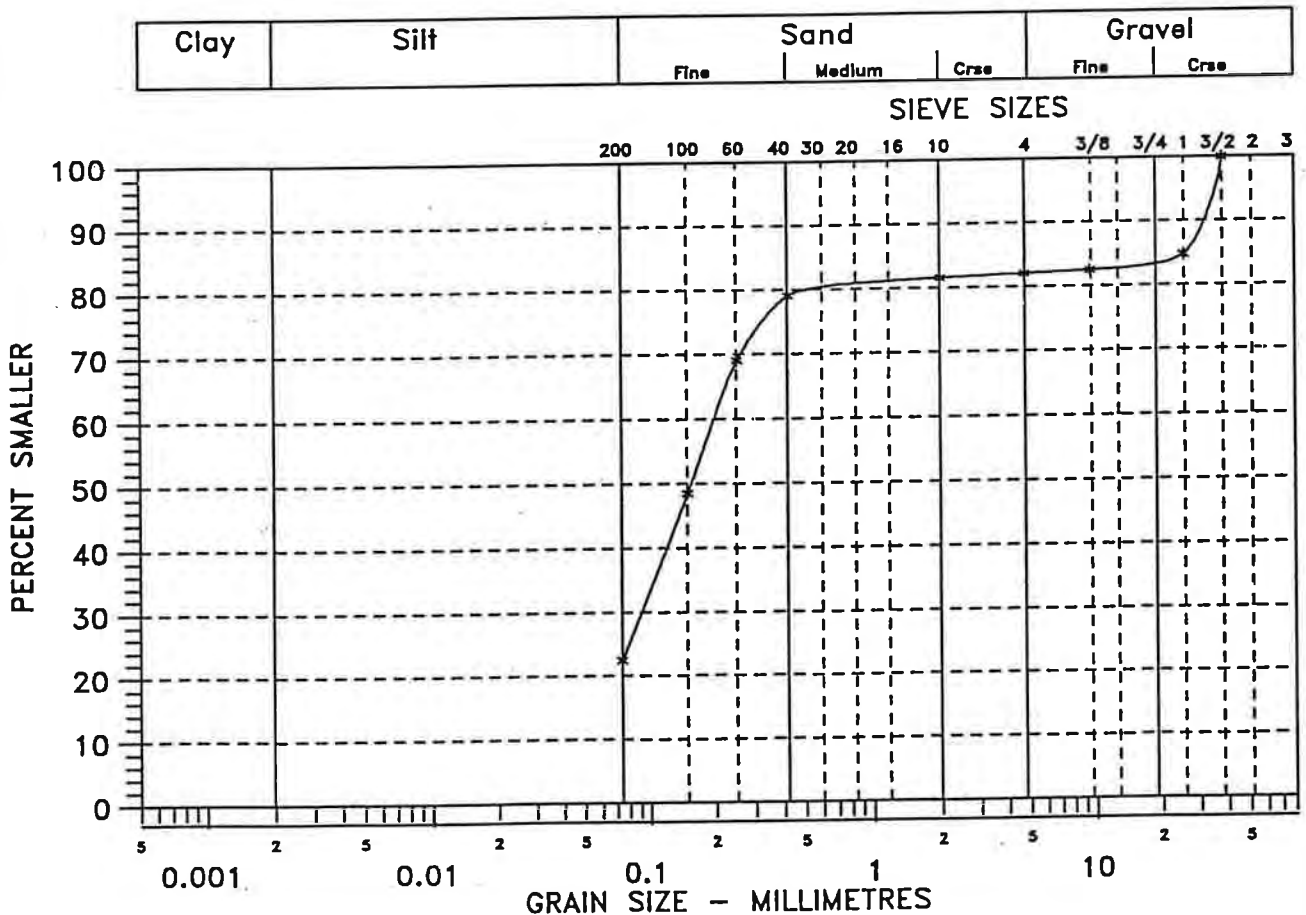
# HONG WEST & ASSOCIATES GRAIN SIZE DISTRIBUTION

Project: Hidden Valley Landfill Closure  
 Client: Emcon Northwest  
 Project Number: 90113  
 Date Tested: 7/18/92  
 Remarks: Olive, silty, gravelly SAND (SM)

Test Hole Number: --  
 Sample Number: BED-5  
 Depth: --  
 Sample Description:  
 Gravel: 17.9  
 Sand: 59.7  
 Silt: 22.4  
 Clay: ---

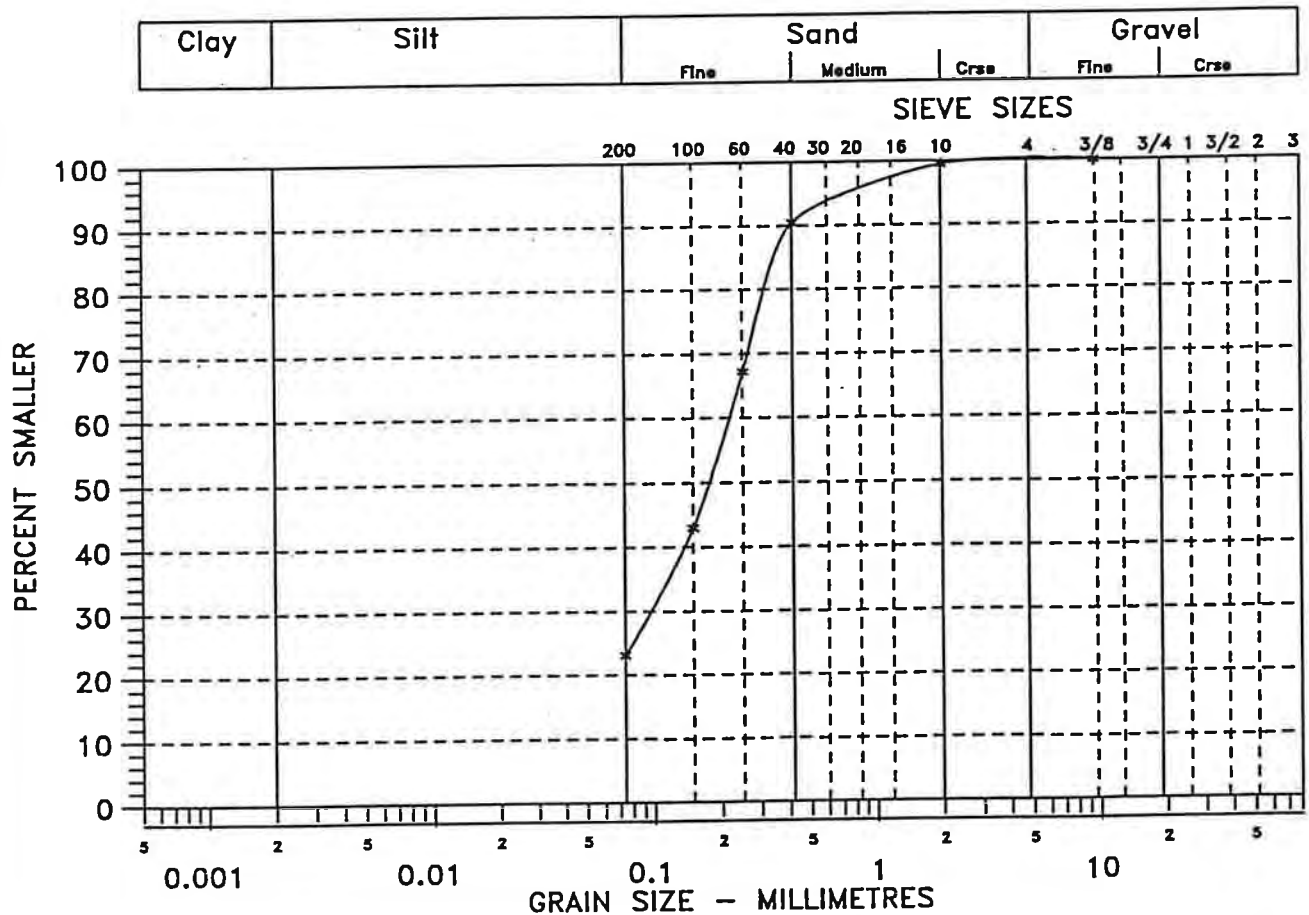
## GRAIN SIZE DISTRIBUTION

Project: Hidden Valley Landfill Closure  
 Client: Emcon Northwest  
 Project Number: 90113  
 Date Tested: 7/21/92  
 Remarks: Olive, silty SAND with trace of  
gravel (SM)

Test Hole Number: --  
 Sample Number: BED-6  
 Depth: --  
 Sample Description:  
 Gravel: 0.1  
 Sand: 76.8  
 Silt: 23.1  
 Clay: ---

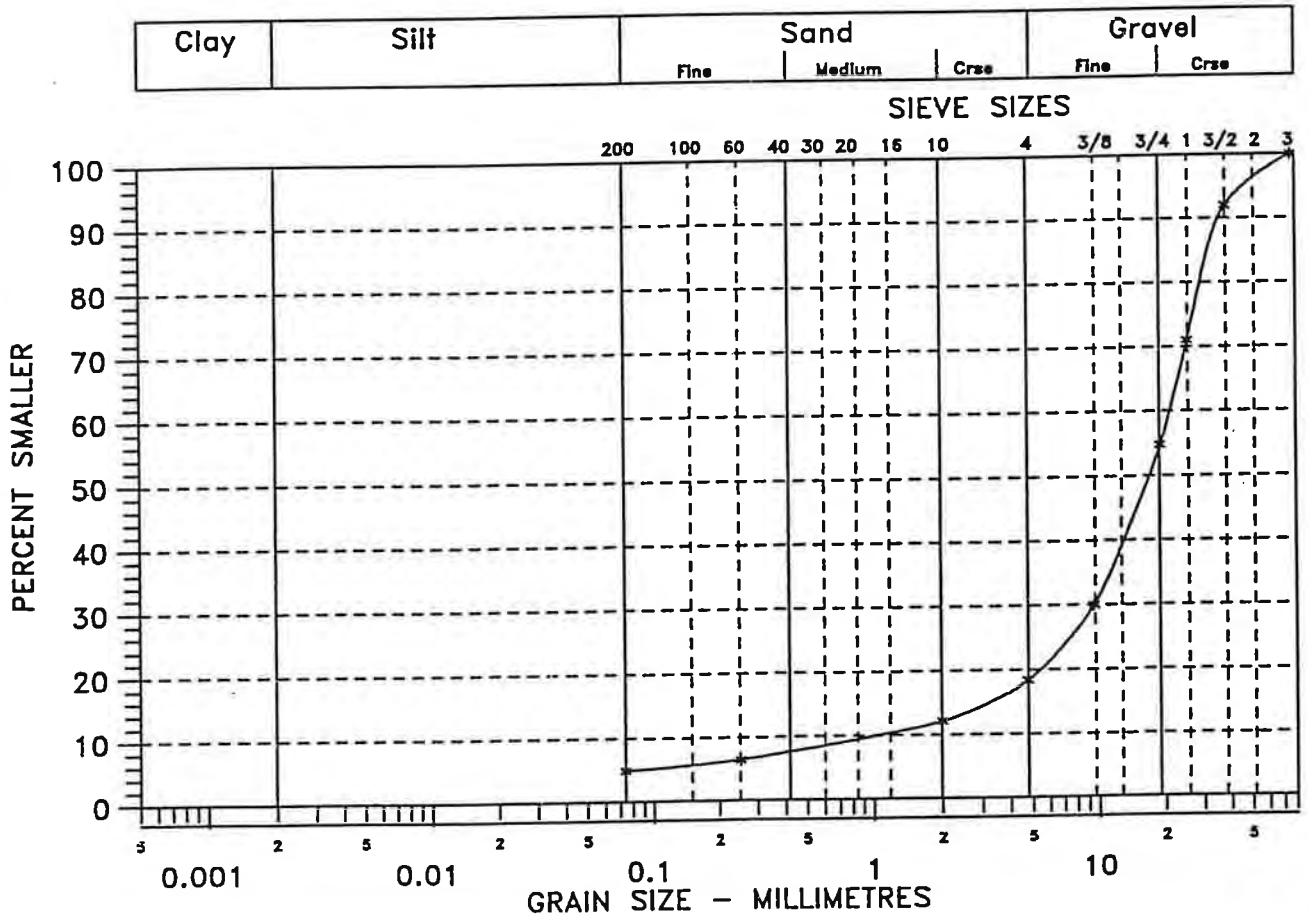
# HONG WEST & ASSOCIATES GRAIN SIZE DISTRIBUTION

Project: Hidden Valley Landfill Closure  
 Client: Emcon Northwest  
 Project Number: 90113  
 Date Tested: 9/3/92  
 Remarks: Light brown, sandy GRAVEL with  
 trace of silt (GP)  
 PERMEABILITY:  $K = 3.8 \times 10^{-2}$  cm/sec

Test Hole Number: ---  
 Sample Number: VEG-1  
 Depth: ---  
 Sample Description:  
 Gravel: 81.6  
 Sand: 13.5  
 Silt: 4.9  
 Clay: ---

<b>SAMPLE NO.</b>	<b>PERMEABILITY CM/SEC</b>
TOP-1	$5.0 \times 10^{-5}$
TOP-2	$1.6 \times 10^{-4}$
TOP-3	$1.4 \times 10^{-4}$
DR-3	$3.7 \times 10^{-2}$
DR-4	$2.4 \times 10^{-2}$
VEG-1	$3.8 \times 10^{-2}$
VEG-3	$1.9 \times 10^{-2}$

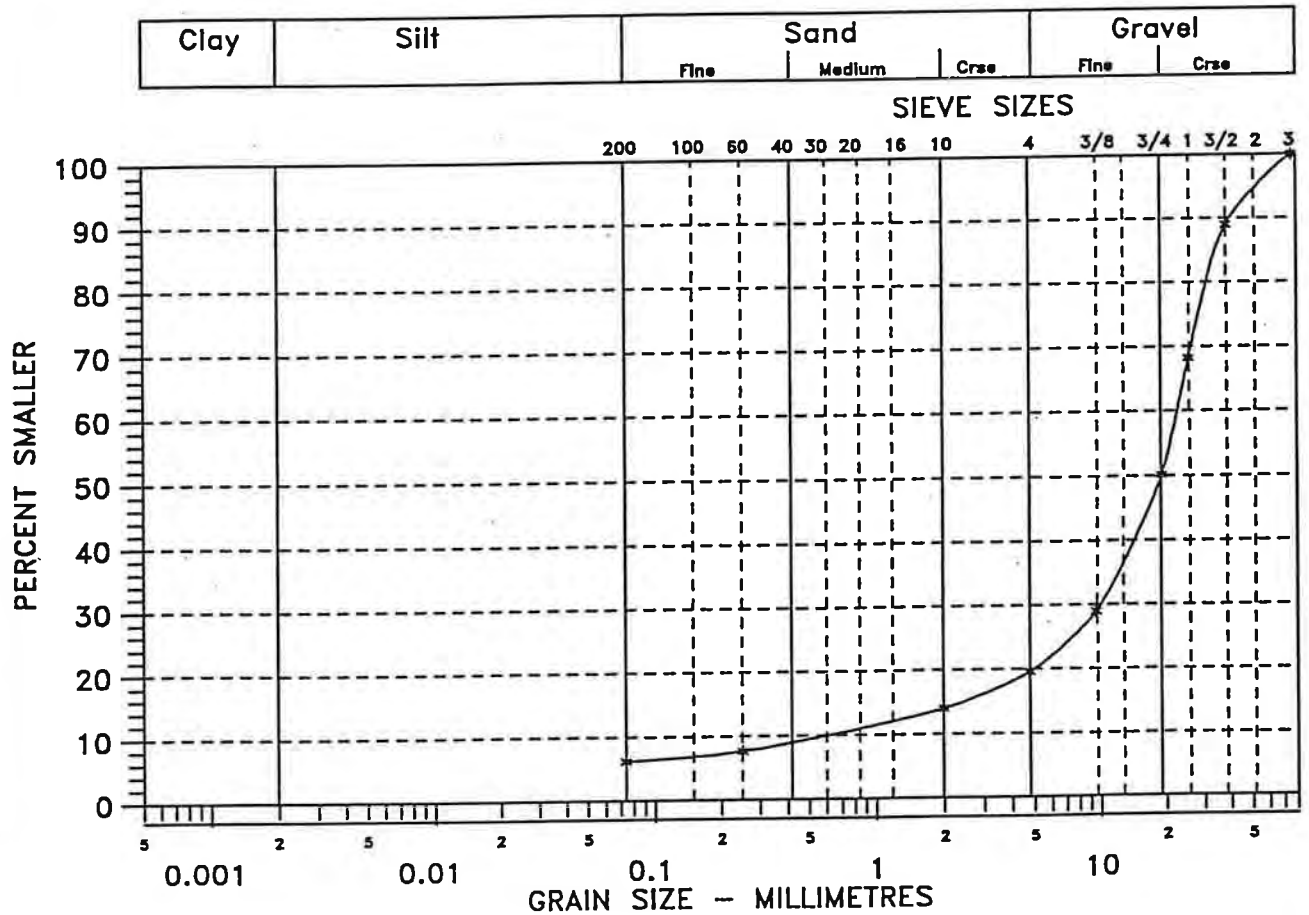
# HONG WEST & ASSOCIATES GRAIN SIZE DISTRIBUTION

Project: Hidden Valley Landfill Closure  
 Client: Emcon Northwest  
 Project Number: 90113  
 Date Tested: 9/21/92  
 Remarks: Light brown, sandy GRAVEL  
with some silt (GP-GM)

Test Hole Number: --  
 Sample Number: VEG-2  
 Depth: --  
 Sample Description:  
 Gravel: 80.4  
 Sand: 13.2  
 Silt: 6.2  
 Clay: ---

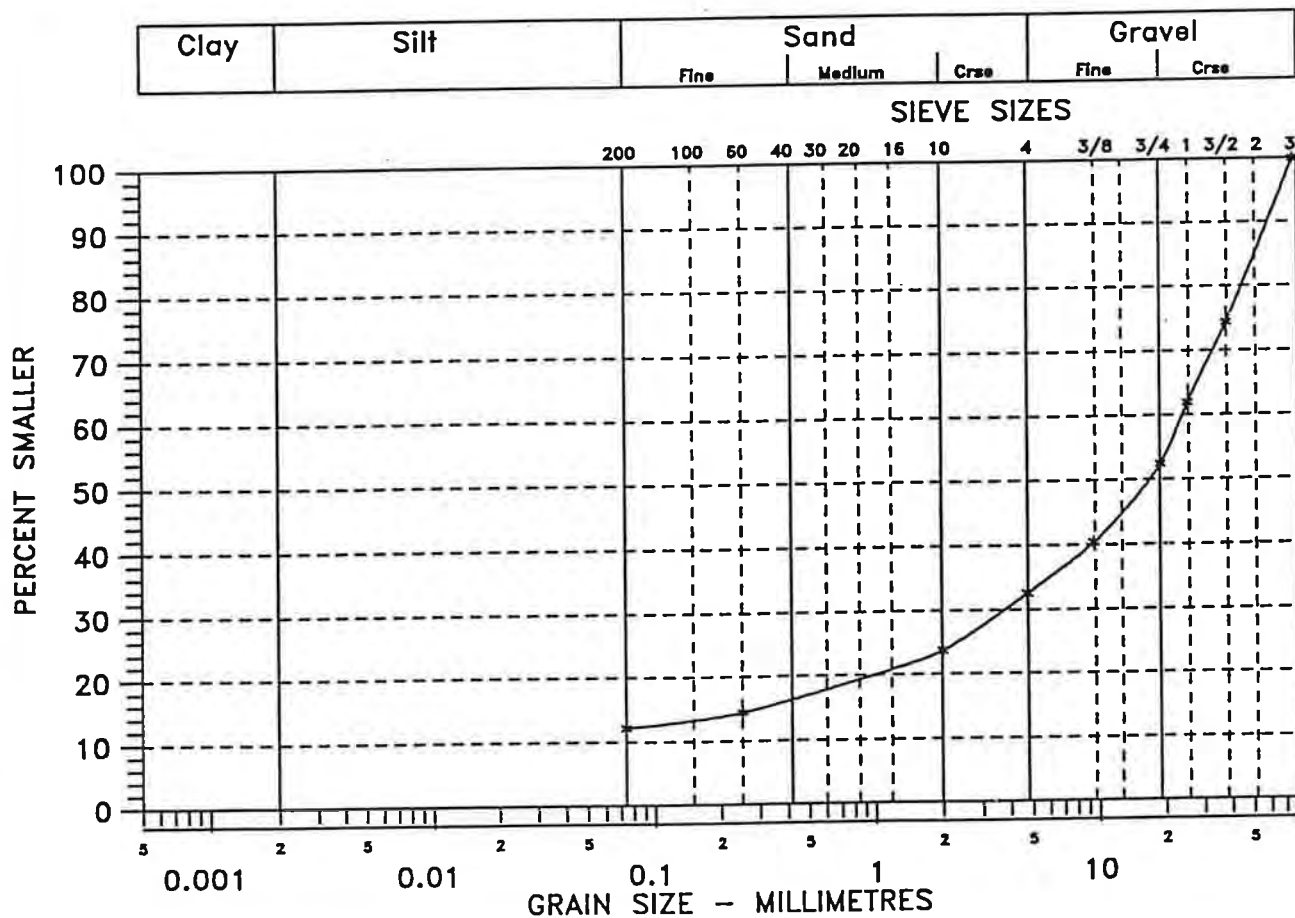
## GRAIN SIZE DISTRIBUTION

Project: Hidden Valley Landfill Closure  
 Client: Emcon Northwest  
 Project Number: 90113  
 Date Tested: 9/2/92  
 Remarks: Light brown, sandy, silty  
GRAVEL (GM)  
PERMEABILITY: K= 1.9x10<sup>-2</sup> cm/sec

Test Hole Number: --  
 Sample Number: VEG-3  
 Depth: --  
 Sample Description:  
 Gravel: 67.5  
 Sand: 20.3  
 Silt: 12.2  
 Clay: ---

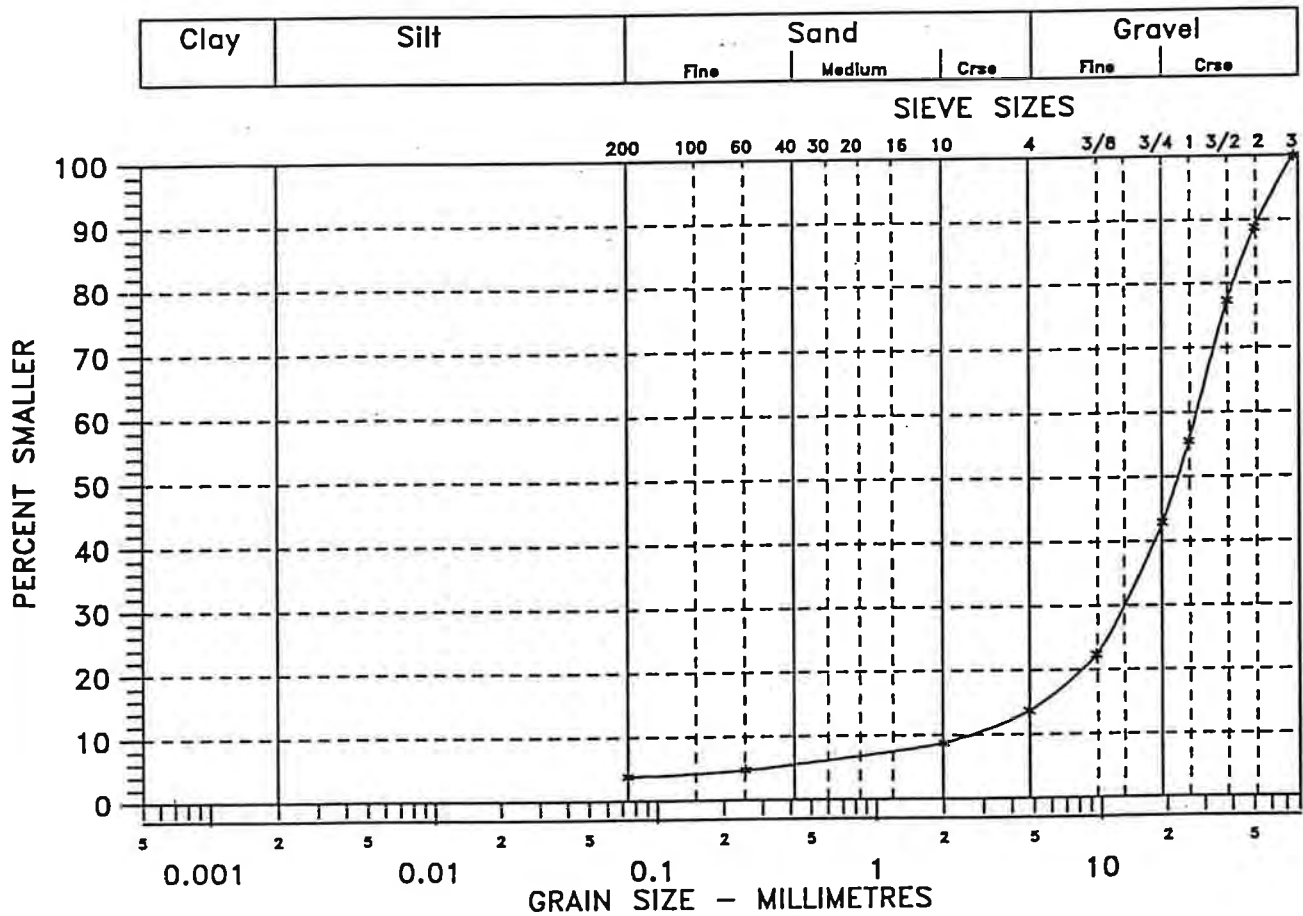
# HONG WEST & ASSOCIATES GRAIN SIZE DISTRIBUTION

Project: Hidden Valley Landfill Closure  
 Client: Emcon Northwest  
 Project Number: 90113  
 Date Tested: 9/3/92  
 Remarks: Grayish brown GRAVEL with some sand  
           and trace of silt (GW)

Test Hole Number: ---  
 Sample Number: VEG-4  
 Depth: ---  
 Sample Description:  
 Gravel: 86.3  
 Sand: 9.9  
 Silt: 3.8  
 Clay: ---

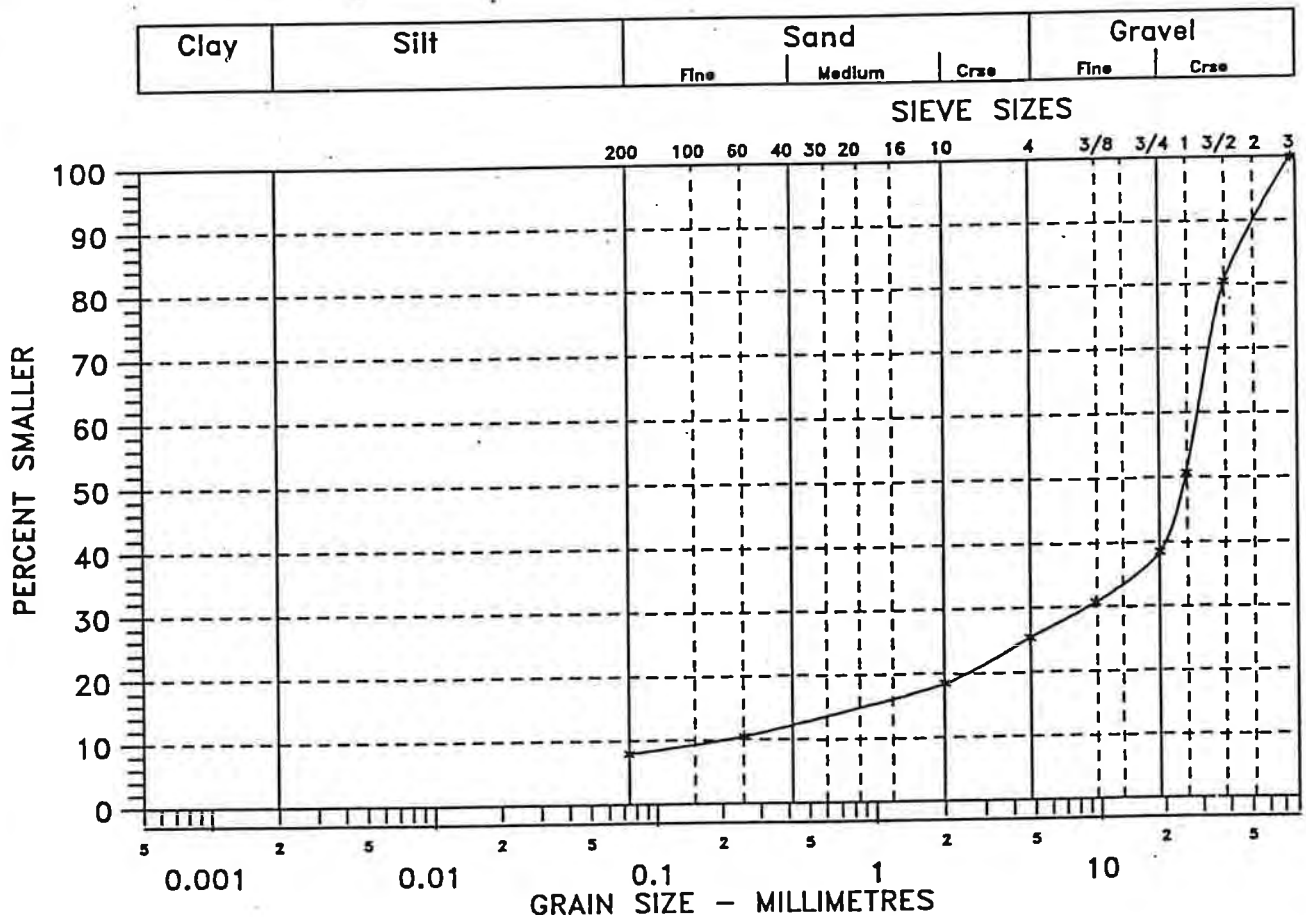
# HONG WEST & ASSOCIATES GRAIN SIZE DISTRIBUTION

Project: Hidden Valley Landfill Closure  
 Client: Emcon Northwest  
 Project Number: 90113  
 Date Tested: 8/28/92  
 Remarks: Yellowish brown, sandy GRAVEL  
with some silt (GW-GM)

Test Hole Number: --  
 Sample Number: VEG-5  
 Depth: --  
 Sample Description:  
 Gravel: 74.7  
 Sand: 17.3  
 Silt: 8.0  
 Clay: --

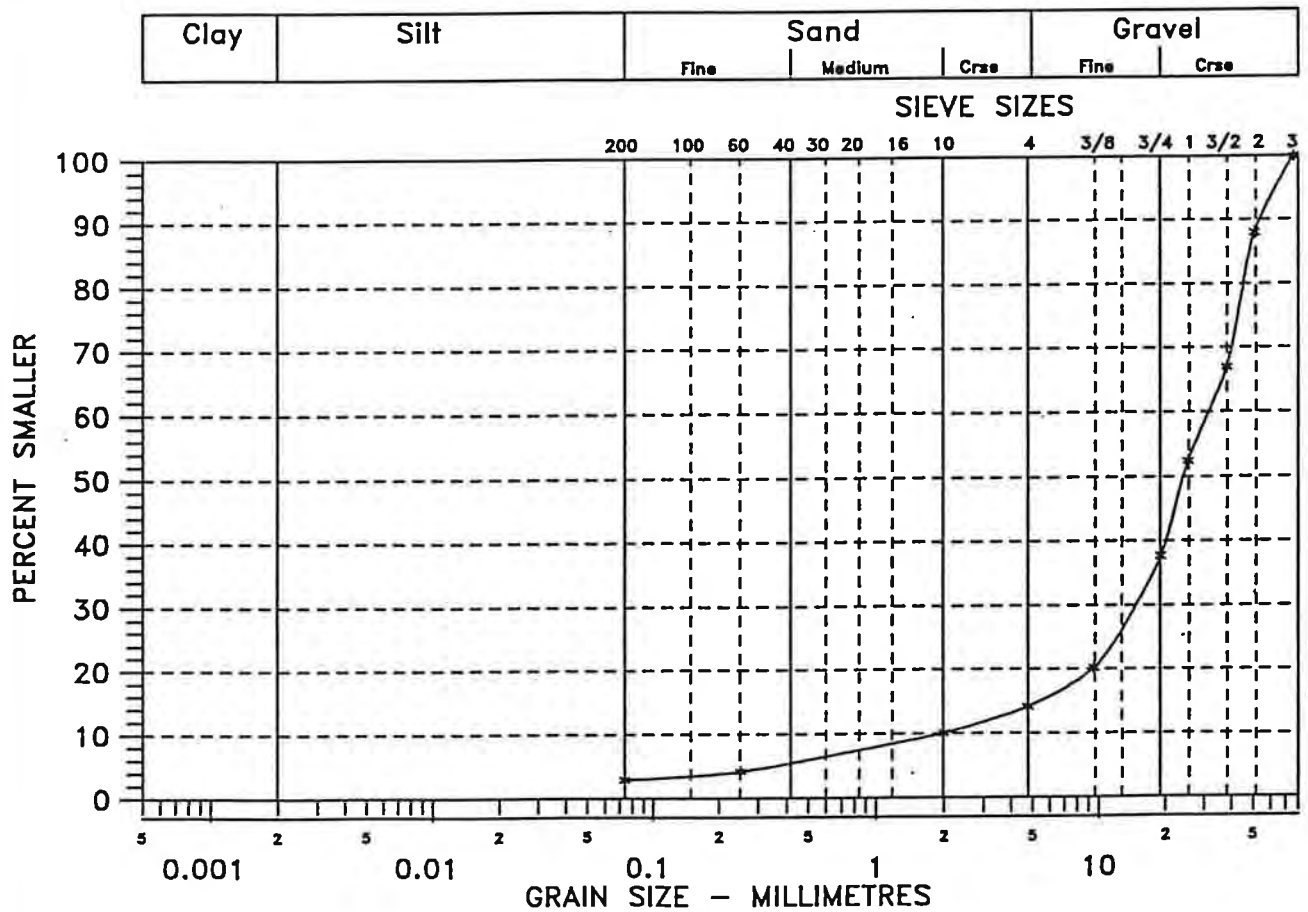
# HONG WEST & ASSOCIATES GRAIN SIZE DISTRIBUTION

Project: Hidden Valley Landfill Closure  
 Client: Emcon Northwest  
 Project Number: 90113  
 Date Tested: 9/3/92  
 Remarks: Brown GRAVEL with some sand  
and trace of silt (GP)

Test Hole Number: --  
 Sample Number: VEG-6  
 Depth: --  
 Sample Description:  
 Gravel: 85.9  
 Sand: 11.2  
 Silt: 2.9  
 Clay: ---
