Monthly Progress Report

Re: Former Reynolds Metals Remediation – Monthly Progress Report, May 2023

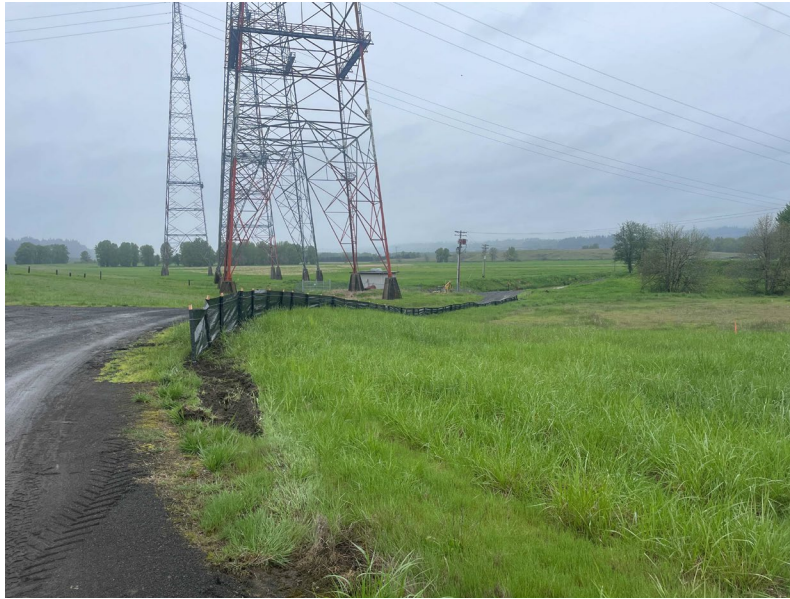
Photograph 1
West Landfill (SU2) South Side

Envirocon installed silt fence along West Landfill perimeter (facing west).

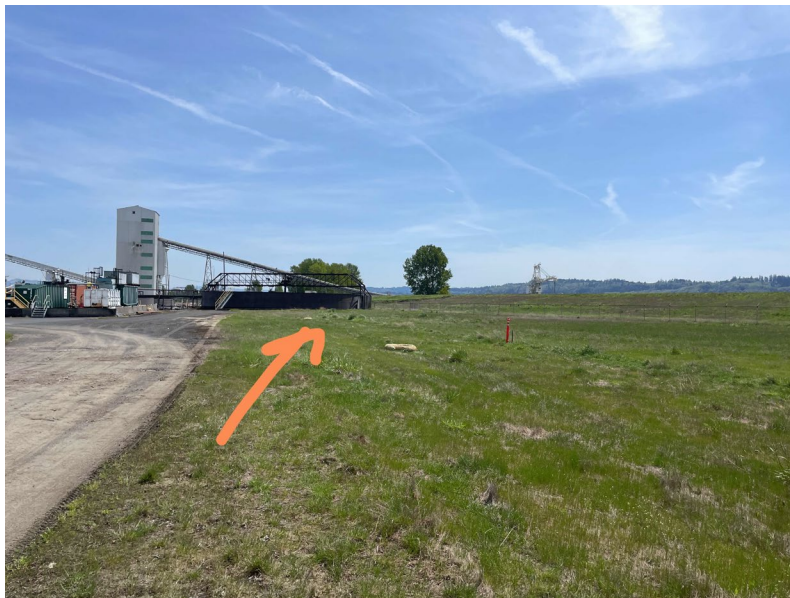
Photograph 2
Facility 73

Envirocon, Inc. (Envirocon), installed additional stormwater inlet protection wattles in grass field adjacent to Facility 73 and Facility 77 (facing southeast).

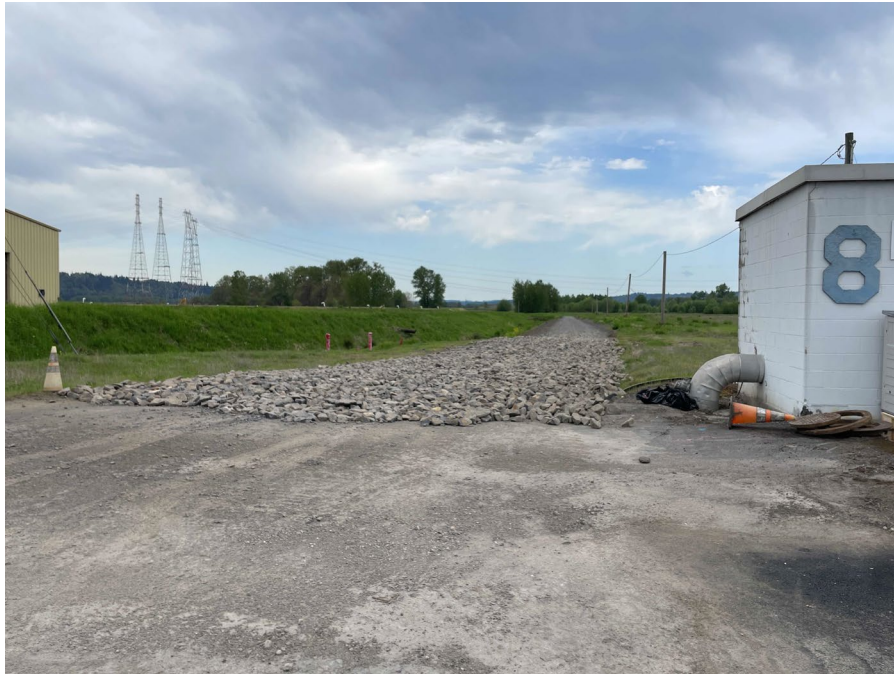
Photograph 3
Staging Area West

Envirocon constructed access road to West Landfill and U-ditch (facing northwest).

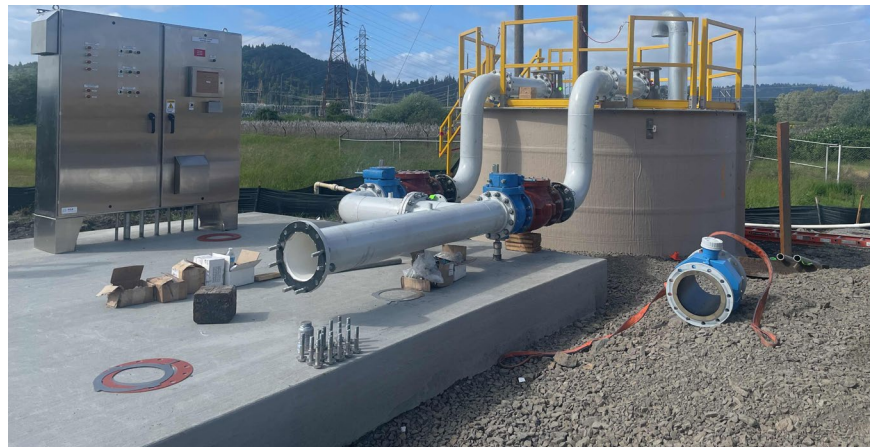
Photograph 4
East Landfill No. 1 – Force Main

Catworks Construction (Catworks), installed East Landfill No. 1 Pump Station wet well, piping, and flow meters (facing northwest).

- Prior to installation of the wet well, subgrade was excavated an additional 2 feet and backfilled with quarry spalls to increase strength and stability.

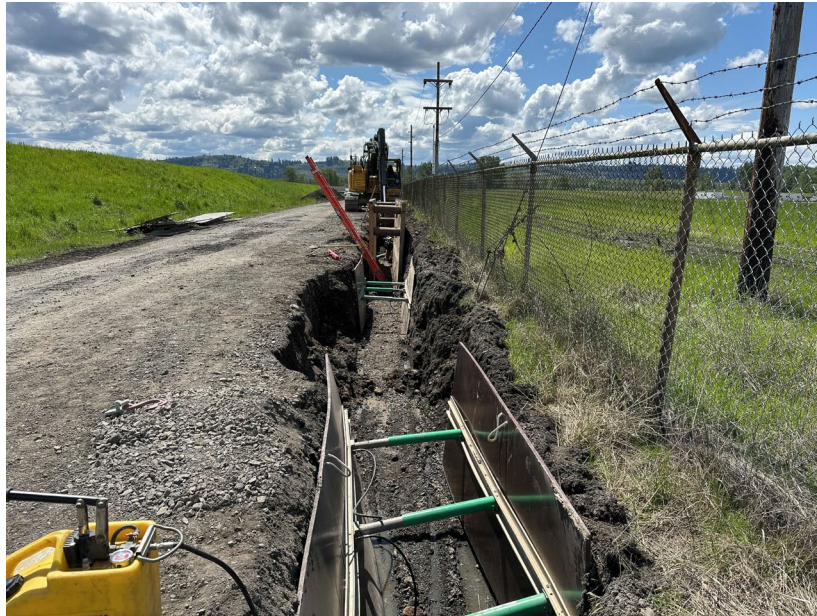
Photograph 5
East Force Main Trenching

Catworks trenching for installation of east force main piping along Berth Road (facing southwest).

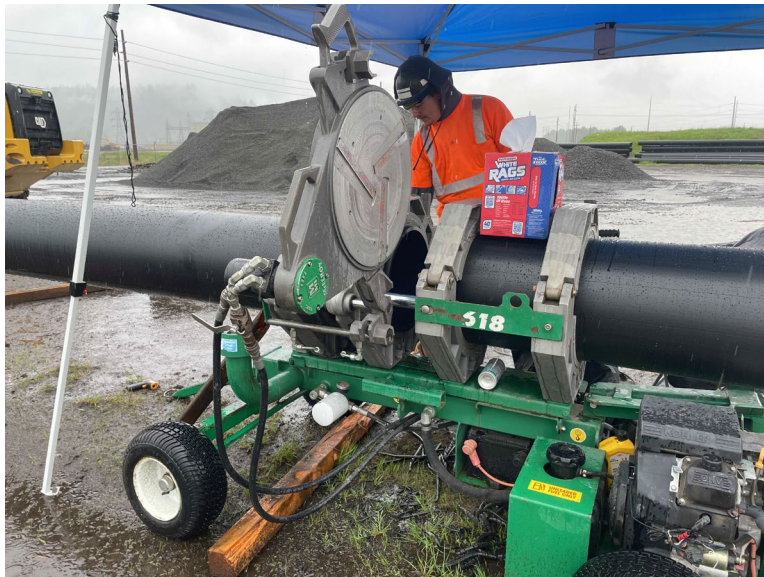
Photograph 6
East Force Main – HDPE Pipe Fusing

Fusing of east force main HDPE piping joints.

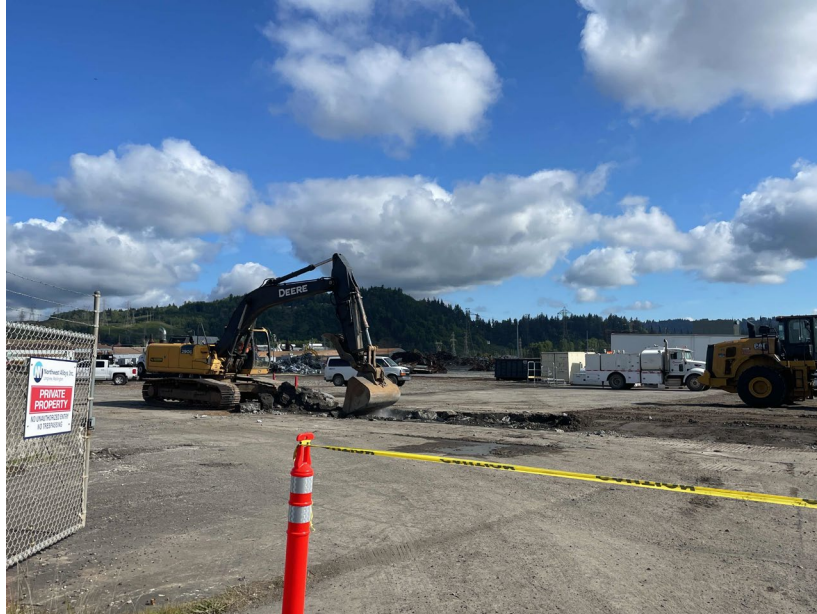
Photograph 7
East Force Main Pipe Trenching

Envirocon removed surficial concrete in preparation for east force main piping installation (facing north).

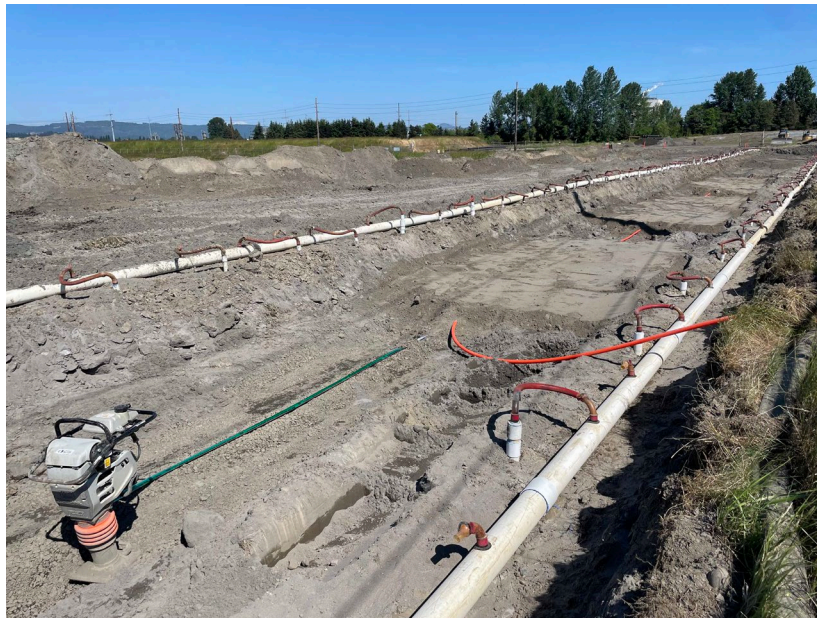
Photograph 8
East Force Main Trench Dewatering

Envirocon installed dewatering wells adjacent to SU5 for trench to facilitate force main piping installation (facing east).

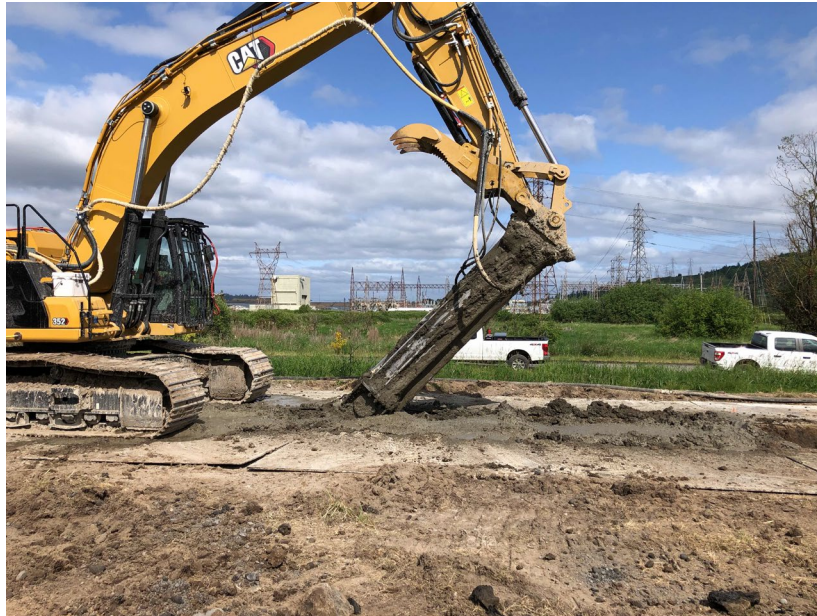
Photograph 9
East Landfill No.1 – Ground Improvements

Keller Management Services, LLC, continued East Landfill No.1 ground improvements (facing northwest).

- Ecology was provided email updates on the progress of the ground improvement on May 9, May 21, and May 31, 2023. These emails communicated that the original testing performed between STA 5+00 and STA 6+00 did not meet UC strength requirements and alternatives tests were planned. On May 25 and 26, Keller completed two tests—the first, using dry quicklime followed by the original cement slurry mixture; the second, using a revised wet mix that replaced 75% of the Portland cement with Terraflow 75 (a recycled slag material). The lime amendment approach was difficult to implement and did not meet specifications. The Terraflow amendment performed well, and UC tests exceeded the 28-day strength requirement of 35 pounds per square inch after 4 days. Ecology approved use of the Terraflow amendment via email on June 2, 2023.

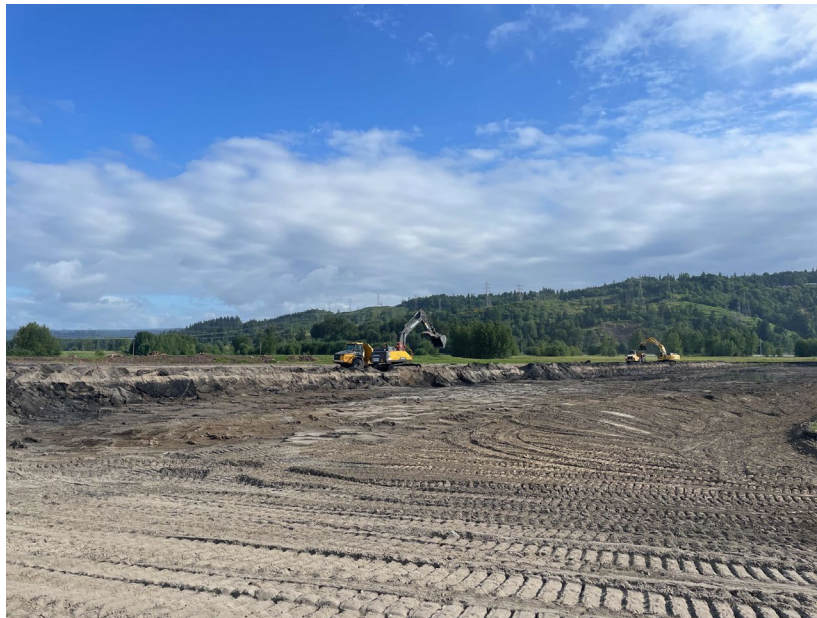
Photograph 10
West Landfill Consolidation

Envirocon continued to consolidate SU1 and SU2 waste material (facing north). Control surveys were conducted throughout activities.

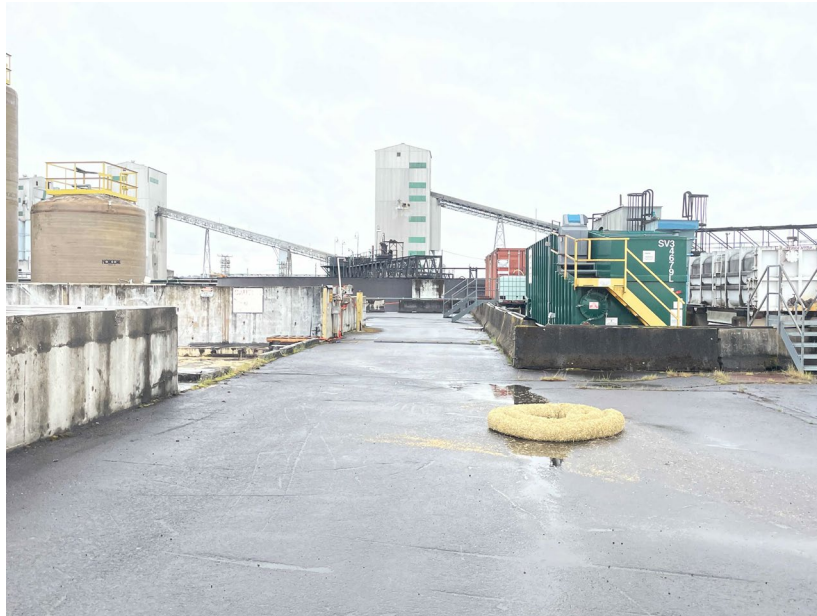
Photograph 11
Stormwater Inlet Protection

Envirocon installed stormwater inlet protection near Facility 71 (facing southeast).

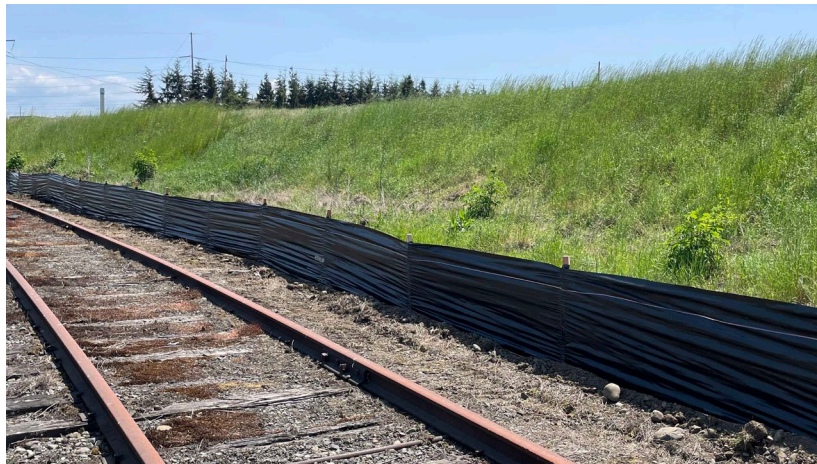
Photograph 12
East Landfill No. 2 TESC Installation

Envirocon installed silt fence around northern perimeter of East Landfill No. 2 (facing southeast).

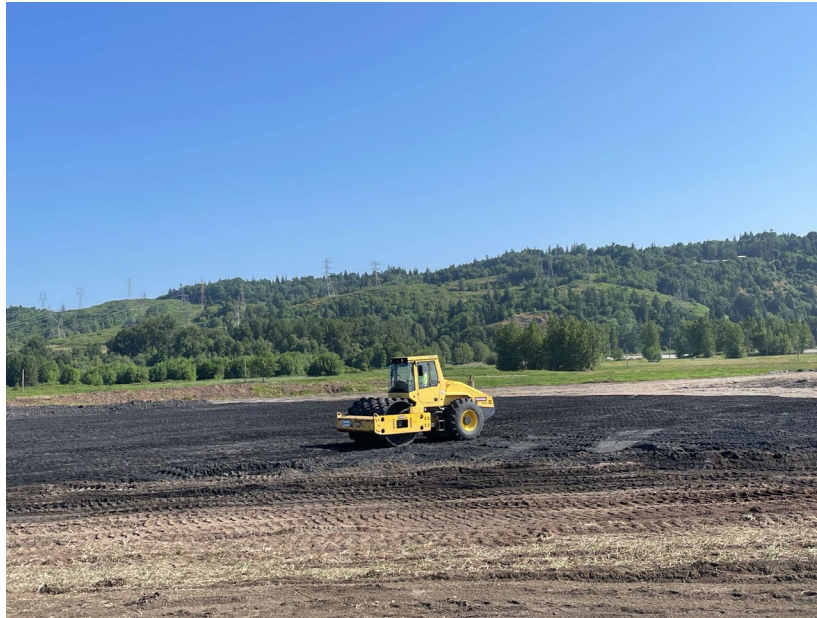
Photograph 13
West Landfill – Compaction

Envirocon roll compacting West Landfill (facing northeast).
