Sumner Auto Repair Petrosave

SHARP Report — Part 1 of 2

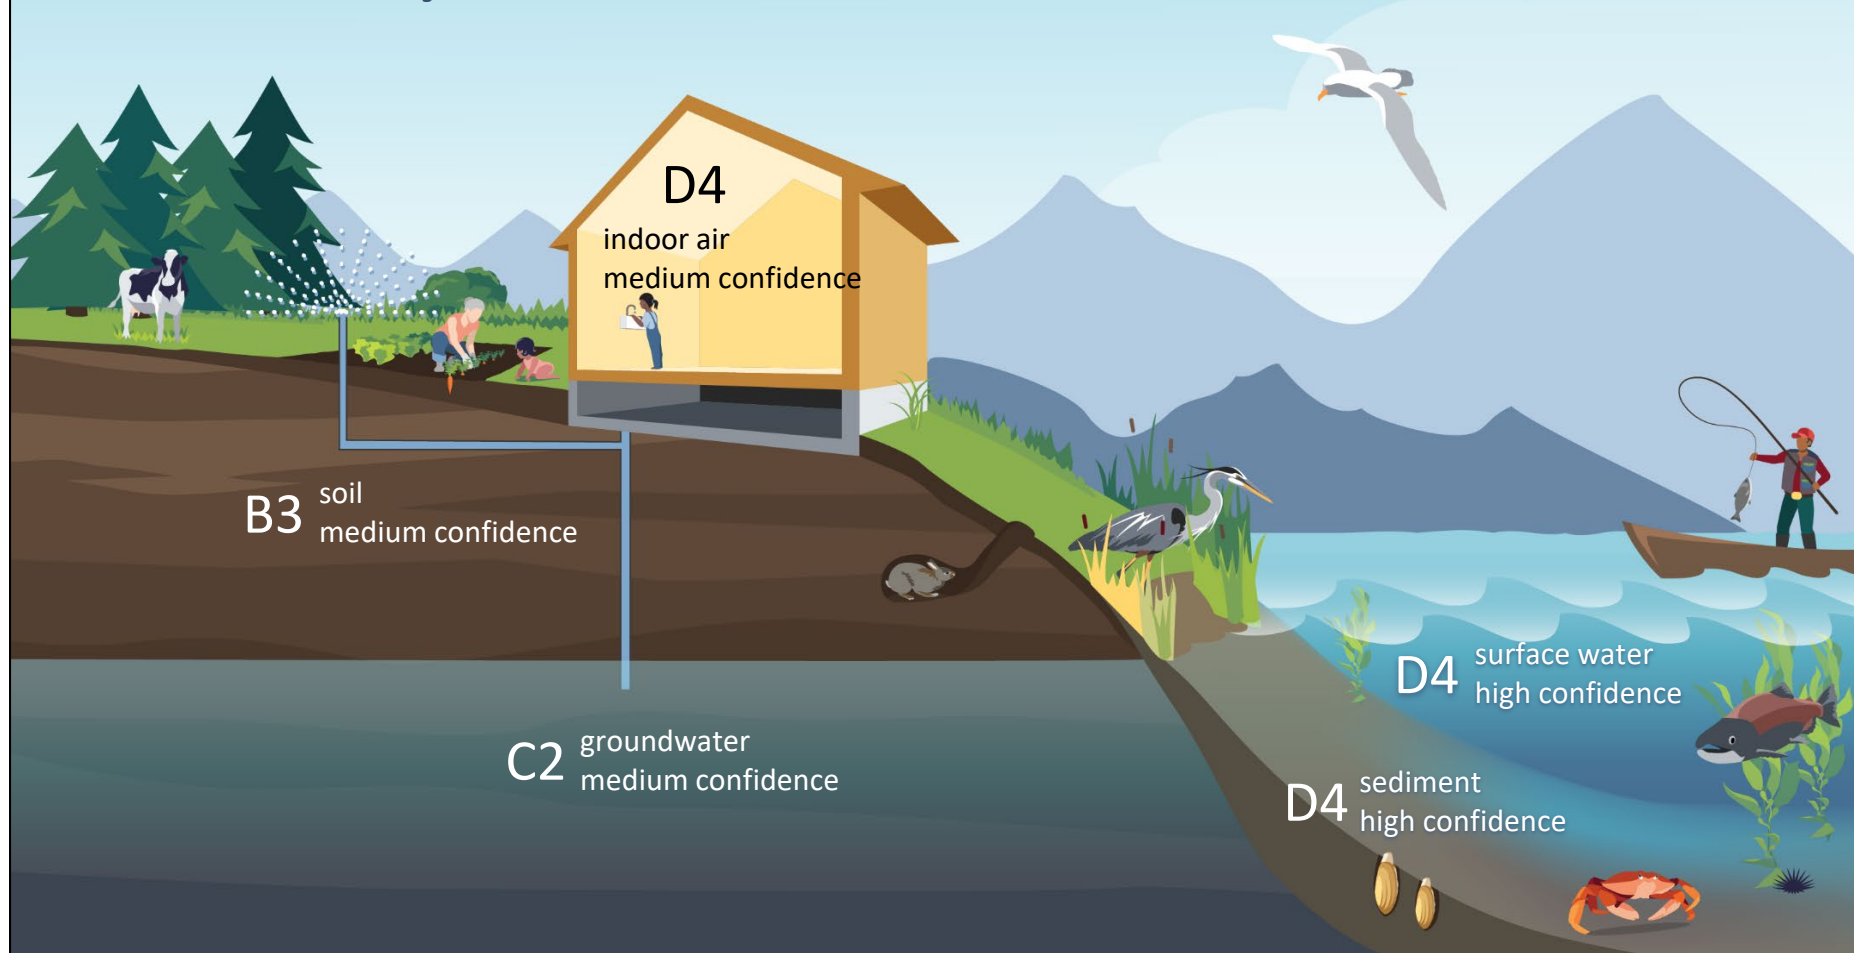
Assessment scores by environmental medium

SHARP Media	Scores	Confidence	Additional Factors	
Indoor air	D4	medium	multiple chemical types	⊗
Groundwater	C2	medium	risk to off-site people	⊗
Surface water	D4	high	climate change impacts	⊗
Sediment	D4	high	plant/animal tissue data	⊗
Soil	B3	medium
