Technical Memorandum

RE: Updated Conceptual Site Model – Upland Soils/Site Definition Jeld Wen Site, Everett, WA (CSID:4402), Facility Site ID: 2757

REVISED CONCEPTUAL SITE MODEL - UPLAND SOILS

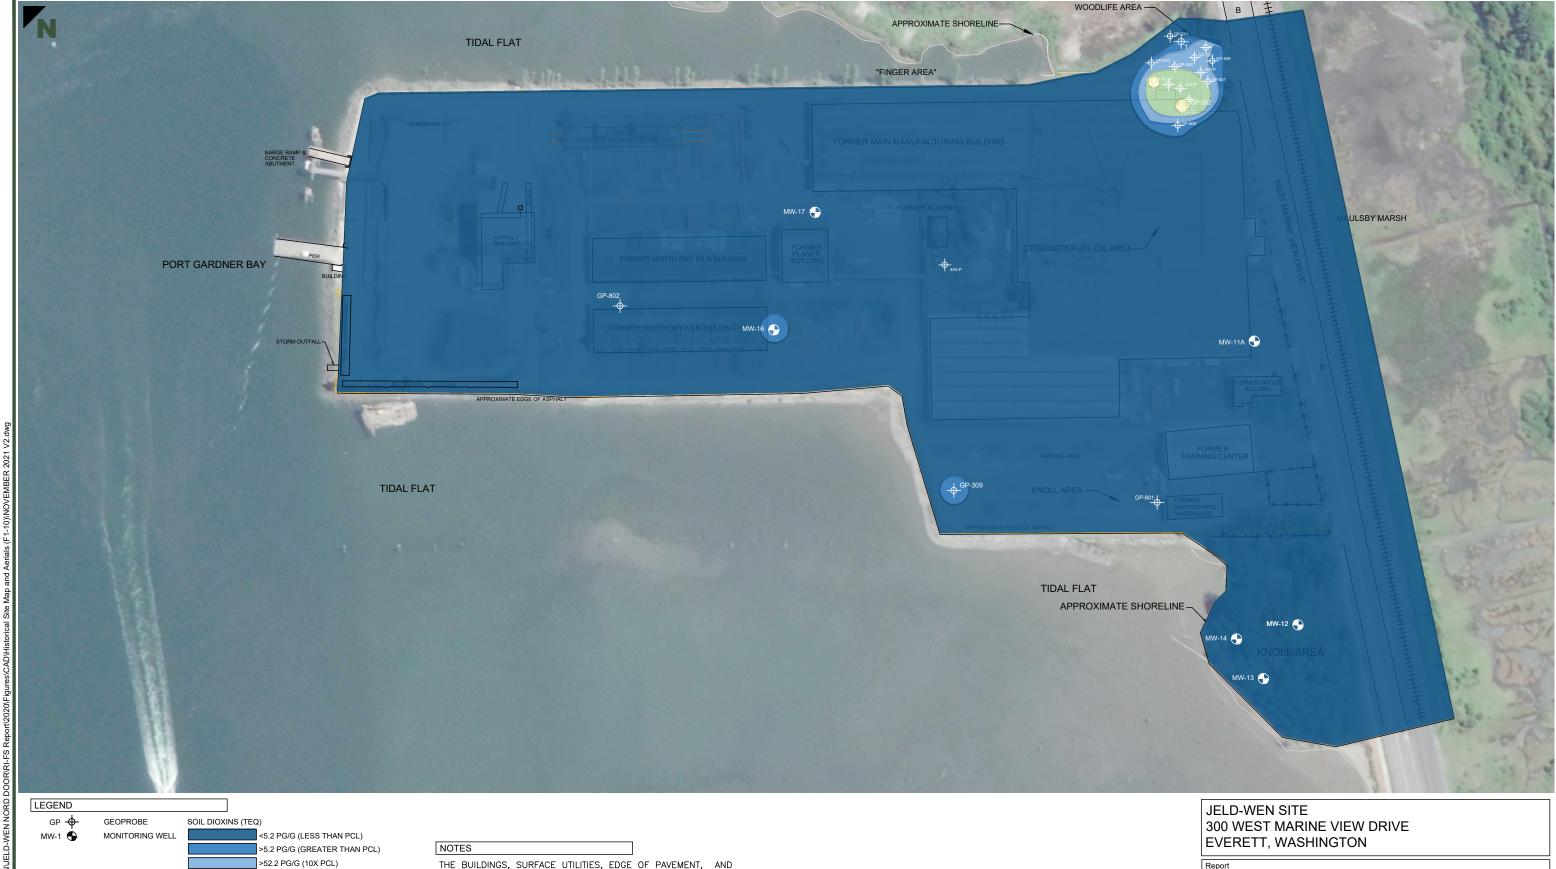
>522 PG/G (100X PCL)

>5,220 PG/G (1,000X PCL)

FIGURE FROM AUGUST 2023 CAP

INDICATOR HAZARDOUS SUBSTANCE PCL EXCEEDANCES - DIOXINS (TEQ) IN SOIL
