**PORT OF FRIDAY HARBOR
ALBERT JENSEN AND SONS INC. BOATYARD AND MARINA
FRIDAY HARBOR, WA**

**MODEL TOXICS CONTROL ACT (MTCA)
AGREED ORDER No. DE 18071**

REMEDIAL INVESTIGATION REPORT – UPLAND AREA

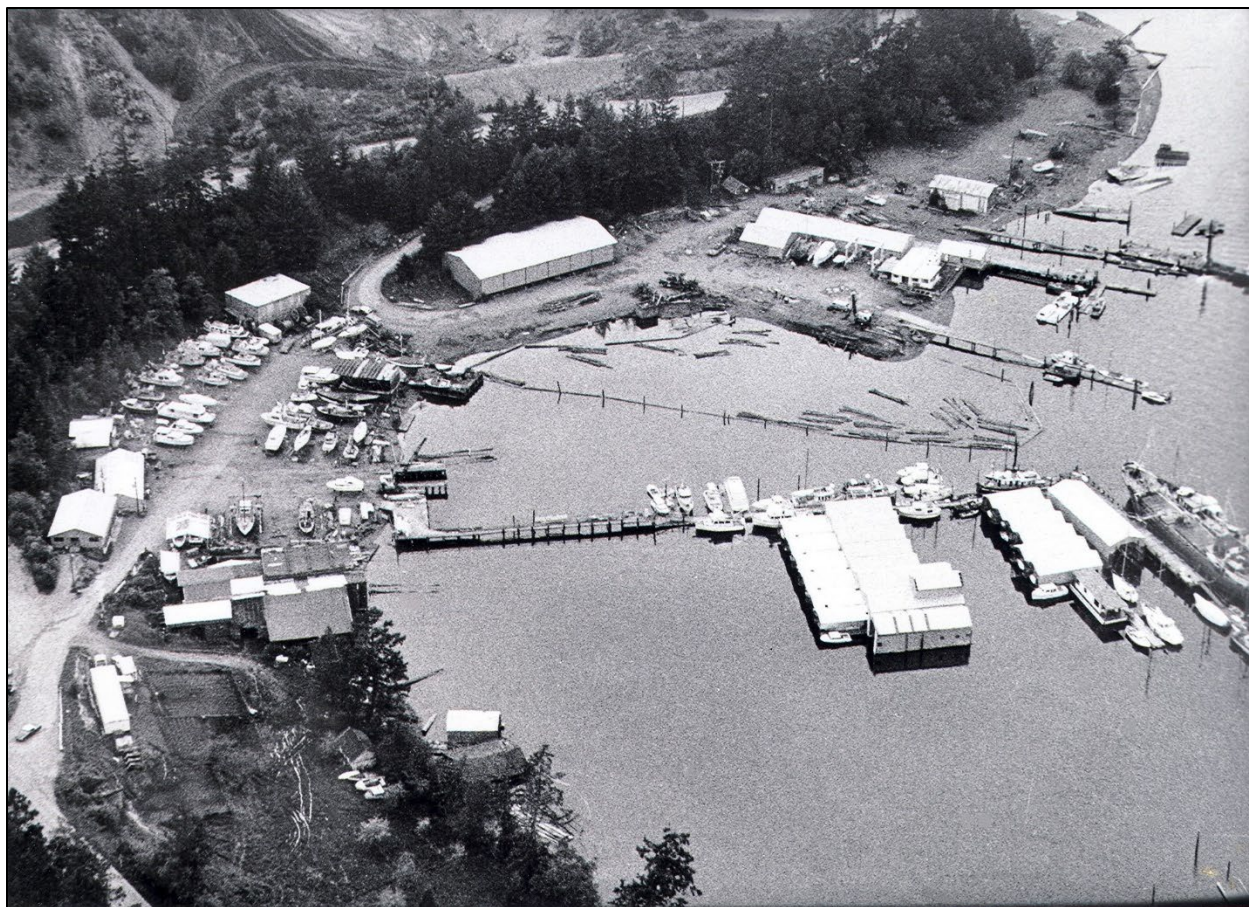
Figure 2-1. Overview of historic Site facility uses (Ecology 2024).

Images from the San Juan Historical Society which depict prior Site facilities are provided in Figures 2-1 and 2-2.

The undeveloped area also contains the remnants of a small derelict cabin (Figure 2-1), a small oil storage building further east, and a shallow dug well. An underground storage tank was formerly located in the field south of the oil storage building. The upper shoreline area appears to be composed of upland fill material and garbage (metal, plastic, concrete, wood waste, etc.), which is consistent with historical descriptions of the area being used as a dump. The garbage and fill material from the upper shoreline are emerging from the bank as it descends to upper intertidal elevations. There appears to be a remnant shoreline timber (some treated) structure, possibly an old pier or ramp, which has left a debris pile extending from the upper shoreline down to intertidal elevations. These observations are generally consistent with the images Ecology obtained from the San Juan Historical Society, which are provided as Figures 2-1 and 2-2 (Ecology 2024).

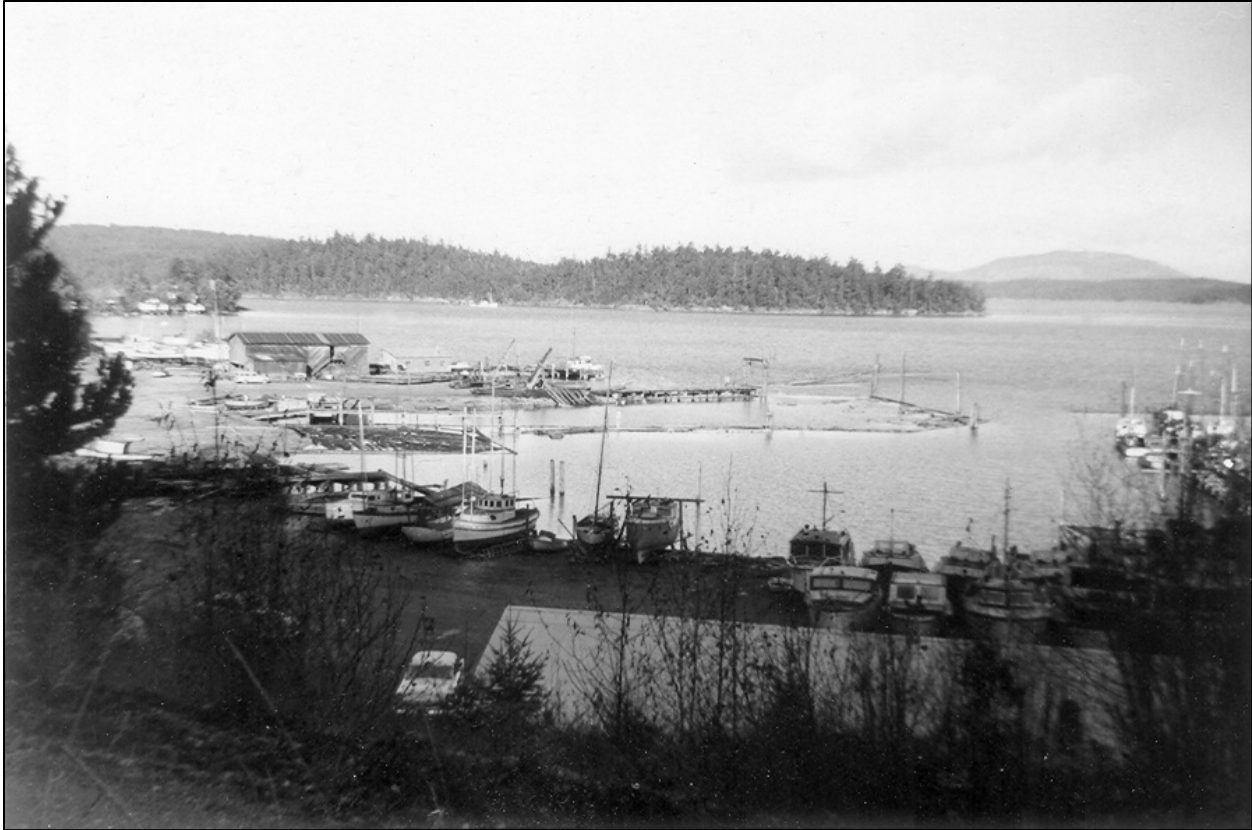
Figure 2-2. Prior Site facility uses, facing north, looking over Shipyard Cove (Ecology 2024).
