Block 79 East

SHARP Report — Part 1 of 2

701 9th Ave N , Seattle, King County, 98109

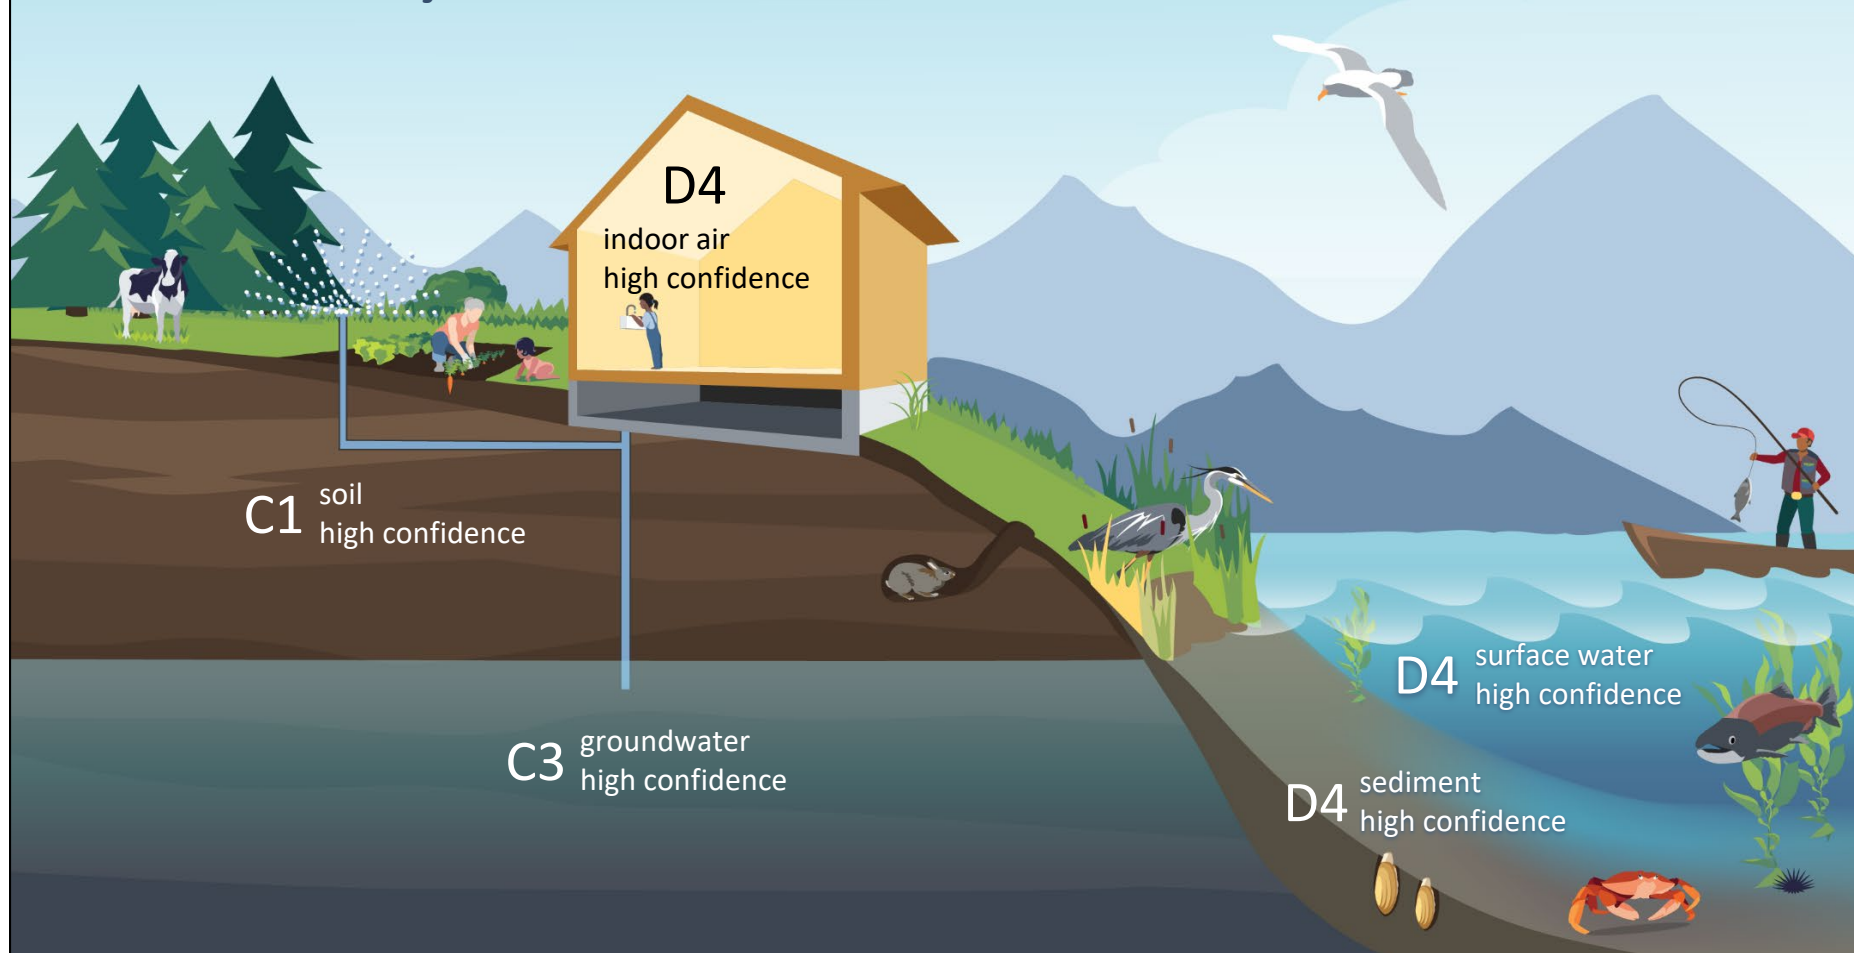
Conceptual site model

Assessment scores by environmental medium

SHARP Media	Scores	Confidence	Additional Factors	
Indoor air	D4	high	multiple chemical types	✓
Groundwater	C3	high	risk to off-site people	⊘
Surface water	D4	high	climate change impacts	⊘
Sediment	D4	high	plant/animal tissue data	⊘
Soil	C1	high
