CLEANUP ACTION PLAN

Texaco Strickland Site

Project No. 180357 • August 4, 2025 PUBLIC REVIEW DRAFT

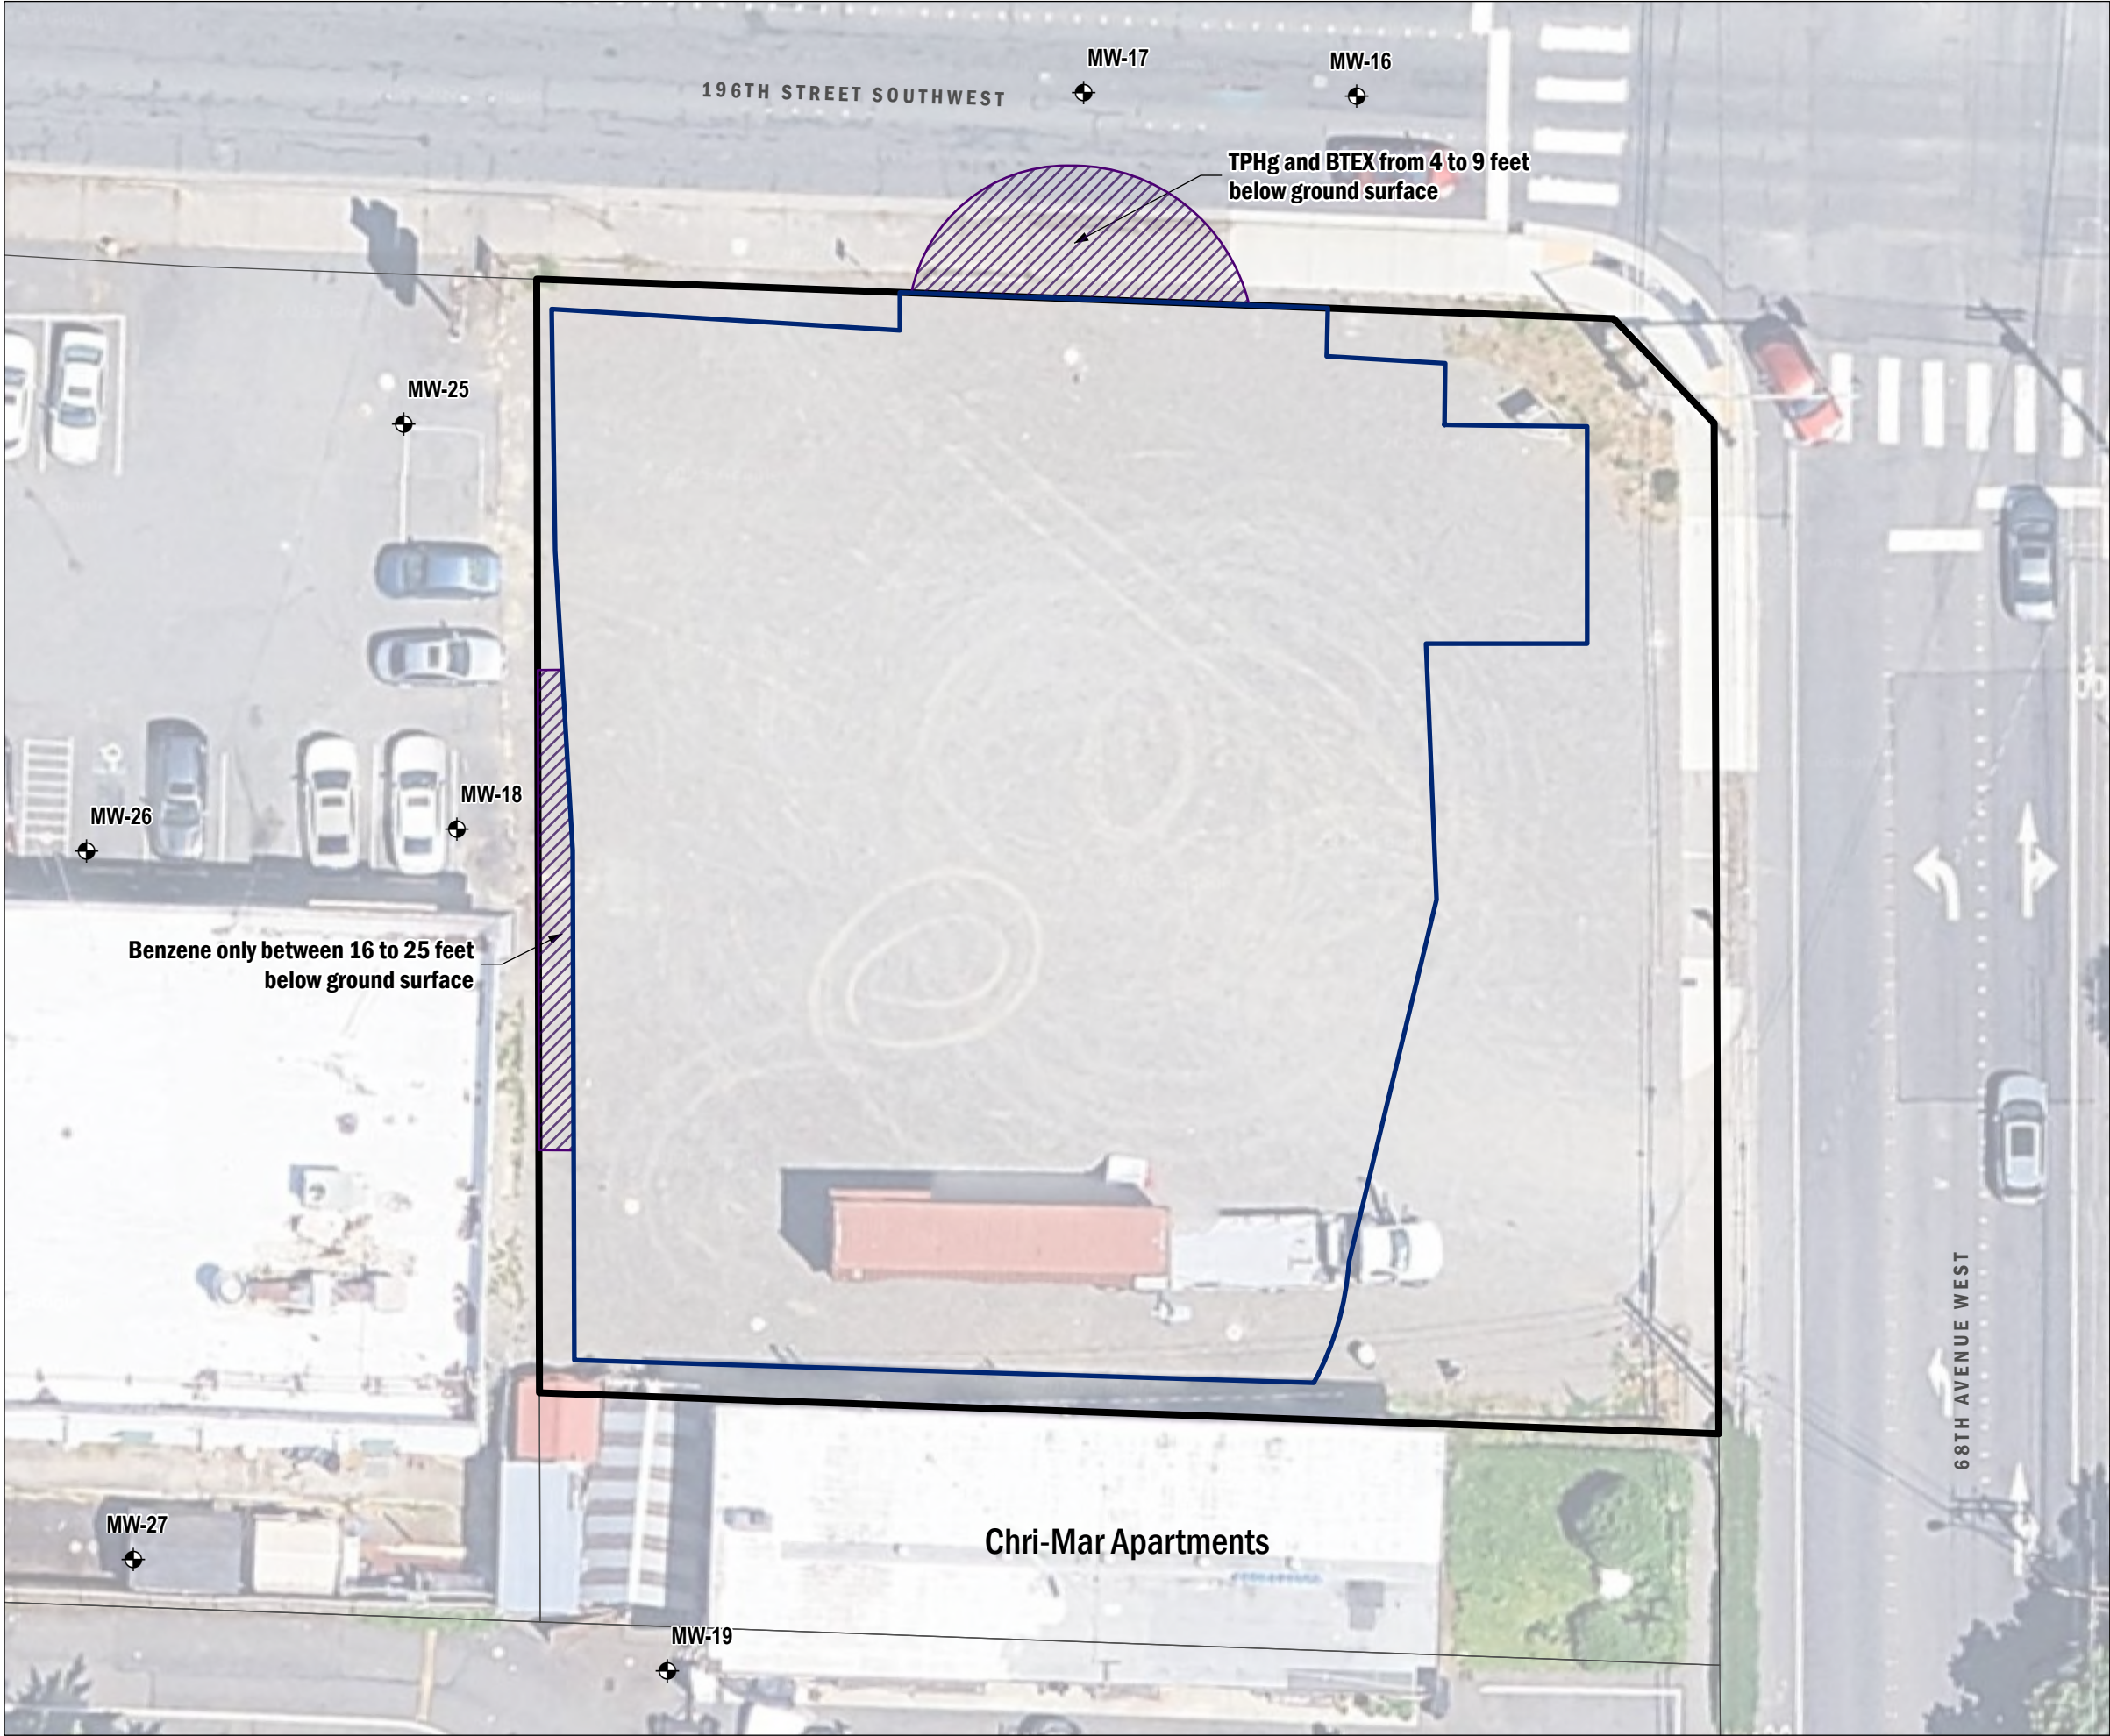
FIGURE NO.
2

- Existing Monitoring Well
- Extents of Soil Exceeding Cleanup Levels
- Previous Interim Action Excavation Area
- Property Boundary
- Snohomish County Tax Parcel

A total of 14,437 tons of petroleum-contaminated soil was permanently removed from the Site and trucked to Cadman's Everett facility as Class III petroleum-contaminated soil for permitted treatment and disposal. The soil removal action was performed to a maximum depth of 28 feet (minimum Elevation 423 feet) and extended to the northern and western Property lines. The previously defined extent of light non-aqueous phase liquid (LNAPL, or free product) was completely removed from the Site. The extent of residual TPH-related impacts in soil exceeding MTCA Method A CULs is shown on Figure 2.

The extent of soil impacts is shown on Figure 2. Detailed analytical results were provided in the Interim Action Report (Aspect 2023b).

Following Interim Action cleanup activities, the only area of the Site not currently in compliance with these cleanup standards is the residual soil impacts in the public right-of-way to the north of the Property at a depth of approximately 4 to 9 feet bgs (Figure 2). Soil impacts remaining in the vadose zone (above the water table) in this area exceed unrestricted Method A CULs and pose a potential PVI risk for future redevelopment of the Property. Additionally, if the existing pavement cap is removed in the right-of-way, the residual impacts could pose a risk to construction workers through direct contact.
