**Figure 4. GRO and Benzene Concentrations in System Vapor Influent and Effluent**  
Second Quarter 2025 Remedial Progress Evaluation Report for Former Circle K 1461  
Seattle, WA

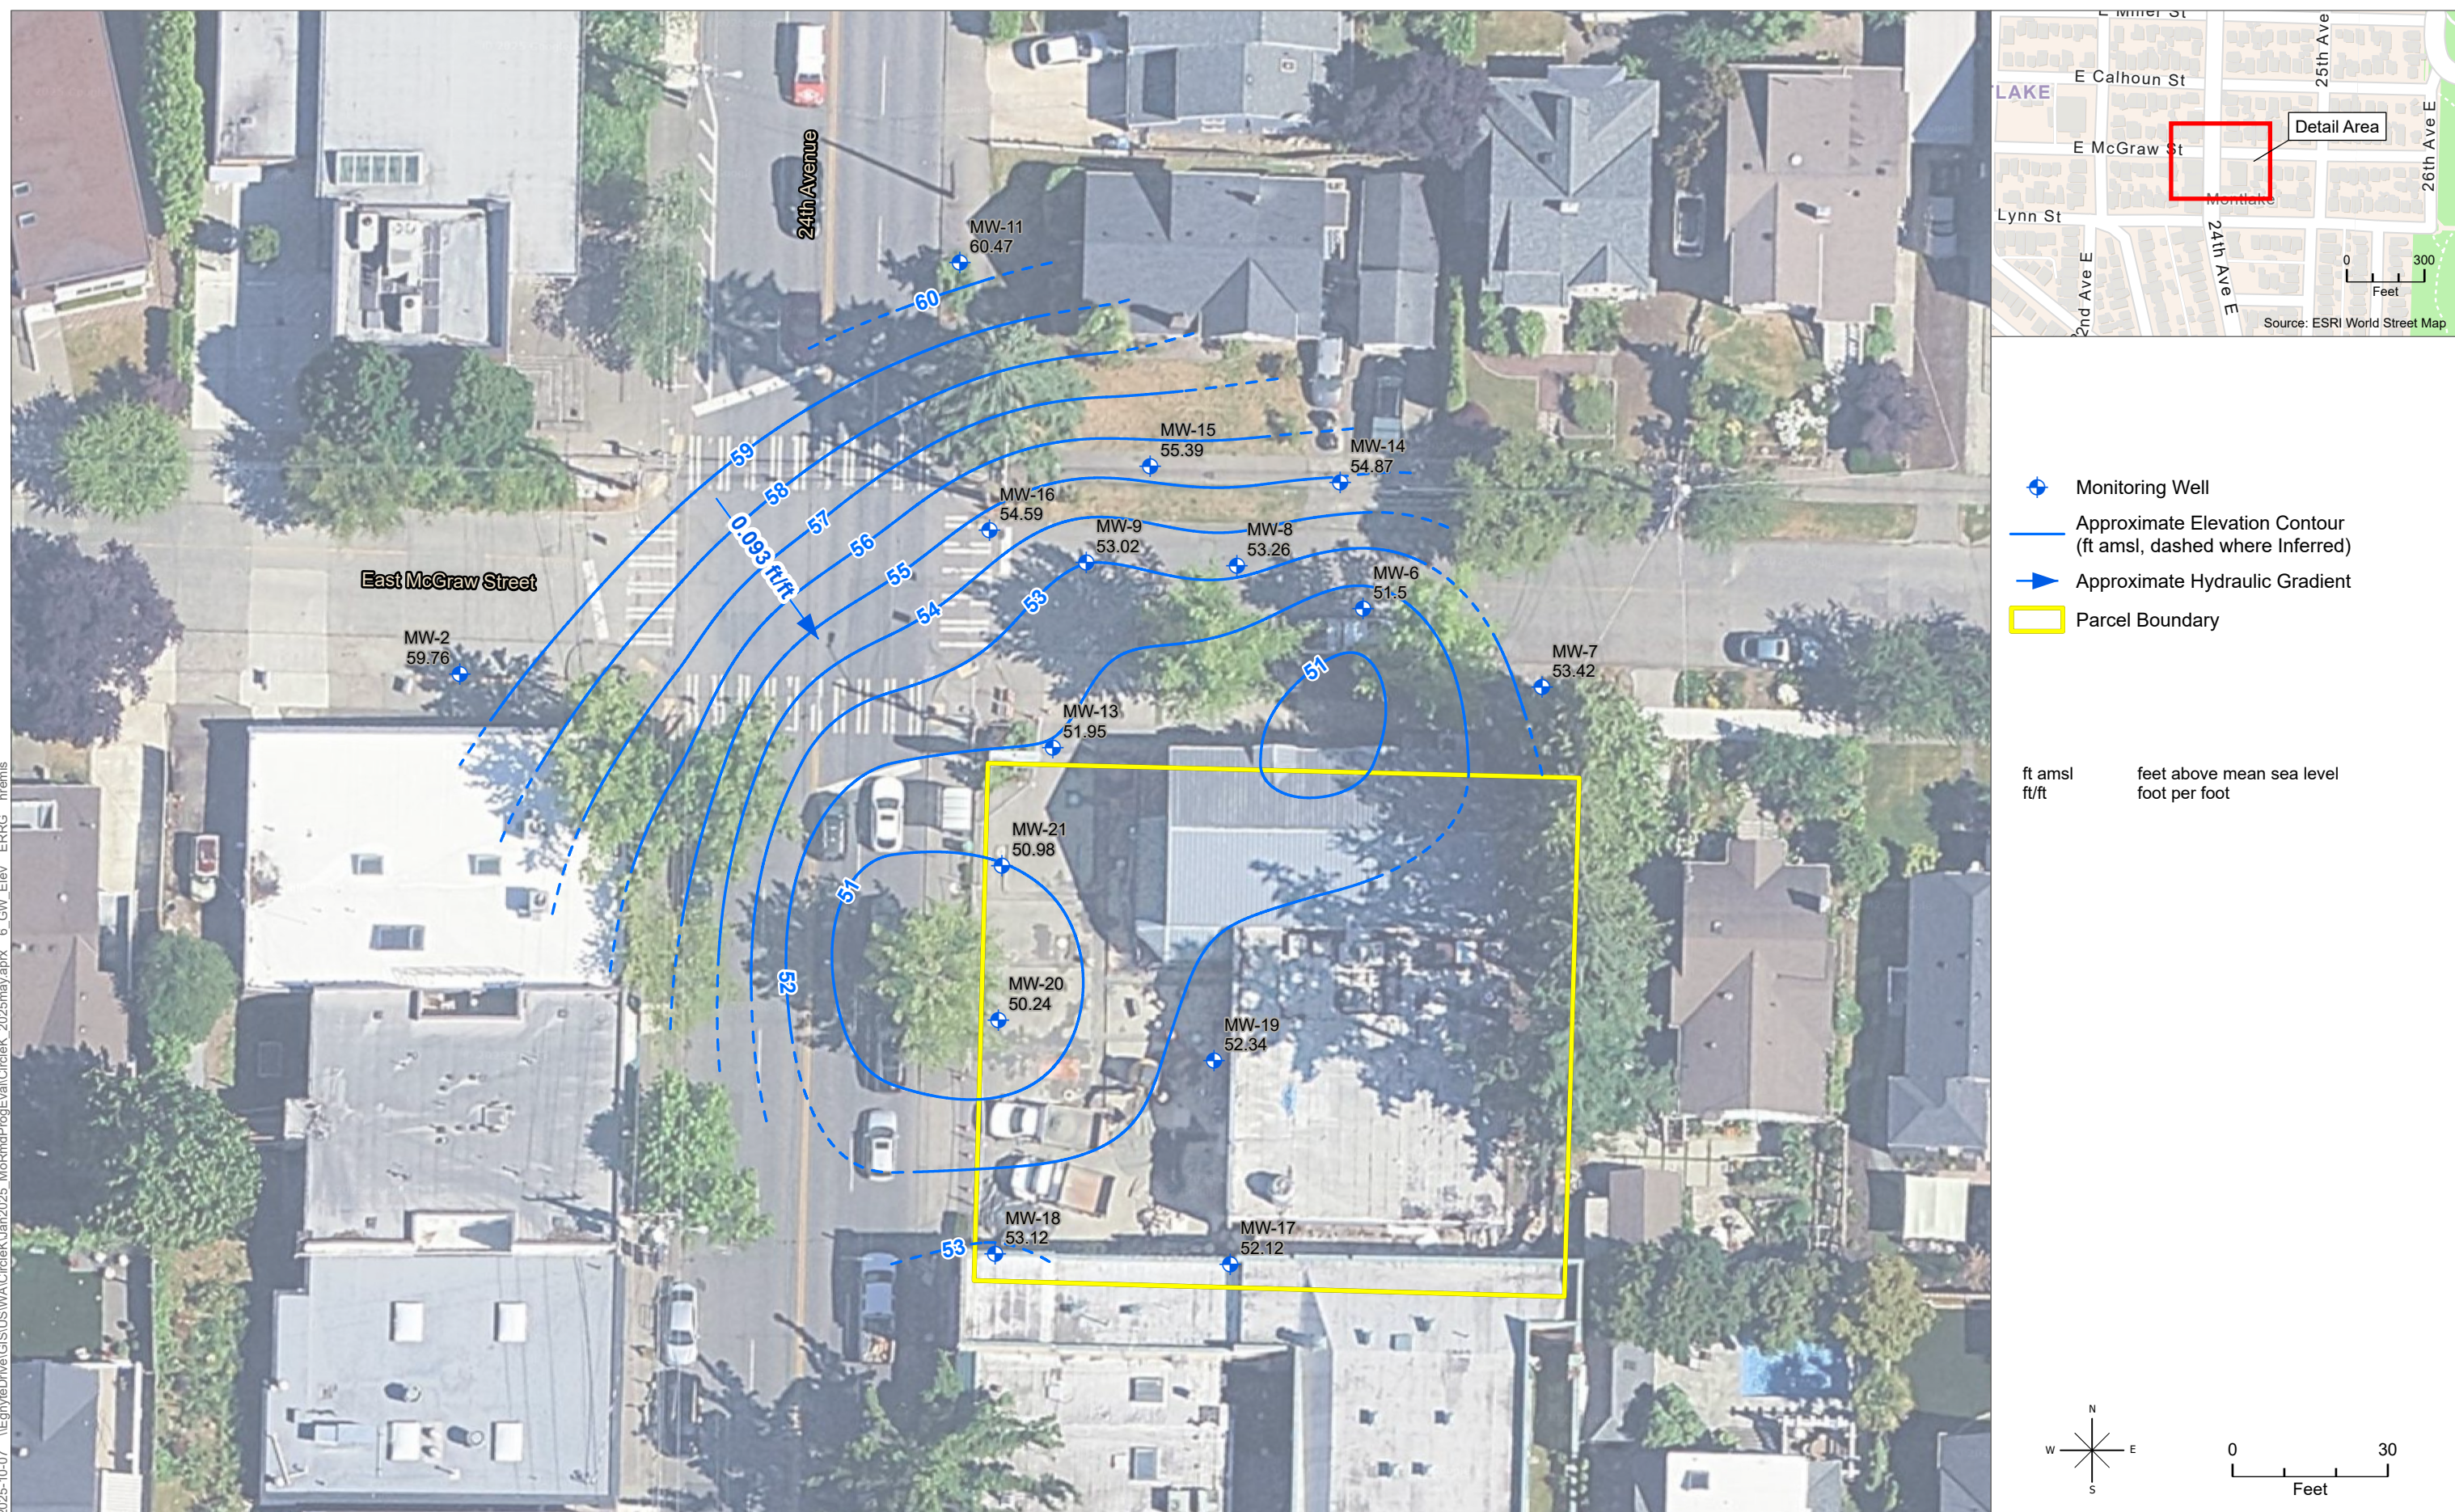
**Figure 6. Groundwater Elevation Contours, May 2025**  
Second Quarter 2025 Remedial Progress Evaluation Report for Former Circle K 1461  
Seattle, WA

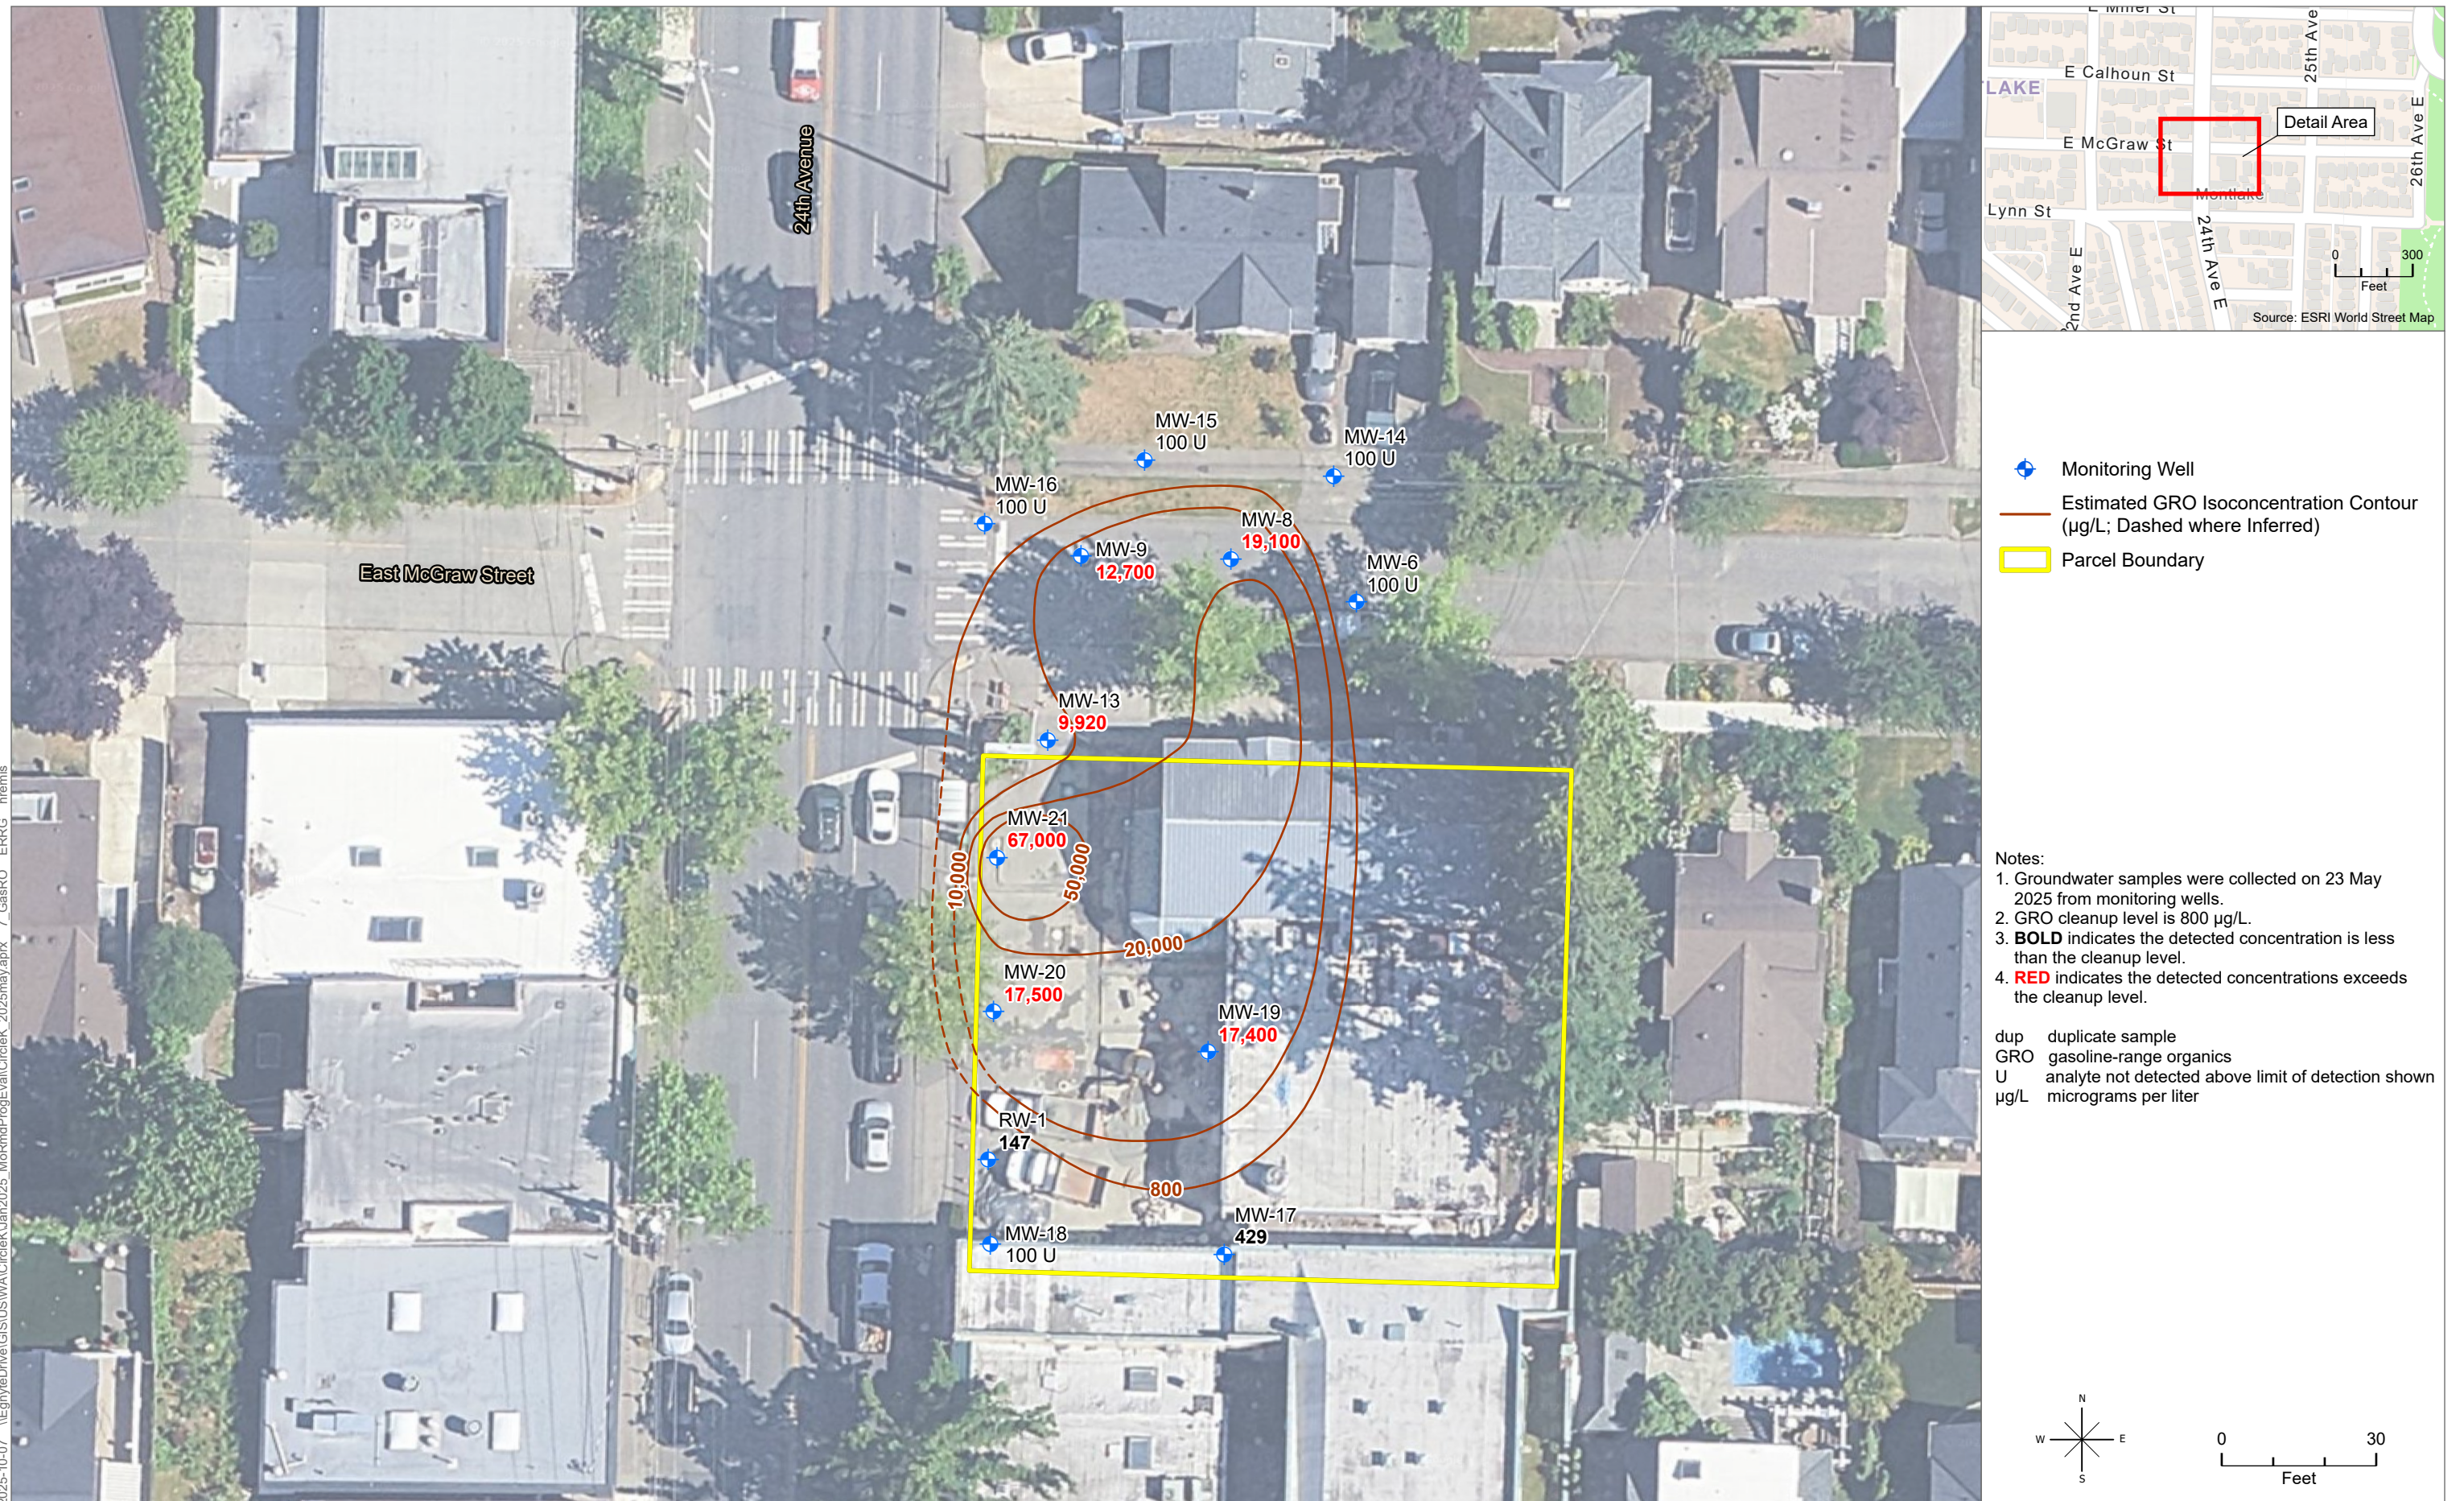
**Figure 7. Groundwater Gasoline-Range Organics Contours, May 2025**  
Second Quarter 2025 Remedial Progress Evaluation Report for Former Circle K 1461  
Seattle, WA

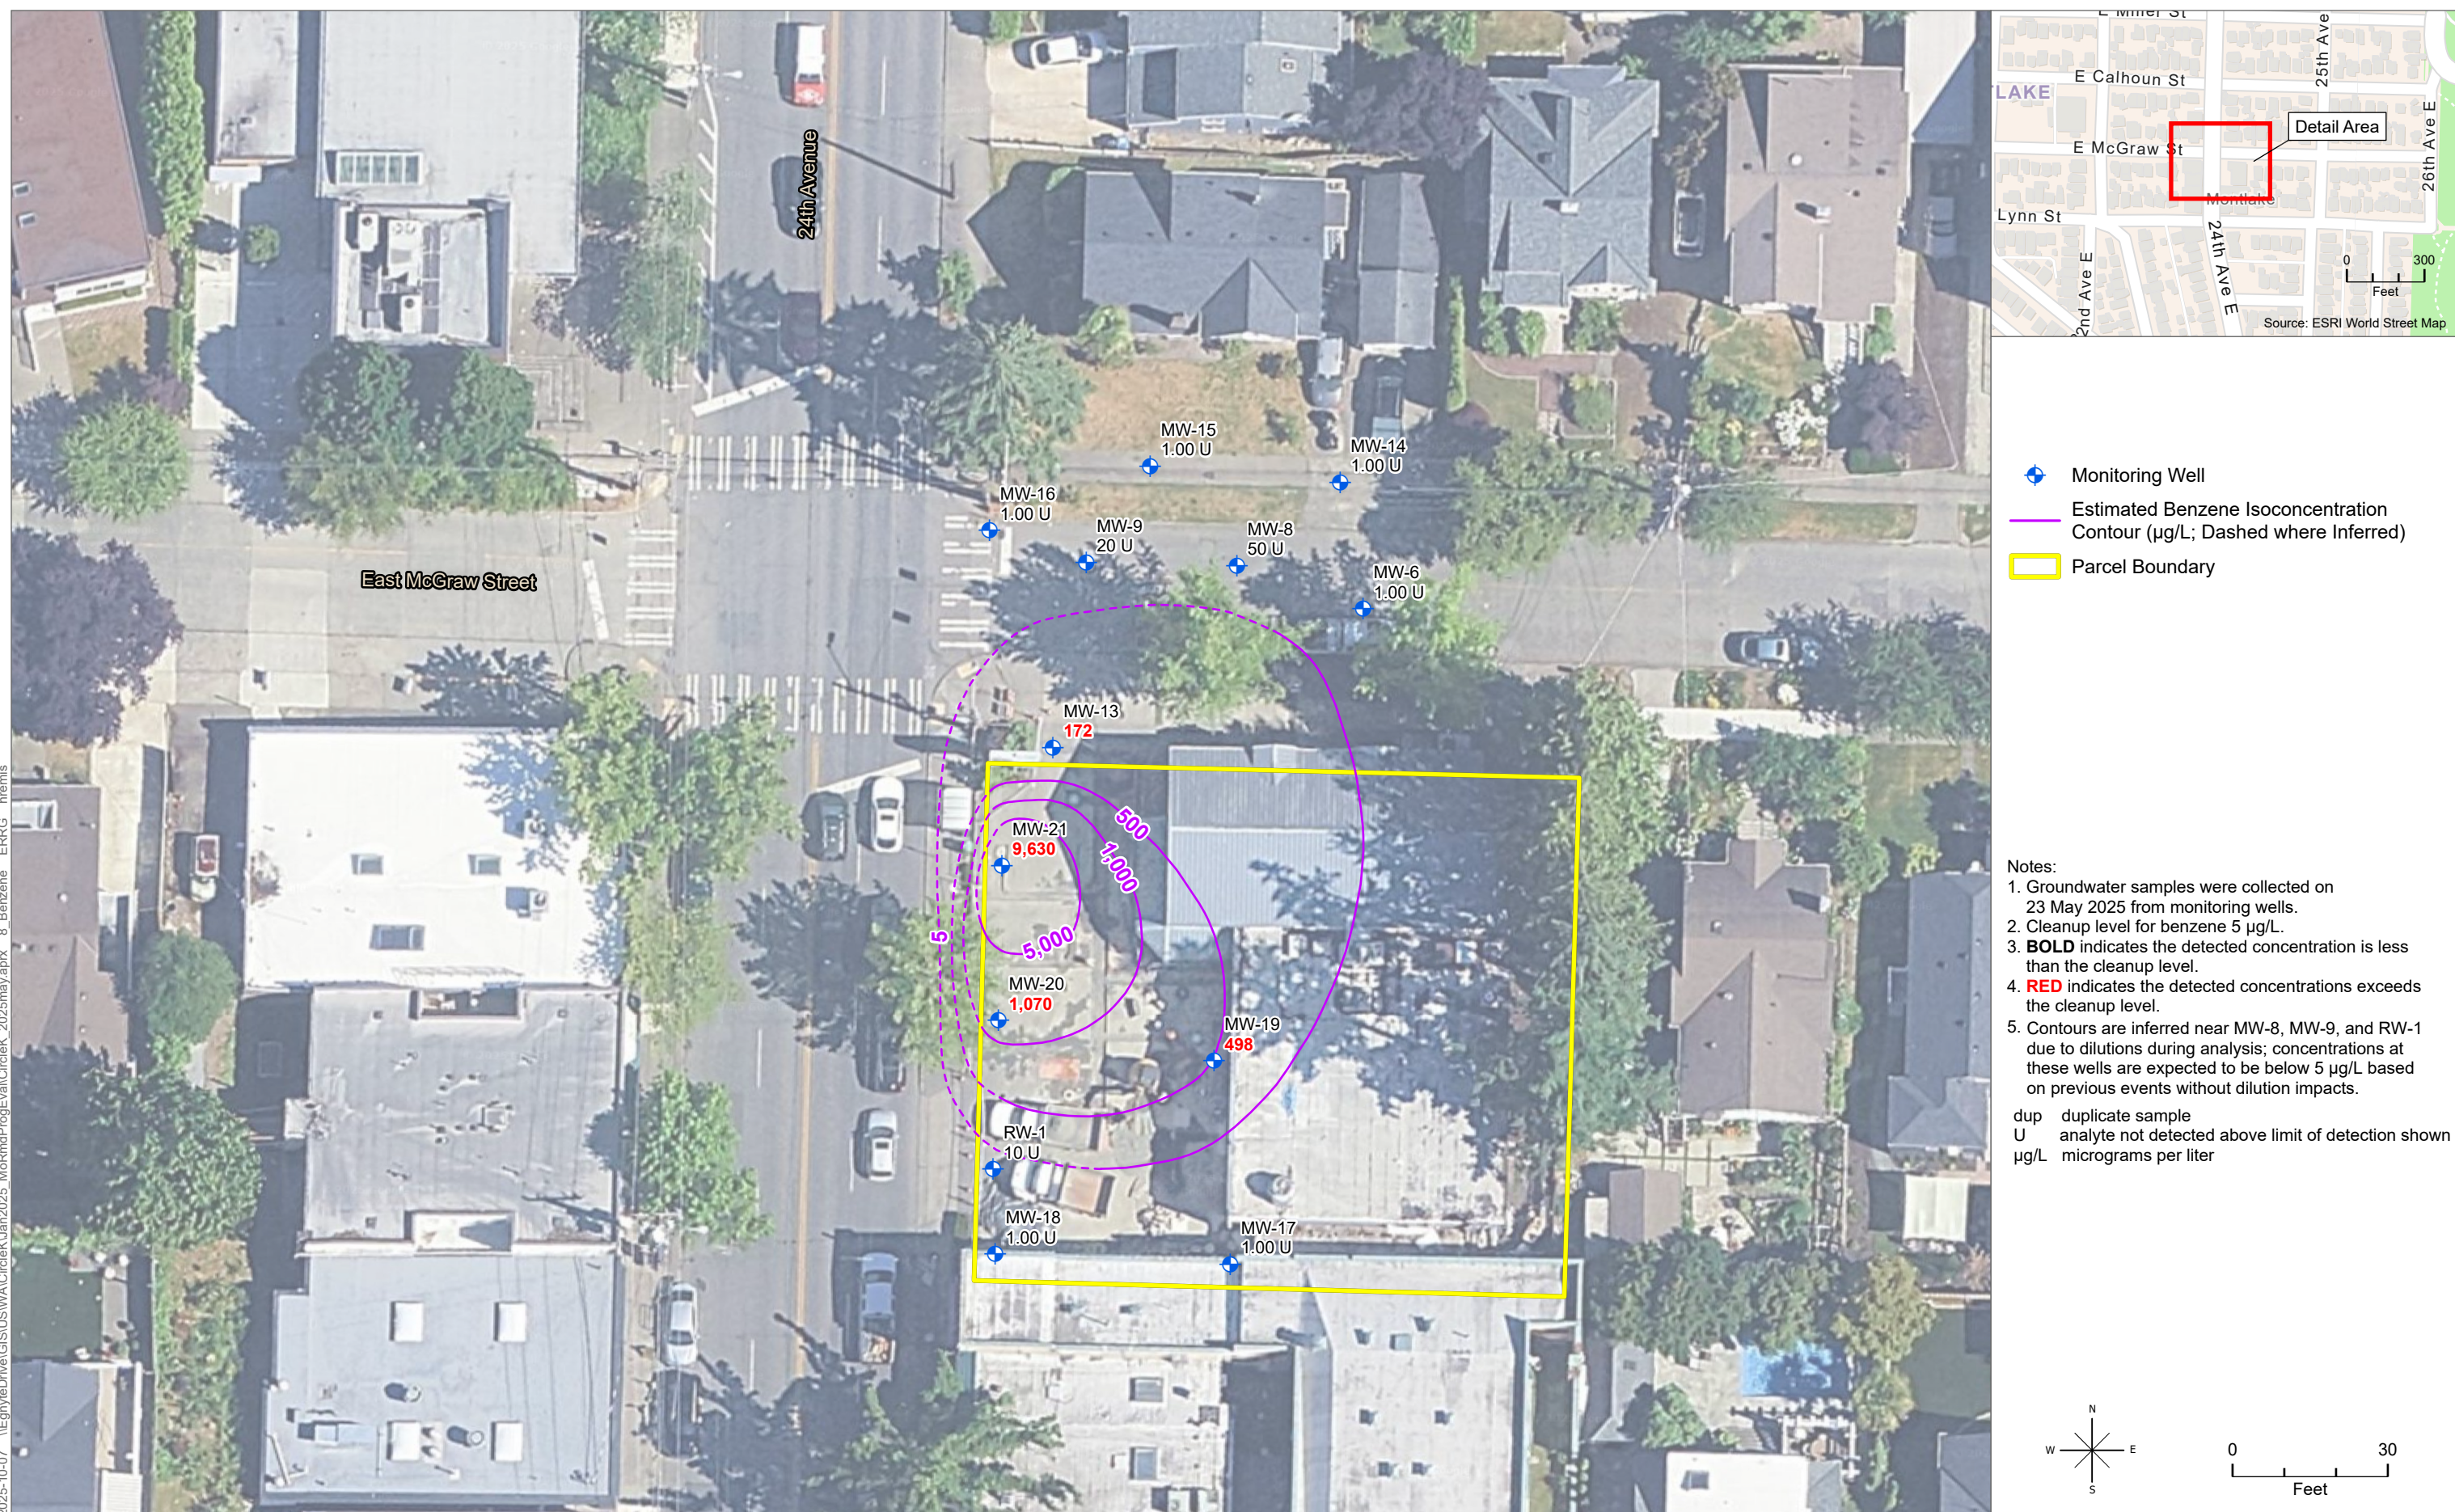
**Figure 8. Groundwater Benzene Concentration Contours, May 2025**  
Second Quarter 2025 Remedial Progress Evaluation Report for Former Circle K 1461  
Seattle, WA
