STATE OF WASHINGTON  
DEPARTMENT OF ECOLOGY

**Re: Opinion Pursuant to WAC 173-340-515(5) on Proposed Remedial Action for the Following Hazardous Waste Site:**

- Name: Spic N Span Cleaners Corp. Inc.
- Address: 652 South Dearborn Street, Seattle, WA
- Facility/Site No.: 54766547
- VCP No.: NW2564

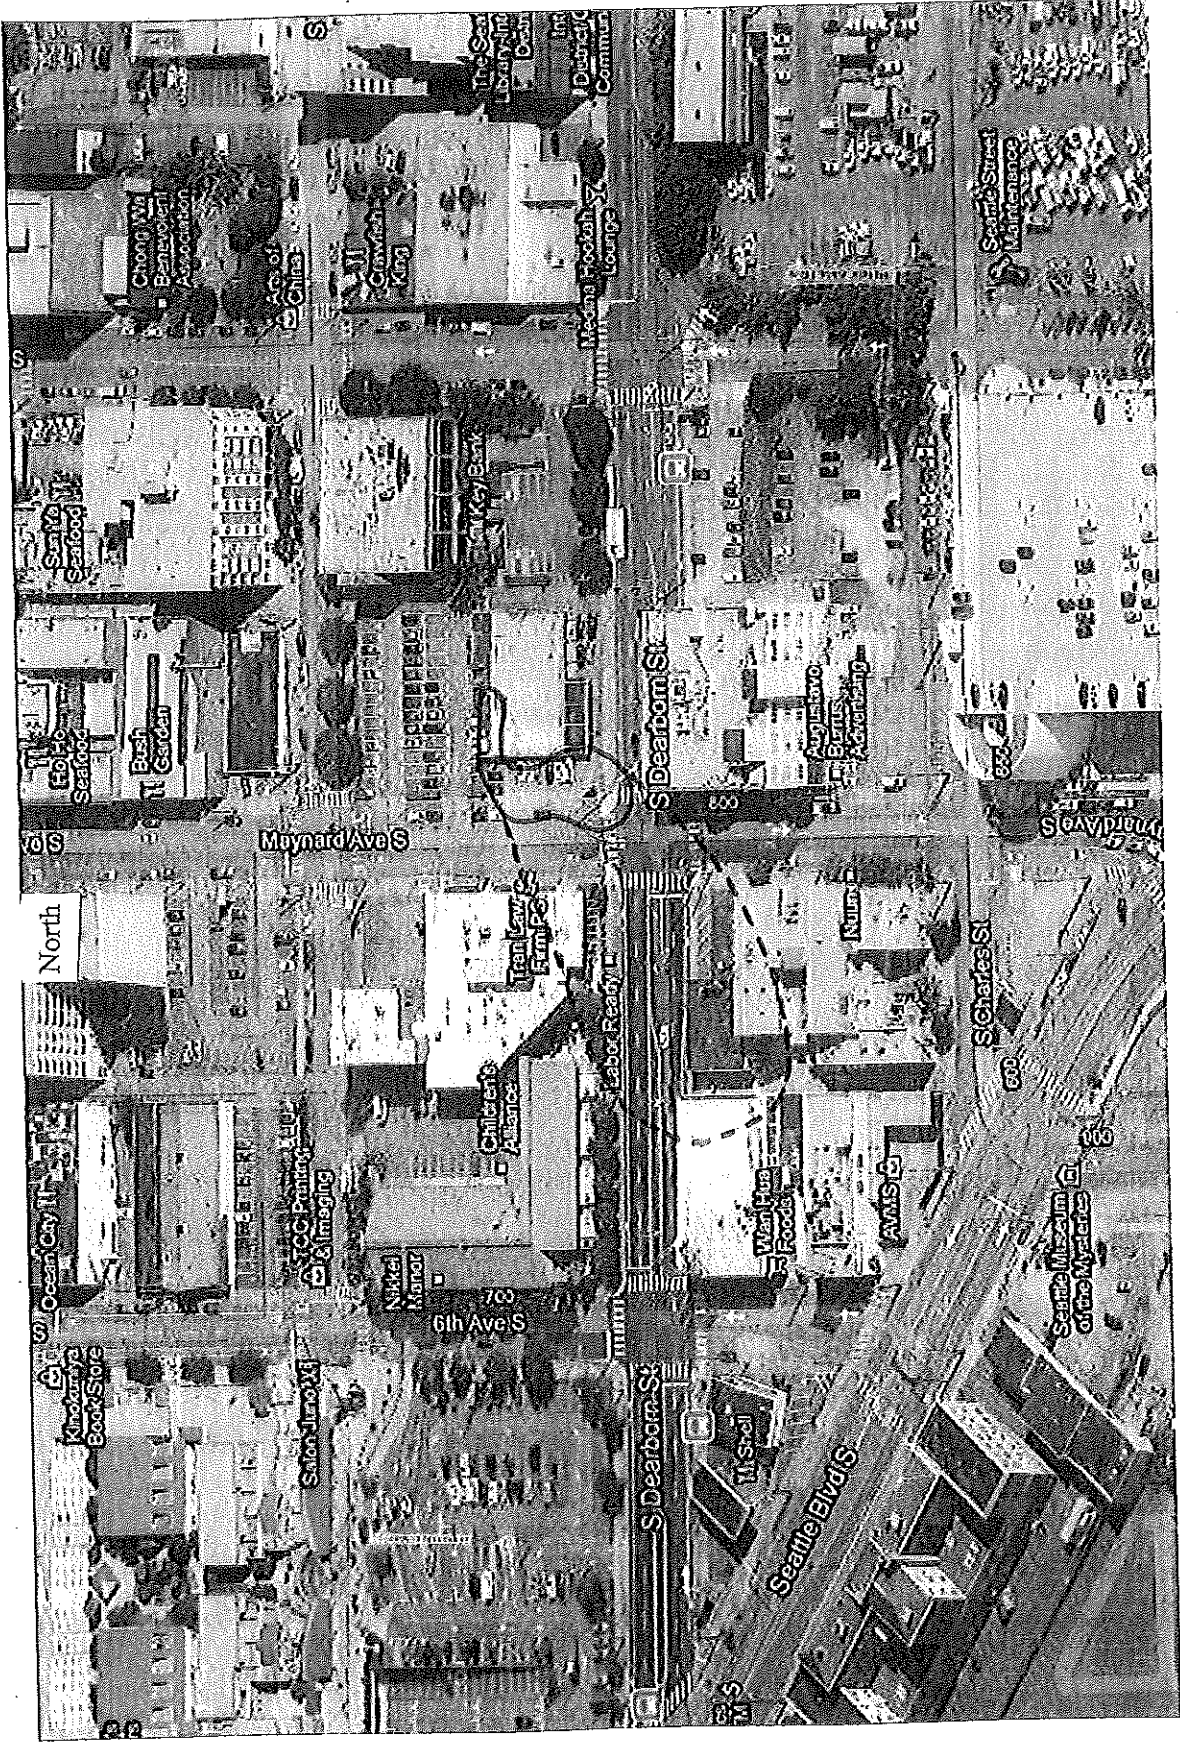
Spic N Span Cleaners Corp.

Approximate Extent of the Site

Soil and Groundwater Contamination

Vinyl Chloride in Groundwater

Contamination remaining in groundwater above cleanup levels consists only of vinyl chloride (VC). The plume of VC contaminated groundwater extends to the west-southwest (groundwater flow direction) approximately 300 ft. from the source area. The maximum length of the plume in this direction has not been completely characterized. The width of the plume appears to be roughly 150 ft. Three monitoring wells (MWs 7, 8, 9) that define the downgradient limits of the plume were constructed with only five-foot screen intervals, and may not accurately delineate the edges of the plume.

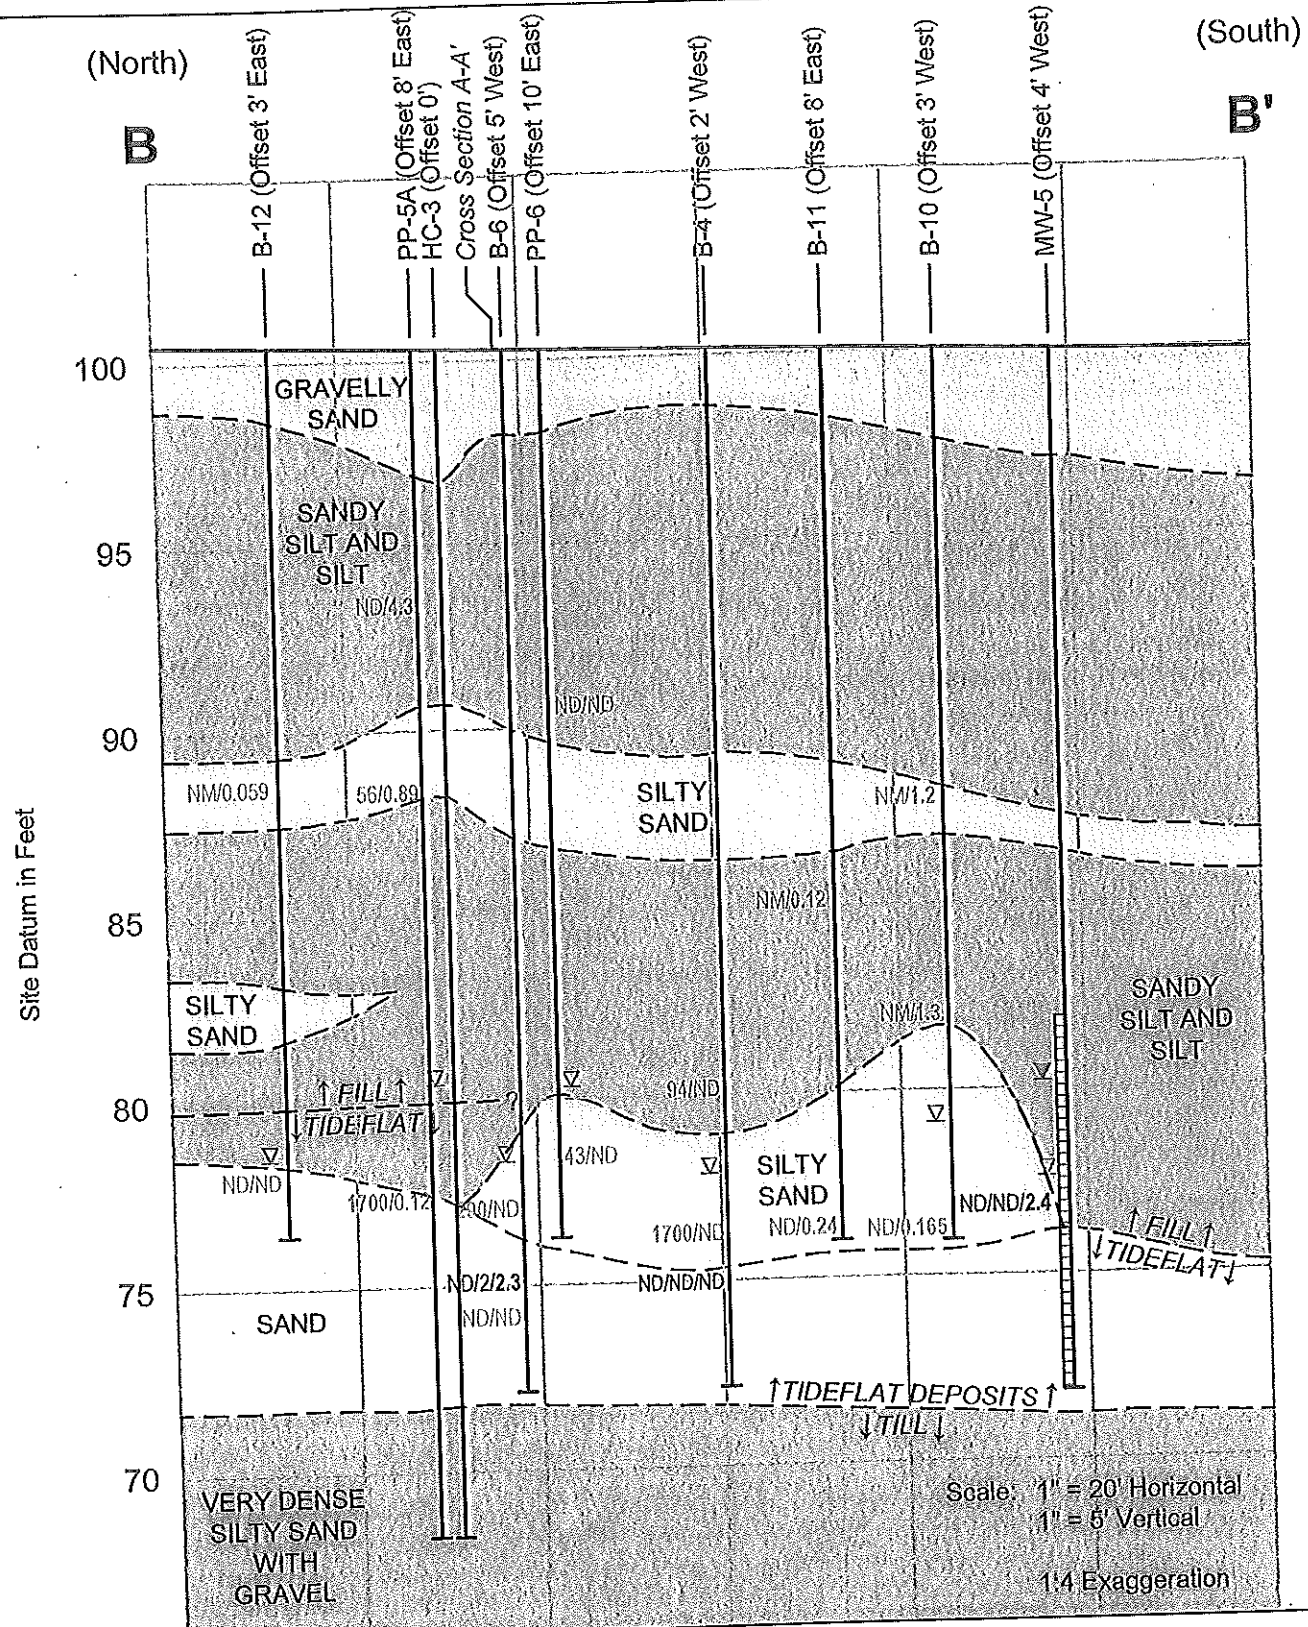
NOV-2011	BY DFR/SCC	FIGURE NO. <b>6</b>
	PROJECT NO 060172	REV BY SCC

-290/0.24	Mineral Spirits/PCE Concentrations in Soil (mg/Kg)
1310/0.02	Mineral Spirits/PCE/Vinyl Chloride Concentrations in Groundwater (µg/L)
NM	Not Measured
ND	Not Detected
<b>ND</b>	Indicates Detected Concentration Exceeds Cleanup Level
▽	Groundwater Level Measured on 3/4/2009
▽	Groundwater Level Observed at Time of Drilling
▬	Monitoring Well Screened Interval

### Cross Section B-B'
