Subject: Final Remedial Investigation Report
8801 East Marginal Way South
Tukwila, Washington
Agreed Order No. 6069

FINAL REMEDIAL INVESTIGATION REPORT

8801 East Marginal Way South
Tukwila, Washington
AGREED ORDER Number 6069

AMEC Earth & Environmental, Inc.
11810 North Creek Parkway North
Bothell, Washington 98011

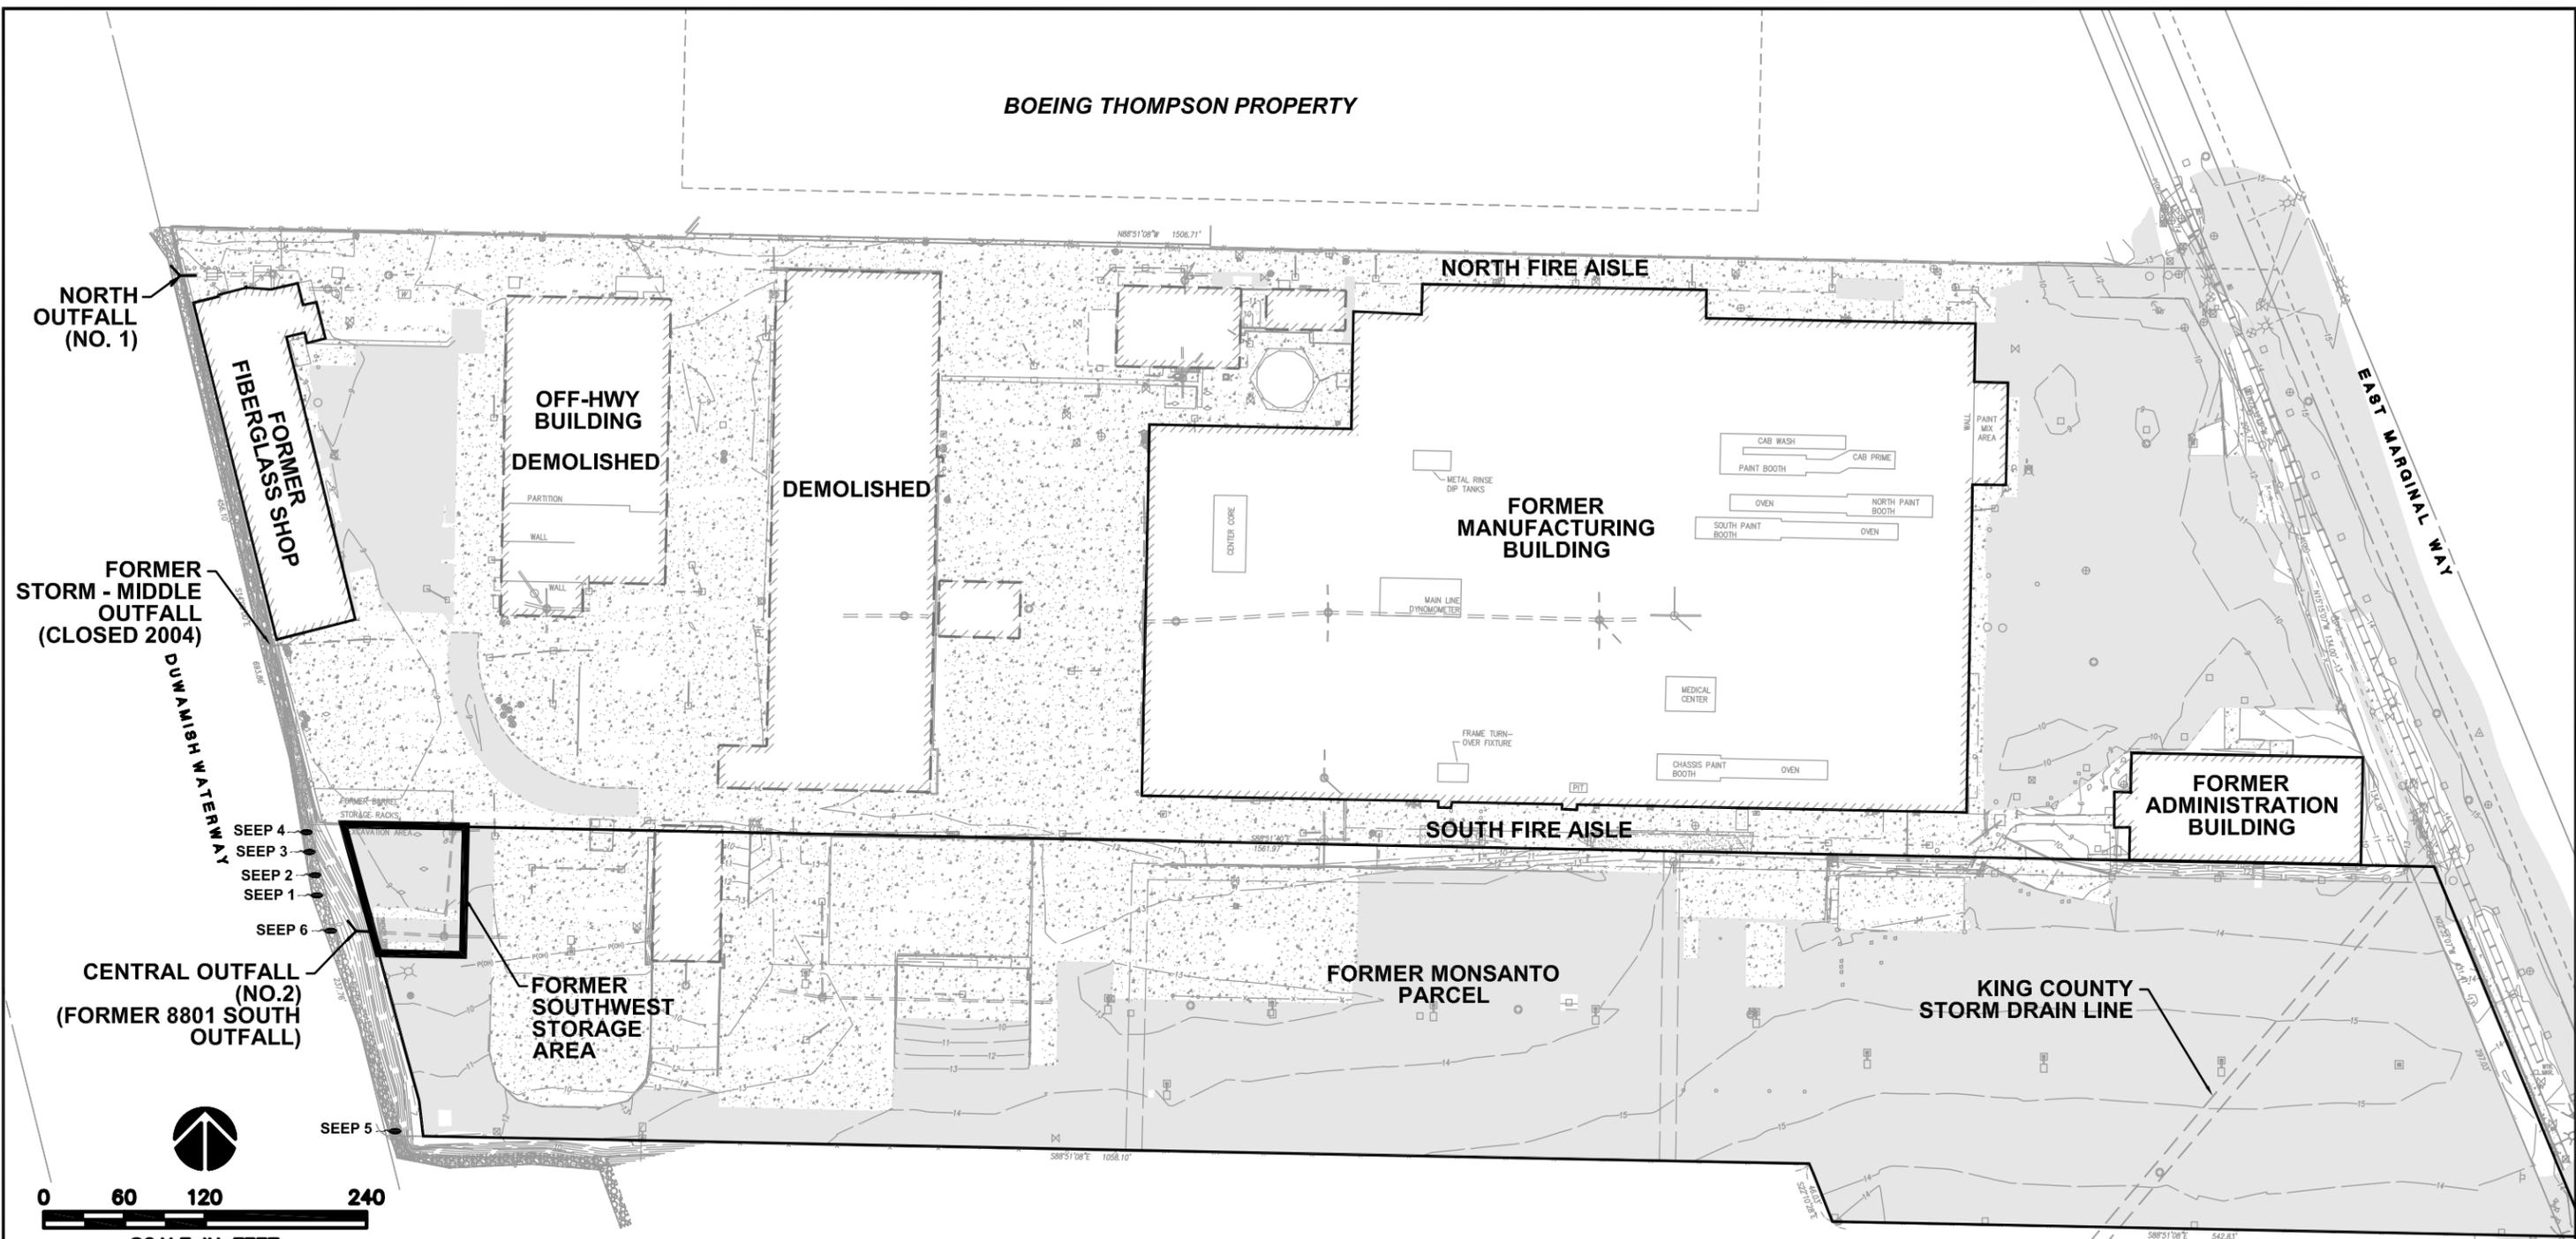
CLIENT LOGO	CLIENT: PACCAR INC	DWN BY: JRS	PROJECT 8801 SITE 8801 EAST MARGINAL WAY SOUTH Tukwila, Washington	DATE: NOVEMBER 2010
			CHK'D BY: MS		PROJECT NO: 9-915-14995-L
			DATUM:	TITLE 8801 SITE KEY SITE FEATURES	REV. NO.:
		AMEC Earth & Environmental 11810 North Creek Parkway North Bothell, WA, U.S.A. 98011-8201	PROJECTION:		FIGURE No. 2
			SCALE: AS SHOWN

King County Tax Assessor records show the 8801 site is zoned for industrial use, and is surrounded primarily by industrial properties. To the north are two parcels (Parcel 0007400033 and 0001600014) owned by The Boeing Company (Boeing), one of which is used for jet engine research. To the south are two parcels (Parcel 5422600010 and 5422600020). The western parcel is currently owned by Container Properties, LLC and is leased to IAAI for storage of damaged and wrecked vehicles. The eastern parcel is currently owned by The Museum of Flight Foundation and is currently vacant. East Marginal Way South bounds the 8801 site to the east. The LDW forms the western boundary of the 8801 site (Figure 2).

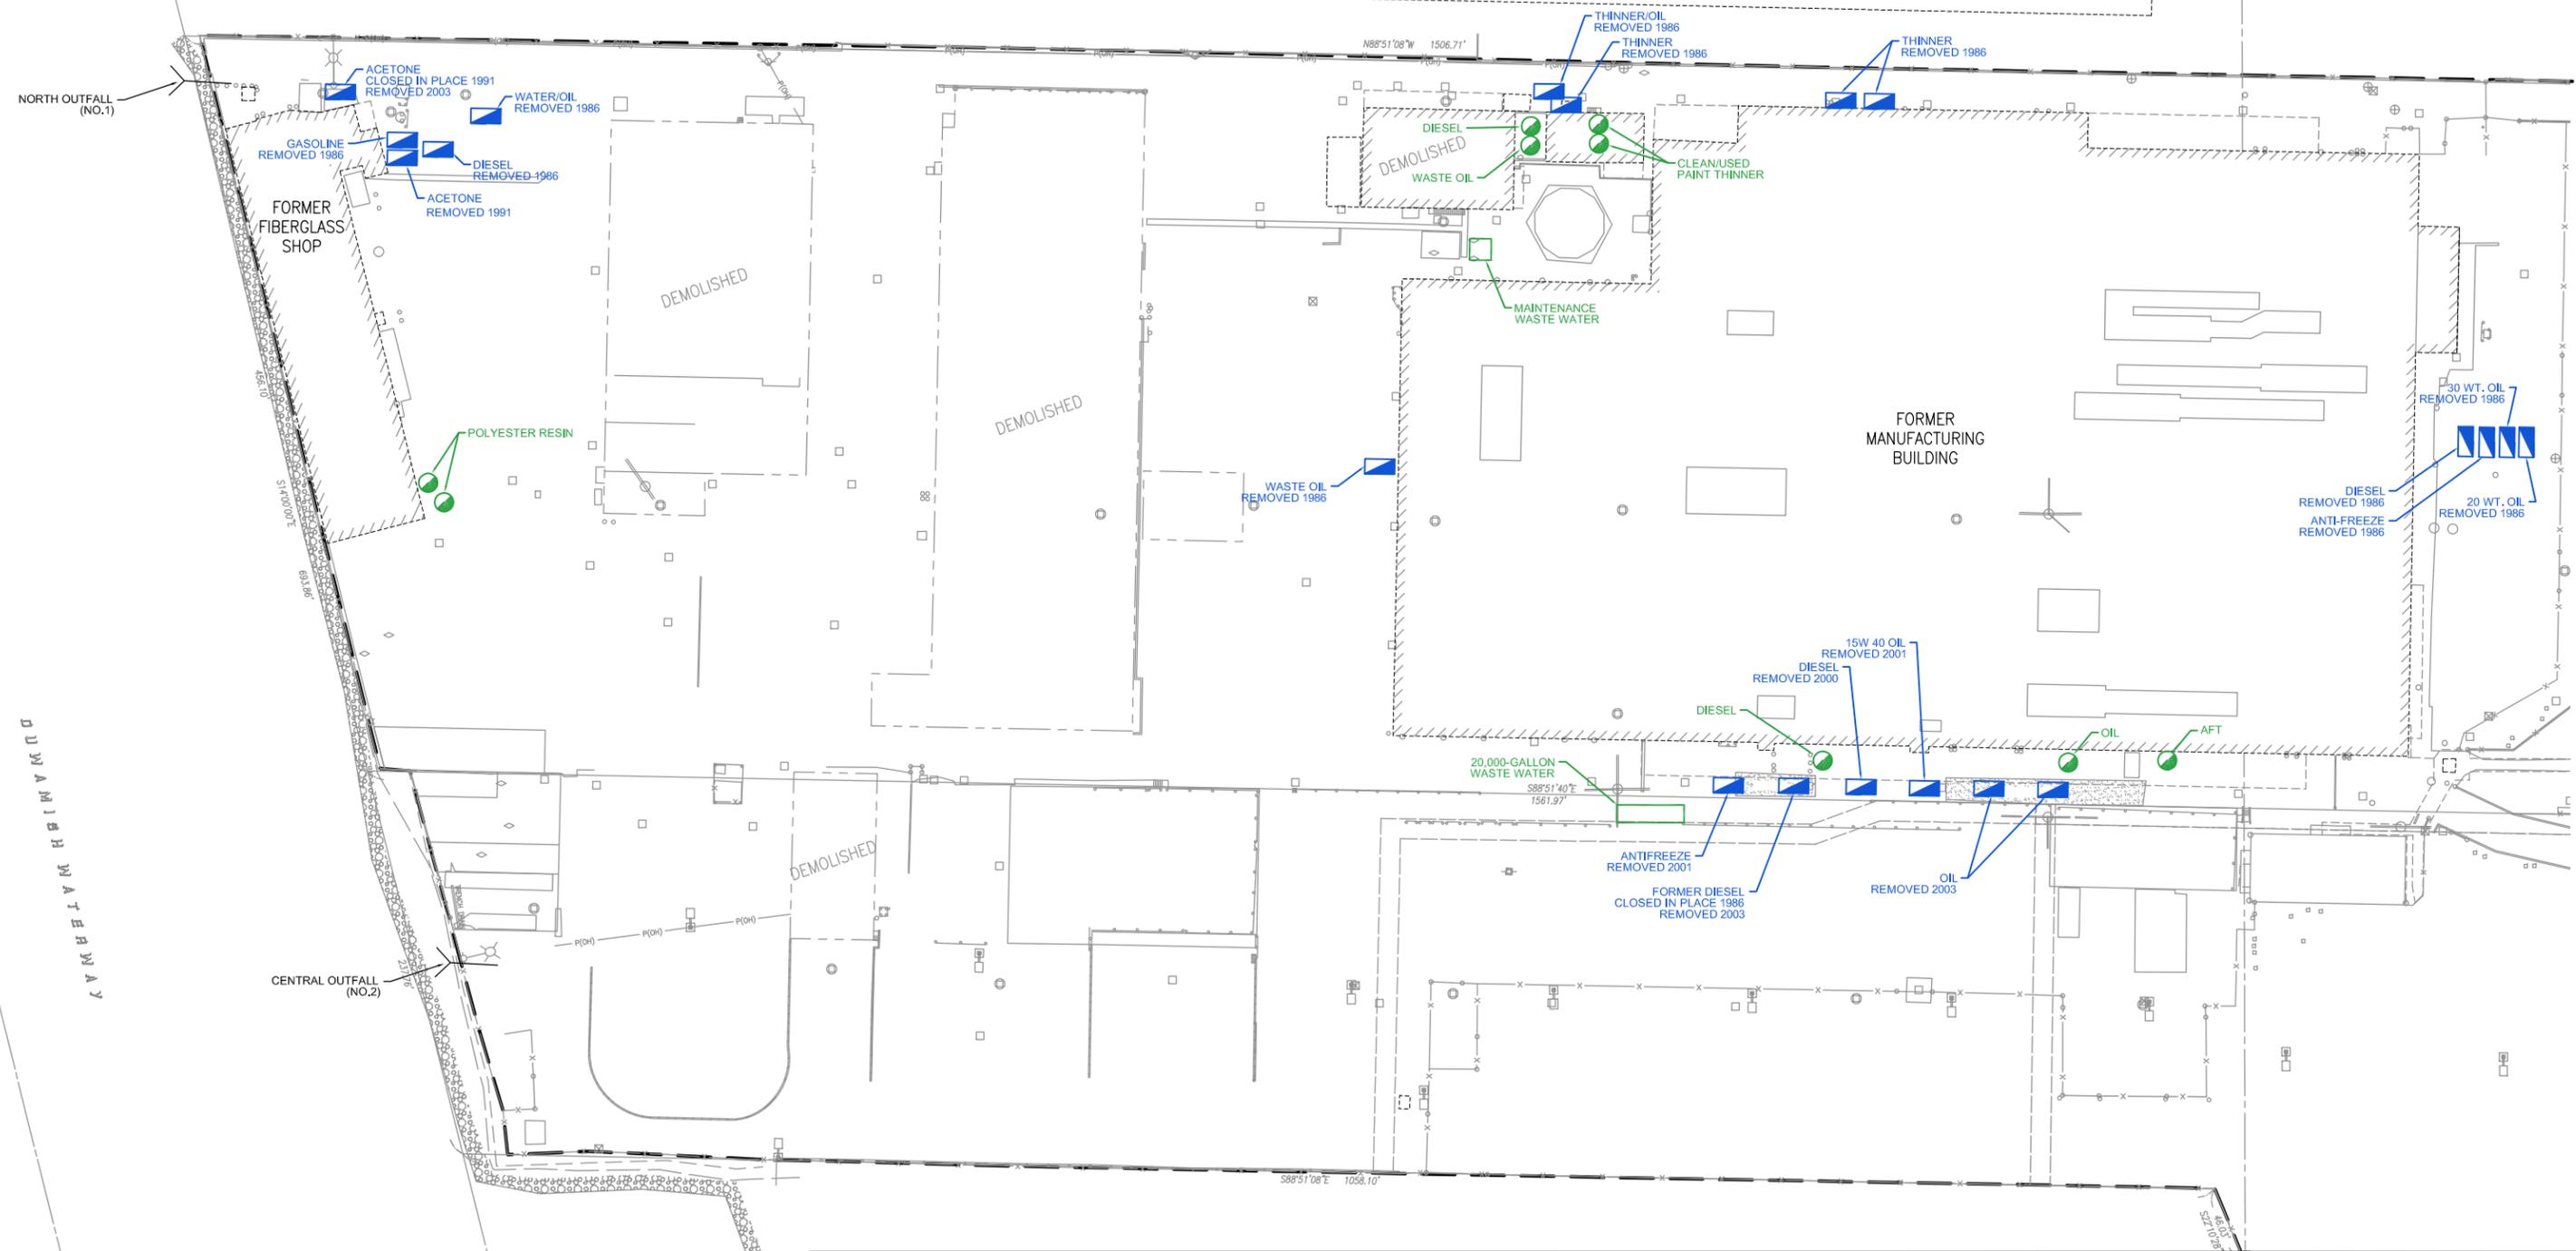
CLIENT: <p style="text-align: center;">PACCAR INC</p>	DWN BY: <p style="text-align: center;">JRS</p>	PROJECT <p style="text-align: center;">8801 SITE 8801 EAST MARGINAL WAY SOUTH Tukwila, Washington</p>	DATE: <p style="text-align: center;">NOVEMBER 2010</p>
AMEC Earth & Environmental 11810 North Creek Parkway North Bothell, WA, U.S.A. 98011-8201	CHK'D BY: <p style="text-align: center;">MS</p>	TITLE <p style="text-align: center;">8801 SITE FORMER UNDERGROUND AND ABOVEGROUND STORAGE TANK LOCATIONS</p>	PROJECT NO: <p style="text-align: center;">9-915-14995-L</p>
	DATUM: <p style="text-align: center;">NONE</p>		REV. NO.: <p style="text-align: center;">0</p>
	PROJECTION: <p style="text-align: center;">NONE</p>		FIGURE No. <p style="text-align: center;">3</p>
	SCALE: <p style="text-align: center;">AS SHOWN</p>

Number of USTs	Contents	Location
4	Paint thinner (typically non-chlorinated, constituents not documented and varied over time), oil	North of Manufacturing Building (North Fire Aisle)
6	Antifreeze, diesel, and oil	South of Manufacturing Building (South Fire Aisle)
4	Antifreeze, diesel, and oil	East of Manufacturing Building
1	Waste oil	West of Manufacturing Building
4	Diesel, gasoline, water/oil and acetone	Near Fiberglass Shop
1	New, state-of-the-art UST replacement (1987) for older acetone-containing UST	Adjacent to Fiberglass Shop

Twelve ASTs of various capacities that stored fresh paint thinner, used paint thinner, diesel fuel, oil, liquid polyester resin, and automatic transmission fluid were also located at the 8801 site (Table 3). The ASTs were placed in secondary containments and vaults to prevent possible releases or leaks from the tanks.

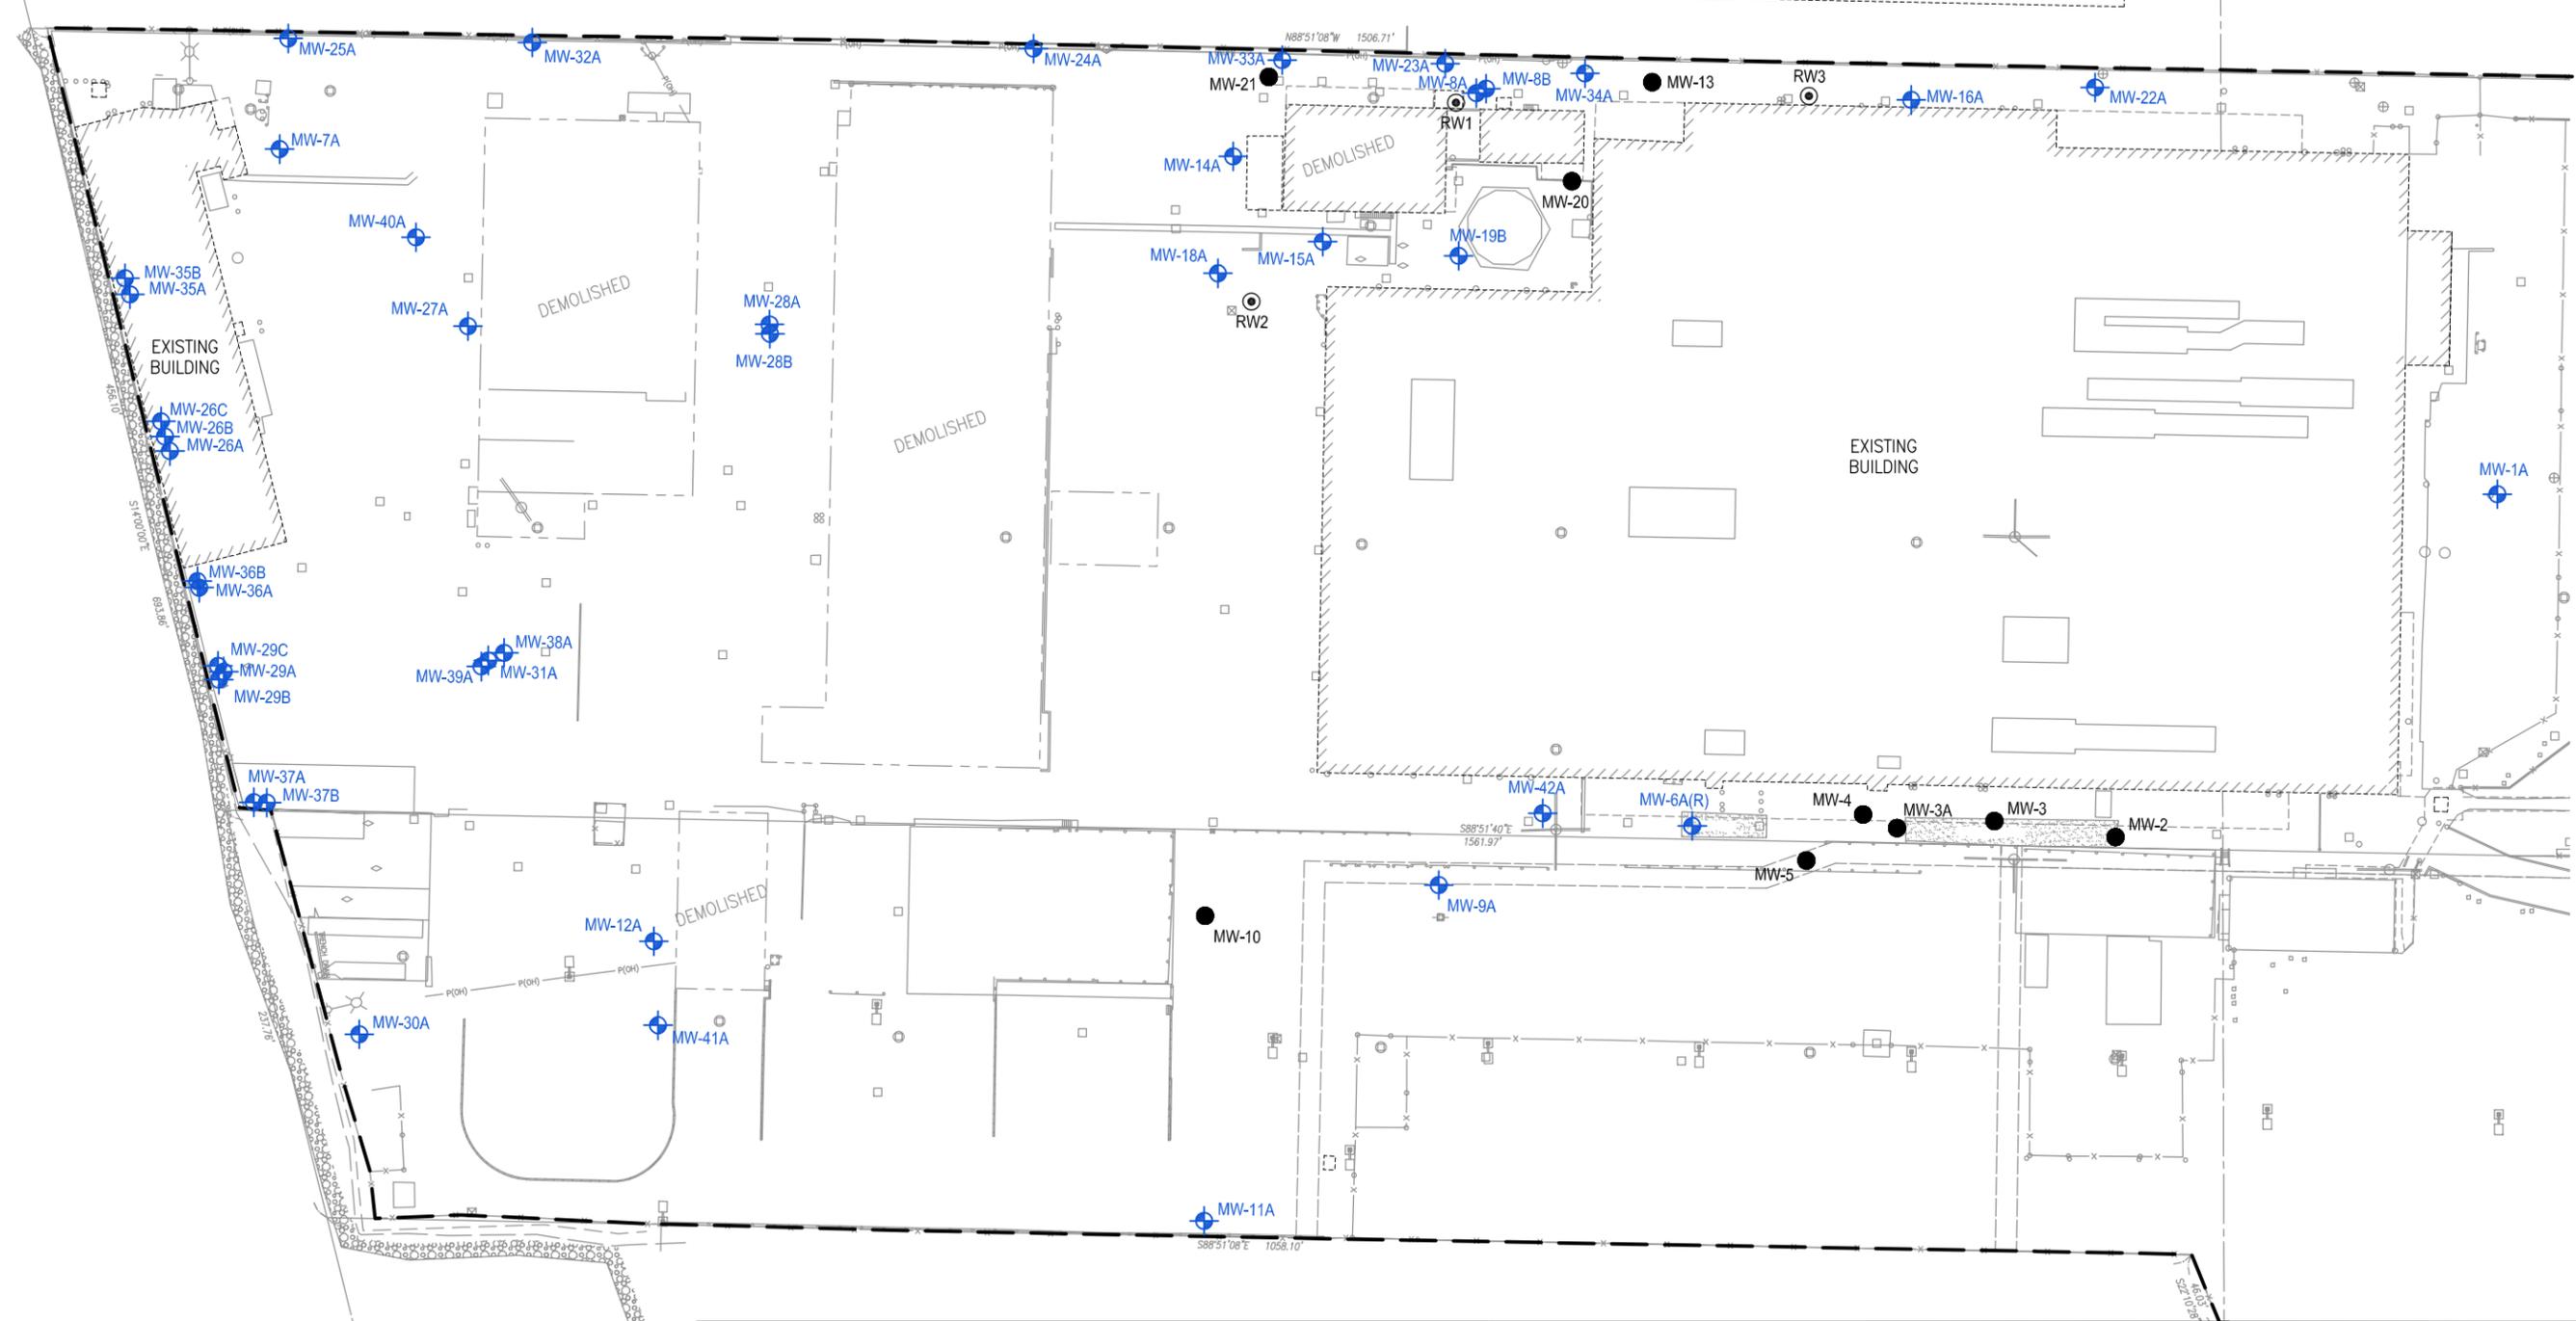
- MW-35B
 MONITORING WELLS
 A - SCREEN INSTALLED IN ZONE A AQUIFER
 B - SCREEN INSTALLED IN ZONE B AQUIFER
 C - SCREEN INSTALLED IN ZONE C AQUIFER
 - RW3
 RECOVERY WELLS (REMOVED)
 - MW-21
 WELLS REMOVED OR COVERED
- NOTE: LOCATION OF MW-17 WAS NOT IDENTIFIED IN PREVIOUS INVESTIGATION REPORTS.

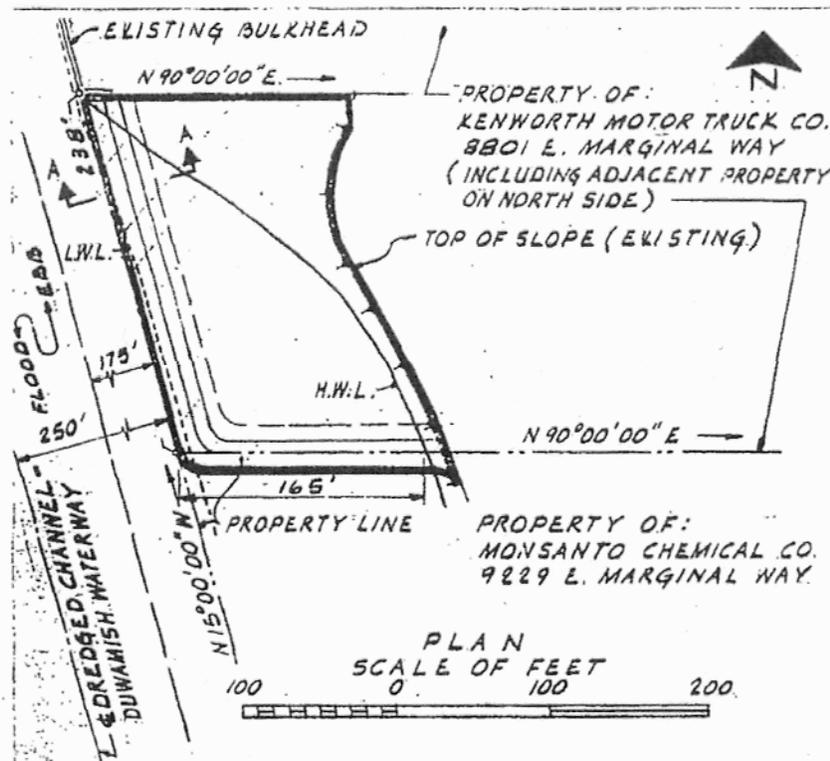
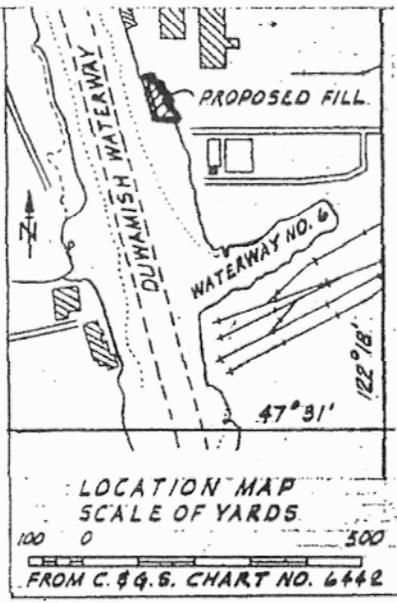
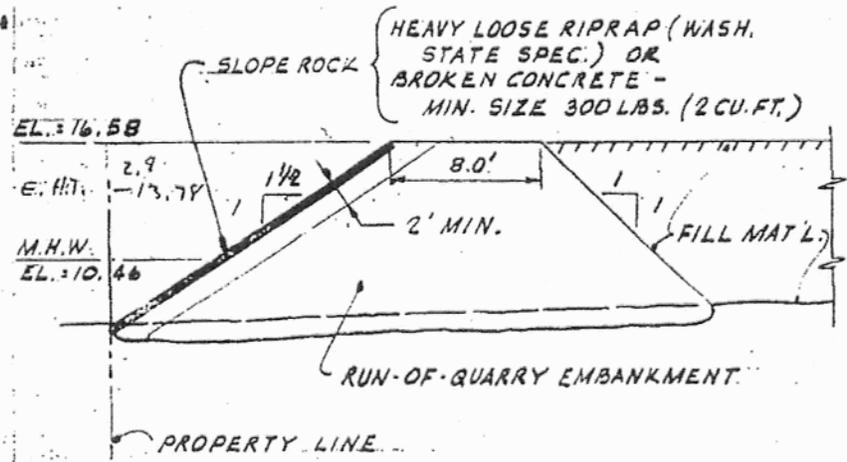
SECTION A-A
SCALE OF FEET
5 0 5 10 15

DATUM: ELEVATIONS BASED ON M.L.L.W. DATUM.
ESTIMATED QUANTITIES
FILL & EMBANKMENT = 7870 CU. YDS.

PROPOSED FILL
in SEATTLE, WASHINGTON
by DUWAMISH WATERWAY
County of KING State WASH
Application by KENWORTH MOTOR TRUCK CO. Date DEC. 7, 1966
