STATE OF WASHINGTON DEPARTMENT OF ECOLOGY

Re: Opinion on Proposed Cleanup of the Following Site:

• Site Name: Taco Time NW Restaurant

• Site Address: 1420 East Madison Street, Seattle, WA

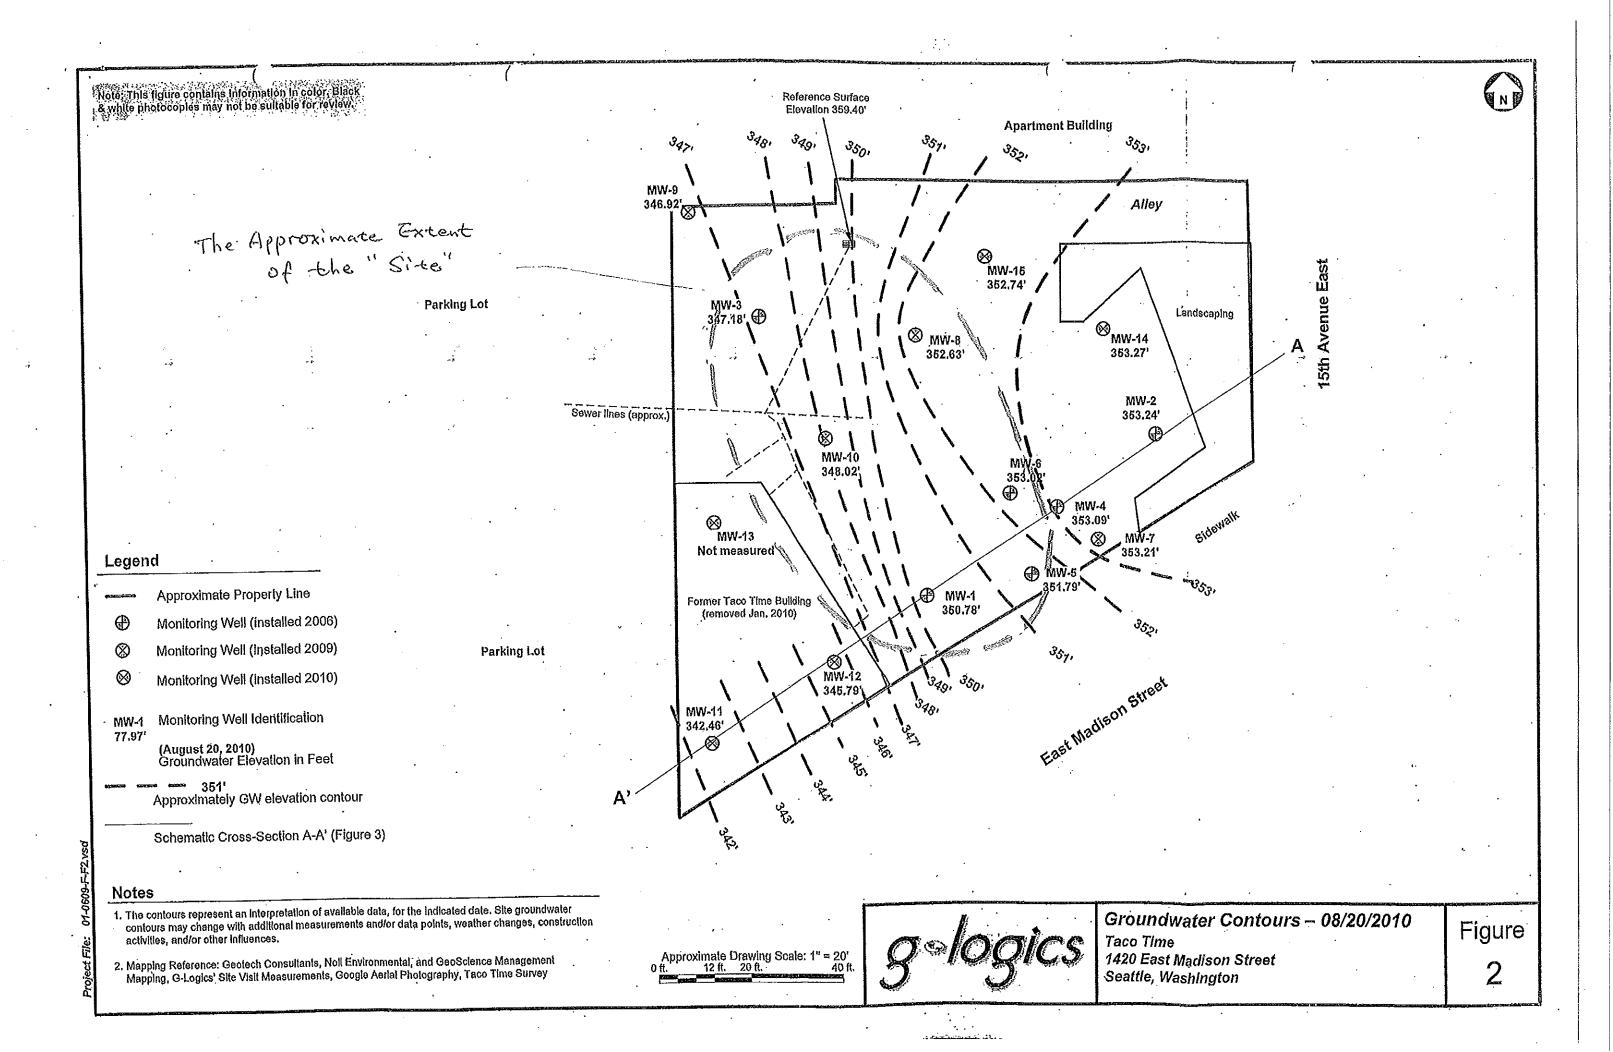
- Area 1 Northeast of the former restaurant building: Elevated concentrations of dieselrange petroleum hydrocarbons occur in soil at depths of 10 to 15 feet bgs. No
 contaminants of concern were detected in groundwater in this area except that diesel was
 detected once in MW-10 slightly above the MTCA Method A cleanup level. The source
 of the contamination has not been determined. It is likely from leaks and spills associated
 with historical on-site activities.

- Area 2 Northwest corner of the Property: Elevated concentrations of diesel and oil
 range petroleum occur in soil within the upper 4 feet of the subsurface. The source of the
 contamination has not been determined. It is likely from leaks and spills associated with
 historical on-site activities. Ground water is not likely being impacted.

- Area 3 South-central area of the Property: Ground water on the Site is contaminated with EDC. During the most recent (August 2012) ground water sampling event, 8 of the 15 existing monitoring wells were sampled. EDC concentrations ranged from 7 to 9.9 µg/L. However, EDC was not detected in any soil samples collected to a maximum depth of 50 feet bgs. No other chlorinated solvents were detected in soil, groundwater or soil-vapor samples collected in this area. It is likely that the presence of EDC in ground water is associated with historical operations on this portion of the Property. EDC contaminated ground water has not migrated off-Property to the west.

Enclosure A includes a detailed description and diagram of the Site, as currently known to Ecology.
