STATE OF WASHINGTON  
DEPARTMENT OF ECOLOGY

Re: The Department of Ecology Decision on Further Investigations at the Landsburg Mine site, Ravensdale

After thorough evaluation of technical issues raised on the Landsburg Mine site cleanup, the Department of Ecology (Ecology) is presenting its decision for work needed to progress further with the cleanup process at this site.

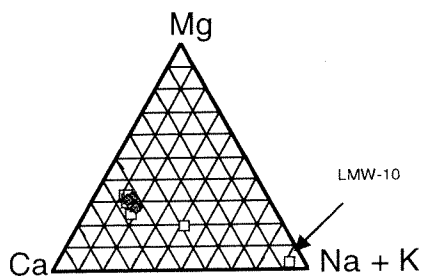
- 2) The well or wells may serve as early warning or sentinel well(s) in the possible event of a release from the source area in the trench. For example, in the event of an earthquake, the buried drums may potentially shift and rupture. Therefore, the deep well(s) may be monitored for contaminants to track contaminant transport.
- 3) The well(s) may be used for remediation or to extract mine water, thus lowering the water table and providing inward hydraulic gradients that will prevent breakout of potentially contaminated mine water.
- 4) There is evidence that deeper groundwater at the site is geochemically different from shallow groundwater based on major cation compositions. For example, the deep northern well LMW-10 that is screened at an elevation of 338.5 feet above sea level is richer in the alkalis Na + K and lower in Ca and Mg compared to other waters:

Data for the above graph was taken from the May 2004 groundwater analytical results. LMW-10 was a recently installed deep well. At present, we cannot preclude the high Na and K to be artifacts of the well installation process (from bentonite seal or from material in Portland cement used to fill the borehole beneath the well screen). Coupled with an upward hydraulic gradient at the discharge (portal) areas, this points to a complex flow system with upward groundwater flow from deeper levels. If there is contaminated water at these deep levels, based on the results of LMW-10, it may be expected that deeper waters may reach the shallow levels that affect groundwater use and surface water quality. Therefore, there is a need to identify the water quality emanating from the deeper region of the former mine.

Section 3.6.3.4 in the 1996 RI/FS for Landsburg Mine distinguished high Na-HCO<sub>3</sub> groundwater from Ca dominant groundwater. The Ca dominant groundwater represented younger groundwater derived from recent recharge and short flowpaths. Private wells installed in the glacial outwash aquifer, the mine portal samples, and site wells (LMW-1 through LMW-6) exhibited this behavior. The second group of Na
