SITE HAZARD ASSESSMENT

Summary Score Sheet

Triad Machinery Inc. Tukwila
11210 Tukwila International Blvd
Tukwila, King County, WA 98168

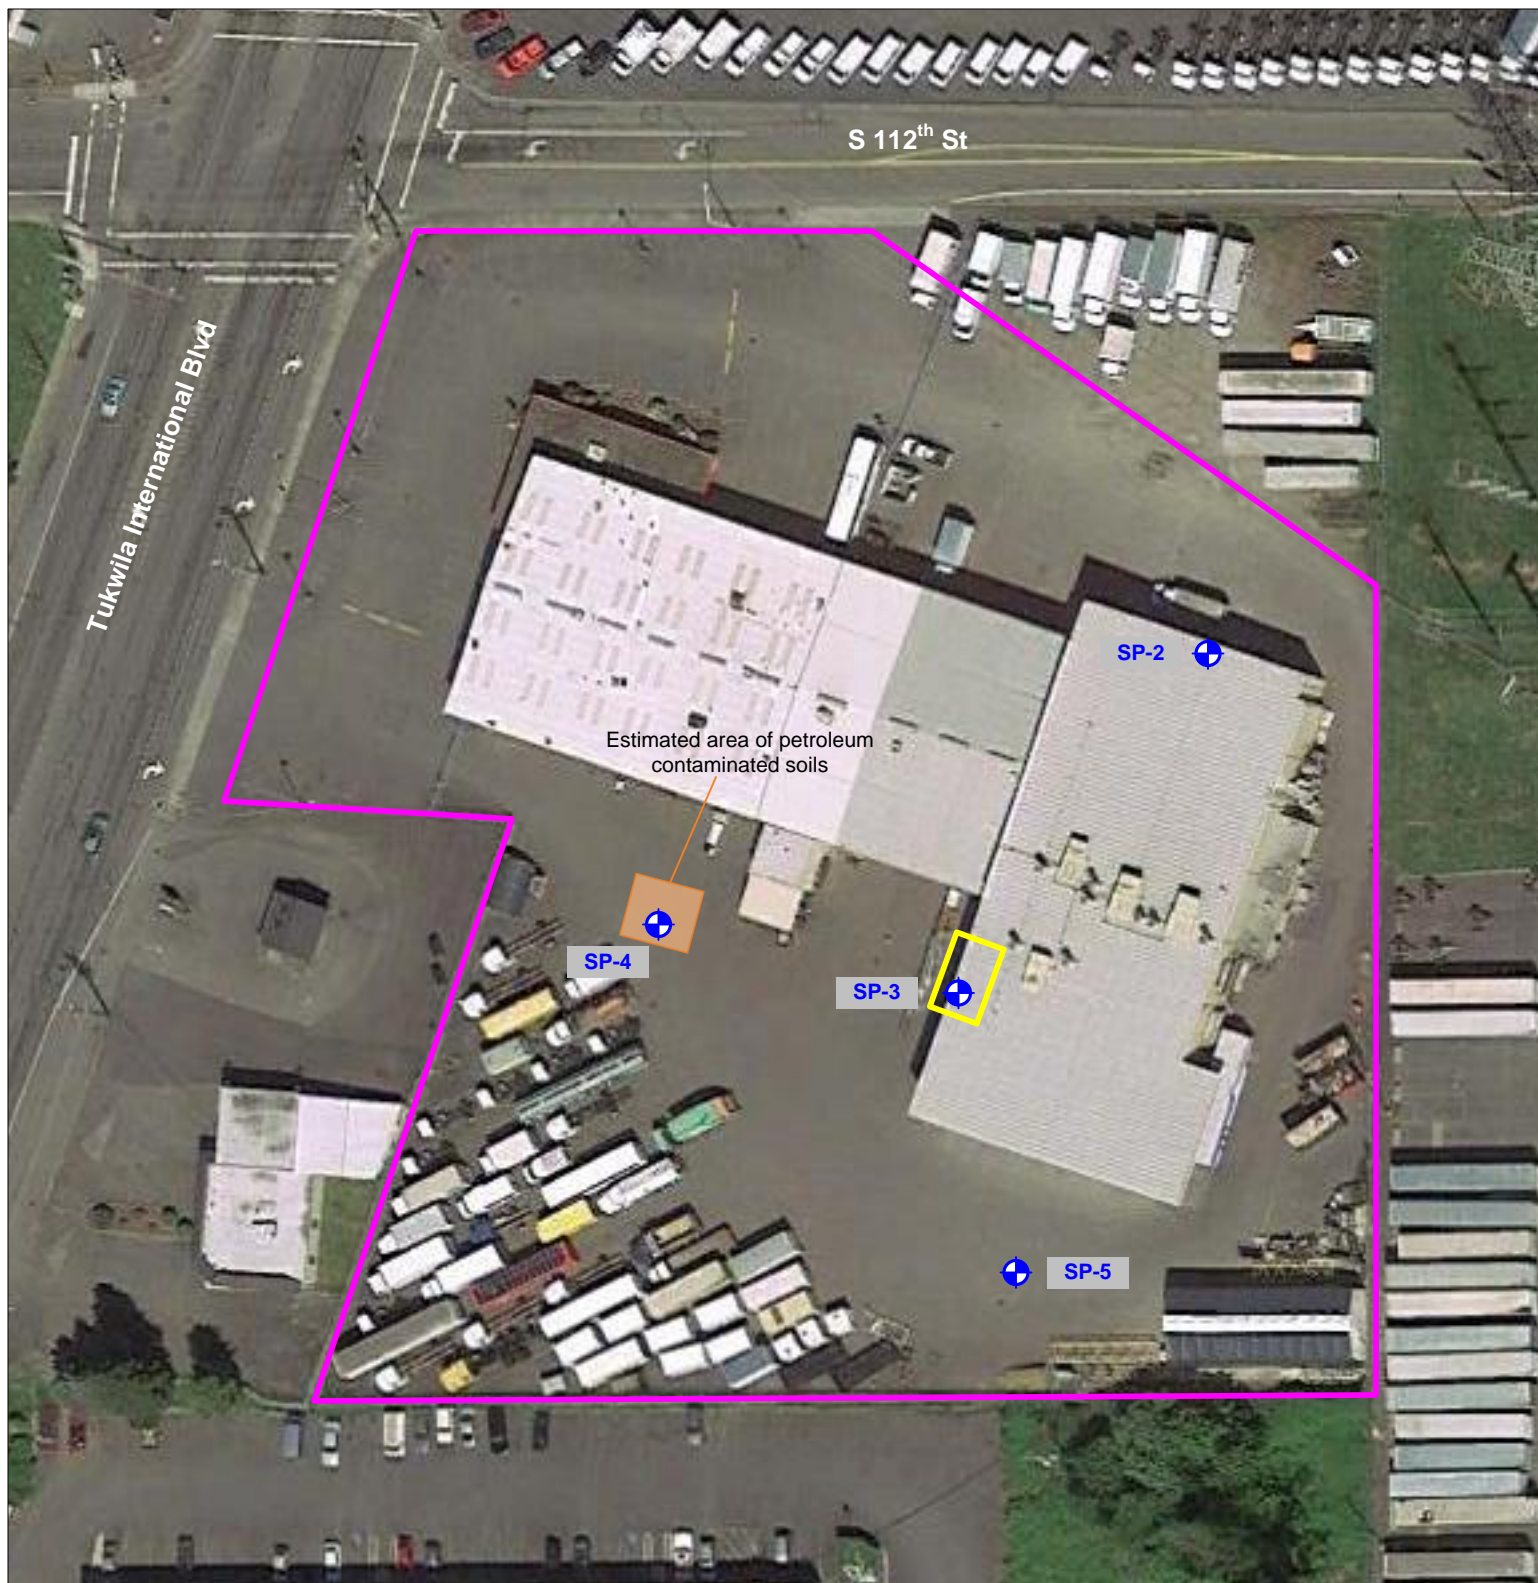
- Property location (approximate)
- Excavation area (approximate)
- Remaining soil contamination (approximate)
- ⊕ Monitoring well (approximate)
