STATE OF WASHINGTON
DEPARTMENT OF ECOLOGY

**Re: No Further Action Determination under WAC 173-340-515(5) for the following
Hazardous Waste Site:**

- Name: Joseph Simon & Sons Kent
- Address: 917, 1025 South Central Avenue, Kent, WA 98032-3045
- Facility/Site No.: 83334411
- VCP No.: NW1079

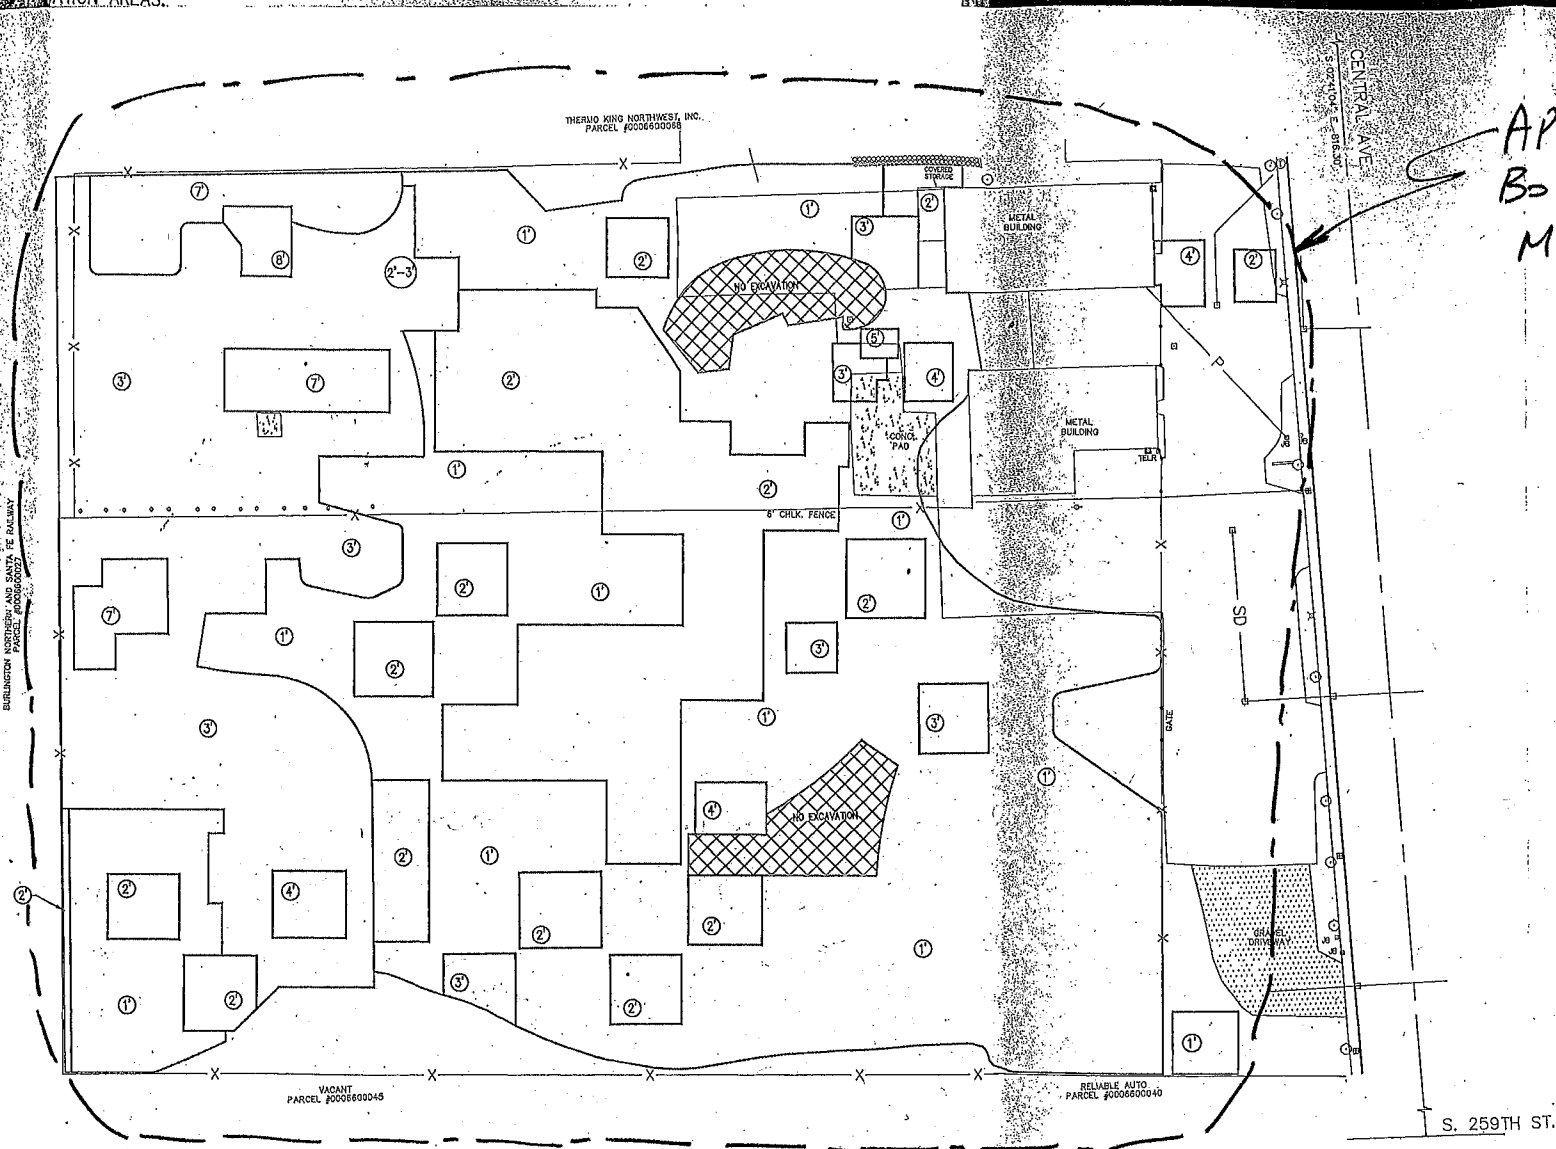
Figure 2/2

PER TO FIGURE 5 FOR PERFORMANCE MONITORING SOIL
ATION AREAS.

APPROXIMATE
BOUNDARY OF
MTCA SITE
