Re: The Department of Ecology Decision on Further Investigations at the Landsburg Mine site, Ravensdale

### **Summary and Recommendations on Issues of Additional Investigation at the Landsburg Mine site in Ravensdale**

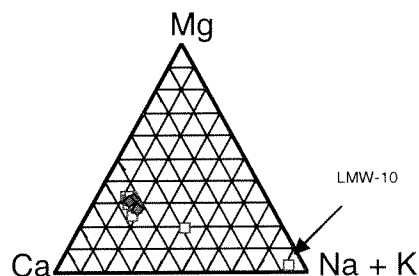
- 2) The well or wells may serve as early warning or sentinel well(s) in the possible event of a release from the source area in the trench. For example, in the event of an earthquake, the buried drums may potentially shift and rupture. Therefore, the deep well(s) may be monitored for contaminants to track contaminant transport.
- 3) The well(s) may be used for remediation or to extract mine water, thus lowering the water table and providing inward hydraulic gradients that will prevent breakout of potentially contaminated mine water.
- 4) There is evidence that deeper groundwater at the site is geochemically different from shallow groundwater based on major cation compositions. For example, the deep northern well LMW-10 that is screened at an elevation of 338.5 feet above sea level is richer in the alkalis Na + K and lower in Ca and Mg compared to other waters:

Data for the above graph was taken from the May 2004 groundwater analytical results. LMW-10 was a recently installed deep well. At present, we cannot preclude the high Na and K to be artifacts of the well installation process (from bentonite seal or from material in Portland cement used to fill the borehole beneath the well screen). Coupled with an upward hydraulic gradient at the discharge (portal) areas, this points to a complex flow system with upward groundwater flow from deeper levels. If there is contaminated water at these deep levels, based on the results of LMW-10, it may be expected that deeper waters may reach the shallow levels that affect groundwater use and surface water quality. Therefore, there is a need to identify the water quality emanating from the deeper region of the former mine.

Section 3.6.3.4 in the 1996 RI/FS for Landsburg Mine distinguished high Na-HCO<sub>3</sub> groundwater from Ca dominant groundwater. The Ca dominant groundwater represented younger groundwater derived from recent recharge and short flowpaths. Private wells installed in the glacial outwash aquifer, the mine portal samples, and site wells (LMW-1 through LMW-6) exhibited this behavior. The second group of Na
