Lower Duwamish Waterway Source Control Action Plan for the Slip 4 Early Action Area

July 2006

Publication No. 06-09-046

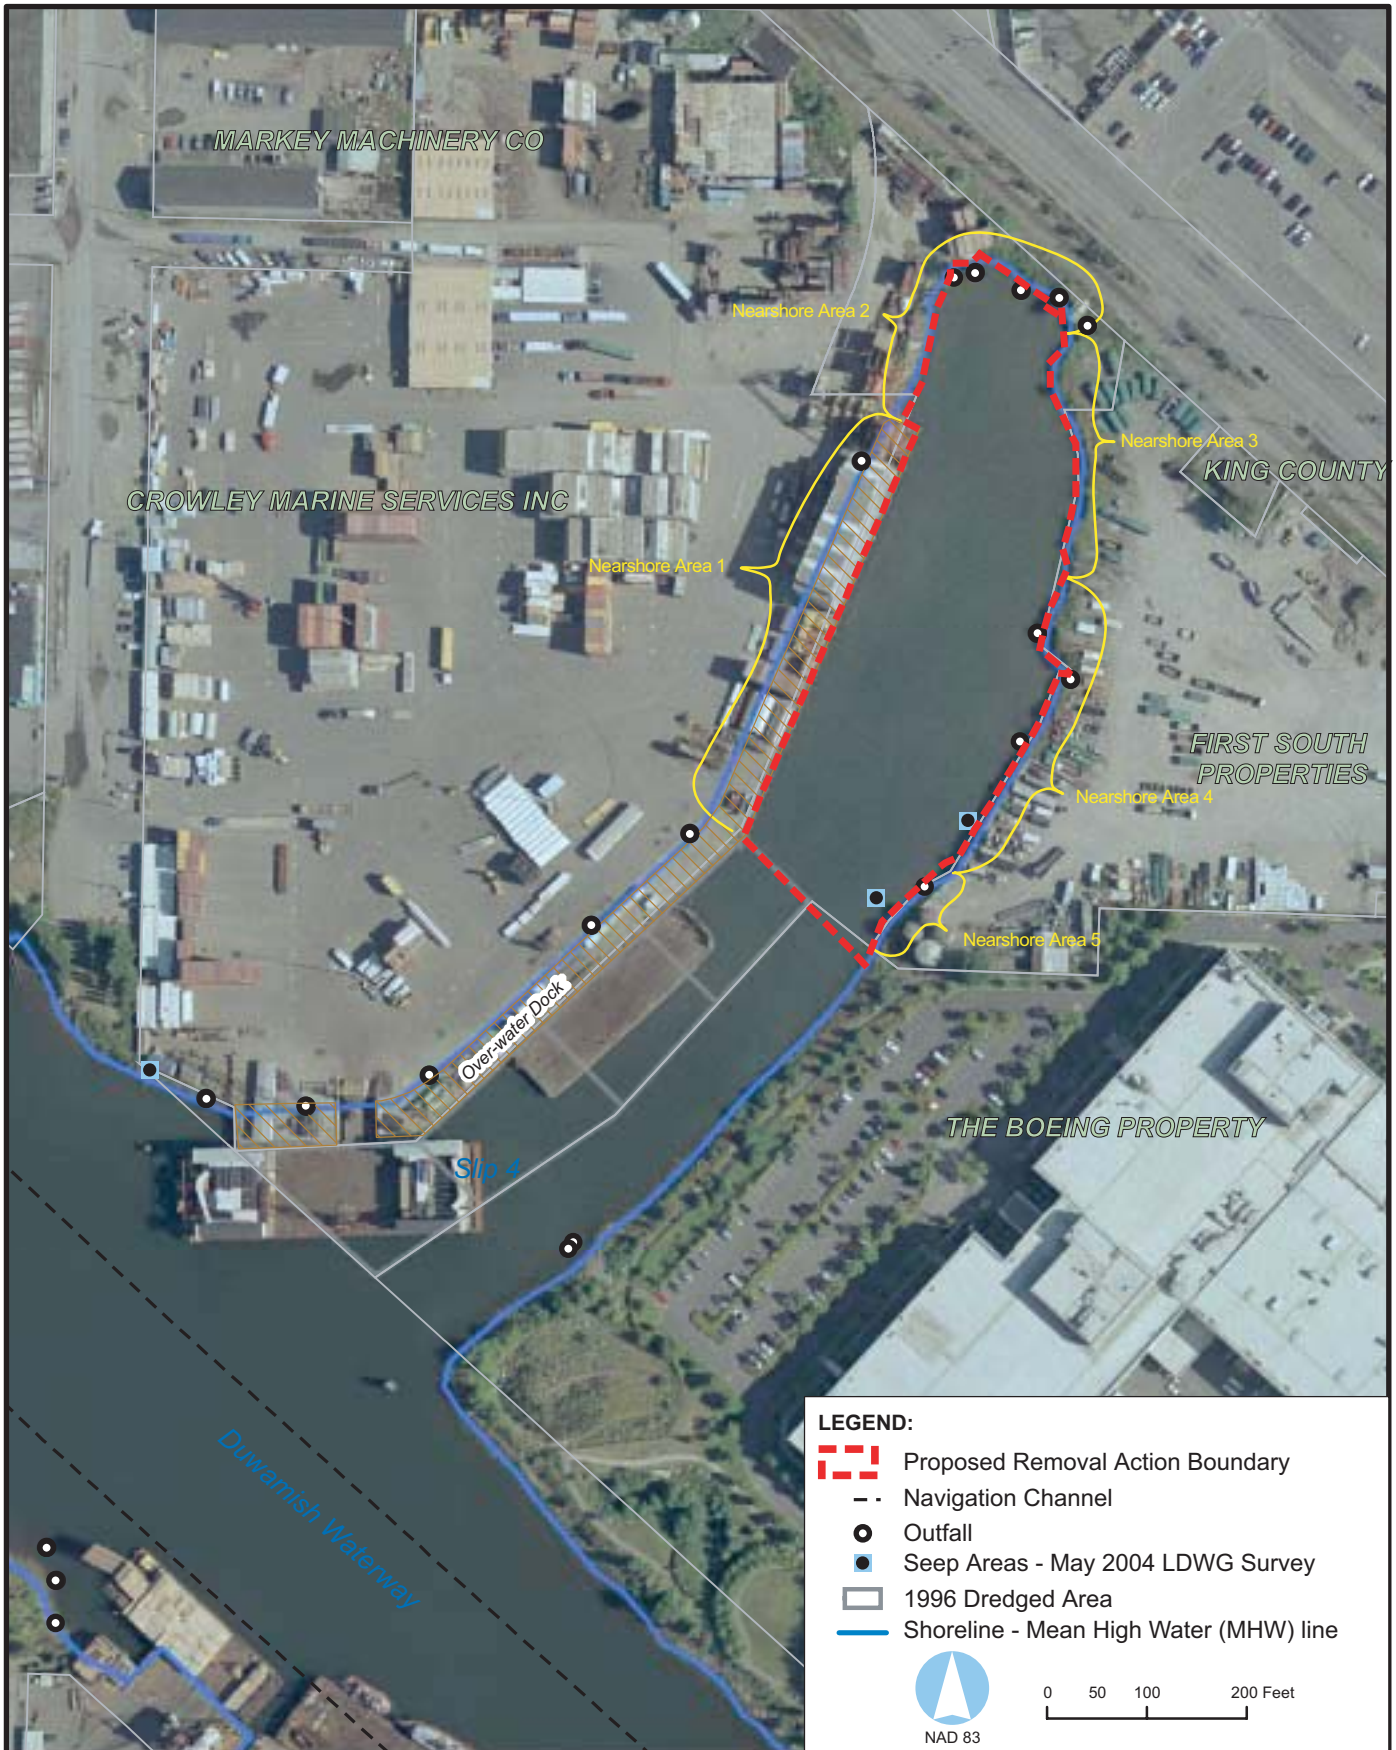
Figure 3. Slip 4 Proposed Removal Action Boundary
 Source: Integral 2006

The proposed removal area identified in the Engineering Evaluation/Cost Analysis (EE/CA) for Slip 4 includes about 3.6 acres of the northern (inner) half of the slip (Integral 2006; Figure 3). This includes all areas where surface sediments have chemical concentrations greater than the sediment quality standards (SQS) except for one isolated station with minor SQS exceedances. Sediments outside the proposed removal area will continue to be evaluated by the LDWG, EPA, and Ecology pursuant to the Lower Duwamish Waterway (LDW) RI/FS.

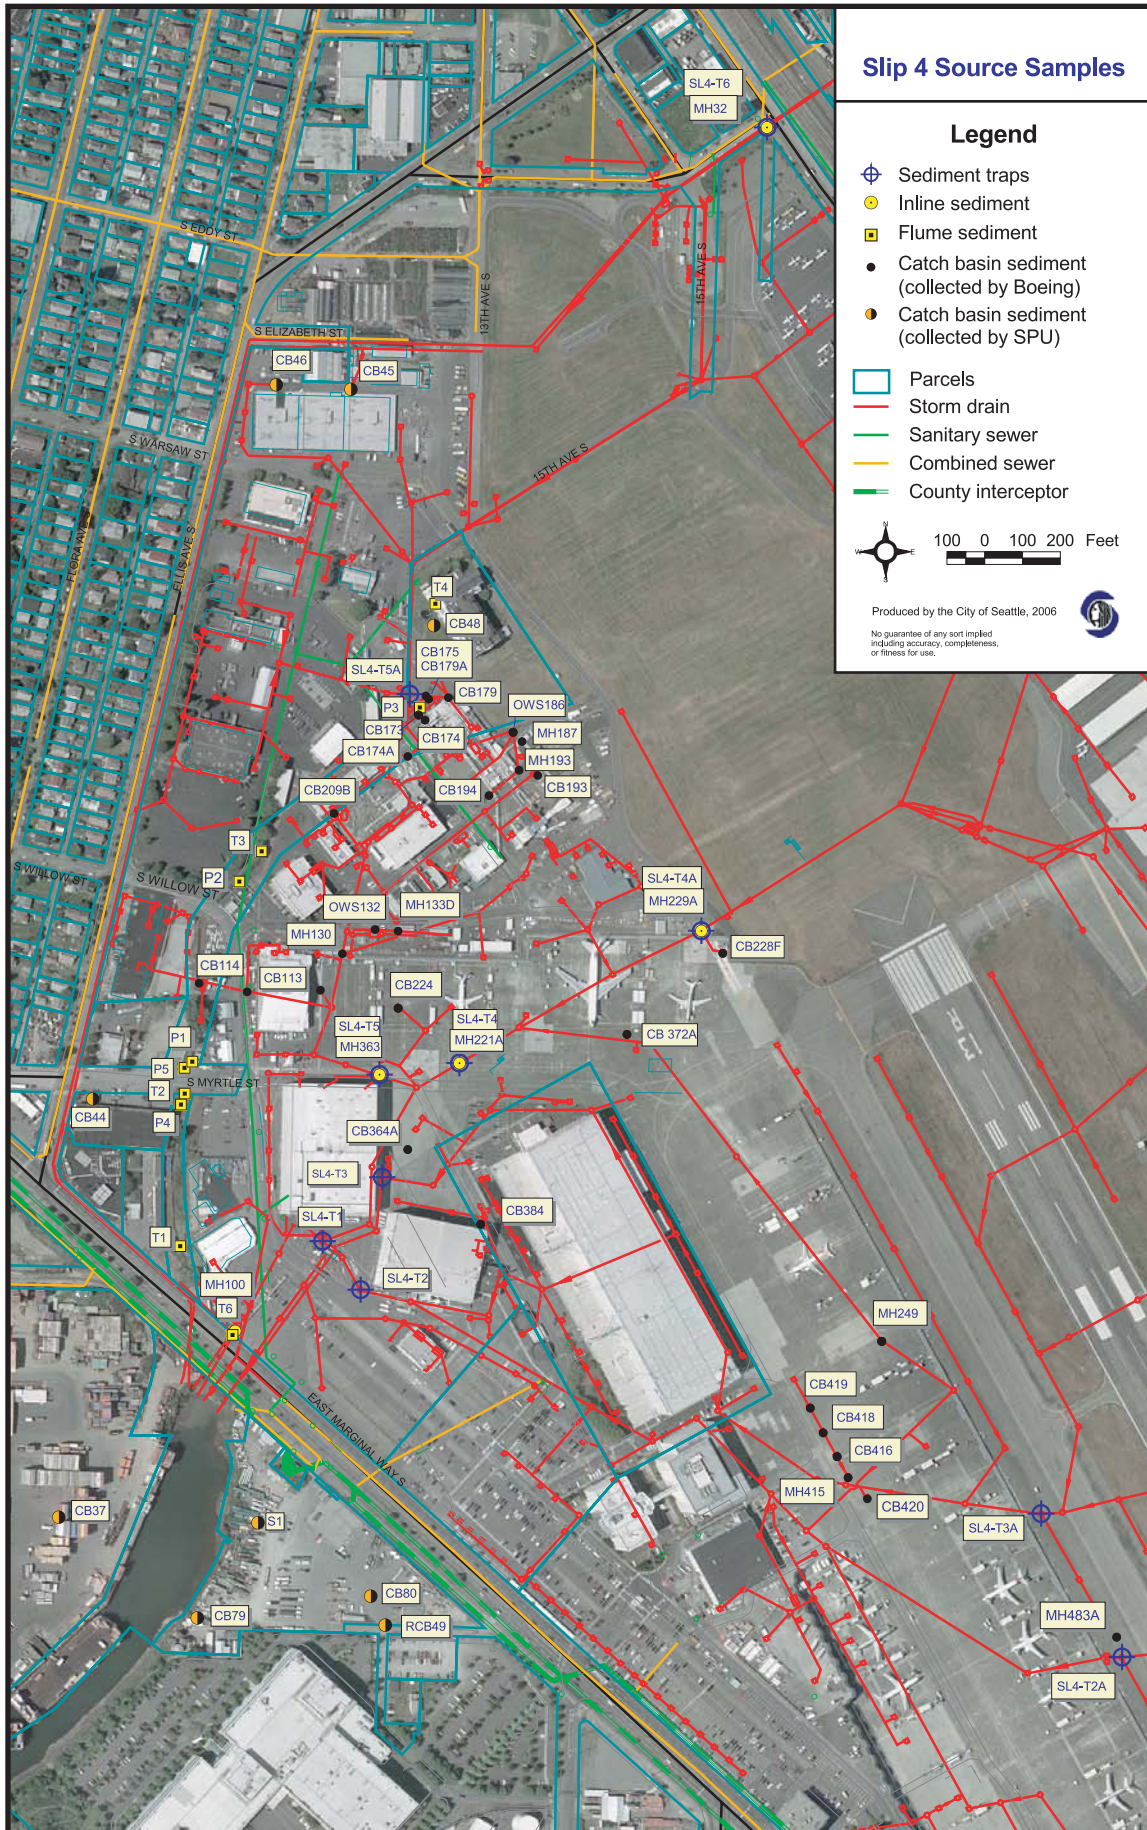
Figure 8. Slip 4 Source Samples
Adapted from: Integral 2006

In March 2005, SPU installed sediment traps at the following 10 stations in the publicly owned storm drains that discharge to Slip 4 (Figure 8):

Samples were also collected by SPU from two catch basins on the southeast corner of the property (one on S. Webster Street) that drain to the combined sewer on E. Marginal Way S. (Integral 2006). Sampling stations are shown on Figure 8, and results are provided in Tables 5 and 6. Of the two catch basins, the onsite catch basin contained elevated concentrations of BEHP (38,000 ug/kg DW, 1,418 mg/kg OC), butylbenzylphthalate (1,800 ug/kg DW, 67 mg/kg OC), dimethylphthalate (1,900 ug/kg DW, 71 mg/kg OC), and di-n-octylphthalate (1,800 ug/kg DW, 67 mg/kg OC). The catch basin on S. Webster Street did not contain contaminants above SQS or MTCA cleanup levels (Integral 2006).

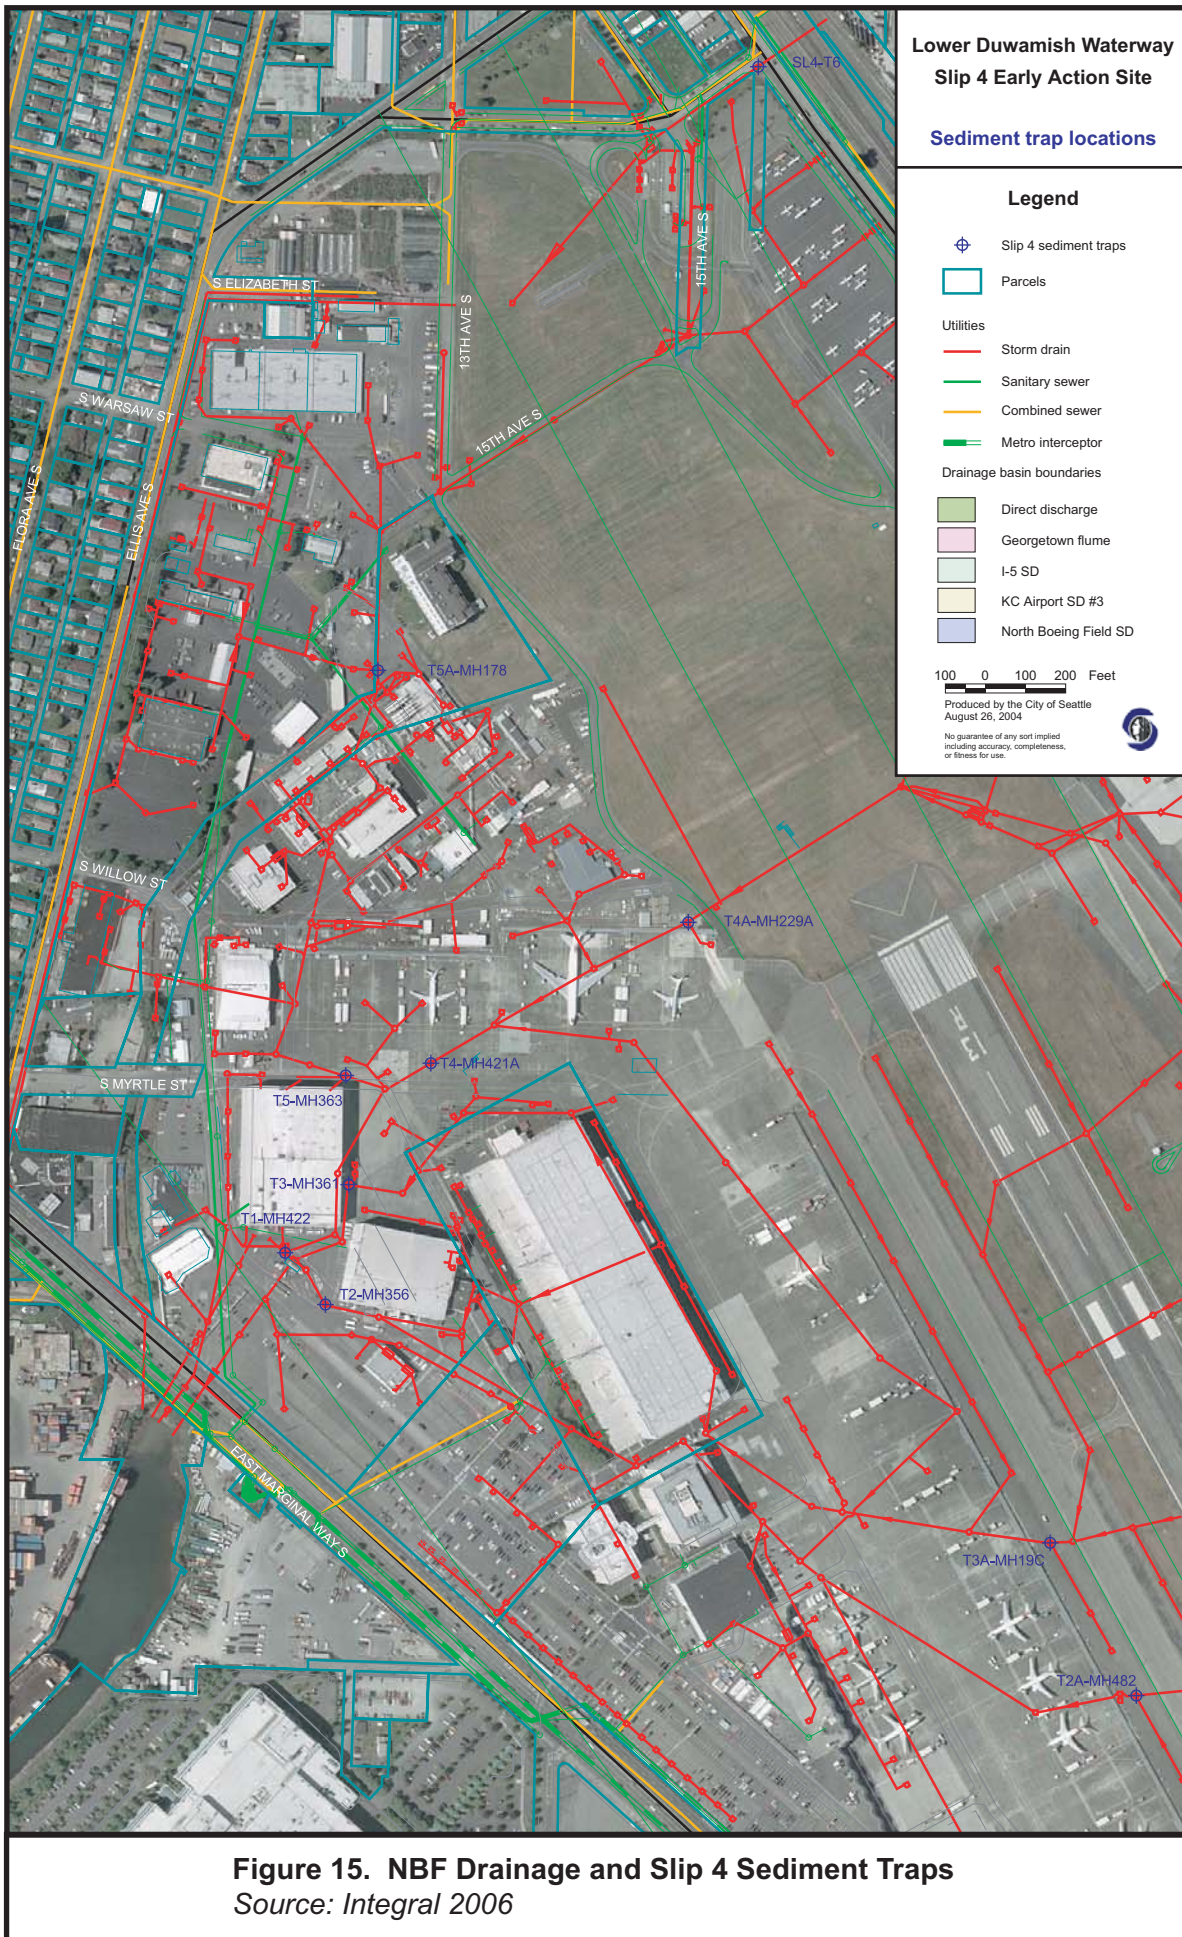
Figure 15. NBF Drainage and Slip 4 Sediment Traps
 Source: Integral 2006
