**Lower Duwamish Waterway
River Mile 2.0-2.3 East
(Slip 3 to Seattle Boiler Works)
Source Control Area**

Summary of Existing Information
and Identification of Data Gaps

Final Report

**WASHINGTON DEPARTMENT OF ECOLOGY
Toxics Cleanup Program
3190 160th Avenue SE
Bellevue, WA 98008**

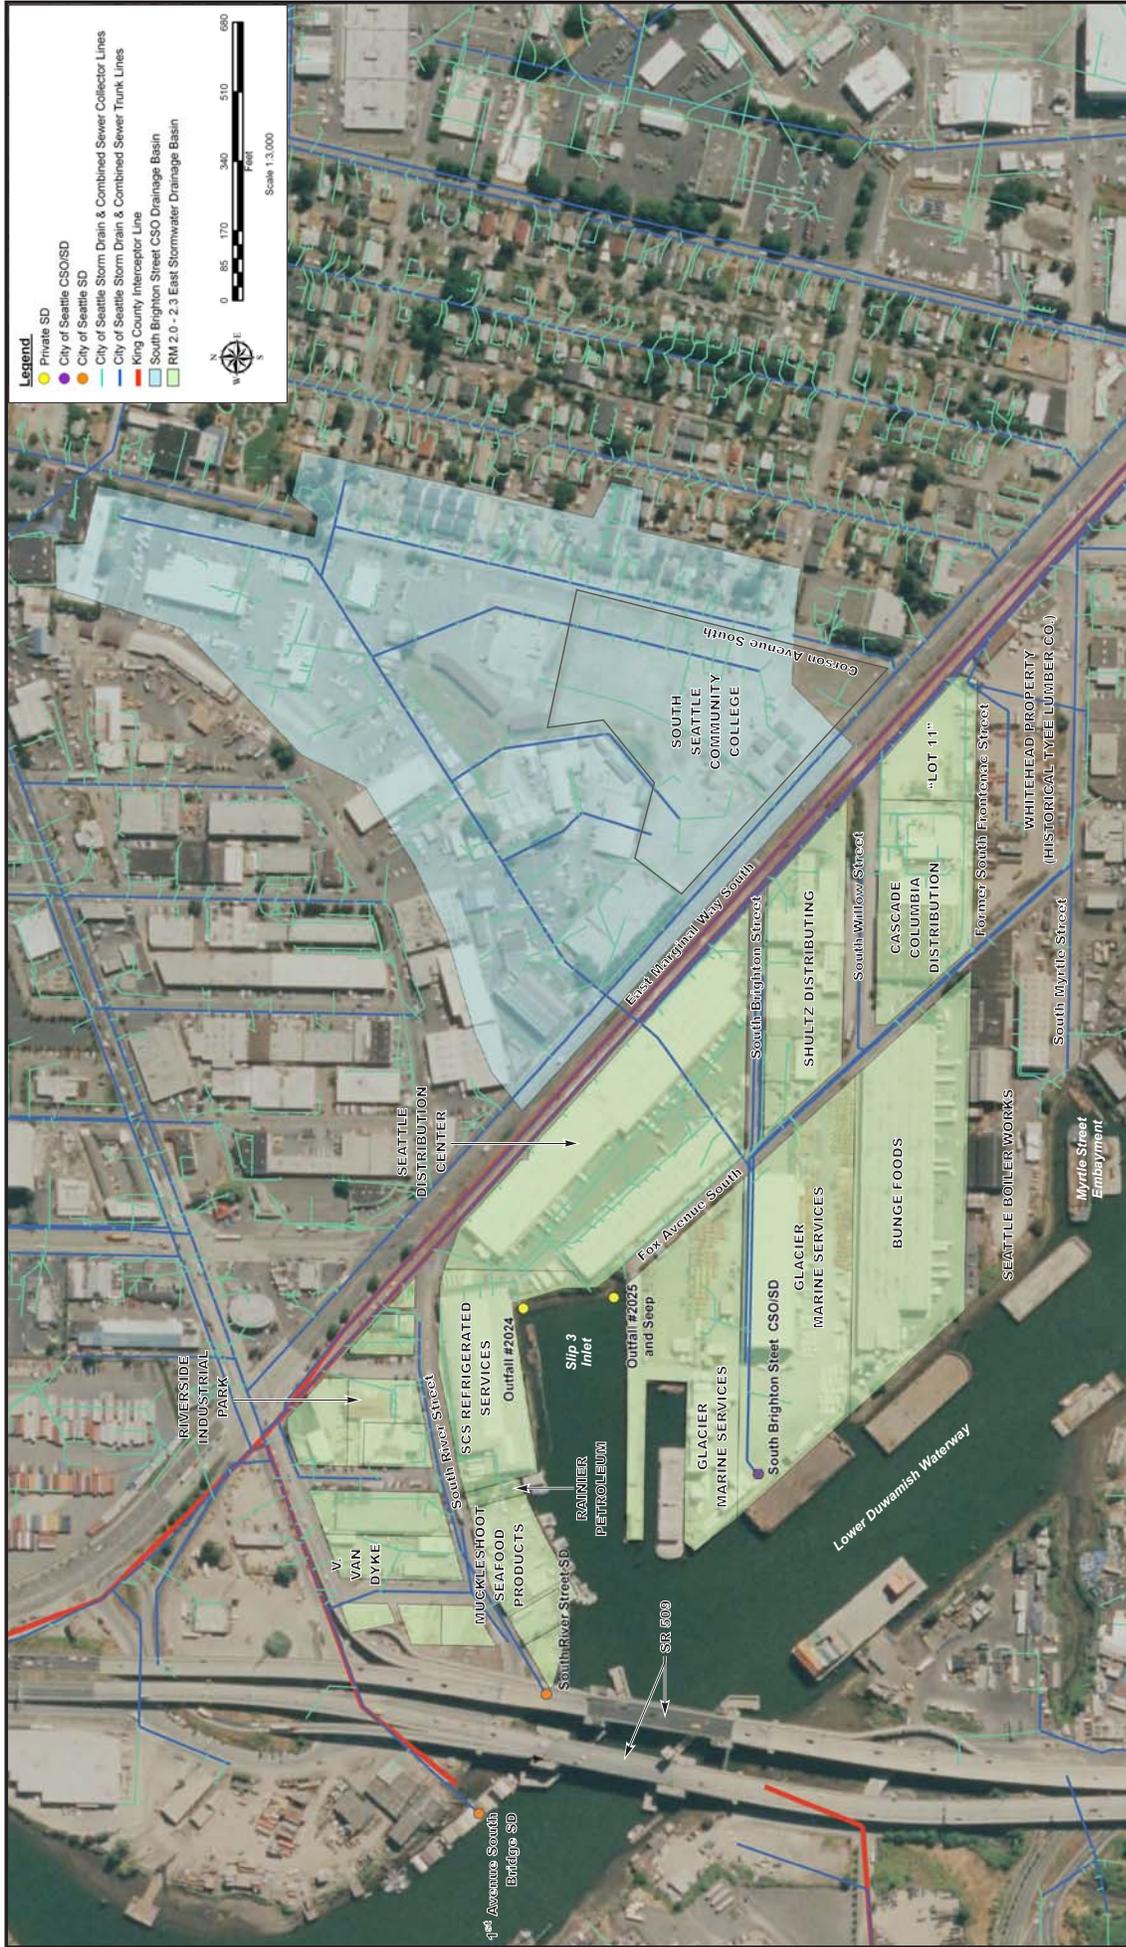
Figure 4
 STORM DRAIN SYSTEM WITHIN RM 2.0-2.3 EAST
 LOWER DUWAMISH WATERWAY
 RM 2.0-2.3 EAST
 Seattle, Washington

Base Map Reference: Ecology and Environment, Inc., GIS department, 2008.
 GIS layer depicting LDW outfalls and "steep" location provided by Seattle Public Utilities, dated September 9, 2003.
 GIS layers depicting storm drain and sewer lines provided by Seattle Public Utilities and King County.
 GIS layers depicting tax parcels and drainage basins provided by Seattle Public Utilities and King County.
 Some tax parcel polygons were edited to conform to the LDW shoreline presentation.

The RM 2.0-2.3 East drainage basin encompasses stormwater drainage under normal conditions for approximately 37 acres of commercial and industrial properties between the LDW and East Marginal Way South (Figure 3). Figures 3 and 4 also illustrate the portion of the RM 2.0-2.3 East drainage basin east of East Marginal Way South. That portion, referred to as the South Brighton Street CSO drainage basin, or combined sewer service area, encompasses 34.4 acres. The Brighton CSO/SD serves as both a storm drain and a combined sewer outfall. Stormwater and wastewater from this basin normally discharge to the King County sanitary system. However, in the event of a combined sewer overflow, this basin can discharge to the LDW through the South Brighton Street combined sewer overflow/storm drain (CSO/SD). Under normal conditions, some stormwater from areas west of East Marginal Way South discharges through the South Brighton Street CSO/SD. The South Brighton Street CSO/SD is discussed in further detail in Section 4. Storm drain and combined sewer systems are discussed in Section 2.3.

V. Van Dyke's storm drain system is shown in Figures 15 and 16. Figure 4 apparently shows the storm drain system connects to the city's storm drain system and discharges to the LDW via the South River Street SD.

V. Van Dyke's storm drain system does not appear to pass through petroleum hydrocarbon soil and groundwater contamination that exists in the vicinity of the former dispenser island and USTs (Figure 14). Figure 4 apparently shows storm drain lines at the facility pass to the east and north of the former dispenser island and USTs; however, according to the *Limited Phase II ESA*, the extent of soil and groundwater contamination is not clearly defined, and the facility's storm drain system is not clearly understood; at least two storm drains have unknown discharge points, and one storm drain may or may not have been taken offline. Therefore, soil and groundwater contamination at the property could infiltrate the storm drain system and discharge to the LDW within RM 2.0-2.3 East via the stormwater pathway.

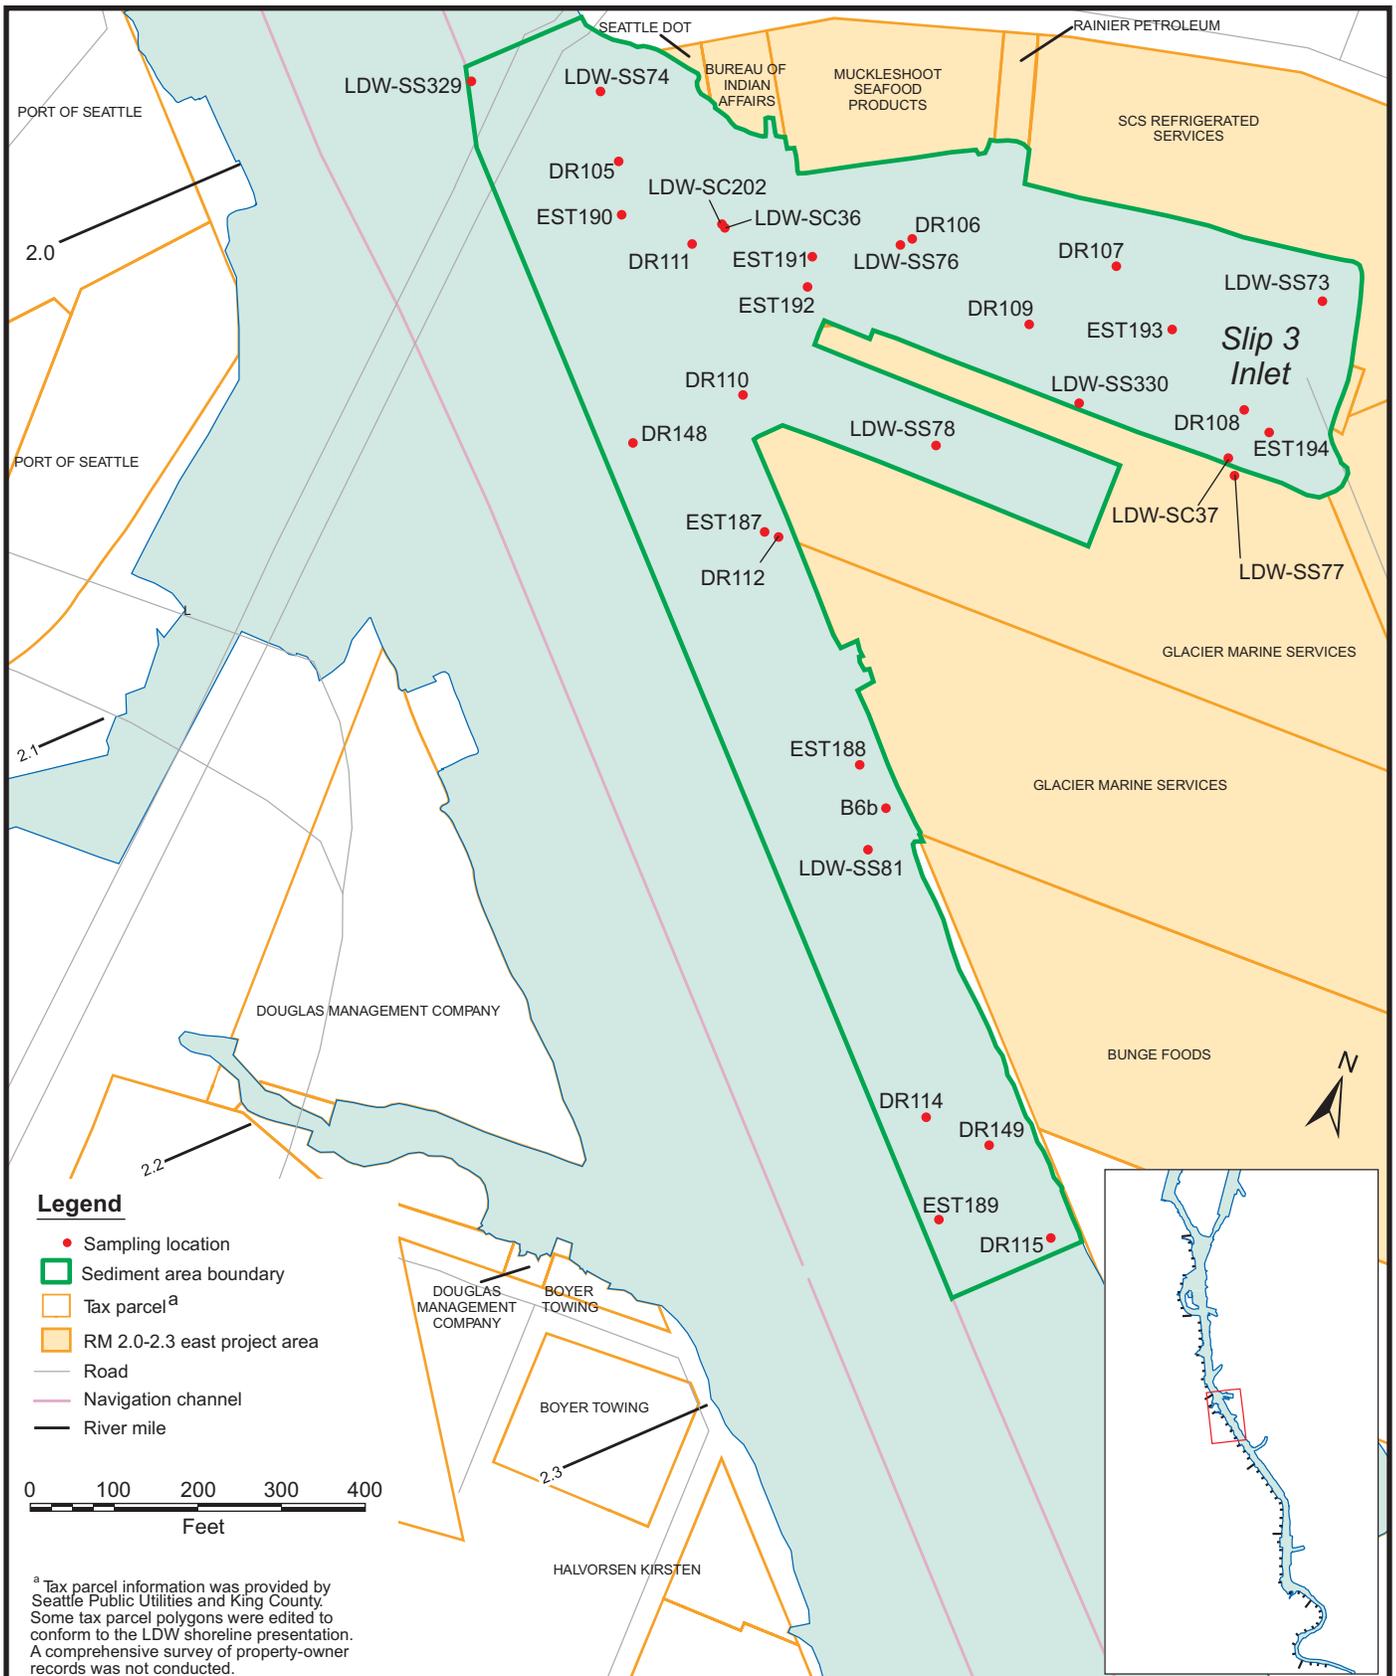
Figure 5
RM 2.0-2.3 EAST
SEDIMENT SAMPLING LOCATIONS

- Sampling location
- ▭ Sediment area boundary
- ▭ Tax parcel^a
- ▭ RM 2.0-2.3 east project area
- Road
- Navigation channel
- River mile

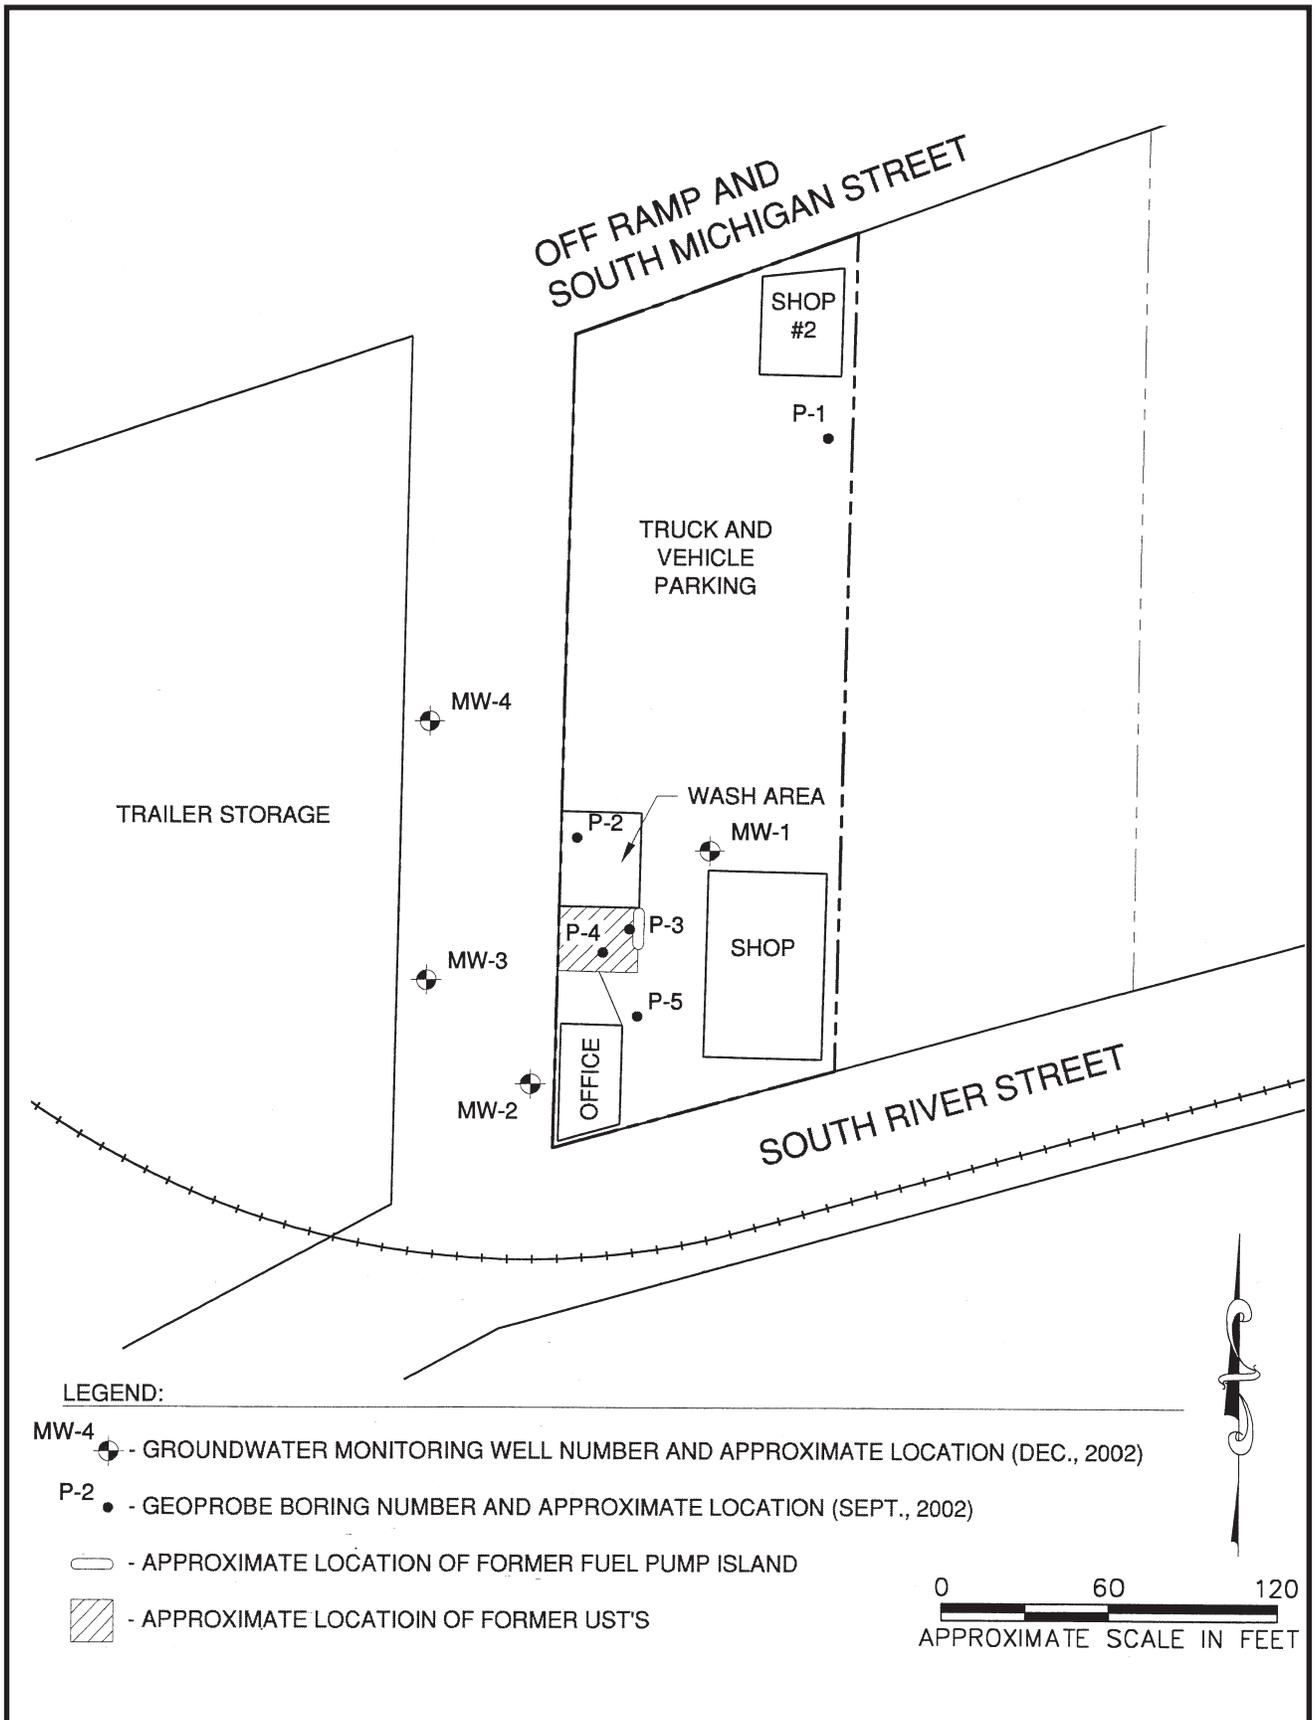
10:002330WD1403\fig 14

- MW-4

In November 2002, Adapt discovered that soil and groundwater in the vicinity of the former dispenser island and USTs (Figure 14) contained concentrations of benzene and gasoline-range petroleum hydrocarbons above MTCA Method A cleanup levels. In December 2002, four monitoring wells were installed downgradient of the existing contamination on the property. Soil and groundwater samples from these wells indicated that the contamination had not migrated off-site. Continued quarterly groundwater monitoring was recommended, but whether it was completed and what the results were are not known.

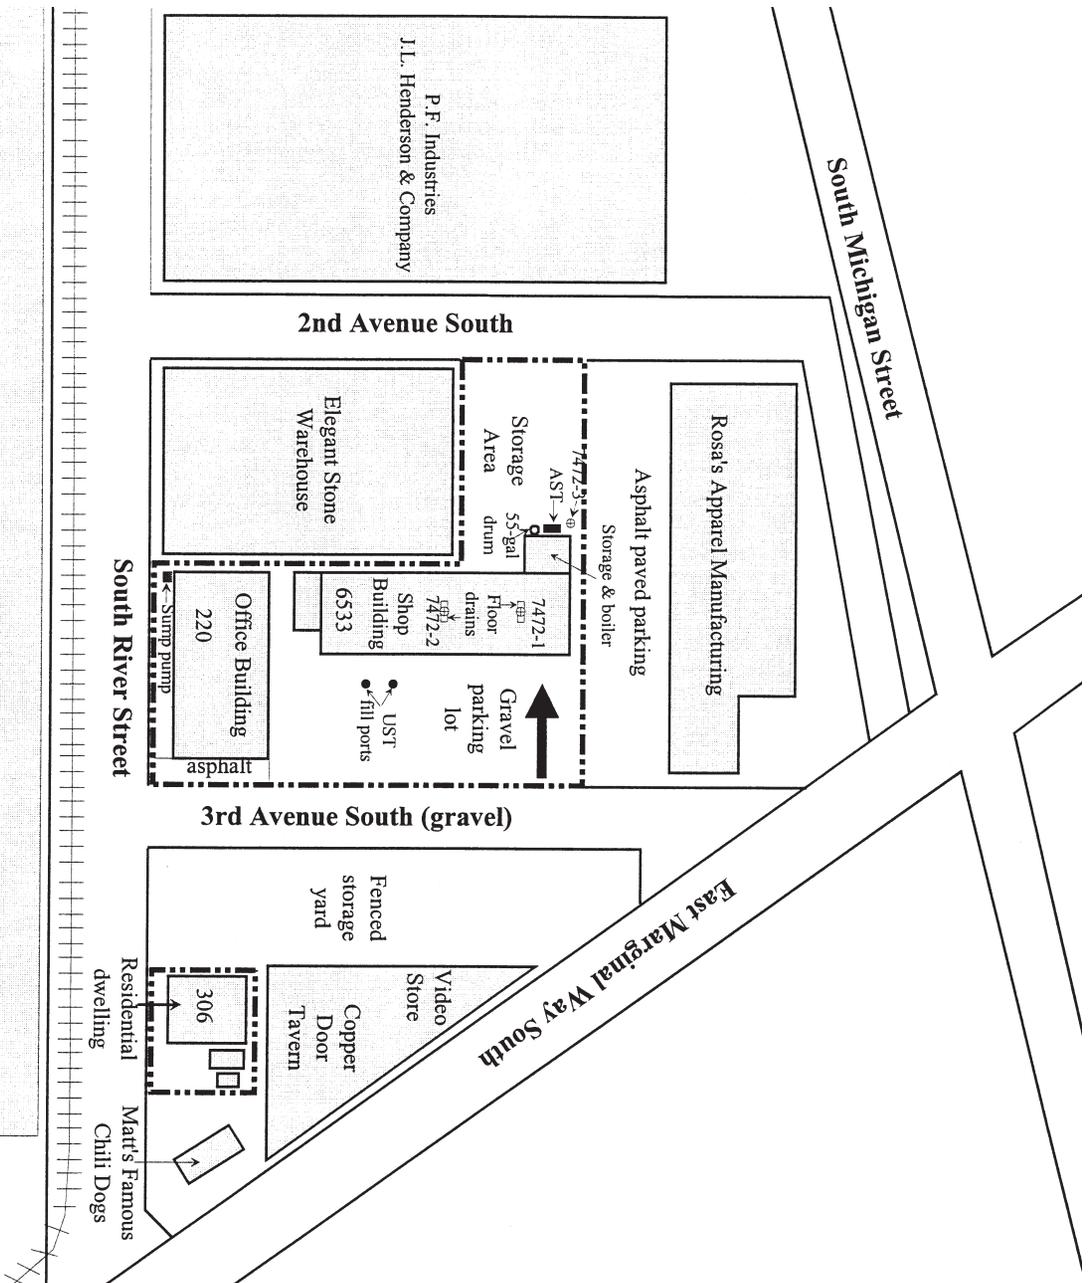
Figure 19

⊕ Approximate location of soil sample

➔ Probable direction of shallow-seated groundwater flow

<p>ecology and environment, inc. International Specialists in the Environment Seattle, Washington</p>		<p>LOWER DUWAMISH WATERWAY RM 2.0-2.3 EAST Seattle, Washington</p>		<p>FACILITY AND PHASE I SITE EXPLORATION MAP - RIVERSIDE INDUSTRIAL PARK (IN OPERATION AS BIG JOHN'S TRUCK REPAIR)</p>	
<p>Base Map Reference: Environmental Associates, Inc. 1999.</p>		<p>Date: 5-21-08</p>	<p>Drawn by: AES</p>	<p>10:002330WD1403\fig 19</p>

The most current available facility map and surrounding area is illustrated in Figure 19, and a portion of the facility can be seen in Figure 6, which is an aerial photo of the Slip 3 Inlet area taken in July 2006. As of May 1999, the shop building was vacant, other than commercial use by Lion Trucking Dispatch in the mezzanine. The office building was used commercially by the manufacturing representatives of Carmody Co. and Hardesty & Co. (EAI 1999c).

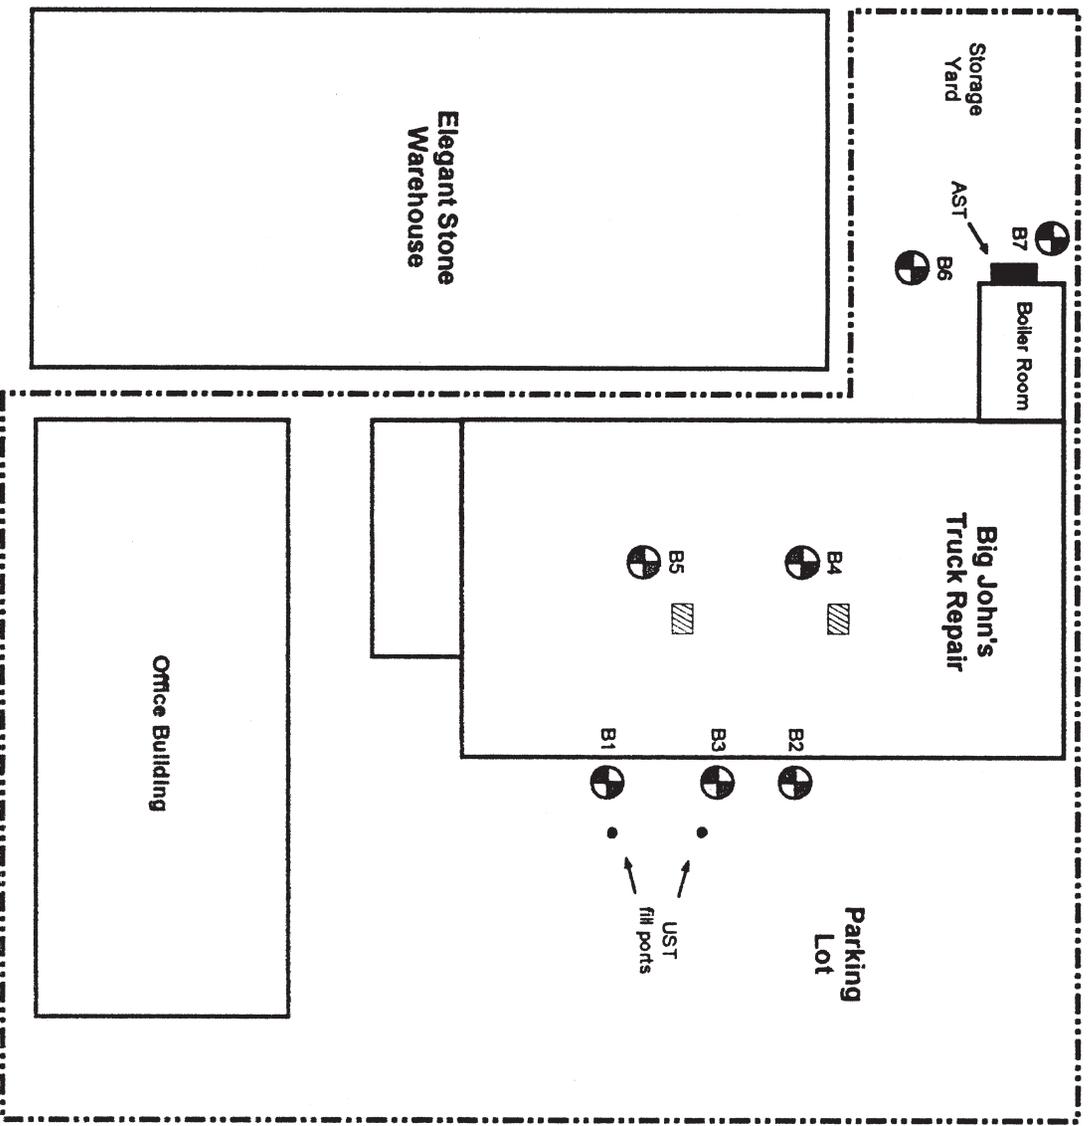
<p>ecology and environment, inc. International Specialists in the Environment Seattle, Washington</p>	<p>LOWER DUWAMISH WATERWAY RM 2.0-2.3 EAST Seattle, Washington</p>		<p>1998 PHASE II SUBSURFACE EXPLORATION MAP - RIVERSIDE INDUSTRIAL PARK (IN OPERATION AS BIG JOHN'S TRUCK REPAIR)</p>	
	<p>Base Map Reference: Geotech Consultants 1998.</p>	<p>Date: 5-21-08</p>	<p>Drawn by: AES</p>	<p>10:002330WD\403\fig 20</p>

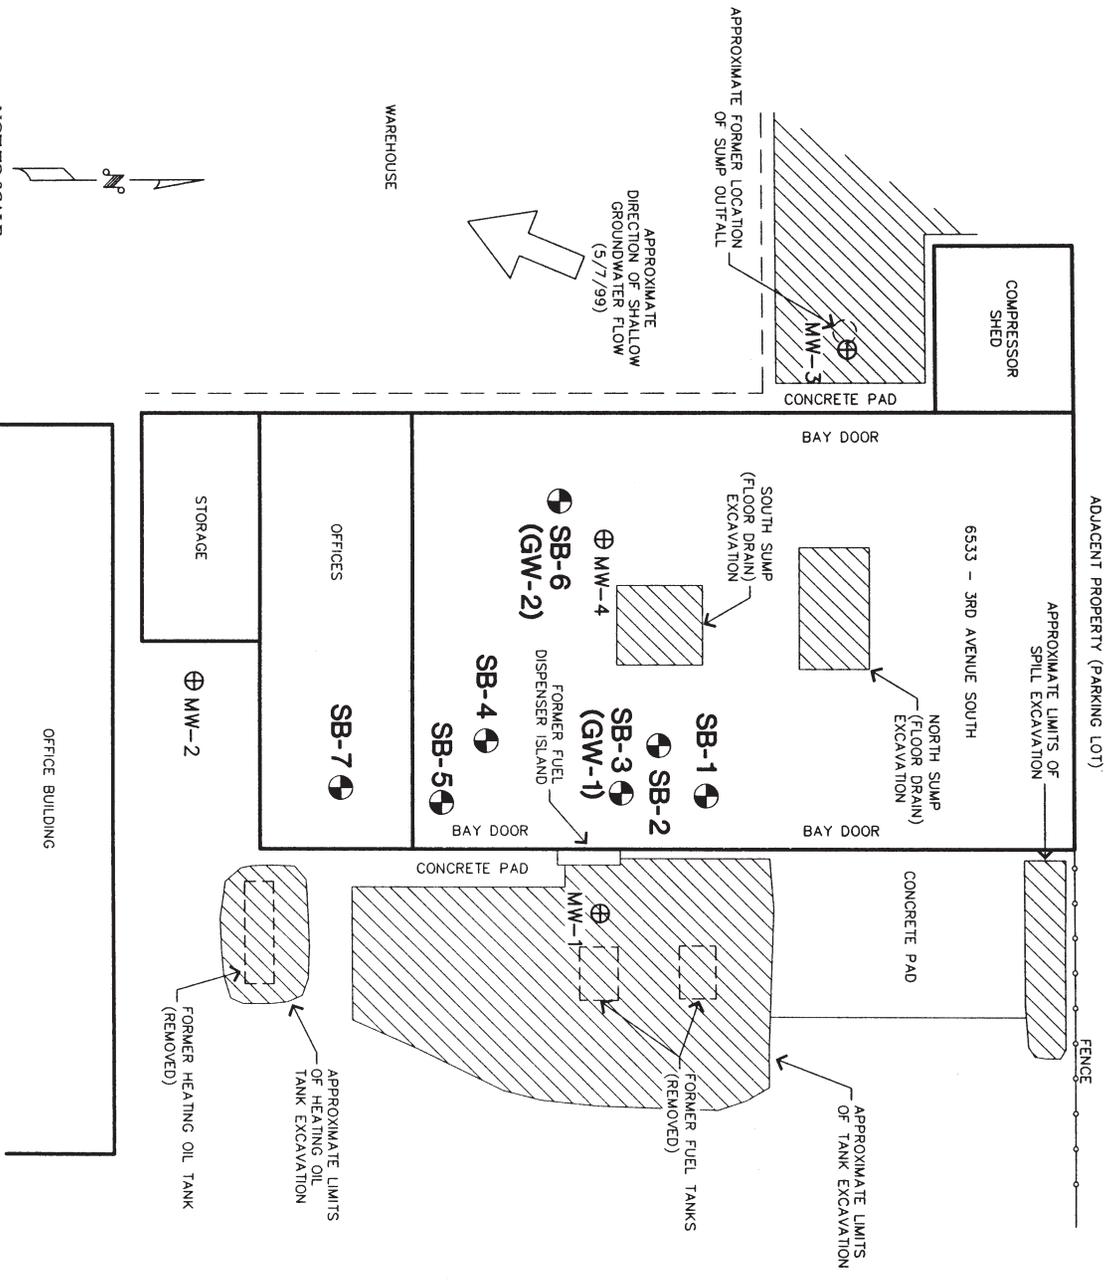
Figure 22

- LEGEND**
- ⊕ MW-1 APPROXIMATE LOCATION OF MONITORING WELL BY OTHERS
 - ⊕ SB-1 SOIL BORING LOCATION BY PBS ENVIRONMENTAL (6/99)
 - ▨ FORMER EXCAVATION

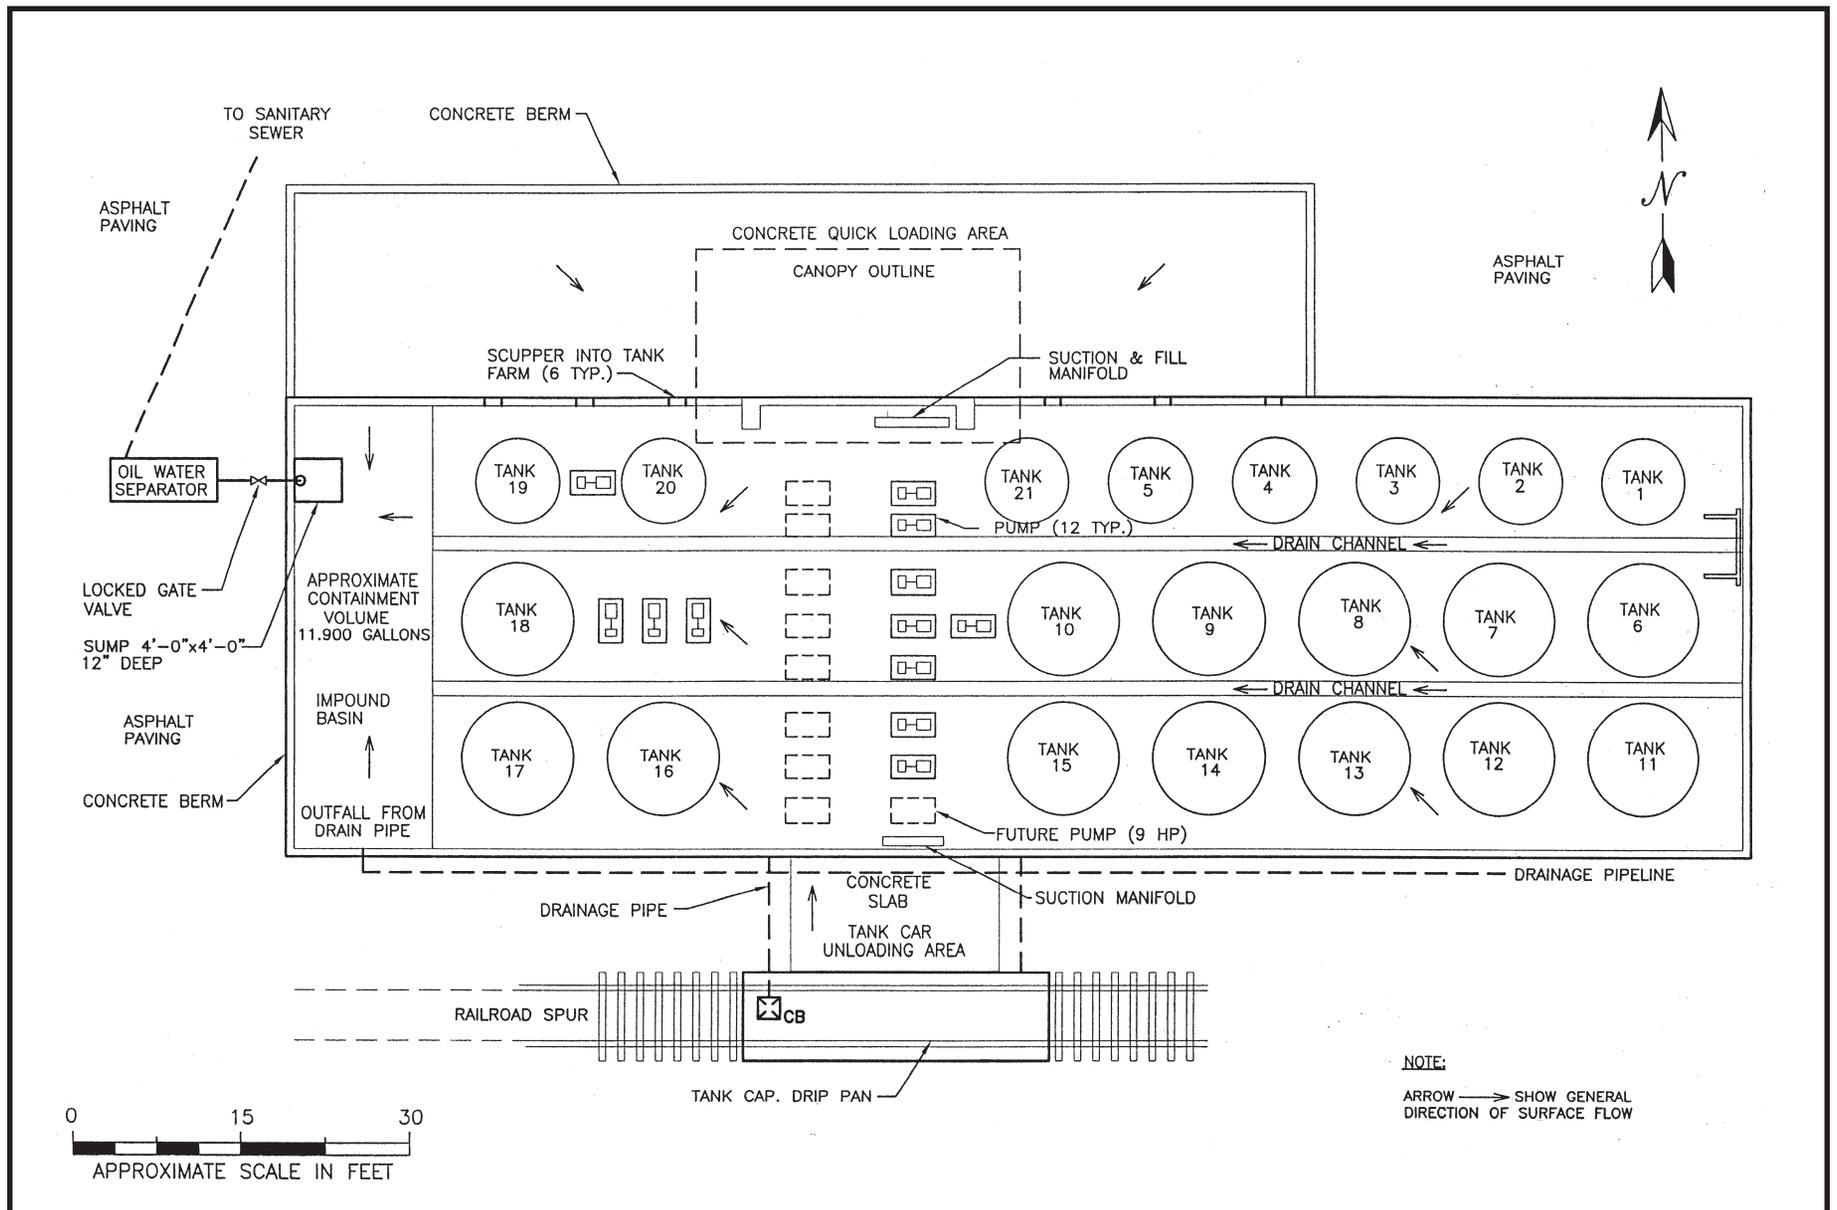
<p>ecology and environment, inc. International Specialists in the Environment Seattle, Washington</p>	<p>LOWER DUWAMISH WATERWAY RM 2.0-2.3 EAST Seattle, Washington</p>	<p>Figure 24 STORM DRAIN SYSTEM AND TANK LOCATIONS - SHULTZ DISTRIBUTING</p>		
	<p>Base Map Reference: EMR Incorporated</p>	<p>Date: 5/21/08</p>	<p>Drawn by: AES</p>	<p>10:002330WD1403\fig24</p>

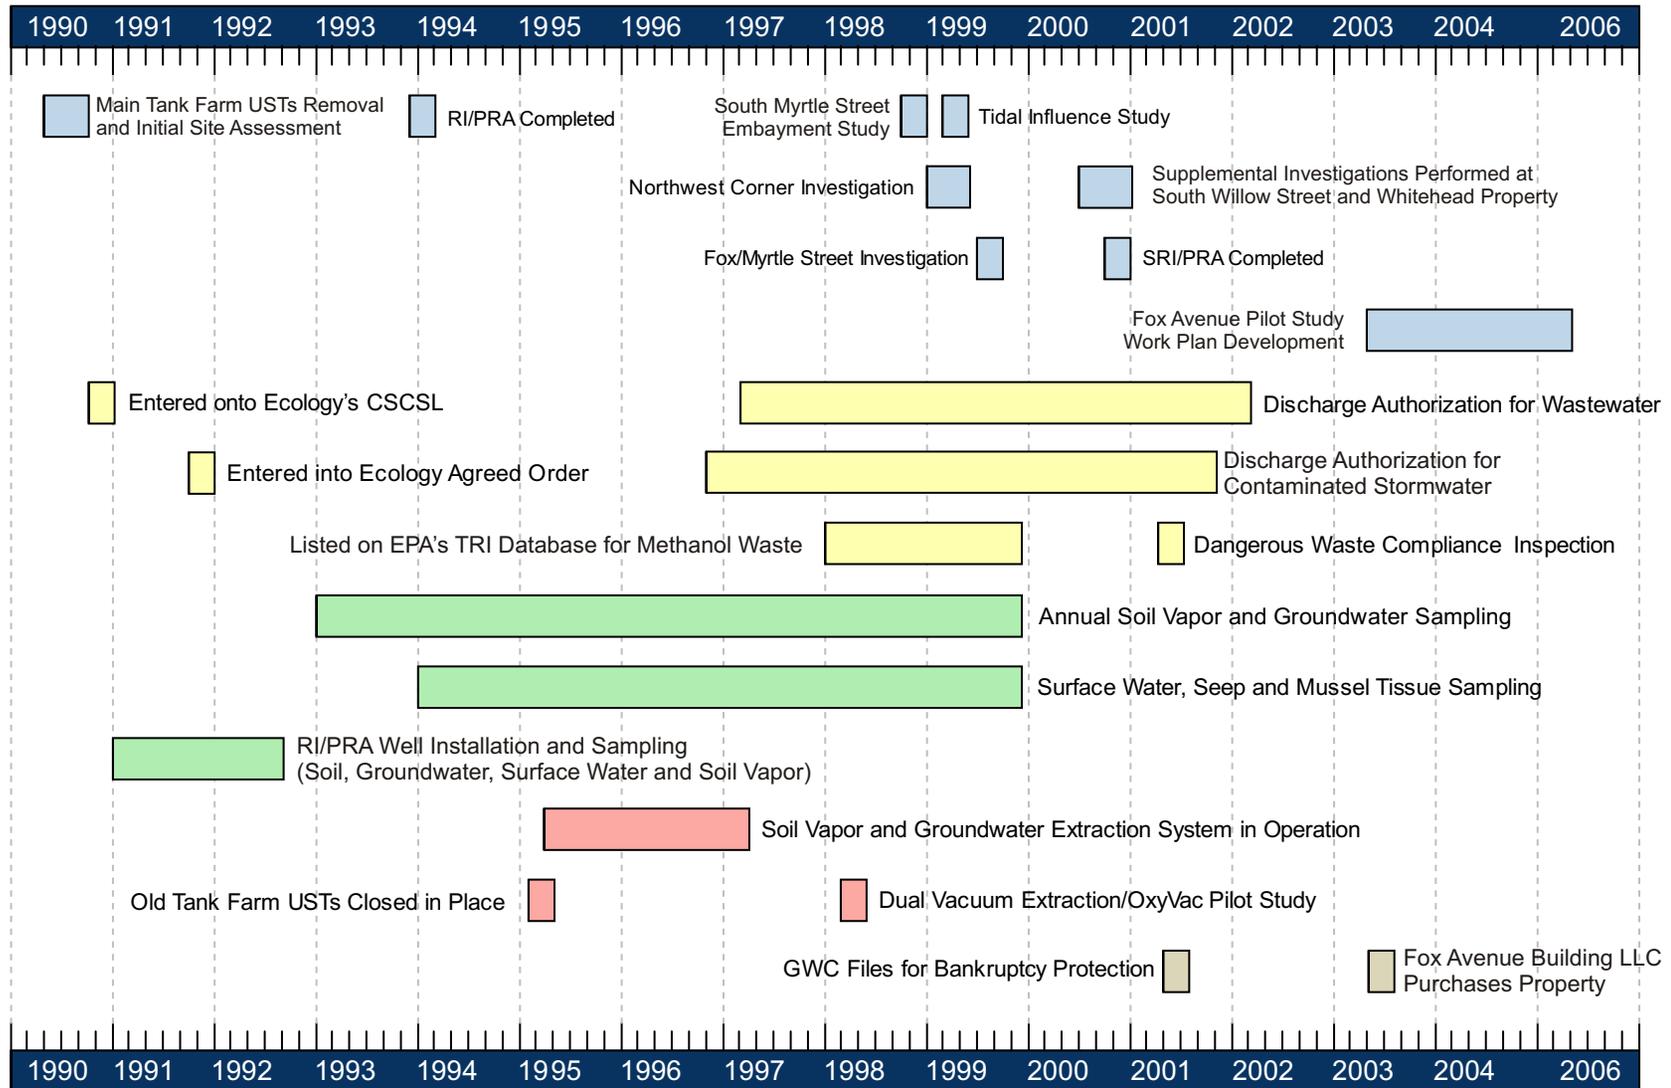
Figure 30
TIMELINE - CASCADE COLUMBIA
DISTRIBUTION PROPERTY

Legend: ■ Investigations ■ Agency Actions ■ Monitoring ■ Cleanup Activities ■ Other

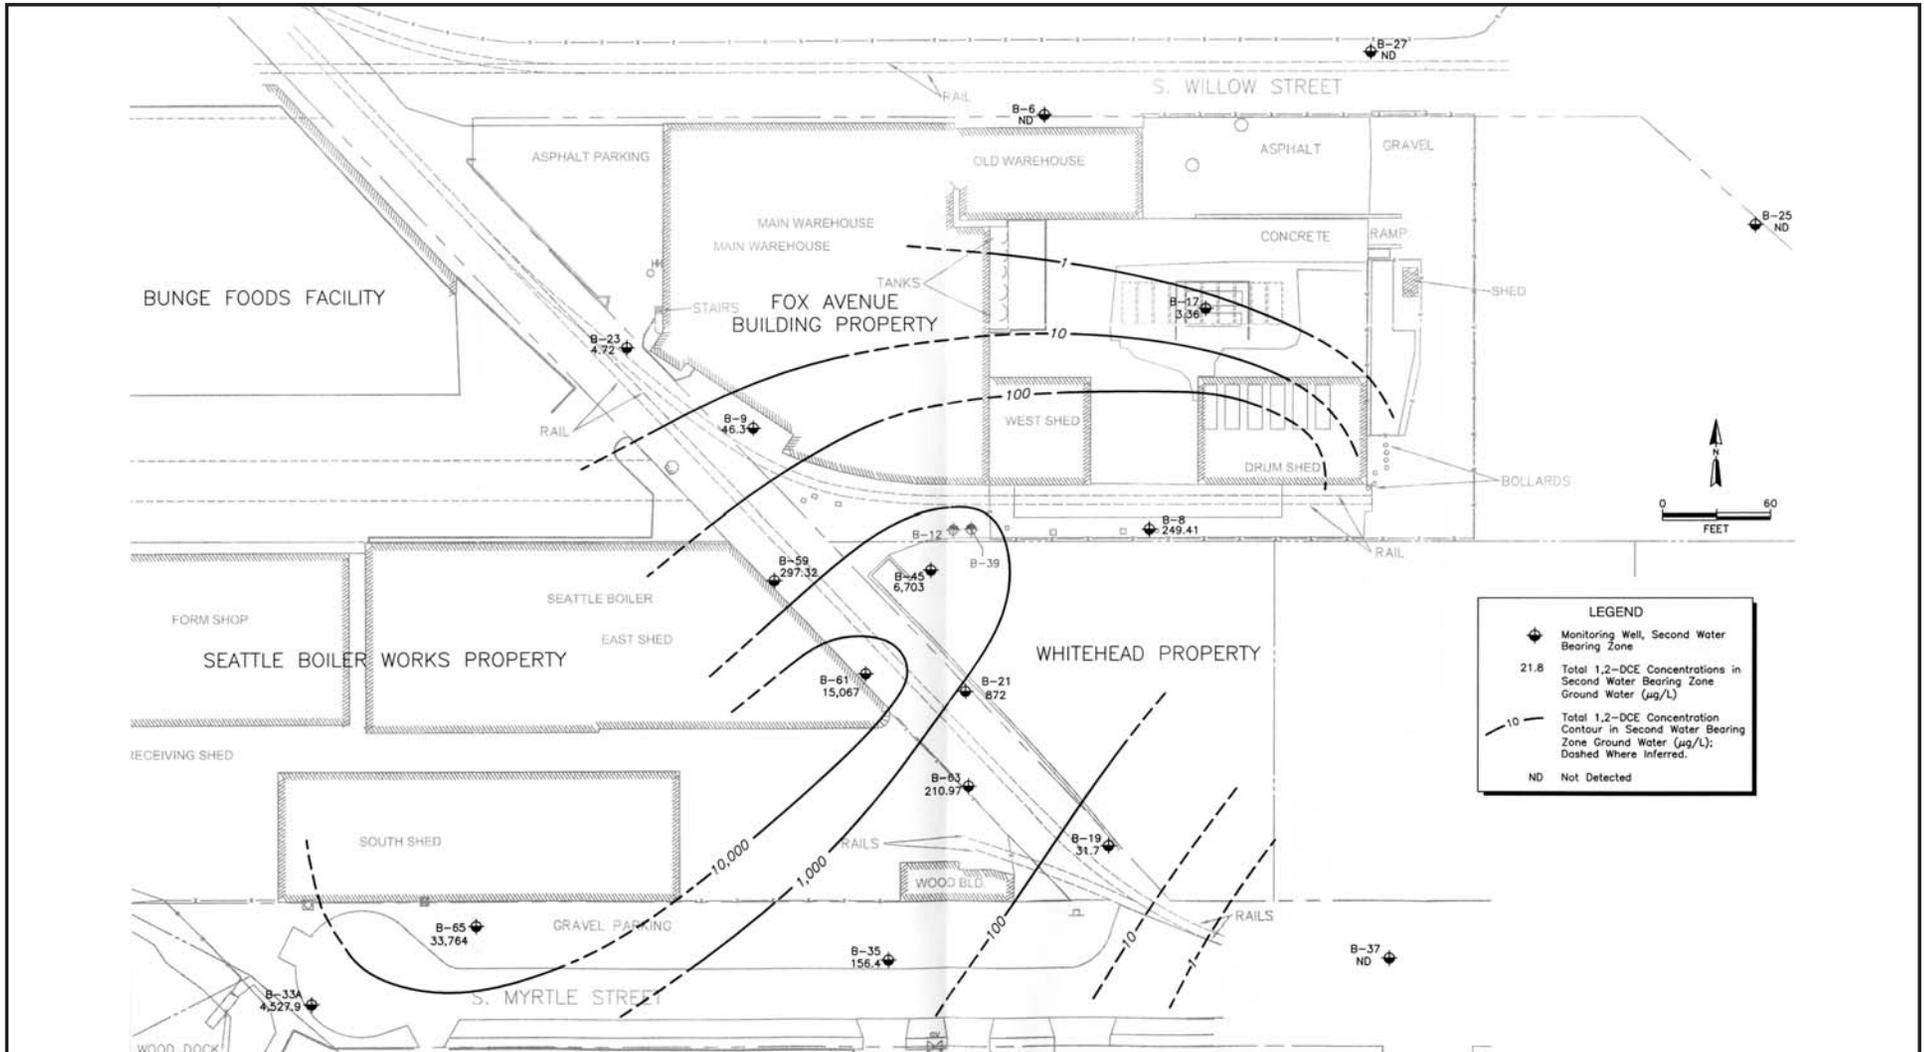
Figure 56
 1,2-DCE IN 2nd WBZ GROUNDWATER (FOX AVENUE PILOT STUDY) -
 CASCADE COLUMBIA DISTRIBUTION

- ◆ Monitoring Well, Second Water Bearing Zone
- 21.8 Total 1,2-DCE Concentrations in Second Water Bearing Zone Ground Water (µg/L)
- 10 Total 1,2-DCE Concentration Contour in Second Water Bearing Zone Ground Water (µg/L); Dashed Where Inferred.
- ND Not Detected

- Figure 54 TCE in 2nd WBZ Groundwater (Fox Avenue Pilot Study) – Cascade Columbia Distribution
- Figure 55 PCE in 2nd WBZ Groundwater (Fox Avenue Pilot Study) – Cascade Columbia Distribution
- Figure 56 1,2-DCE in 2nd WBZ Groundwater (Fox Avenue Pilot Study) – Cascade Columbia Distribution
- Figure 57 VC in 2nd WBZ Groundwater (Fox Avenue Pilot Study) – Cascade Columbia Distribution

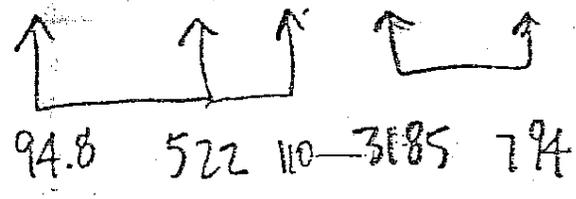
Relative concentrations of heavy metals

Upper	Fox & drain	below drain	drake runoff	Syners Lift (sediment)	Syners Lift (water)	dry drake	west drake	Co...
Pb	.17	.12	.09	.06	.10	.06	.03	.15	.1
As	.07	.31	.13	.07	.05	.06	.46	.39	.1
Zn	.54	.46	.61	.45	.48	.46	.35	.27	.1
Cu	.21	.10	.17	.41	.37	.41	.14	.17	.1

Total	92	11926	1640	94.8	522	110	3185	794	12
	metal concentrations
