Lower Duwamish Waterway Source Control Action Plan for Early Action Area 7

September 2007

Publication No. 07-09-003

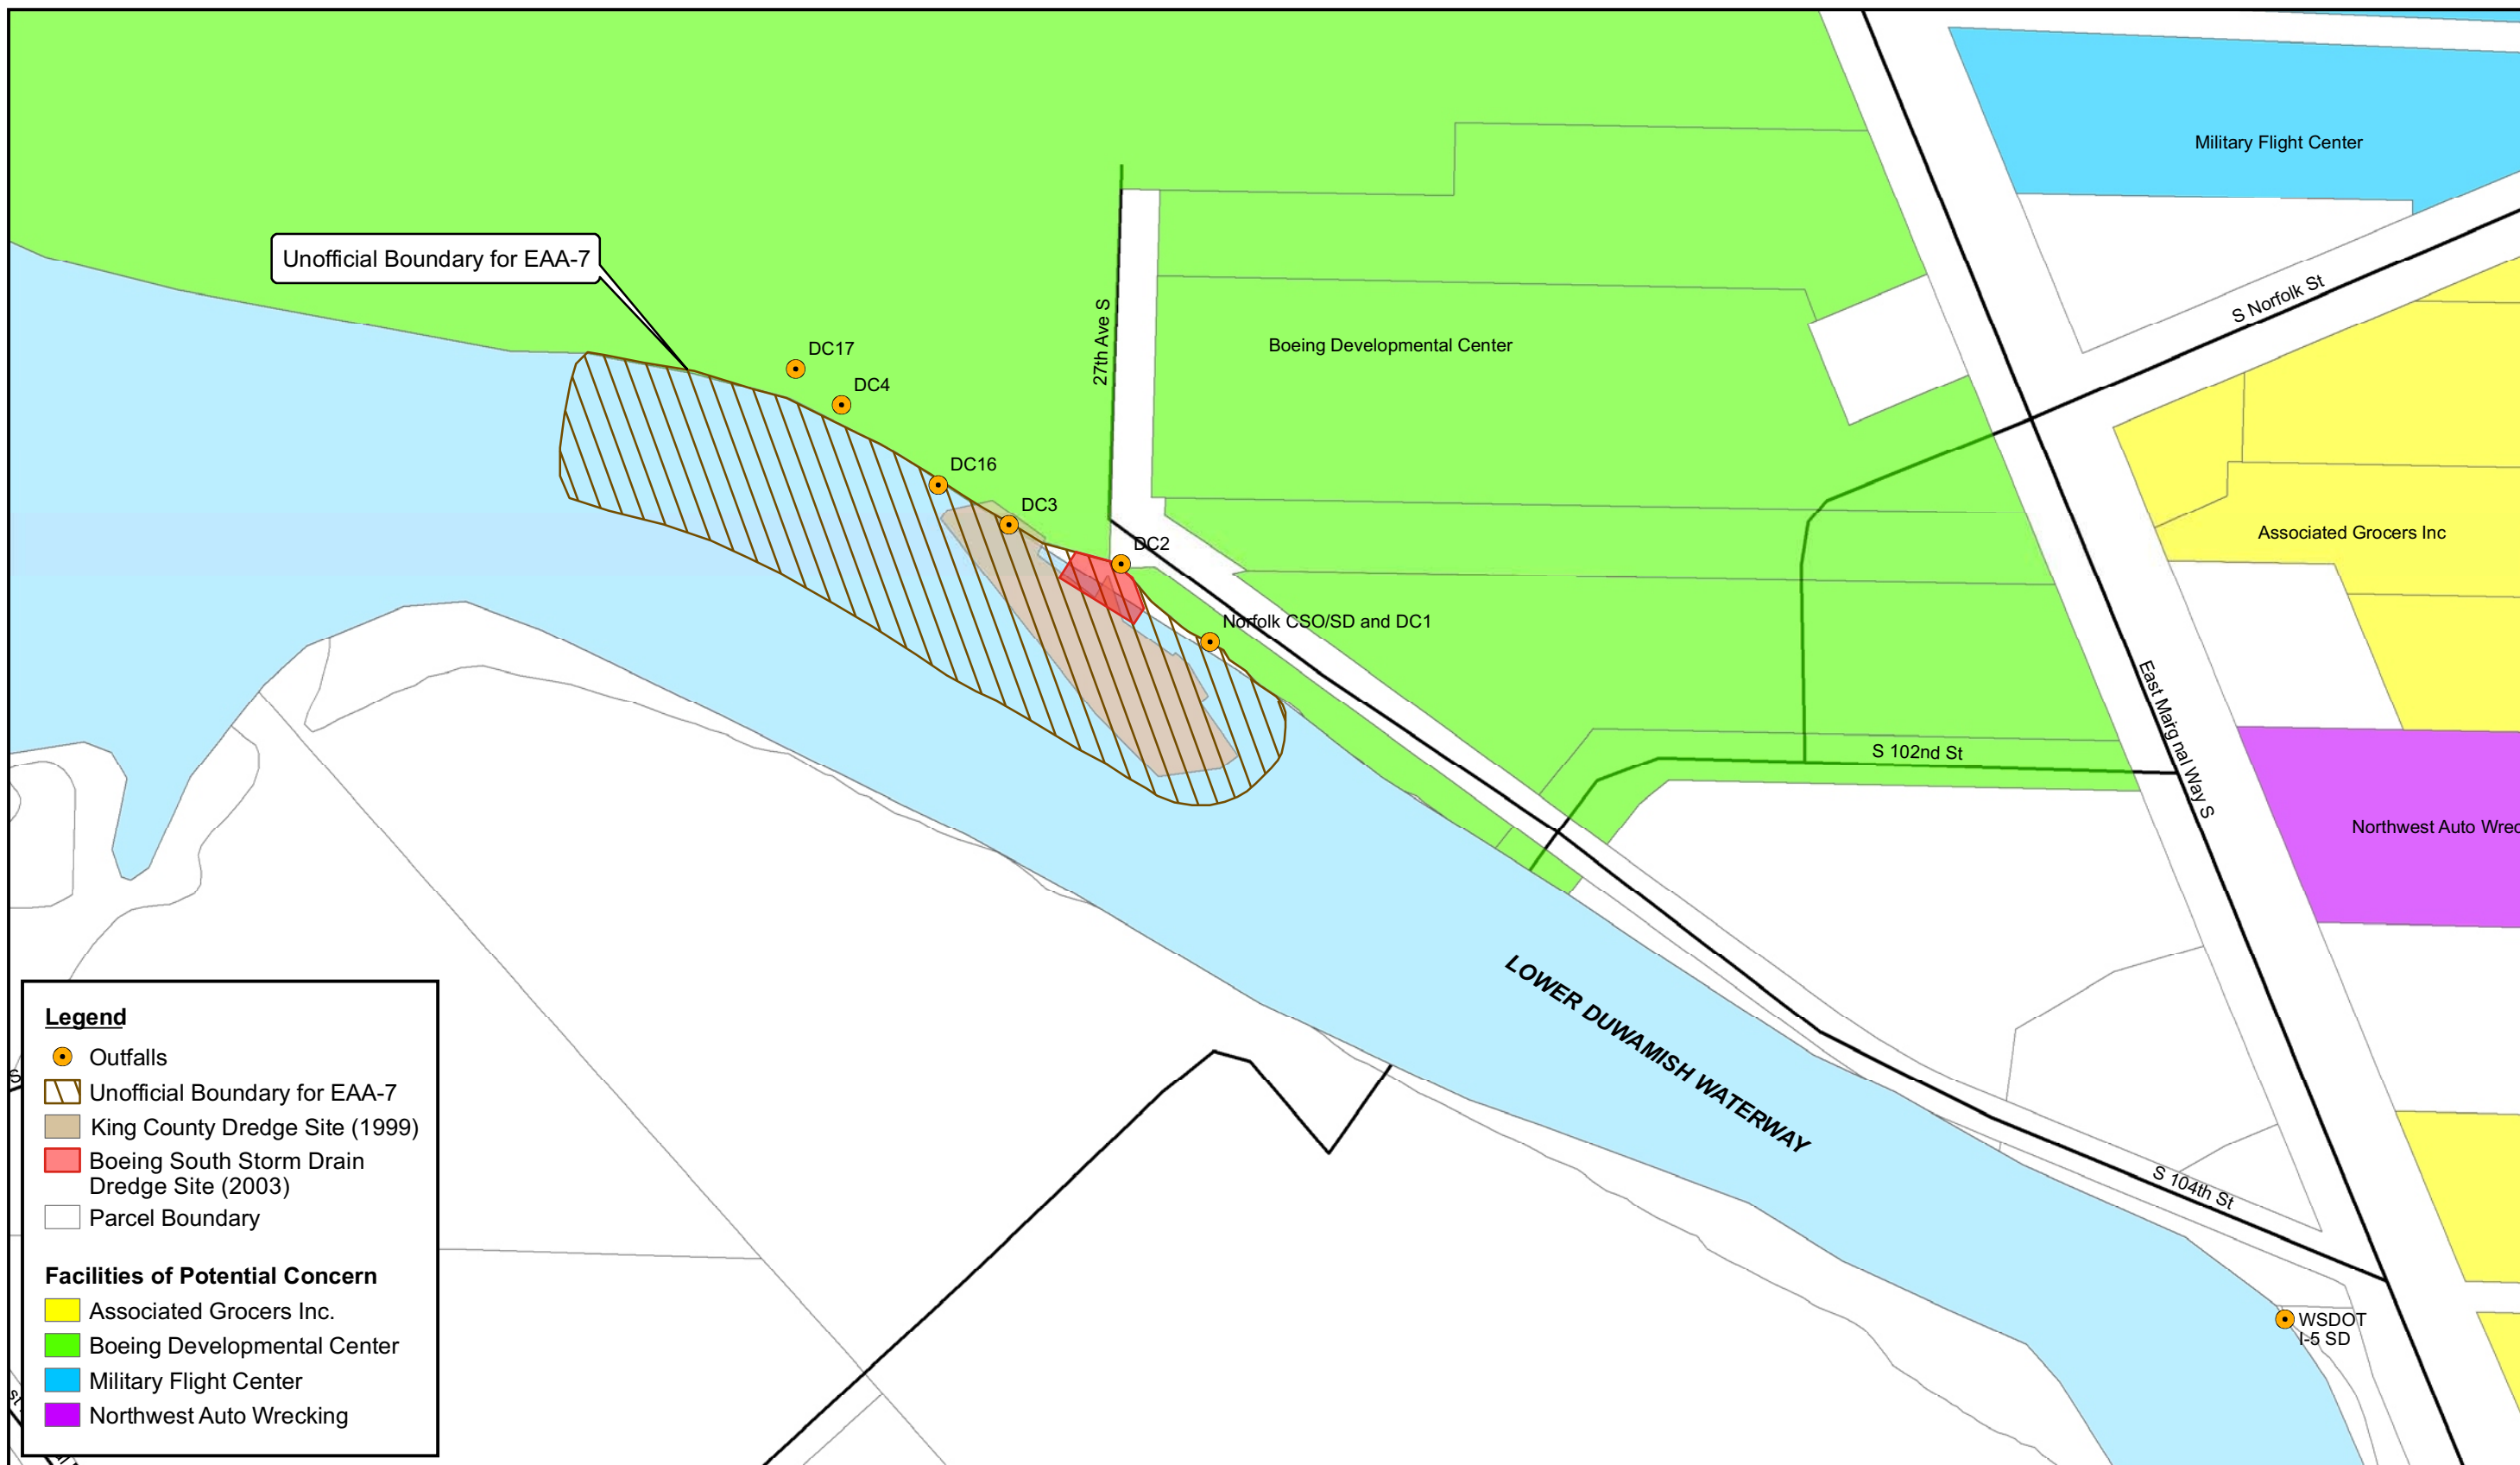
- Outfalls
- ▨ Unofficial Boundary for EAA-7
- ▨ King County Dredge Site (1999)
- Boeing South Storm Drain Dredge Site (2003)
- Parcel Boundary

EAA-7 is located between 4.8 and 5.0 miles from the south end of Harbor Island on the east bank of the LDW. The location of EAA-7 is shown in Figure 1 (labeled 7. Norfolk CSO Area). This area is adjacent to the outfalls of the Norfolk CSO/SD and private storm drains at the Boeing Developmental Center (BDC). The locations of the Norfolk CSO/SD outfall and the private storm drain outfalls at BDC are shown in Figure 2.

Point discharges to the LDW within EAA-7 include the Norfolk CSO/SD and five private discharge points or outfalls owned by Boeing (BDC discharge points DC17, DC4, DC16, DC3, and DC2), illustrated in Figures 2 and 4. Figure 5 presents a photograph provided by Ecology that shows BDC discharge point DC2 in relation to the Norfolk SCO/SD outfall. According to the Stormwater Pollution Prevention Plan (SWPPP) for the BDC, a sixth private storm drain system owned by Boeing connects to the Norfolk CSO/SD at discharge point DC1, located a short distance upstream of the Norfolk CSO/SD's outfall into the LDW. Discussion of discharge point DC1 is included in the discussion of the Norfolk CSO/SD below. Known private and public drain lines and discharge points to the LDW are discussed in Section 3.1.

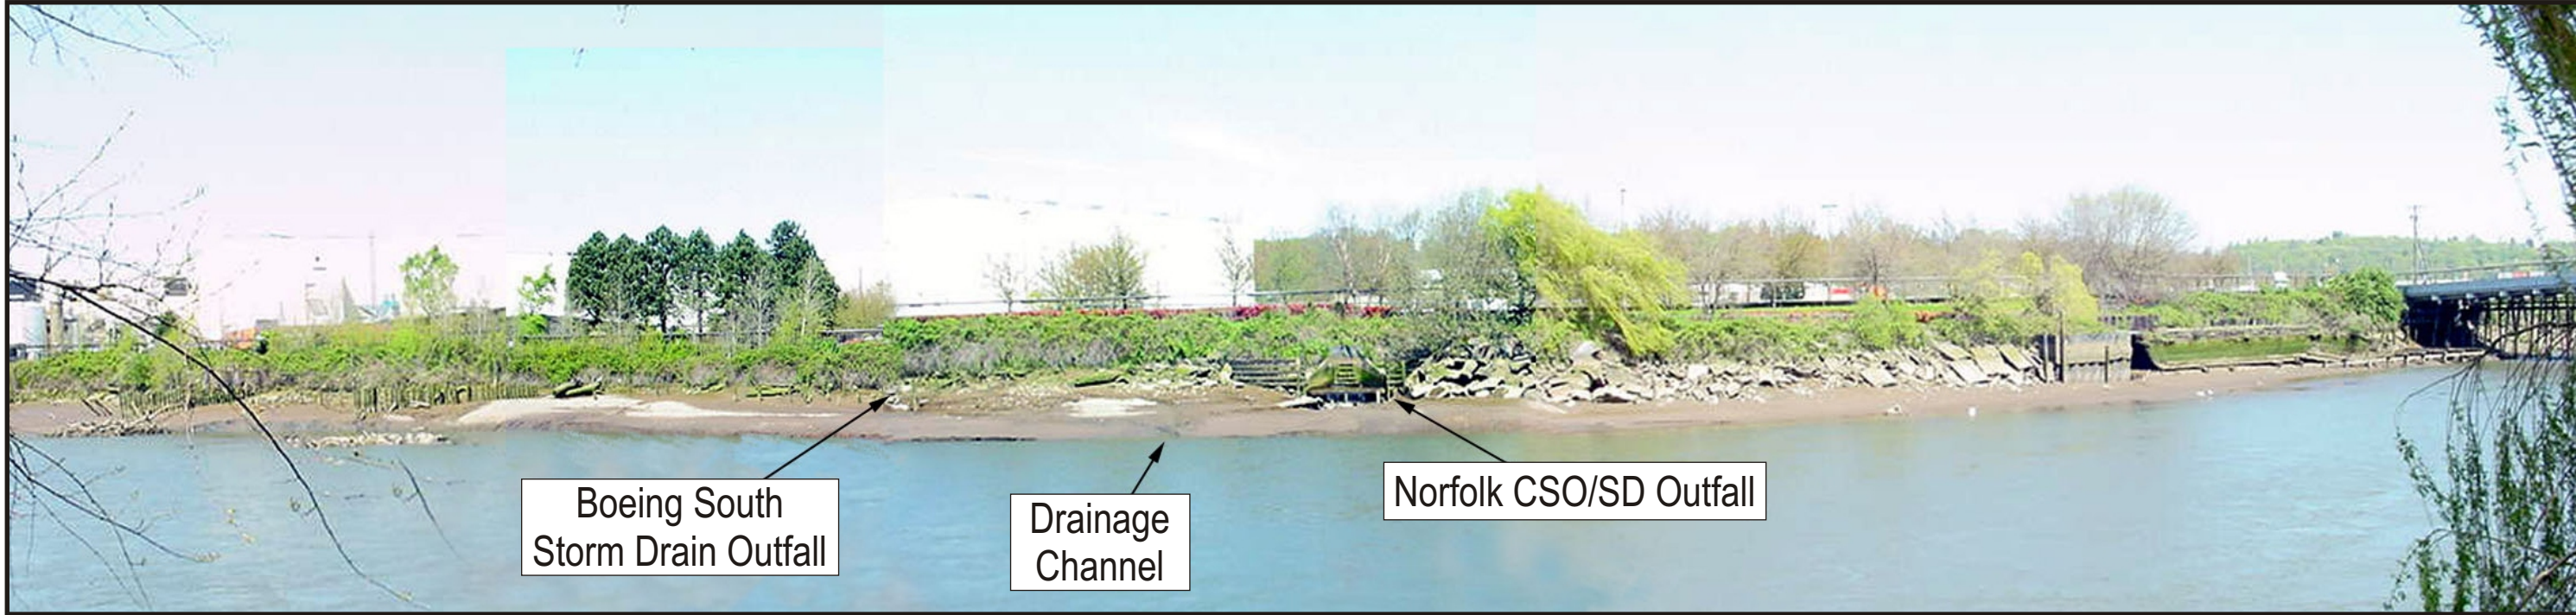
Boeing South
Storm Drain Outfall

Drainage
Channel

The boundary for the EAA-7 sediments has not been officially determined by EPA; however, for the purposes of this document, EAA-7 includes the area where King County dredged contaminated sediments located near the Norfolk CSO/SD outfall in 1999 and the area where Boeing removed contaminated sediments near the Boeing south storm drain outfall in 2003. These sediment dredging actions are discussed further below. A photograph of the Norfolk CSO/SD outfall is presented in Figure 4. A photograph of the Norfolk CSO/SD and one of the Boeing-owned storm drain outfalls (labeled “Boeing South Storm Drain Outfall”) is presented in Figure 5. The Boeing south storm drain outfall is also referred to as DC2, as shown in Figures 2 and 6.

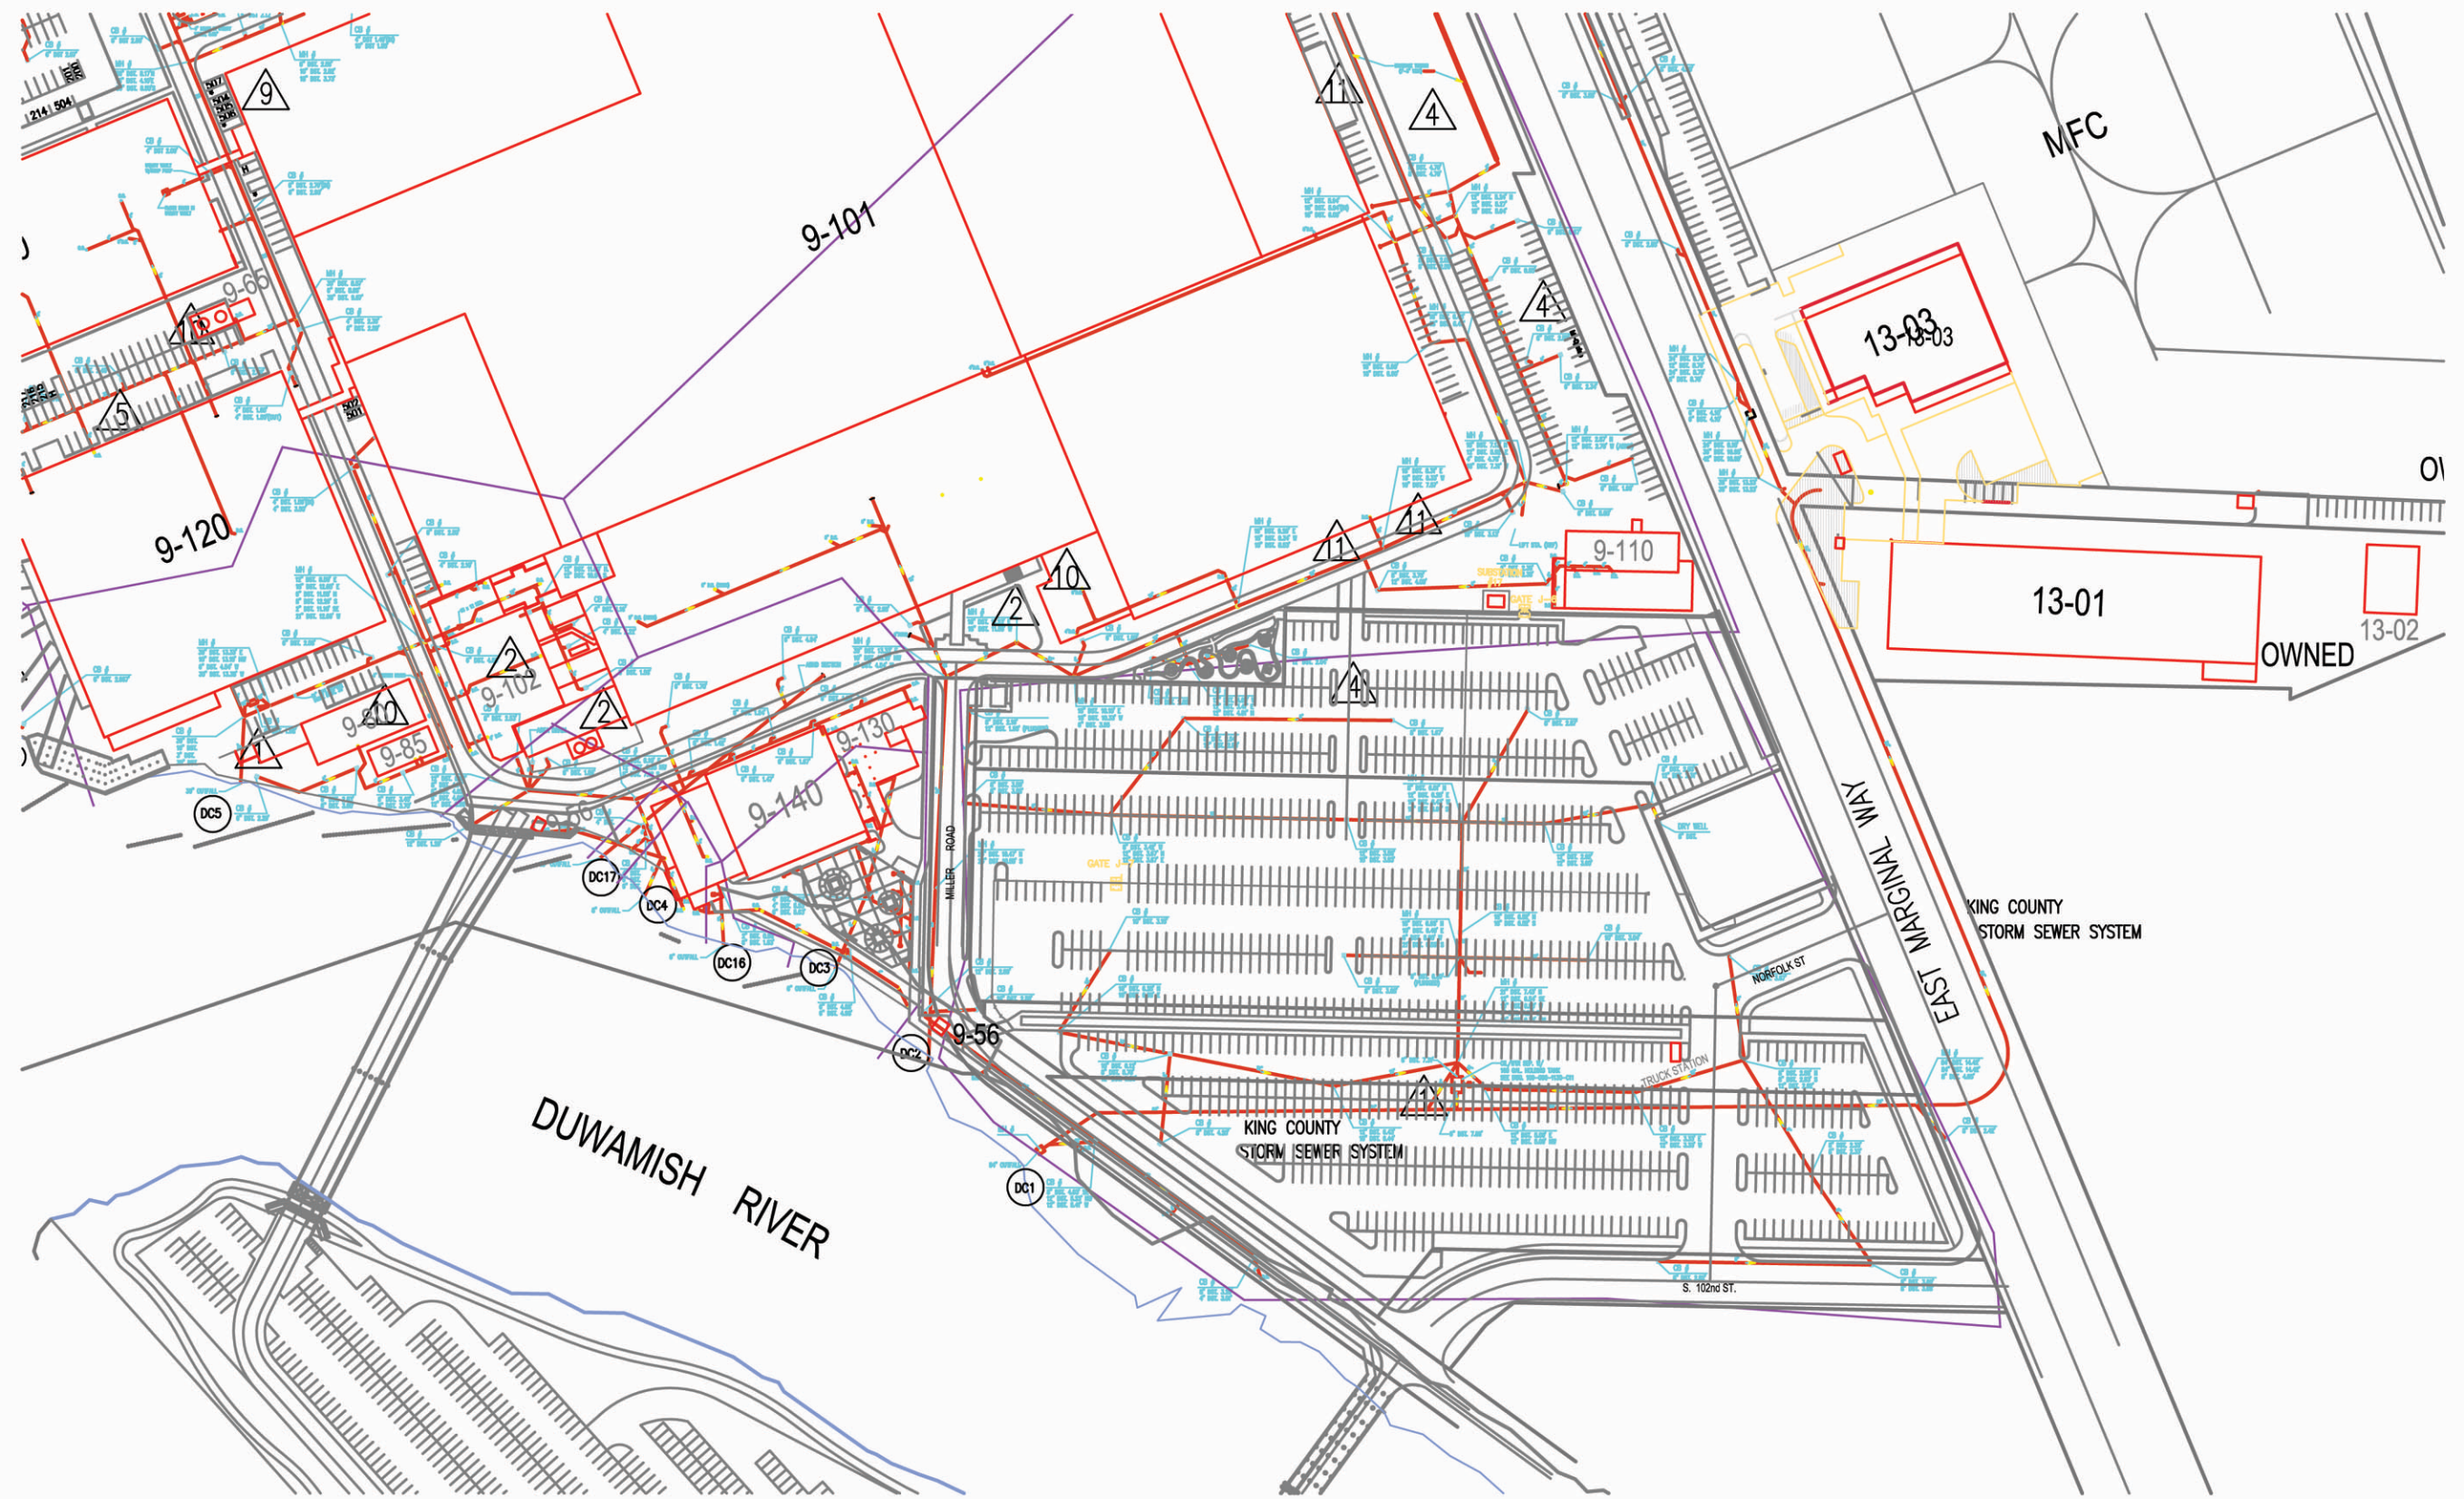
Figure 6
BOEING DEVELOPMENTAL CENTER
STORMWATER DRAINAGE SYSTEM
LOWER DUWAMISH WATERWAY
EARLY ACTION AREA 7
Tukwila, Washington

-   DISCHARGE POINT AT DUWAMISH RIVER
-   OIL/WATER SEPERATOR (STORM)
-   OUTSIDE FUEL TANKS (NOT INCLUDING COMPRESSED GASES)
-   HAZARDOUS MATERIALS AND HAZARDOUS WASTE BUILDING.
-   EQUIPMENT STORAGE
-   SOLID WASTE CONTAINERS
-   DATA DESTROY, PAPER SHREDDER
-   CONTAINER, KITCHEN GREASE
-   OIL/WATER SEPARATOR, SANITARY
-   GROUND WATER PUMP AND TREAT
-   COOLING TOWERS
-   DUST COLLECTOR (OUTDOORS)
-   FUEL STATION
-   CATCH BASINS
-   DRAINAGE AREAS

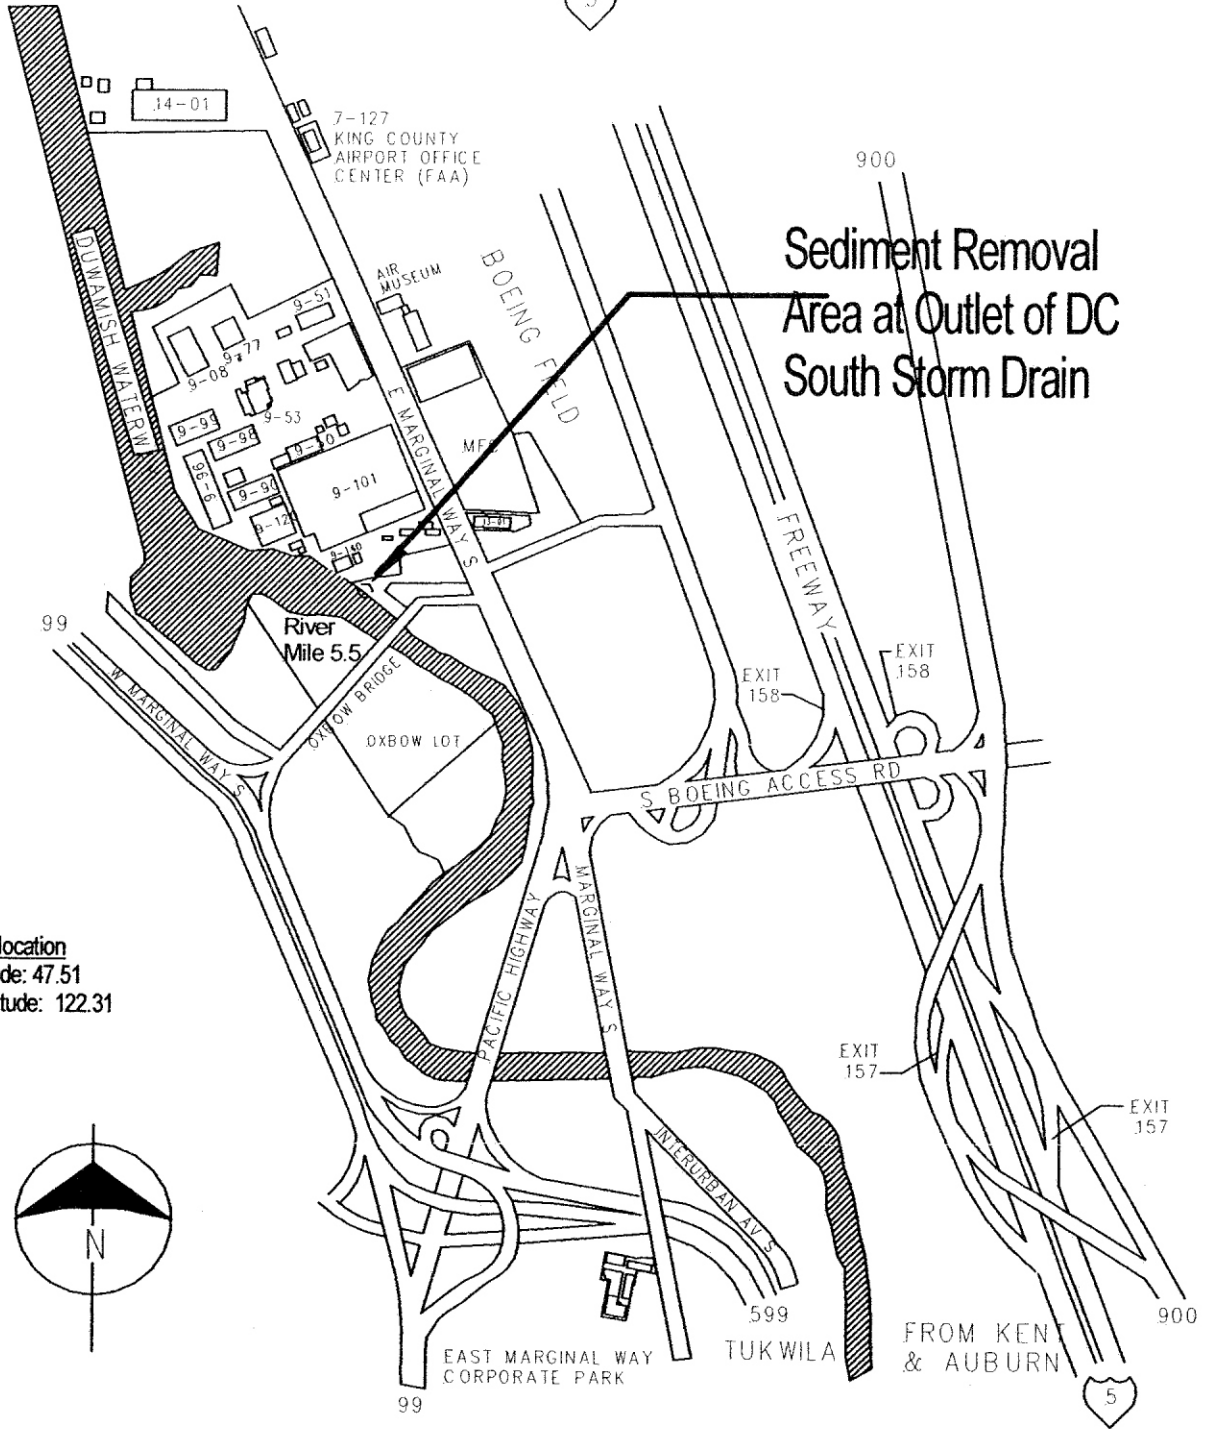
Sediment Removal Area at Outlet of DC South Storm Drain

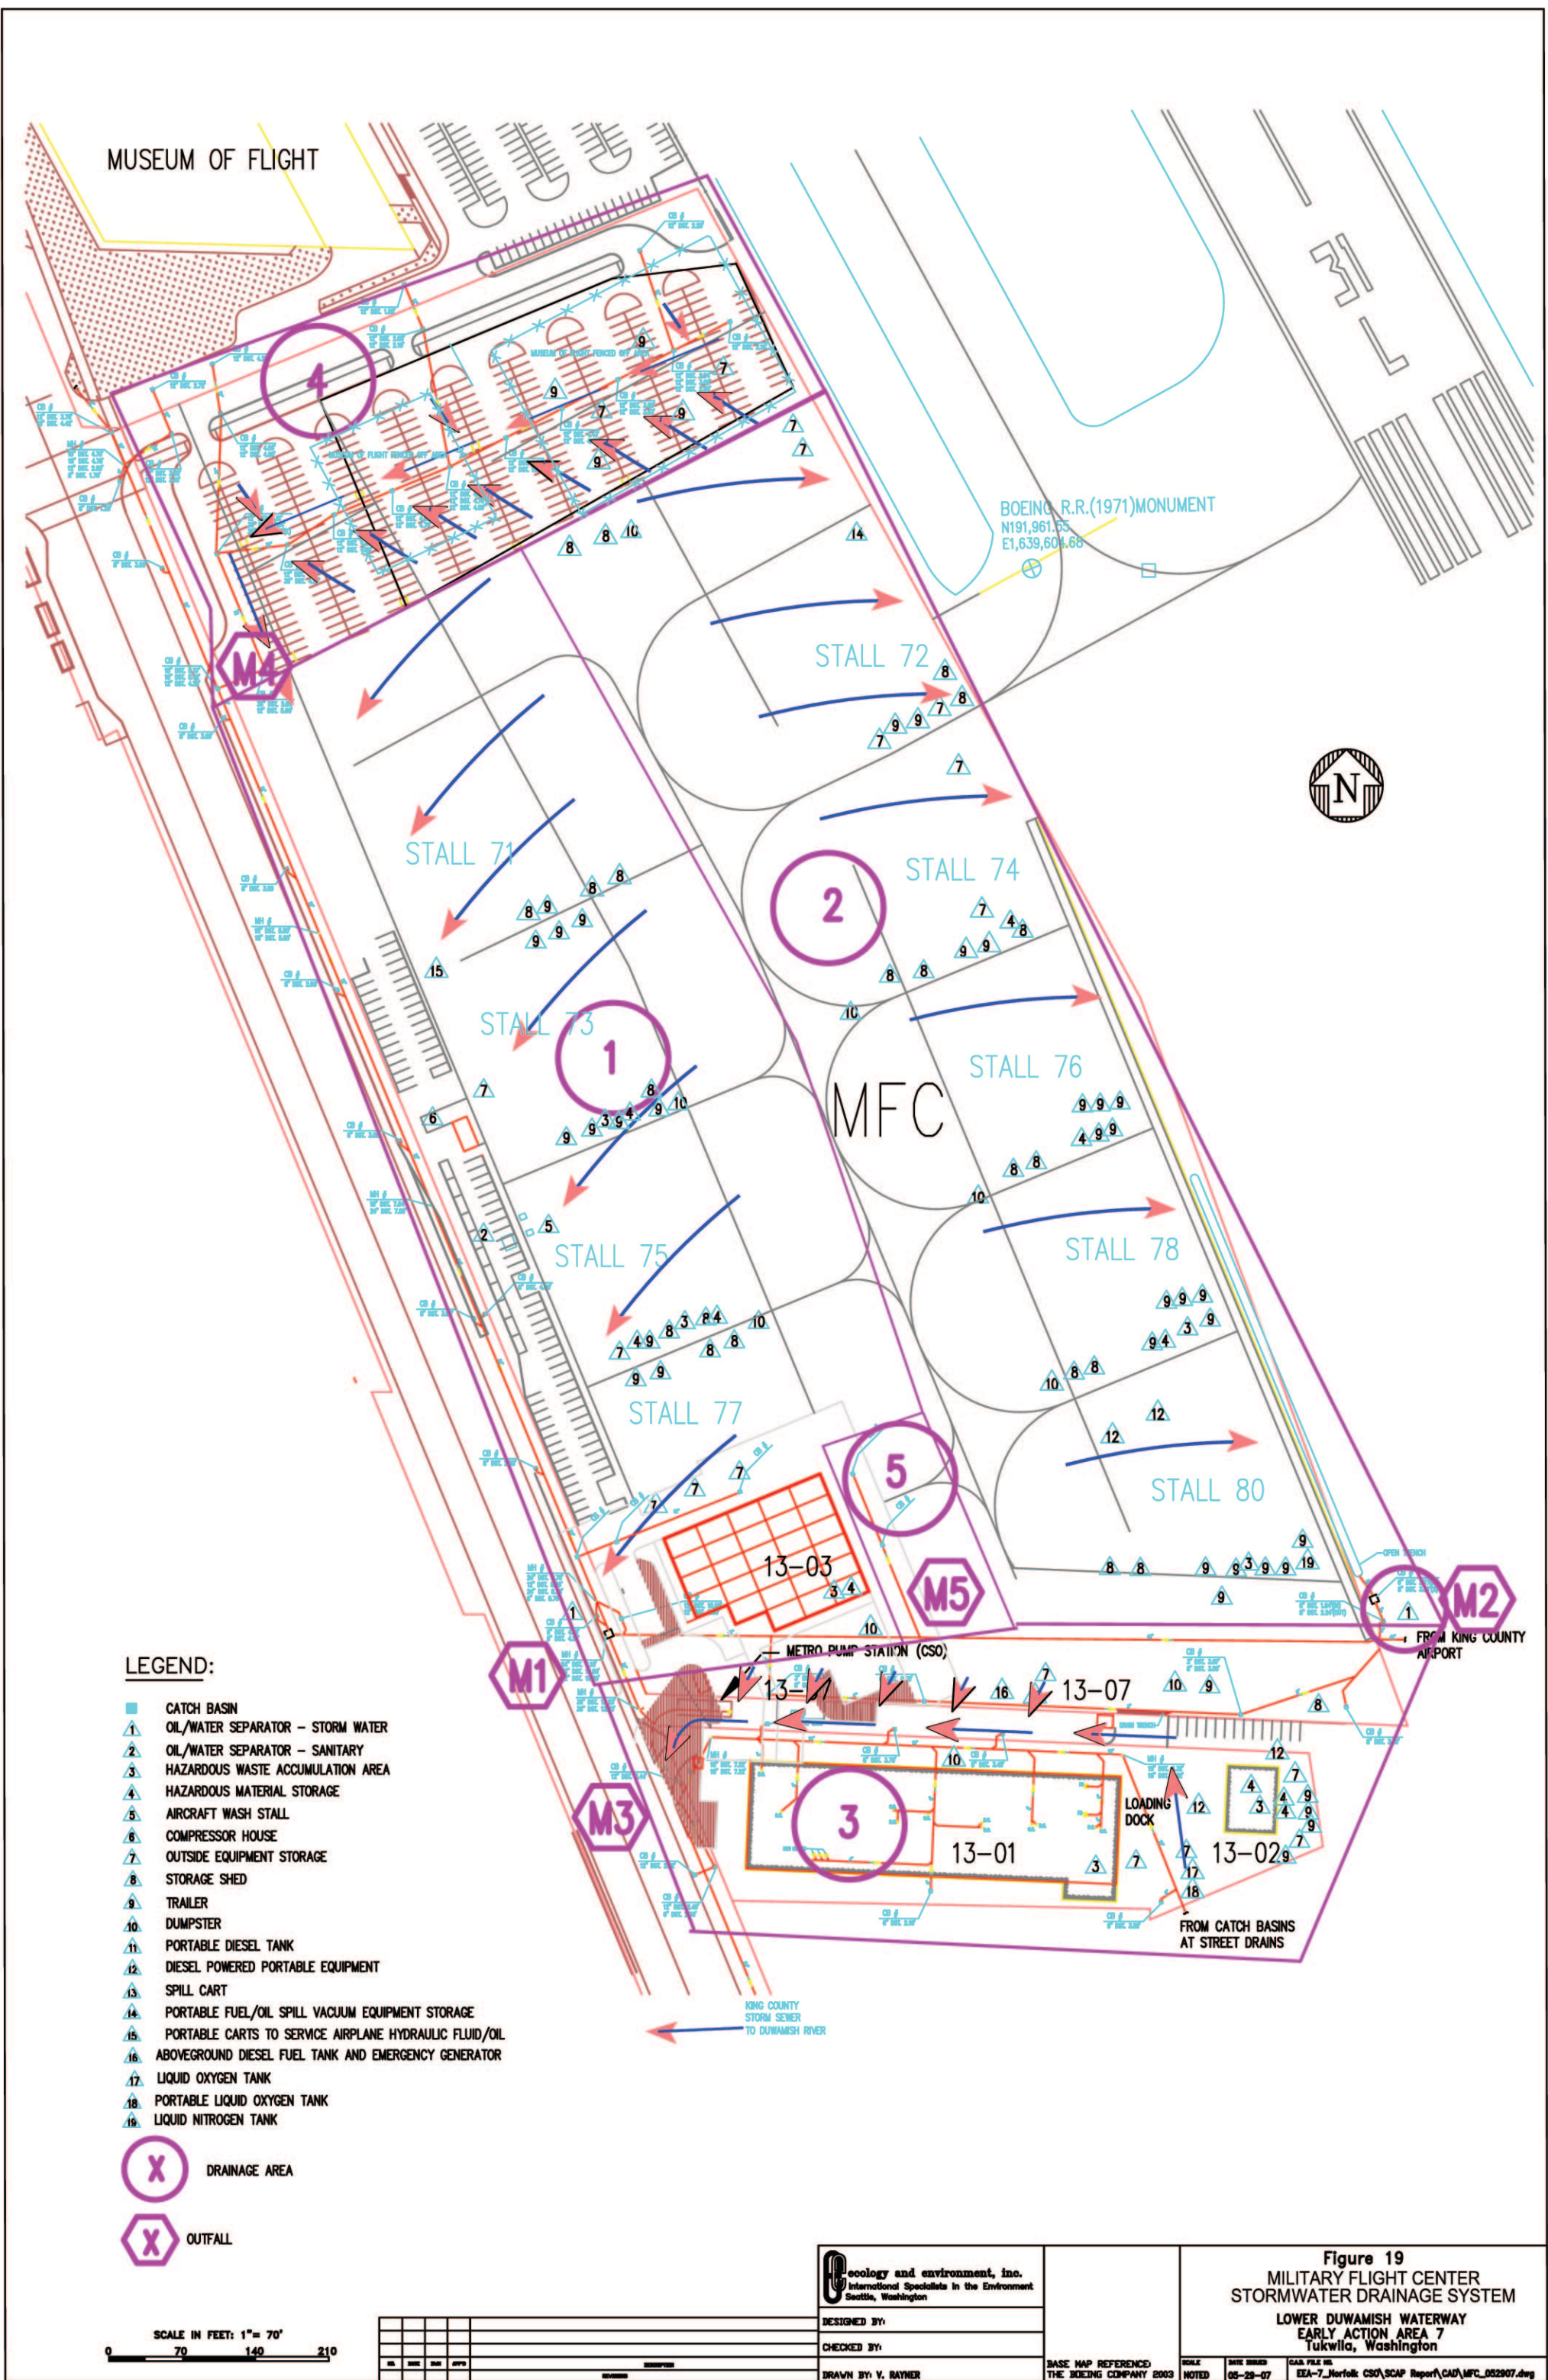
Figure 19
MILITARY FLIGHT CENTER
STORMWATER DRAINAGE SYSTEM
LOWER DUWAMISH WATERWAY
EARLY ACTION AREA 7
Tukwila, Washington

- CATCH BASIN
- ▲ OIL/WATER SEPARATOR - STORM WATER
- ▲ OIL/WATER SEPARATOR - SANITARY
- ▲ HAZARDOUS WASTE ACCUMULATION AREA
- ▲ HAZARDOUS MATERIAL STORAGE
- ▲ AIRCRAFT WASH STALL
- ▲ COMPRESSOR HOUSE
- ▲ OUTSIDE EQUIPMENT STORAGE
- ▲ STORAGE SHED
- ▲ TRAILER
- ▲ DUMPSTER
- ▲ PORTABLE DIESEL TANK
- ▲ DIESEL POWERED PORTABLE EQUIPMENT
- ▲ SPILL CART
- ▲ PORTABLE FUEL/OIL SPILL VACUUM EQUIPMENT STORAGE
- ▲ PORTABLE CARTS TO SERVICE AIRPLANE HYDRAULIC FLUID/OIL
- ▲ ABOVEGROUND DIESEL FUEL TANK AND EMERGENCY GENERATOR
- ▲ LIQUID OXYGEN TANK
- ▲ PORTABLE LIQUID OXYGEN TANK
- ▲ LIQUID NITROGEN TANK

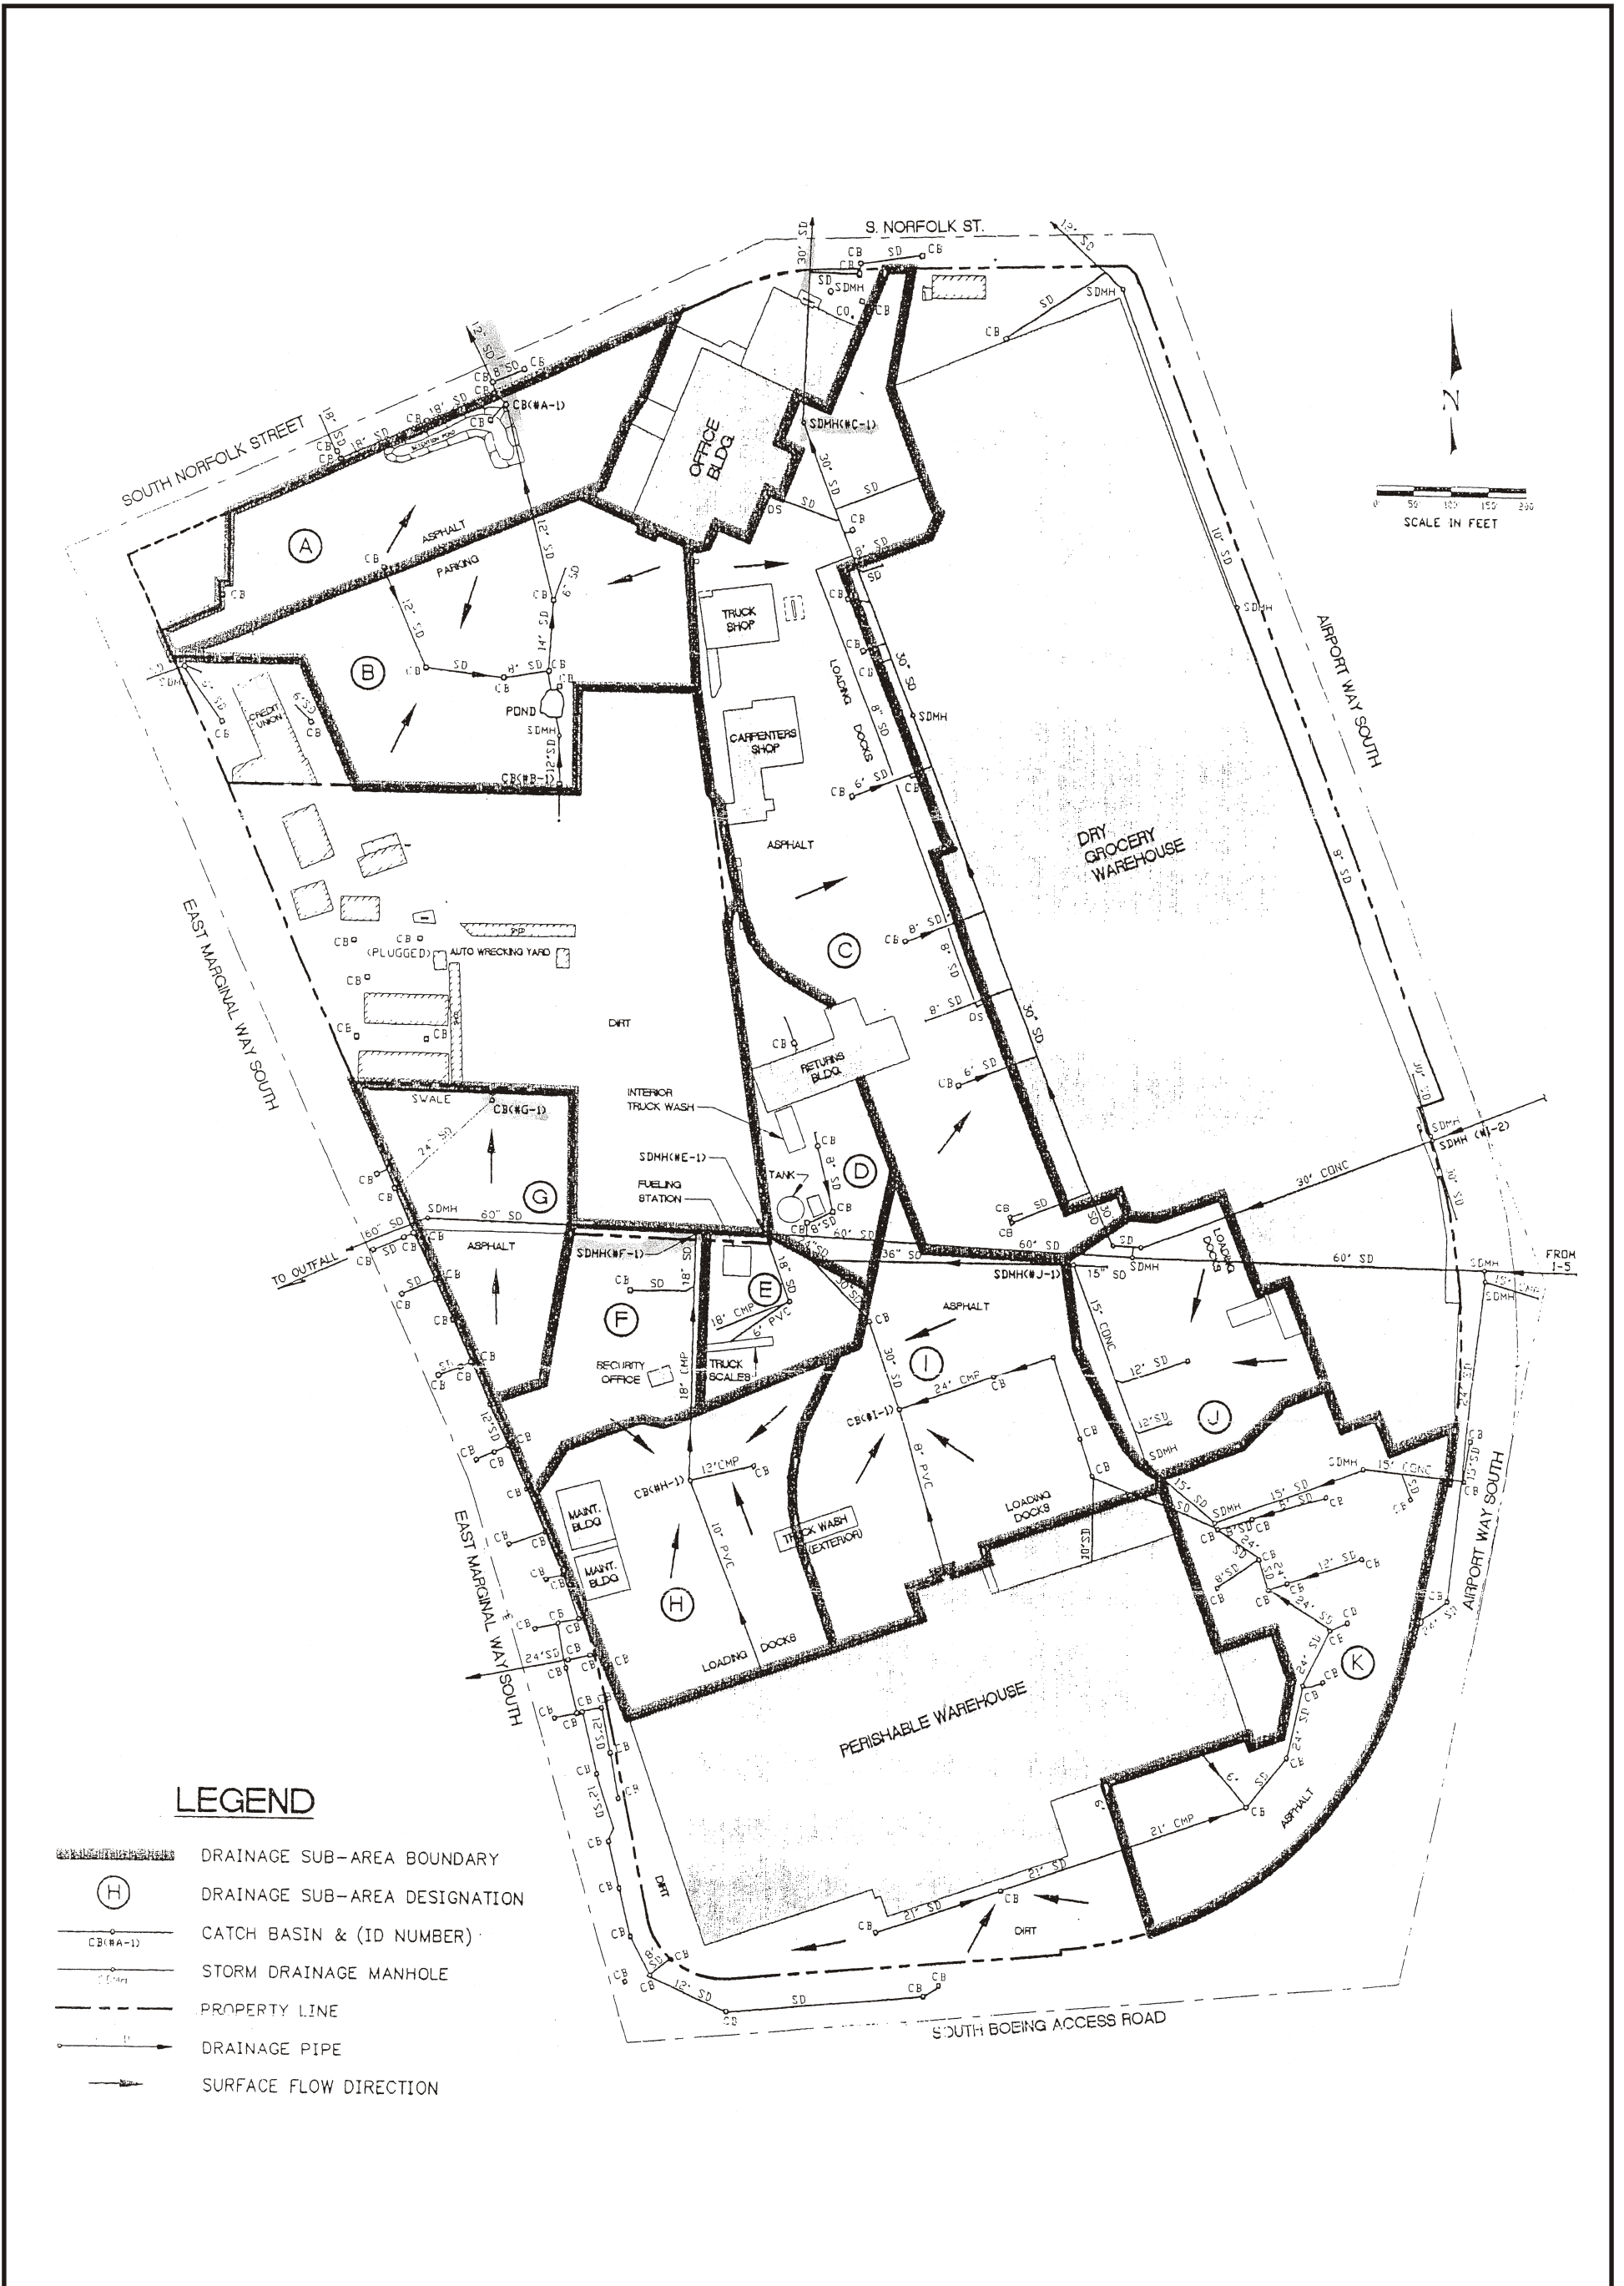
- DRAINAGE SUB-AREA BOUNDARY
- DRAINAGE SUB-AREA DESIGNATION
- CATCH BASIN & (ID NUMBER)
- STORM DRAINAGE MANHOLE
- PROPERTY LINE
- DRAINAGE PIPE
- SURFACE FLOW DIRECTION

The surface drainage flow direction, drainage sub-area boundaries, and storm drainage system configuration of Associated Grocers, Inc. are illustrated in Figure 25. Runoff from the southern portion of the property discharges into the 60-inch WDOT storm drain and runoff from the northern portion of the property discharges into the Norfolk CSO/SD.

Groundwater contamination has been identified at the former truck shop (Figures 21 and 22). USTs were removed from the southern end of the maintenance shop. These areas are drained by drainage sub-area C of Associated Grocers' storm drainage system (Figure 25). Groundwater and soil contamination has been identified at the former Humble service station, located in drainage sub-areas A and B of Associated Grocers' storm drainage system (Figure 25). Drainage sub-areas A, B, and C drain into the Norfolk CSO/SD system.
