**Lower Duwamish Waterway
RM 3.9-4.4 East
(Slip 6)
Summary of Existing
Information and Identification of
Data Gaps
Final Report**

**Contract No. C0700036
Work Assignment No. EANE012**

February 2008

**WASHINGTON DEPARTMENT OF ECOLOGY
Toxics Cleanup Program
3190 160th Avenue SE
Bellevue, WA 98008-5452**

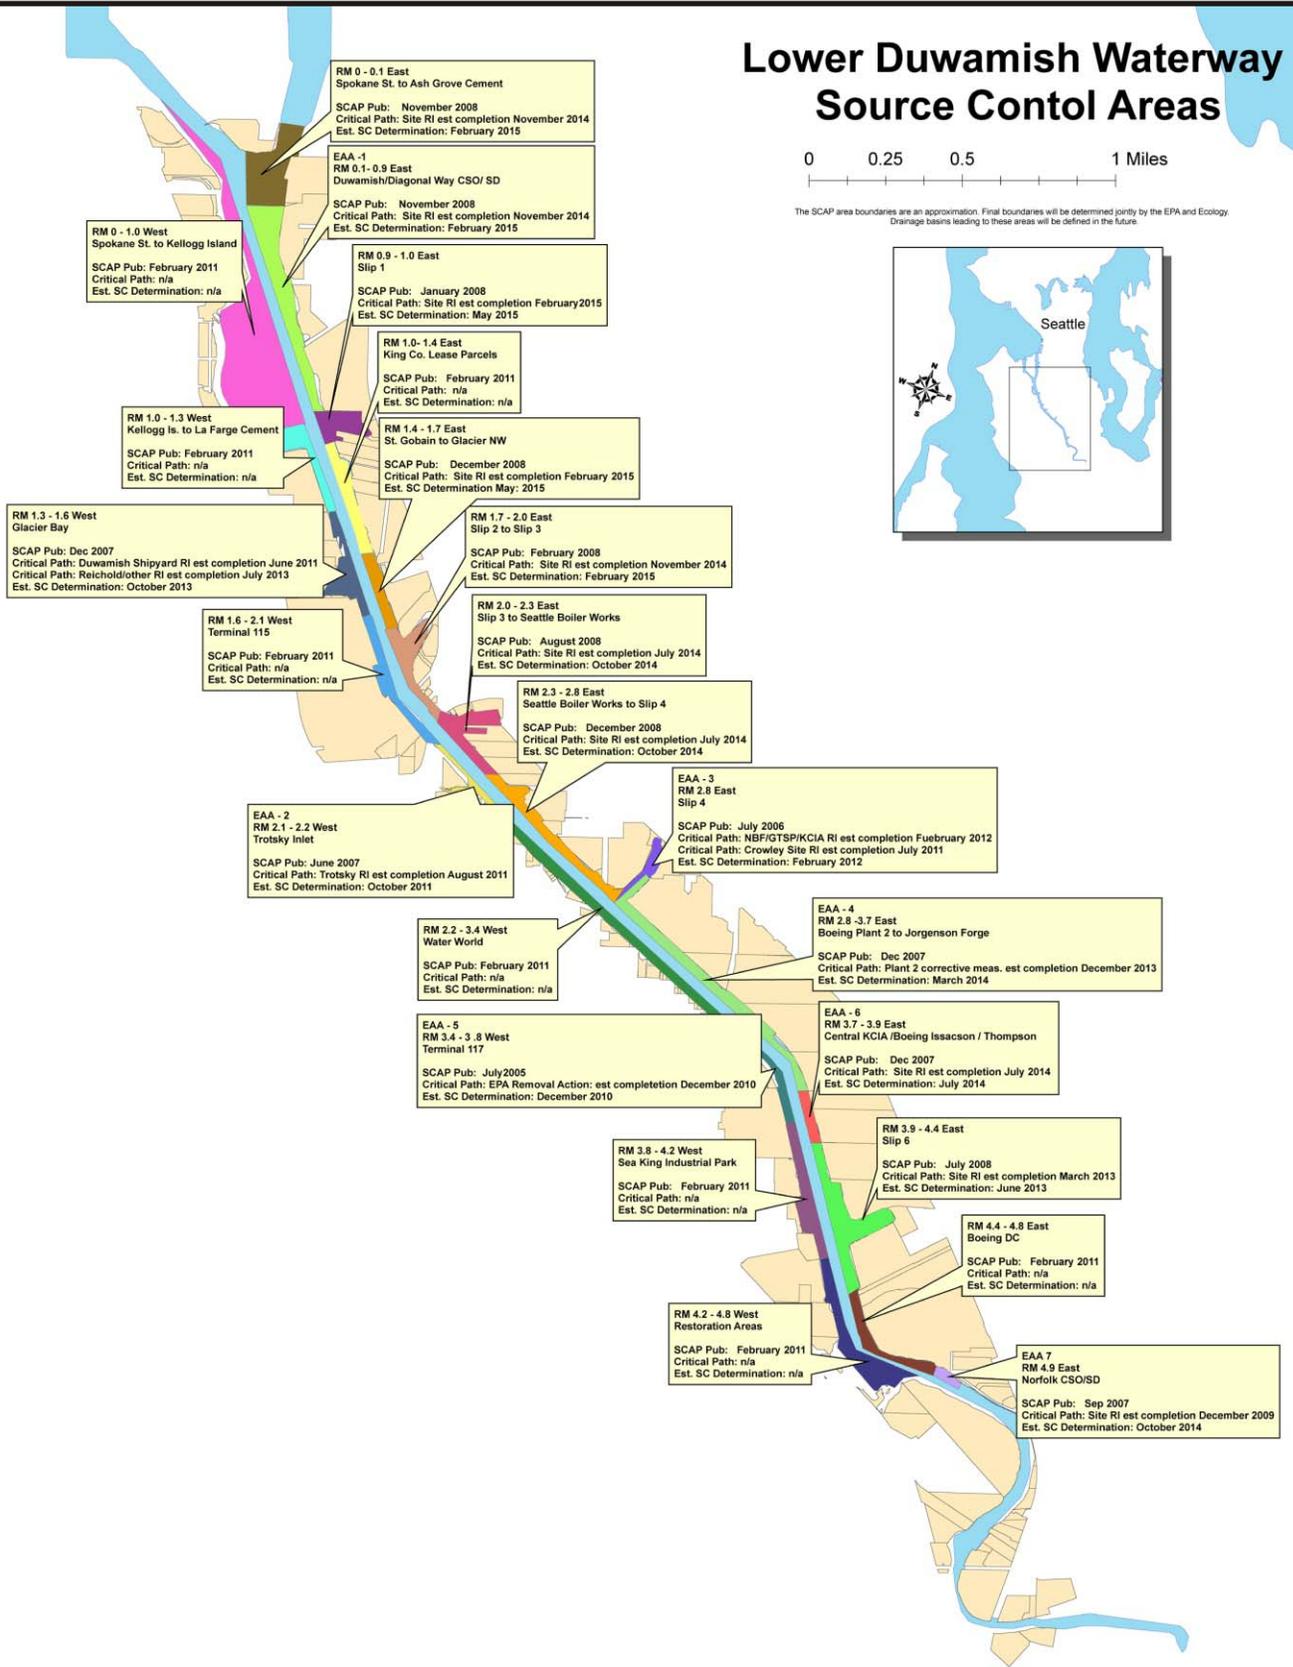
Figure 1
DESIGNATED SOURCE CONTROL AREAS
(DRAFT)

The SCAP area boundaries are an approximation. Final boundaries will be determined jointly by the EPA and Ecology. Drainage basins leading to these areas will be defined in the future.

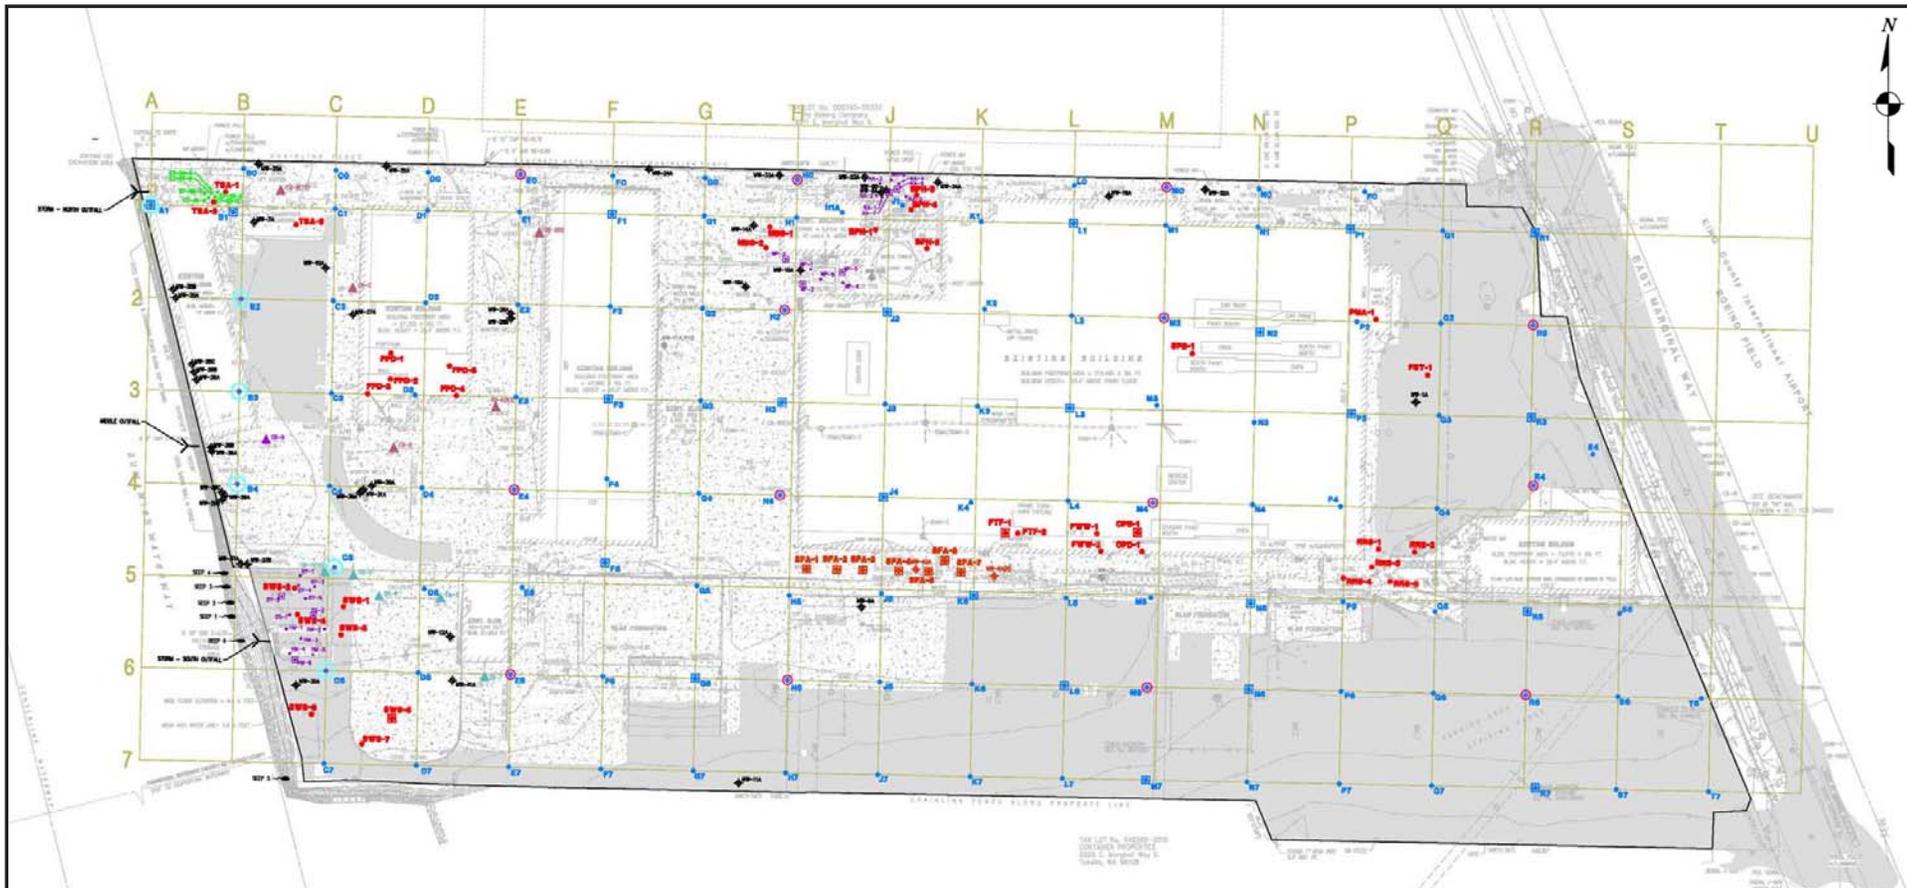
Figure 6
PHASE II DATA GAPS INVESTIGATION SAMPLING LOCATIONS

- LEGEND:**
- PHASE II SAMPLE LOCATIONS**
- GRID SOIL SAMPLING LOCATION
 - GRID RECONNAISSANCE GROUNDWATER SAMPLING LOCATION
 - FOCUSED SOIL SAMPLING LOCATION
 - FOCUSED RECONNAISSANCE GROUNDWATER SAMPLING LOCATION
 - SOUTH FIRE ASLE (SFA) ASSESSMENT SOIL SAMPLING LOCATION
 - SFA RECONNAISSANCE GROUNDWATER SAMPLING LOCATION
 - GRID BORING ADVANCED TO SILTY CONFINING LAYER
 - SOIL SAMPLES ANALYZED FOR LOW SUITE OF COMPOUNDS
 - F# SAMPLE LOCATION DESIGNATION - GRID SAMPLING LOCATION
 - F#-# SAMPLE LOCATION DESIGNATION - FOCUSED SAMPLING LOCATION
 - SFA GROUNDWATER MONITORING WELL (INSTALLED DURING PHASE I)

- Additional investigation of soil and groundwater for petroleum hydrocarbons, PAHs, VC, PCBs, and metals in the Southwest Storage Area and southern portion of the site (approximately grid locations C6 through P6, as shown on Figure 6).

- Confirmation and re-evaluation of soil and groundwater compliance sampling for petroleum hydrocarbons, PAHs, and metals surrounding the former USTs north of the Administration Building (approximately grid locations Q2 and Q3 through P2 and P3, as shown on Figure 6).

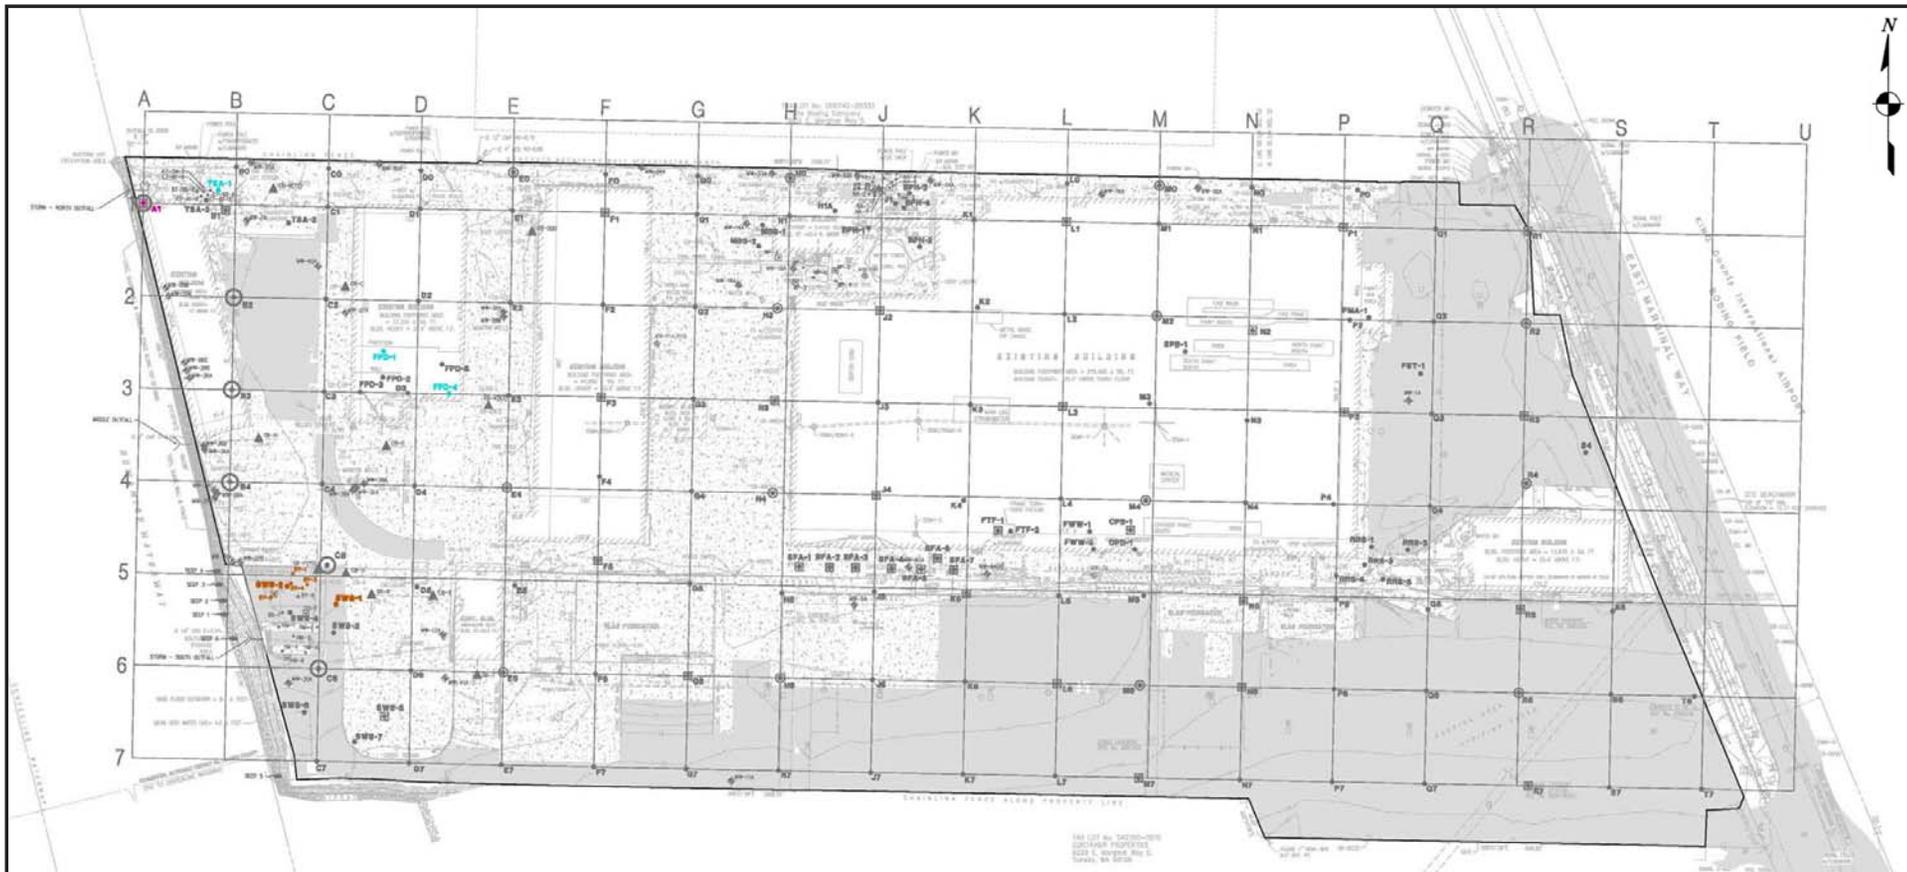
Figure 7
 BORING LOCATIONS EXCEEDING
 MTCA INDUSTRIAL SOIL CLEANUP LEVELS

- GRID SOIL SAMPLING LOCATION
- GRID RECONNAISSANCE GROUNDWATER SAMPLING LOCATION
- FOCUSED SOIL SAMPLING LOCATION
- FOCUSED RECONNAISSANCE GROUNDWATER SAMPLING LOCATION
- SOUTH FIRE ARSLE (SFA) ASSESSMENT SOIL SAMPLING LOCATION
- SFA RECONNAISSANCE GROUNDWATER SAMPLING LOCATION
- GRID BORING ADVANCED TO SILTY CONTAINING LAYER
- SOIL SAMPLES ANALYZED FOR LOW SUITE OF COMPOUNDS
- F4 SAMPLE LOCATION DESIGNATION – GRID SAMPLING LOCATION
- SWB-S SAMPLE LOCATION DESIGNATION – FOCUSED SAMPLING LOCATION
- SWB-SW2 SFA GROUNDWATER MONITORING WELL (INSTALLED DURING PHASE I)
