Lower Duwamish Waterway RM 2.0–2.3 East (Slip 3 to Seattle Boiler Works)

Source Control Action Plan Final Report

April 2009

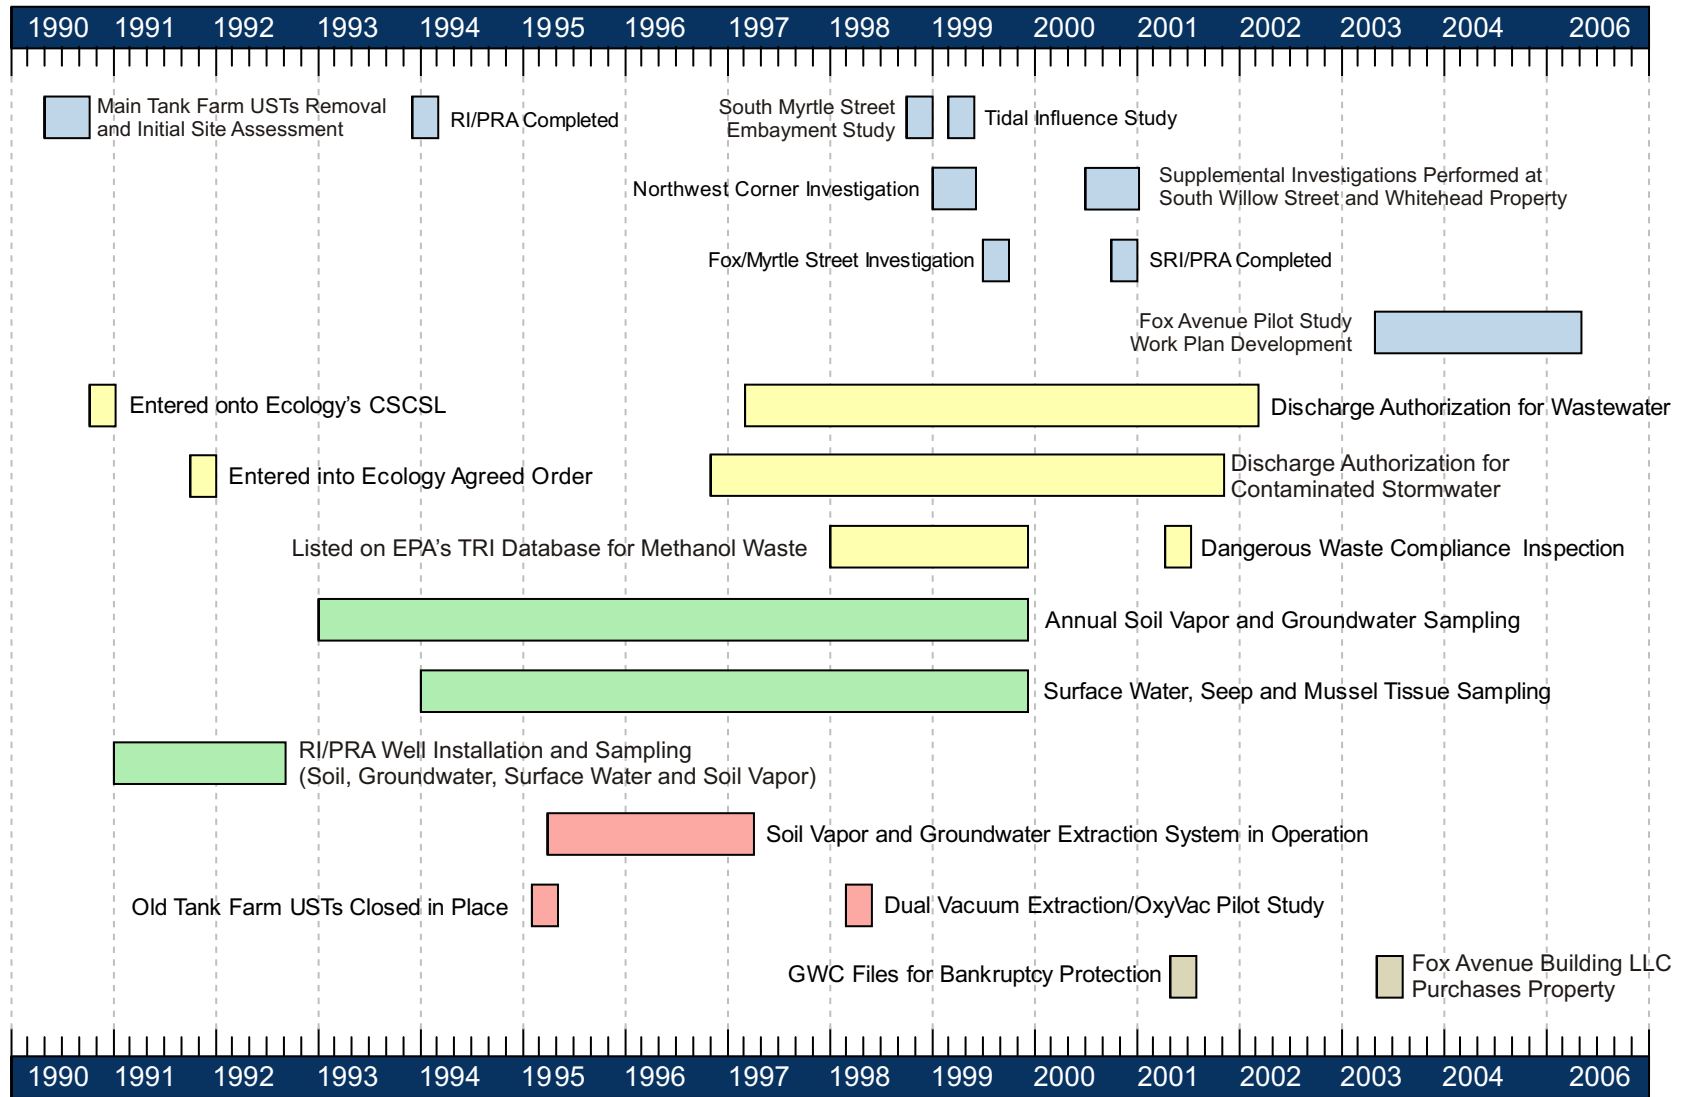
Figure 18
TIMELINE - CASCADE COLUMBIA
DISTRIBUTION PROPERTY

Legend: ■ Investigations ■ Agency Actions ■ Monitoring ■ Cleanup Activities ■ Other

Several environmental investigations and cleanup activities have been conducted at the Cascade Columbia Distribution property since 1989. Major investigations and cleanup activities are summarized in a timeline provided as Figure 18. Environmental investigations and cleanup activities are described in detail in *RM 2.0–2.3 East Summary of Existing Information and Identification of Data Gaps Report* (E & E 2008); the report includes analytical results for soil and groundwater at the facility, and figures showing sample locations. A summary of site geology and hydrology is also provided, including descriptions of the silt horizons and water bearing zones, which is necessary for understanding contaminant migration at the site.
