Lower Duwamish Waterway RM 1.6 to 2.1 West (Terminal 115)

Summary of Existing Information and Identification of Data Gaps

June 2011

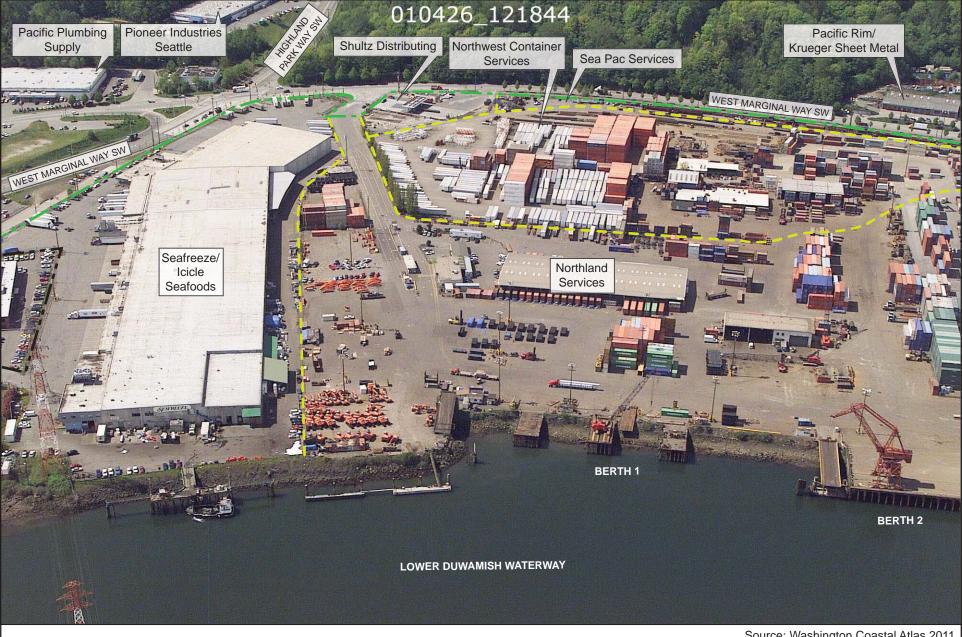
Figure B-11a. RM 1.6 to 2.1 West (Terminal 115): Shoreline Photo, 2001 Source: Washington Coastal Atlas 2011 Photo Date: 04/26/01

Terminal 115 approximate property boundary within source control area

Few changes are observed between the 1999 and 2001 aerial photographs (Figures B-10 and B-11a through B-11c).
