Lower Duwamish Waterway RM 2.2 to 3.4 West Riverside Drive

Summary of Existing Information and Identification of Data Gaps

Toxics Cleanup Program
Northwest Regional Office
Washington State Department of Ecology
Bellevue, Washington

Science Applications International Corporation
18912 North Creek Parkway, Suite 101
Bothell, WA 98011

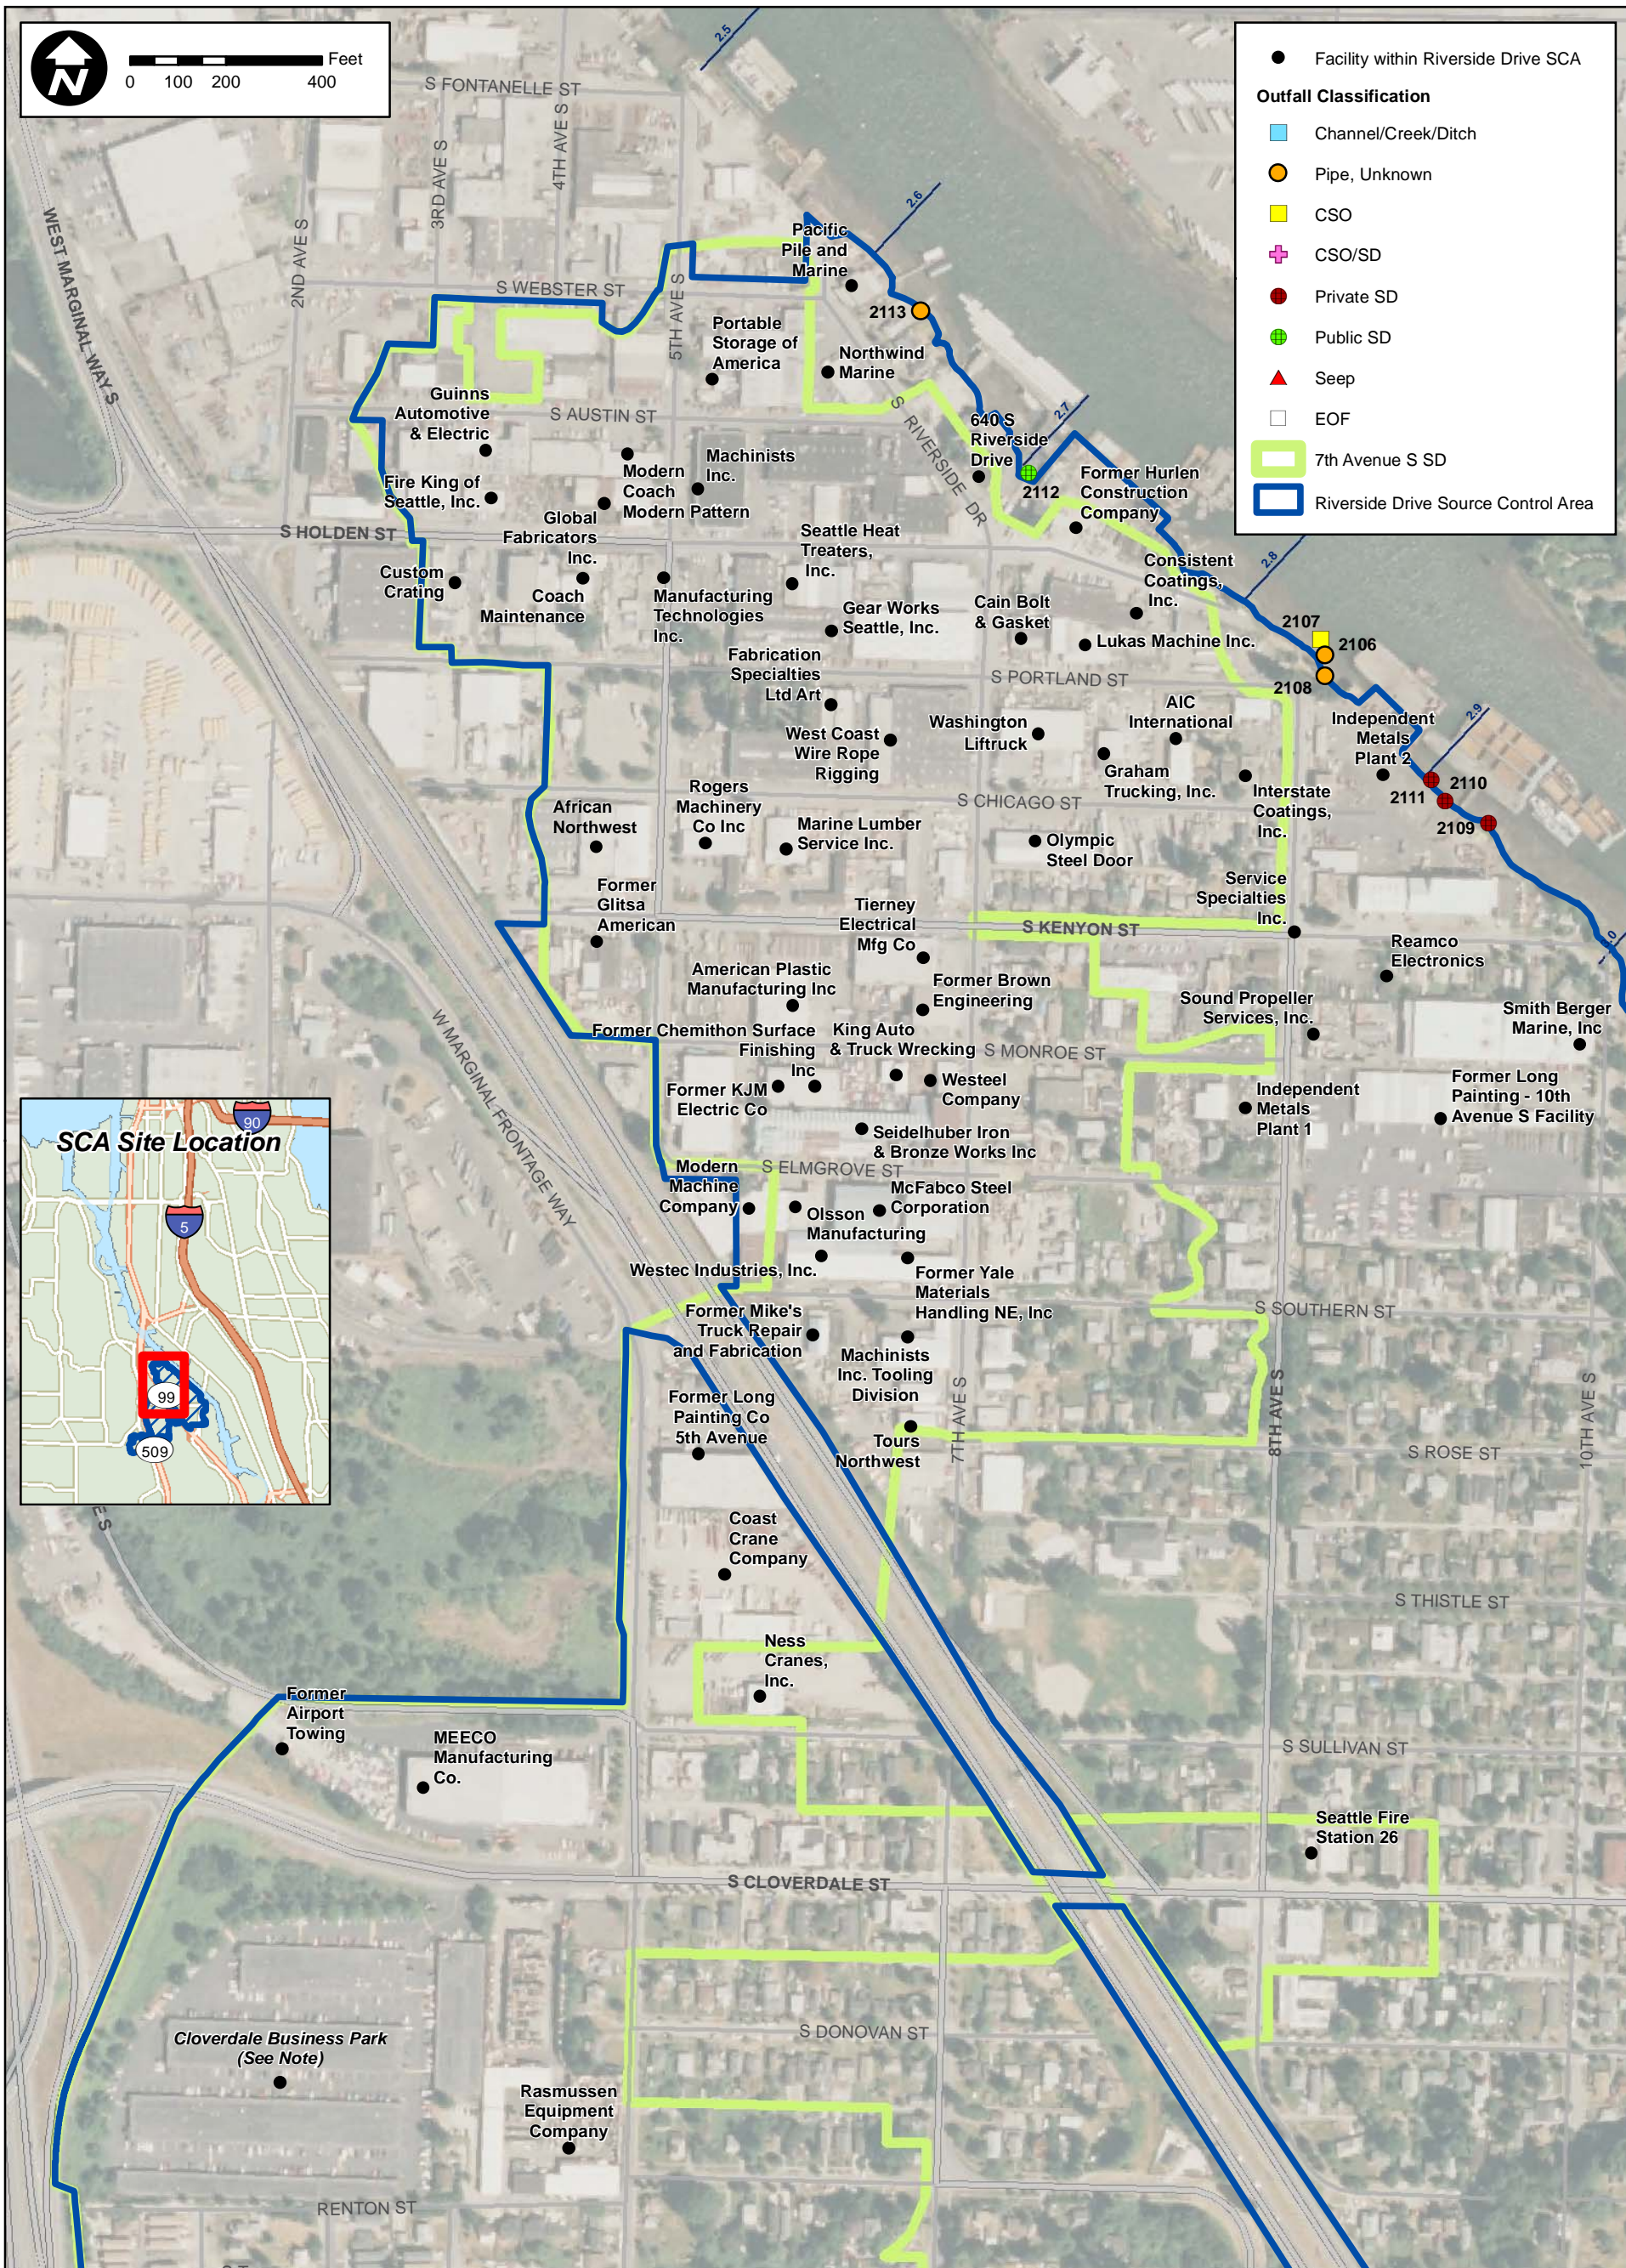
Figure 4b. Riverside Drive Source Control Area – Northern Portion

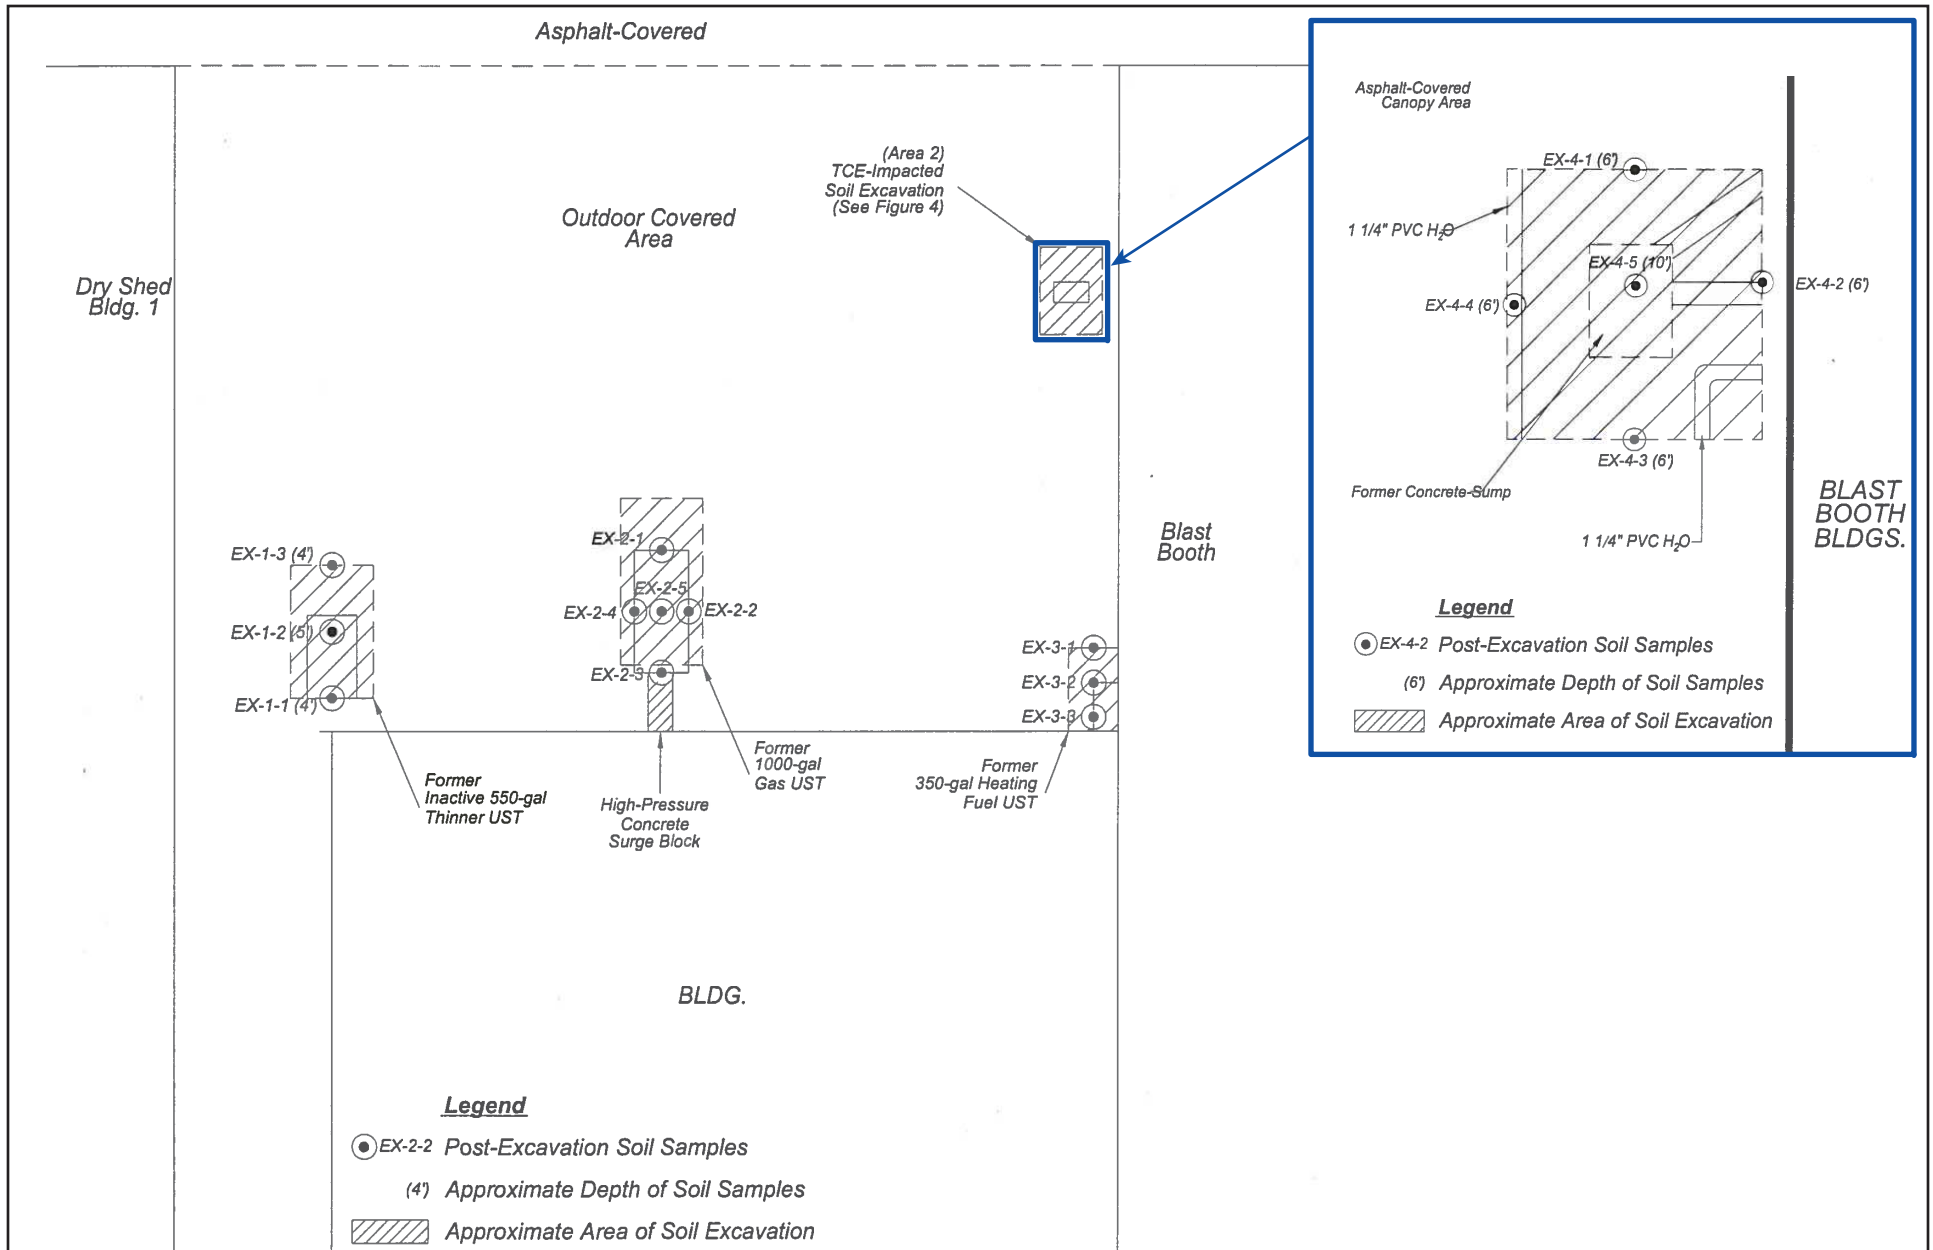
**Figure 13b. Former Long Painting – 10th Avenue S
Facility Map and Historical Sample Locations**
