Lower Duwamish Waterway RM 4.3 to 4.9 East (Boeing Developmental Center)

Summary of Existing Information and Identification of Data Gaps

September 2010

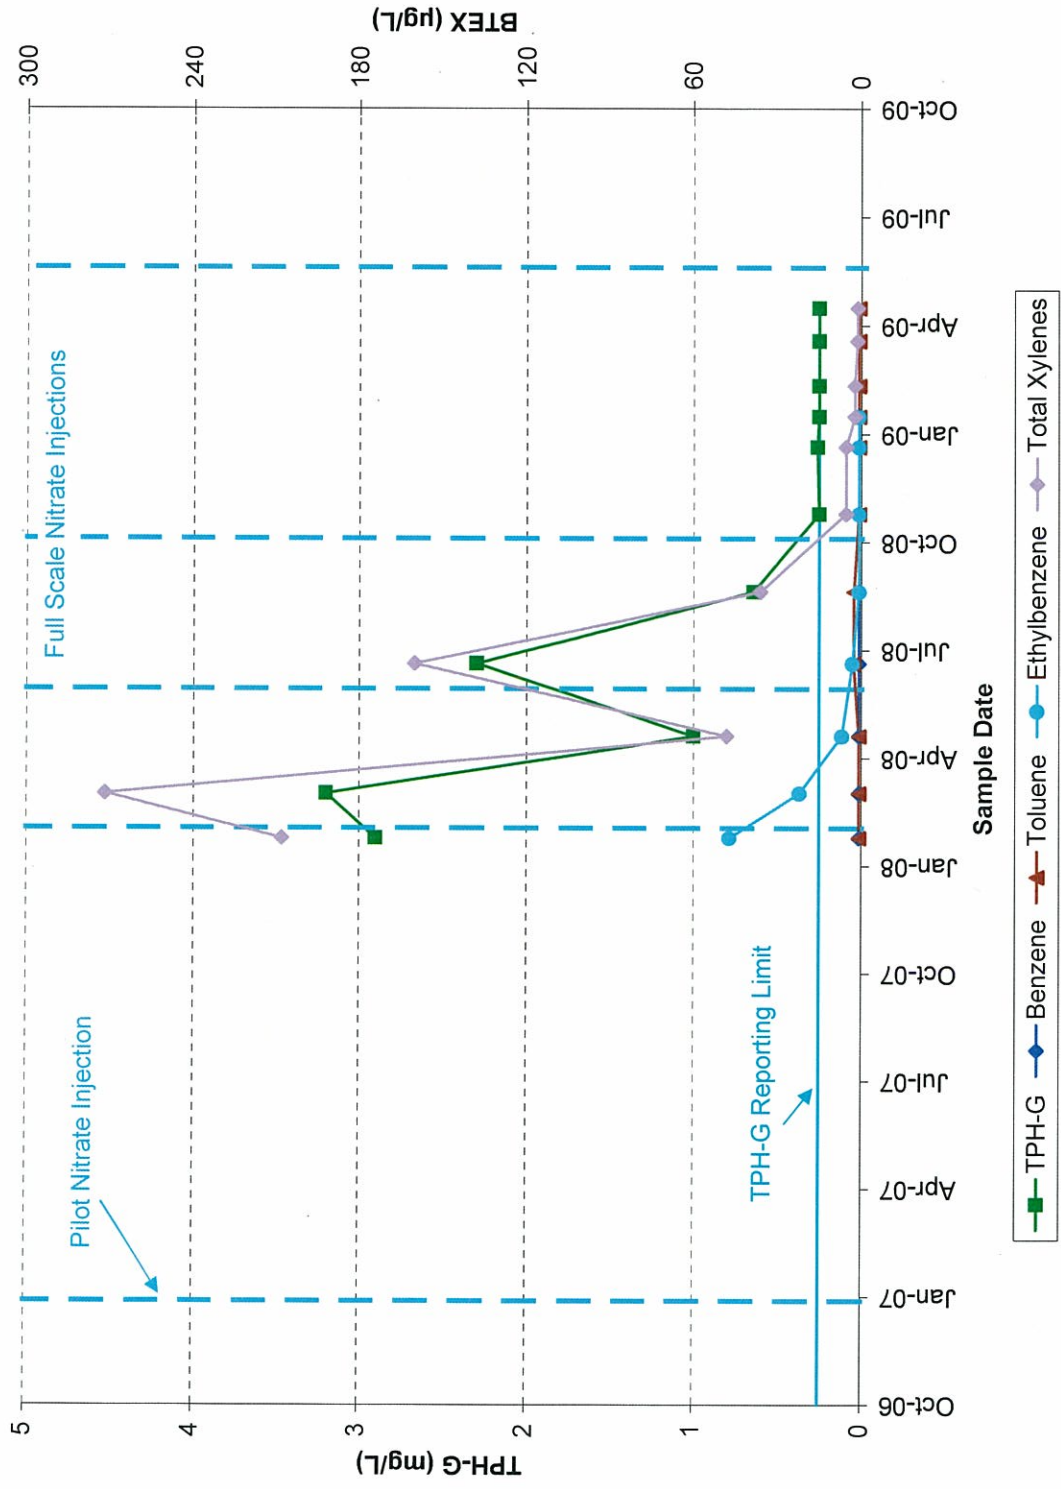
BDC-104 TPH-G and BTEX Concentrations Beginning with 2007 Pilot Testing

The nitrate injections have been successful in remediating TPH-G and BTEX concentrations in groundwater at monitoring wells BDC-103 and BDC-104; however, a diminished rate of degradation was observed during monitoring performed following the October 2008 injection (third full-scale injection event). Observations, including slower depletion of injected nitrate and partial rebound in the concentrations of petroleum hydrocarbons, suggest that biodegradation in AOC-05 had become nutrient-limited to some degree. It has been concluded at other sites using a similar treatment approach that biotreatment has been inhibited by the inadequate availability of phosphorous, a macronutrient that is required along with nitrogen for microorganisms to proliferate.

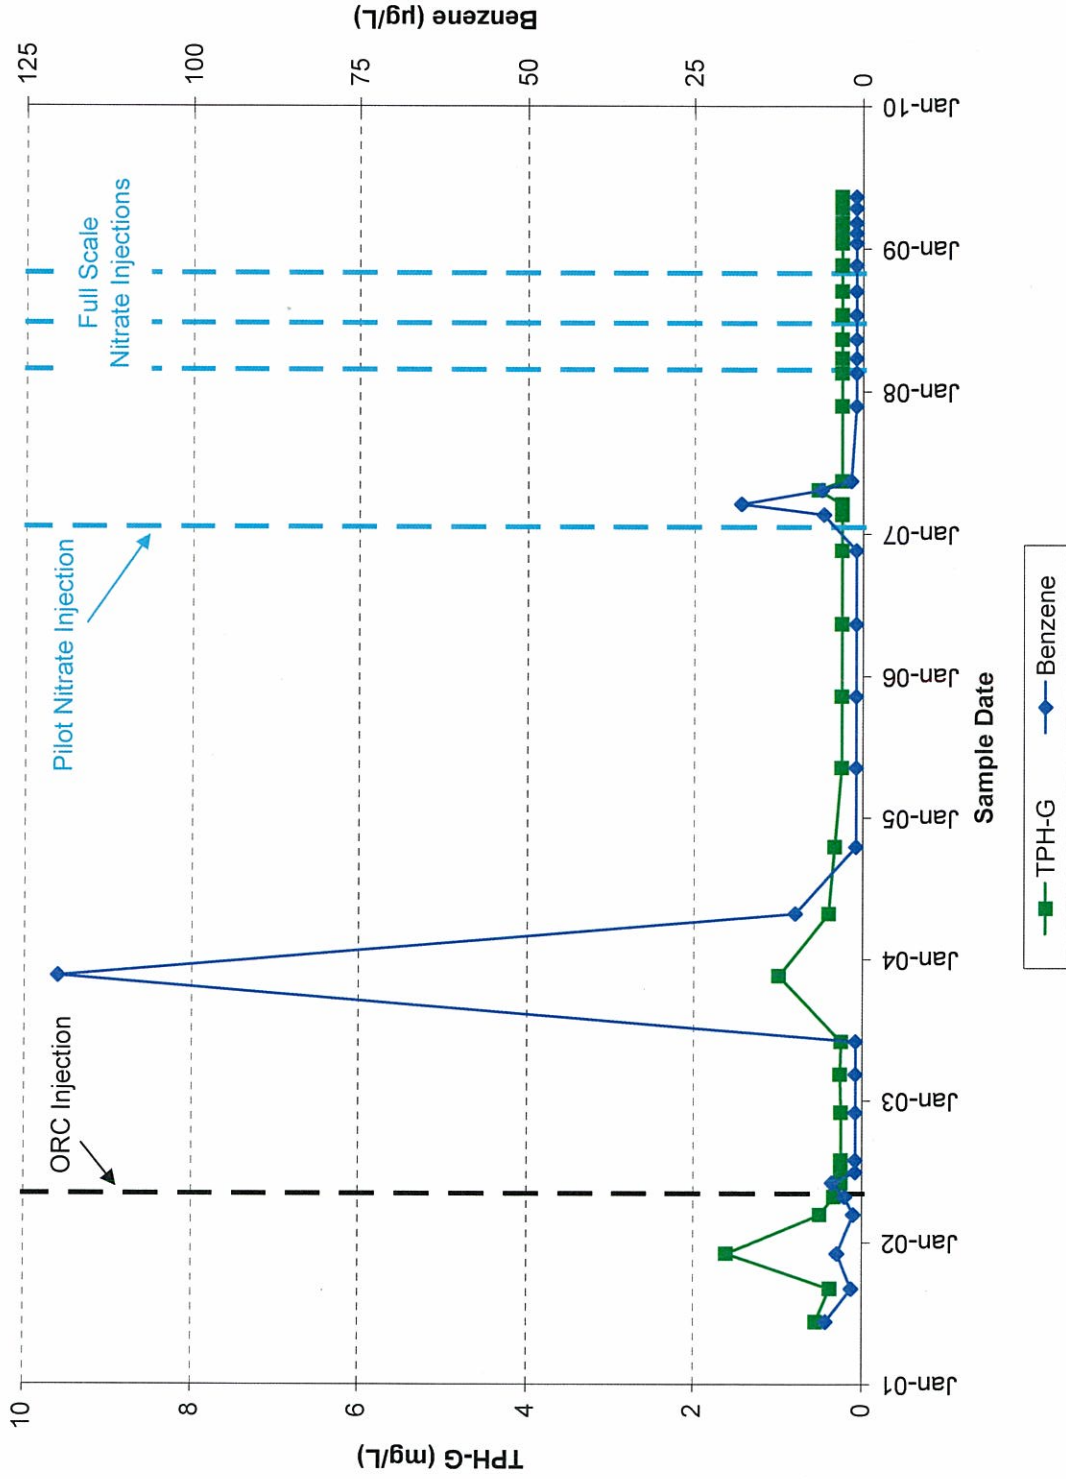
BDC-102 TPH-G and Benzene Concentrations Since 2001

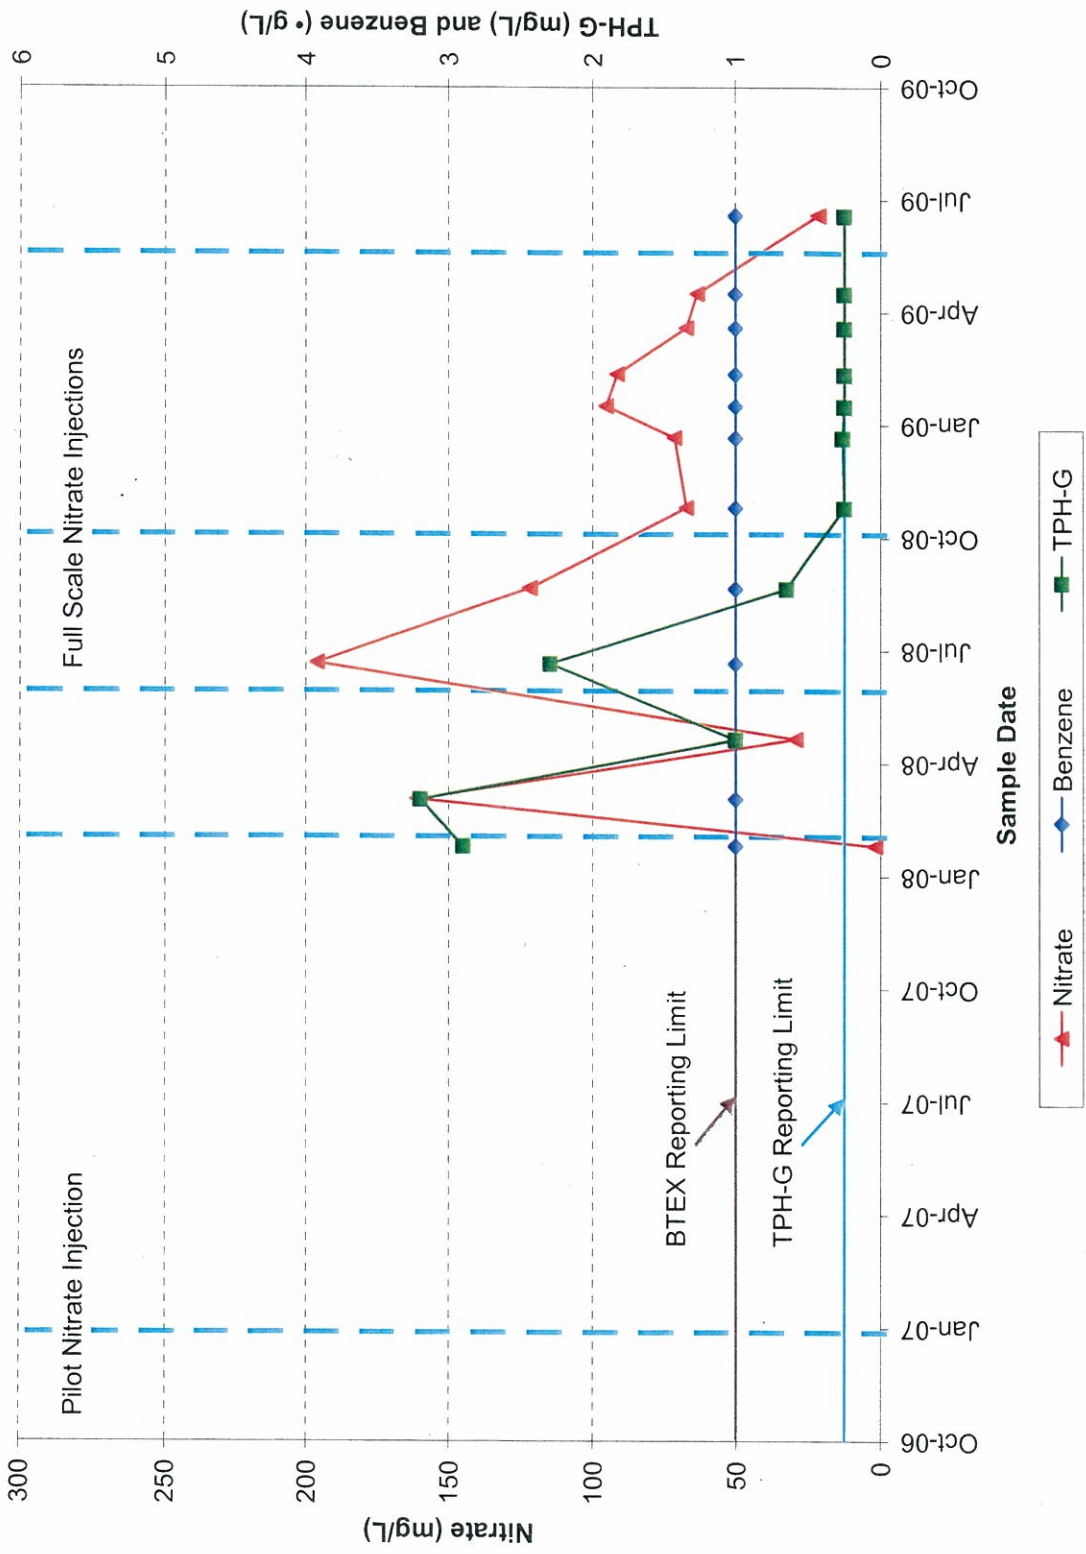
Figure 4

BDC-104: Nitrate, TPH-G, and Benzene Concentrations

Boeing notified the Washington State Department of Ecology (Ecology) of the intent to include ammonium phosphate (in addition to the ammonium nitrate specified in the Work Plan) as part of the fourth aquifer amendment (Bet 2009). On June 16-17, 2009, both mono-ammonium phosphate and ammonium nitrate were injected in monitoring wells BDC-103 and BDC-104. In accordance with the
