DEPARTMENT OF
ECOLOGY
State of Washington

Lower Duwamish Waterway RM 3.8 to 4.2 West (Sea King Industrial Park)

Source Control Action Plan

August 2013

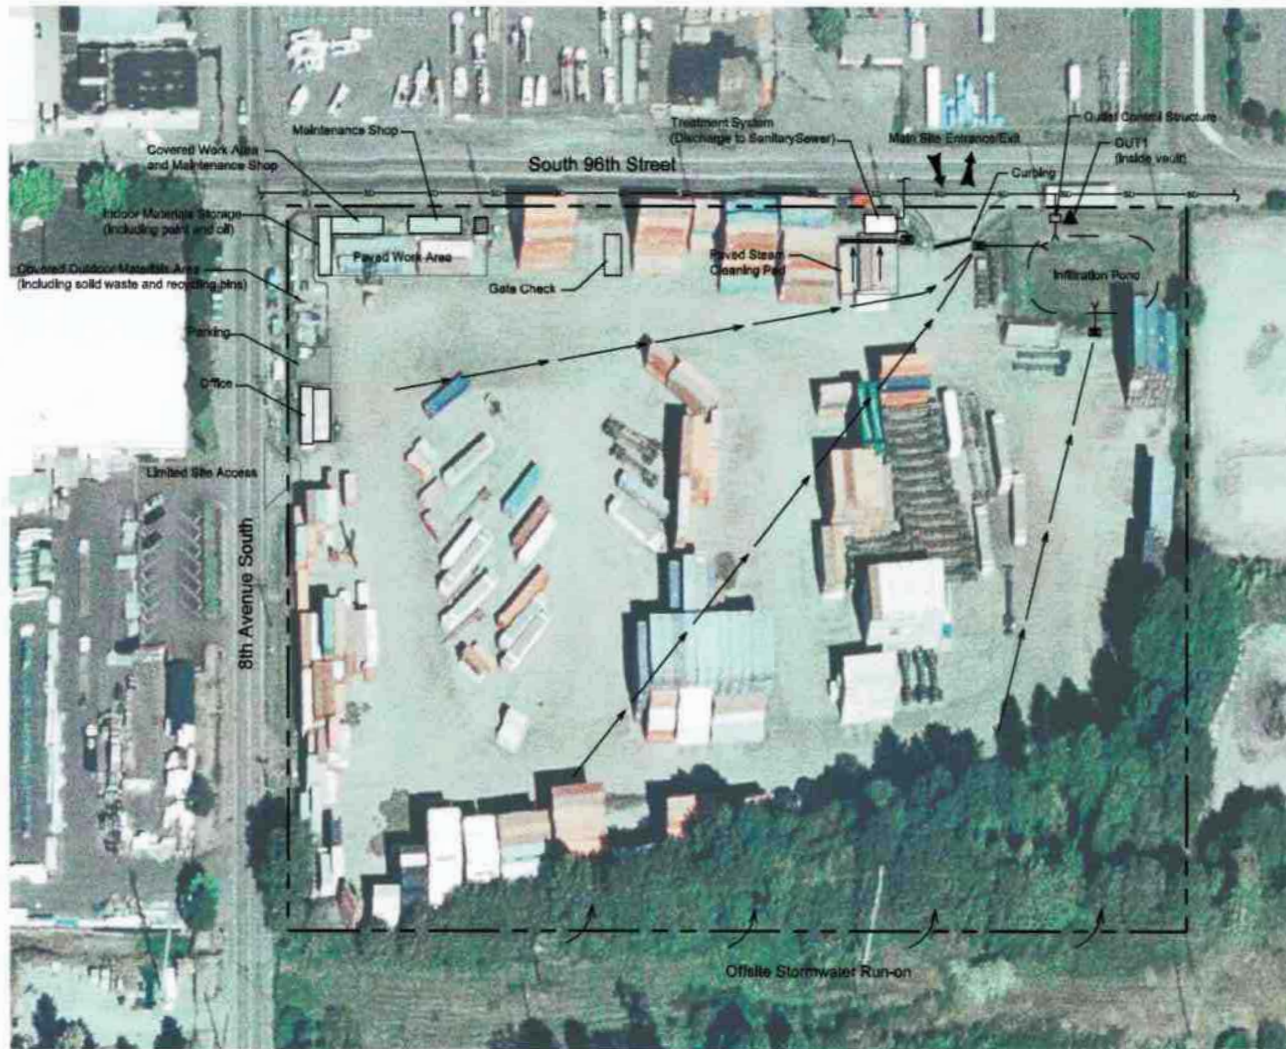
OUT1 ▲ Collect stormwater samples from inside the vertical corrugated metal standpipe located within vault only when flow is observed exiting the outlet.
