# Lower Duwamish Waterway RM 3.8 to 4.2 West Sea King Industrial Park

## Summary of Existing Information and Identification of Data Gaps

Toxics Cleanup Program  
Northwest Regional Office  
Washington State Department of Ecology  
Bellevue, Washington

Science Applications International Corporation  
18912 North Creek Parkway, Suite 101  
Bothell, WA 98011

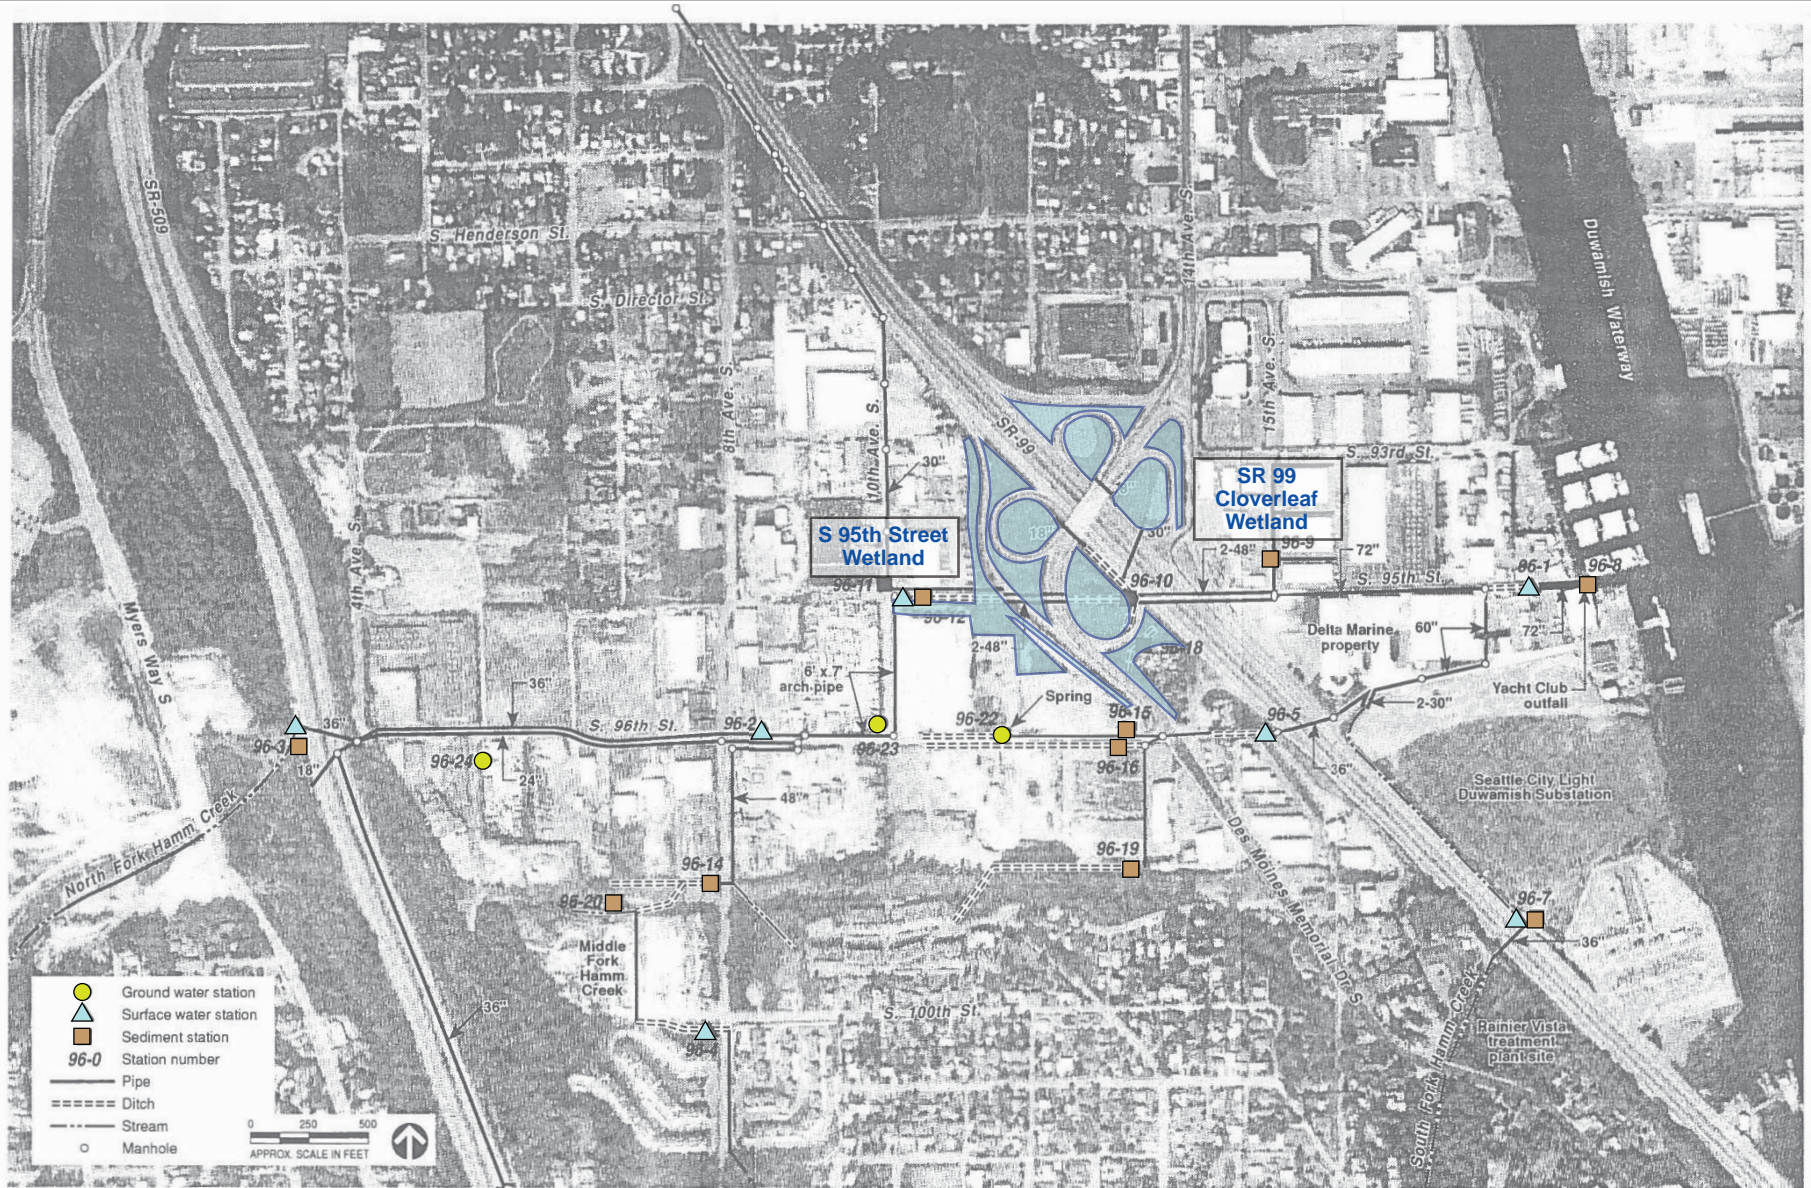
Figure 15a. S 96th Street Drainage Basin (1994)  
and Water Quality Engineering Study Sample Locations

■ 96-17 Culvert at S 104th & 10th Ave S below golf course

■ 96-21 Culvert on South Fork of Hamm Creek below golf course
