2014 Construction Completion Report Cornet Bay Marina Remediation Cornet Bay, Whidbey Island, Washington

14 October 2014

Washington State Department of Ecology PO Box 47600 Olympia, Washington 98504

K/J Project No. 1396010.00

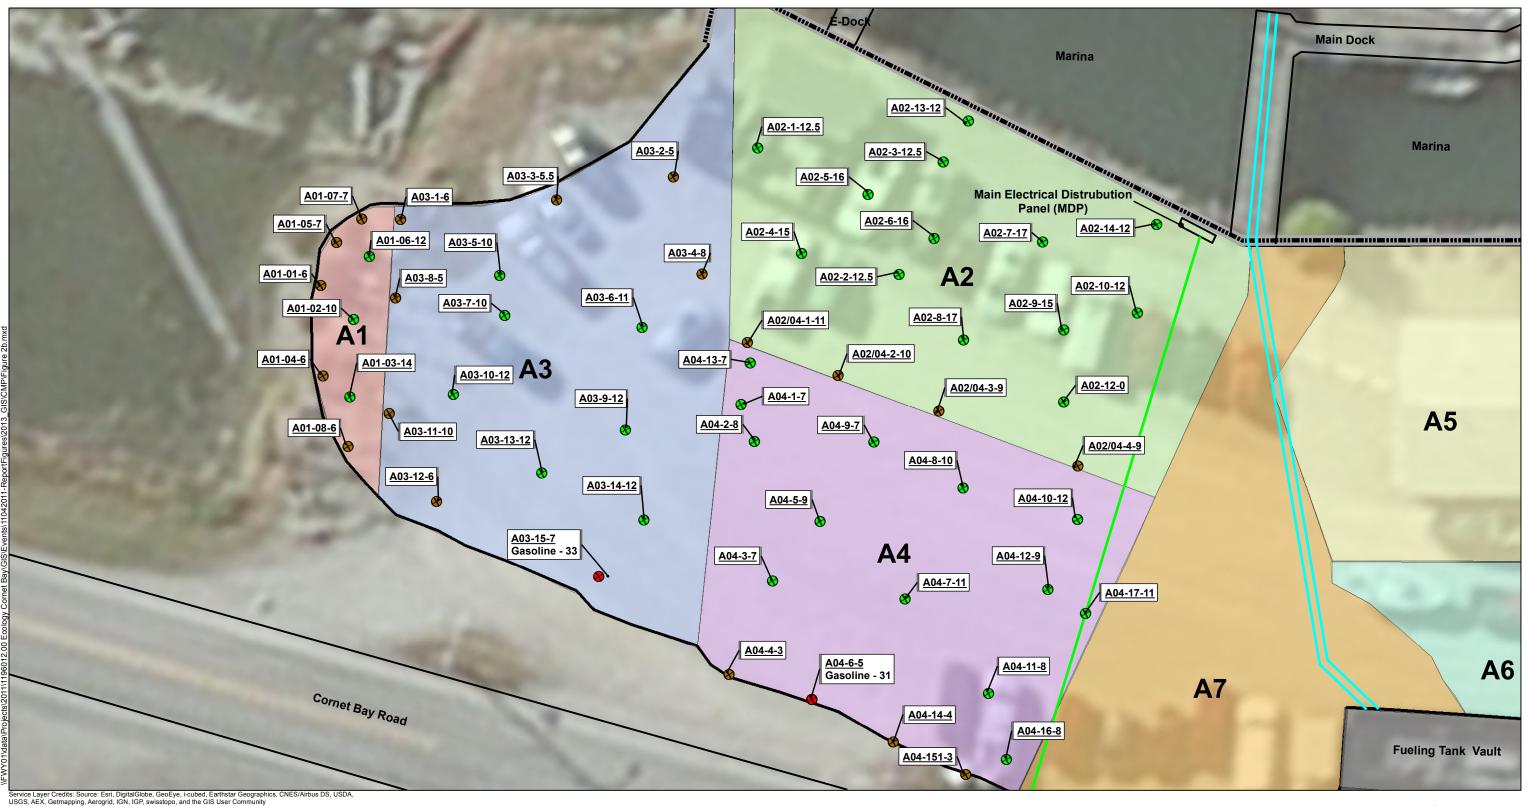
> > > Figure 3

Fuel Lines

Excavation of petroleum contaminated soil began on 27 January 2014 and was completed on 27 March 2014. Glacier provided an excavation plan in the Plan of Operations. Glacier excavated contaminated soils in seven separate areas. Backfilling of each area began after performance soil sampling results indicated that the contaminated soils had been removed. During soil removal, clean overburden was segregated from contaminated materials to the extent practicable. Contaminated soils were segregated into piles for Class 2 or Class 3 material to the extent practicable. Figures 3 and 4 show the approximate location of the excavation areas.

Final performance sampling locations are shown on Figures 3 and 4 and the final sample results (indicative of residual soil conditions) are summarized in Tables 4 through 11. Final performance monitoring analytical reports are provided in Appendix K.
