Technical Memorandum

To: Eugene Freeman, Washington State Department of Ecology
From: Jessica Faragalli, Dean Malte, and Ty Schreiner
Subject: Former Precision Engineering Facility
Site Summary and Data Gaps Assessment
K/J 1396024*00

The purpose of this Technical Memorandum is to summarize documents reviewed by Kennedy/Jenks Consultants for the Precision Engineering facility (Site) that were provided by Washington State Department of Ecology (Ecology) and to identify the current Site conditions related to environmental conditions, including the potential for impacts to the Lower Duwamish Waterway (LDW) Superfund Site.

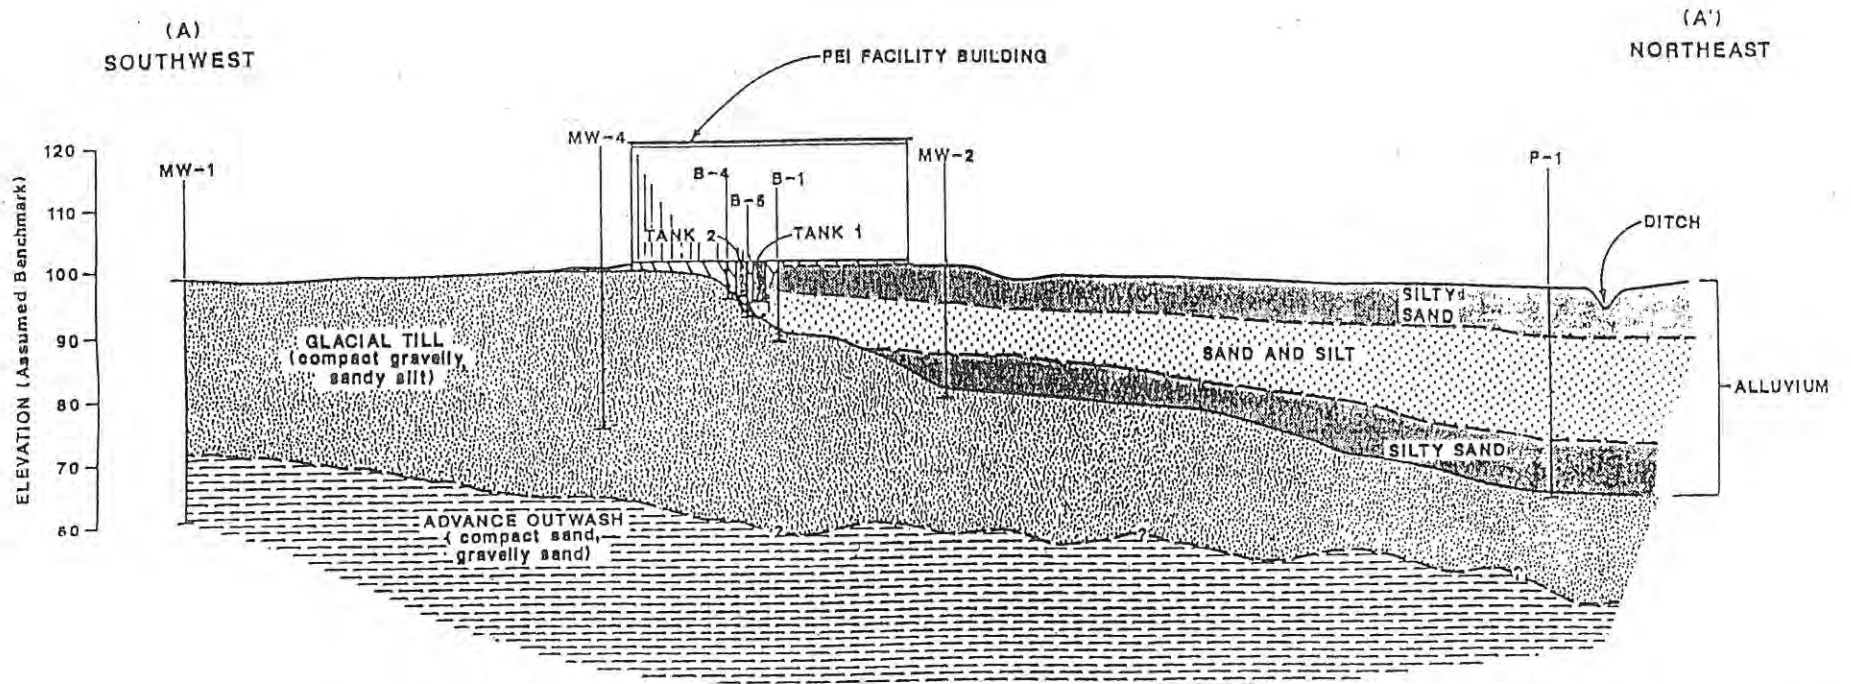
PRECISION ENGINEERING, INC.
GEOLOGIC CROSS-SECTION

VERTICAL EXAGGERATION = 2.5
VIEWING NORTHWEST

Figure 2.8.1 is a cross-section through the study area that depicts the stratigraphic relationship between the soil units. The cross-section shows the alluvium thinning towards the west until it is absent beneath the PEI facility.

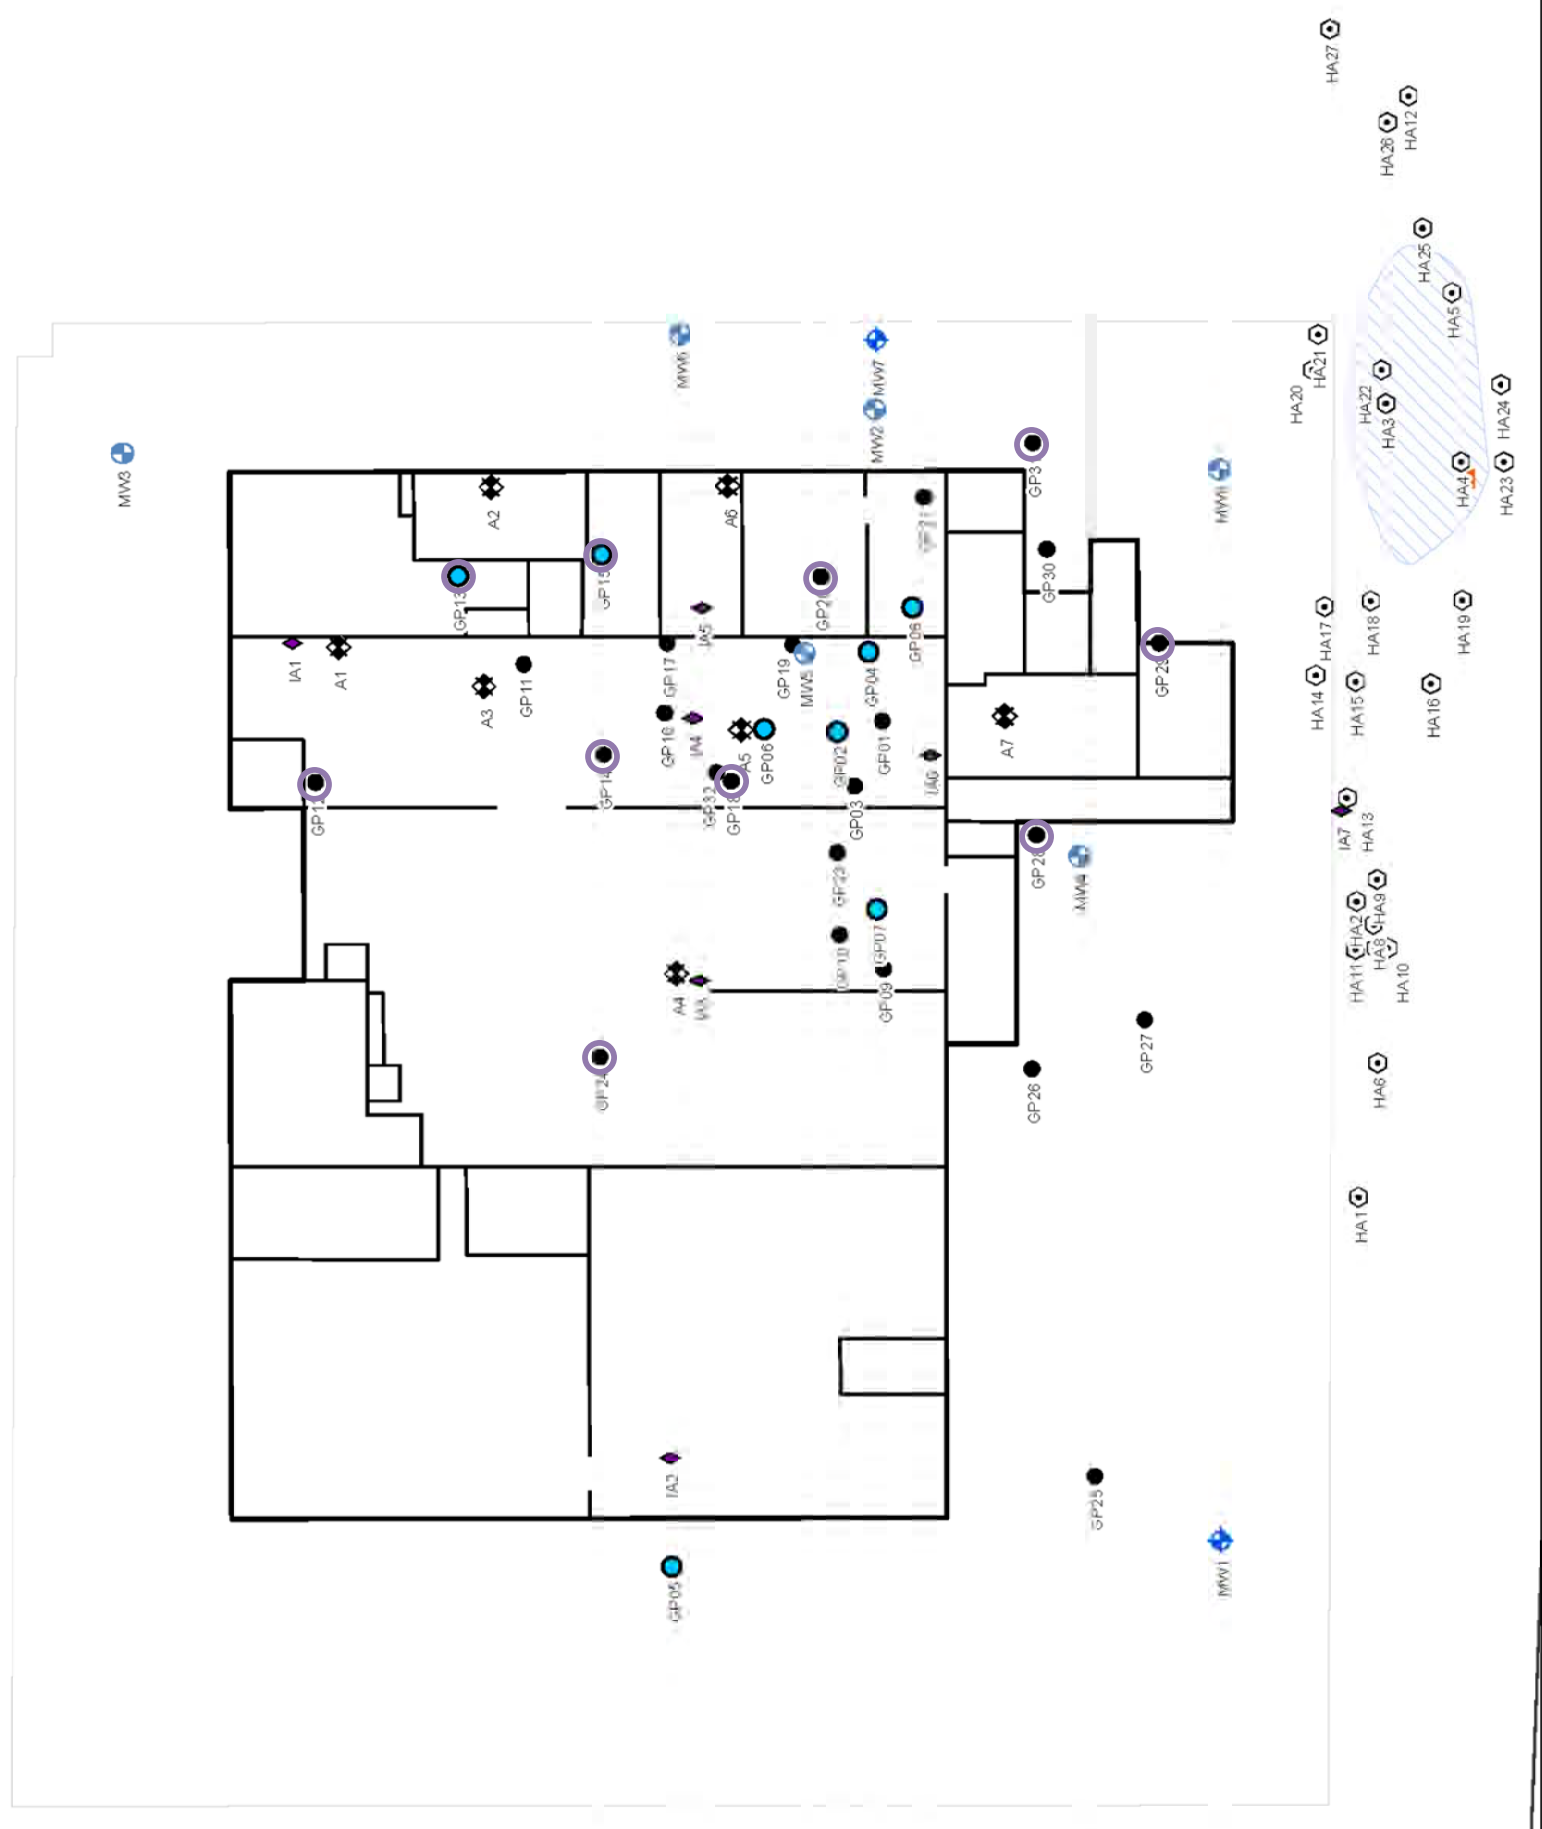
Prior Drilling and Sampling Locations
Arsenic in Soil

○ Arsenic in Soil > 1.4 mg/kg
(2x MTCA Method B Soil)

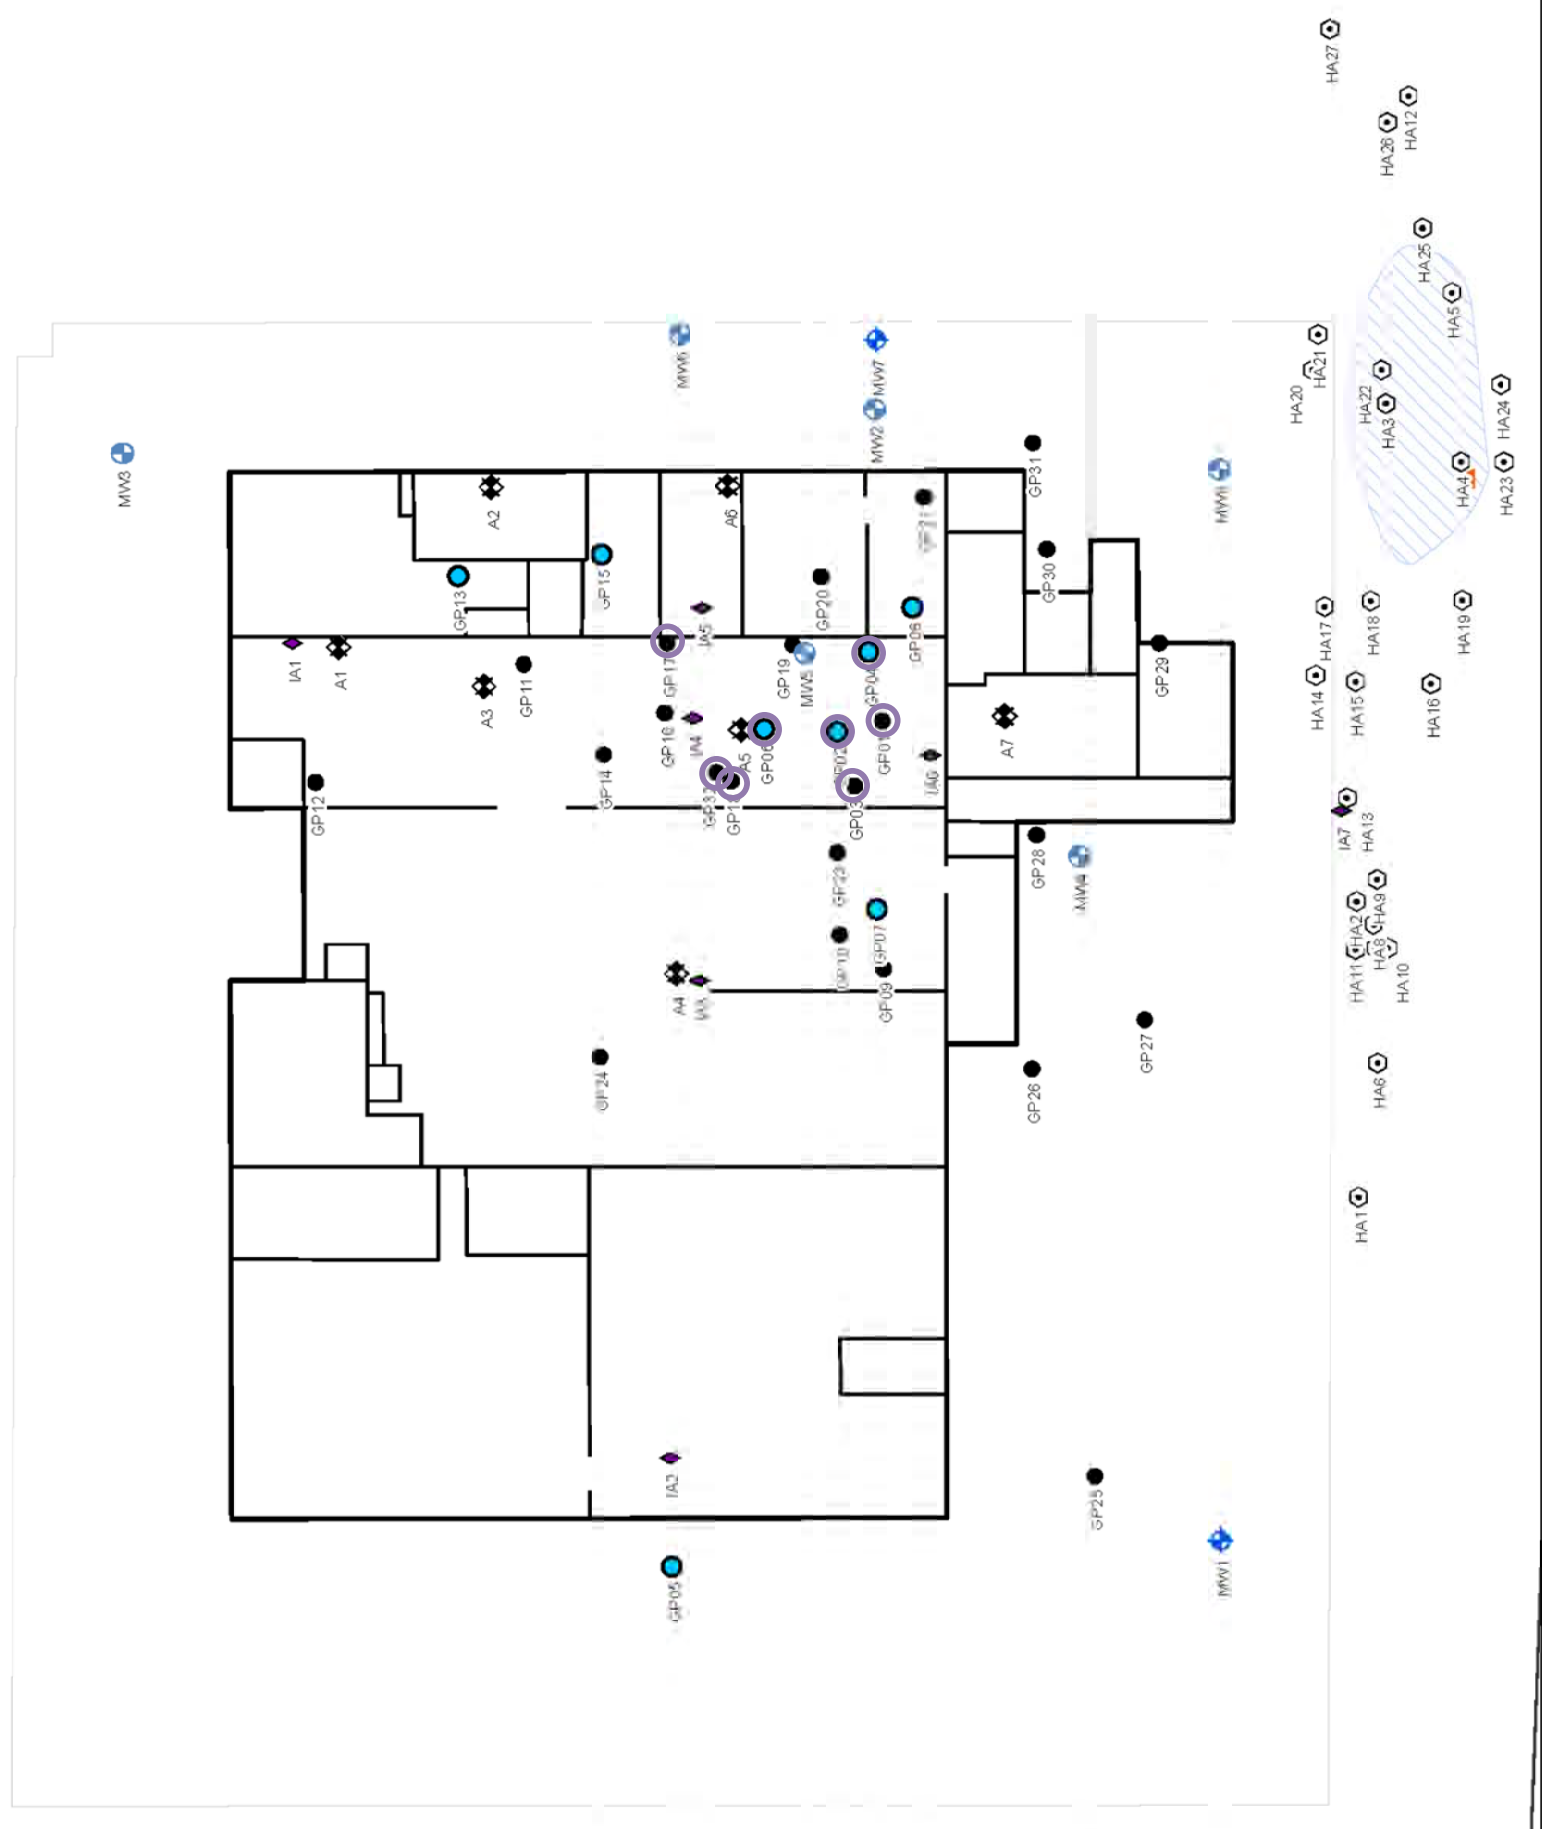
Prior Drilling and Sampling Locations
 Hexavalent Chromium
 in Soil

○ Hexavalent Chromium in Soil > 38 mg/kg
(2x MTCA Method A Soil)
