## TECHNICAL MEMORANDUM

July 25, 2014

Re: Cornet Bay Marina Model Toxic Control Act Cleanup Mitigation Plan As-Built Report

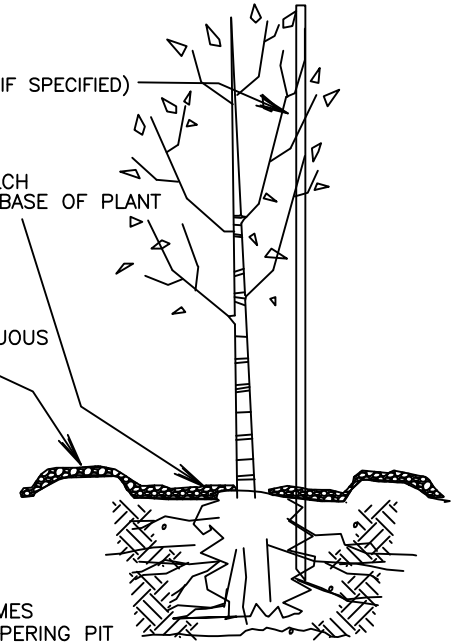
## TREE + SHRUB PLANTING DETAIL

LOCATOR LATH (IF SPECIFIED)

APPROXIMATELY 3" DEEP LAYER OF MULCH APPROXIMATELY 12" DIAMETER AROUND BASE OF PLANT HOLD BACK 2"-3" FROM STEM

FEATHER EXCESS SOIL TO CREATE CONTINUOUS WATER BASIN BERM

- PLANT SHRUBS IN GROUPS OF 3 TO 5 OF SAME SPECIES AT SPACING SPECIFIED IN PLAN
- REMOVE CONTAINER & WORK ROOTS FREE OF SOIL; SPREAD ROOTS INTO EXCAVATION
- BACKFILL TO BE SETTLED USING WATER ONLY
- EXCAVATE TREE PIT AT A MIN. OF 4 TIMES DIA. OF ROOTBALL AT BALL CENTER, TAPERING PIT GRADE TO FINISH GRADE
- WATER IMMEDIATELY AFTER INSTALLATION
- BARE-ROOT SIMILAR; EXCAVATE TO FULL DEPTH OF ROOT MASS AND CANOPY DIAMETER. SPREAD ROOTS TO FULL WIDTH OF CANOPY. WATER IMMEDIATELY AFTER INSTALLATION

Section 5.2.5 of the approved Mitigation Plan for detailed instructions for installing plant material. Further, it is recommended that a biologist be present during the plant installation to ensure proper location and installation of the plants.
