# SITE HAZARD ASSESSMENT

### Summary Score Sheet

Rainier Brewery

Cleanup Site ID: 5478

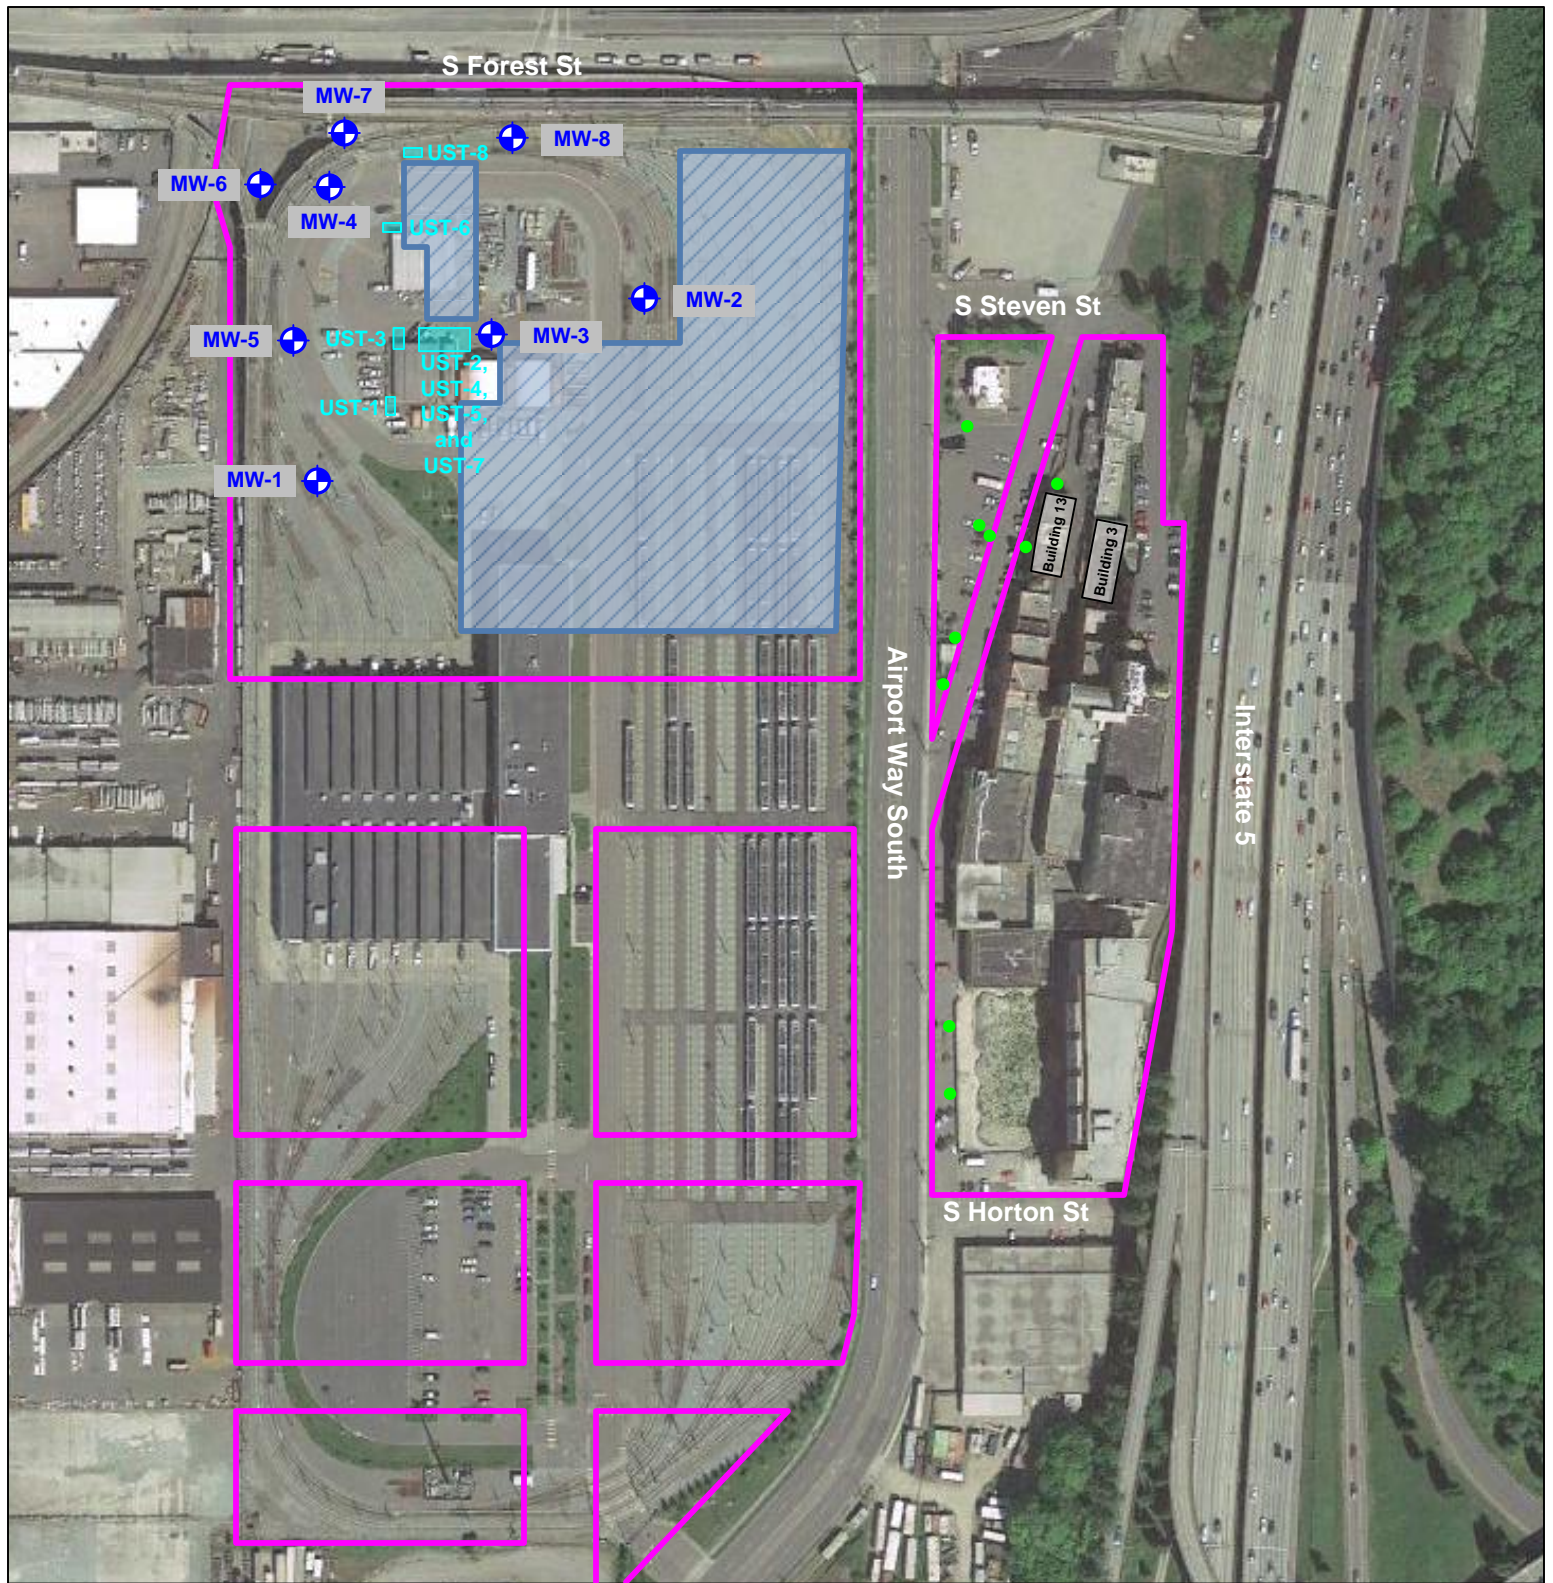
- Property location (approximate)
- Former UST location (approximate)
- Former building location (approximate)
- ⊕ Monitoring well (approximate)
- 2003/2004 Soil sample (approximate)
